Distributed fiber optics sensing and coda wave interferometry techniques for damage monitoring in concrete structures

Antoine Bassil, Xi Wang, Xavier Chapeleau, Ernst Niederleithinger, Odile Abraham, et al.. Distributed fiber optics sensing and coda wave interferometry techniques for damage monitoring in concrete structures. *Sensors*, 2019, 19 (2), pp.1-15. 10.3390/s19020356 . hal-02007049

Distributed Fiber Optics Sensing and Coda Wave Interferometry Techniques for Damage Monitoring in Concrete Structures

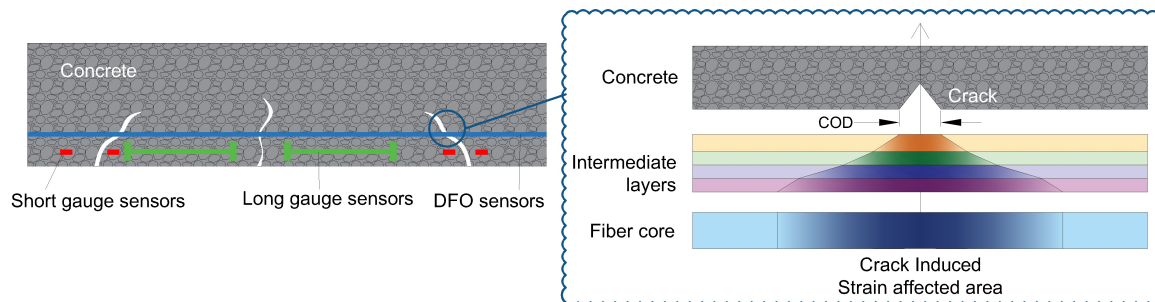
Figure 1. Crack detection using Distributed Fiber Optics Sensing (DFOS) techniques.

As mentioned in the previous paragraph, DFOS techniques provide spatially distributed strain measurements. Thus, as shown in Figure 1, direct damage detection and localization can be achieved

contrary to short gauge and long gauge sensors where sophisticated algorithms are required [18]. Previous works [19–23] have already demonstrated the ability of DOFS to detect and localize cracks in concrete structures. However, the quantification of crack opening assessment from this kind of measurements remains a challenge that this paper aims to tackle. For civil structures applications, optical fibers are usually surrounded by protective layers or adhesives in order to prevent fiber breakage and to glue the fiber on the surface of the structure [24]. As shown in Figure 1, it was found that the deformation discontinuity due to the crack formation is transferred to the optical fiber, through the intermediate layers, and in the form of a localized strain distribution covering an important length (several centimeters) of the optical cable [22].

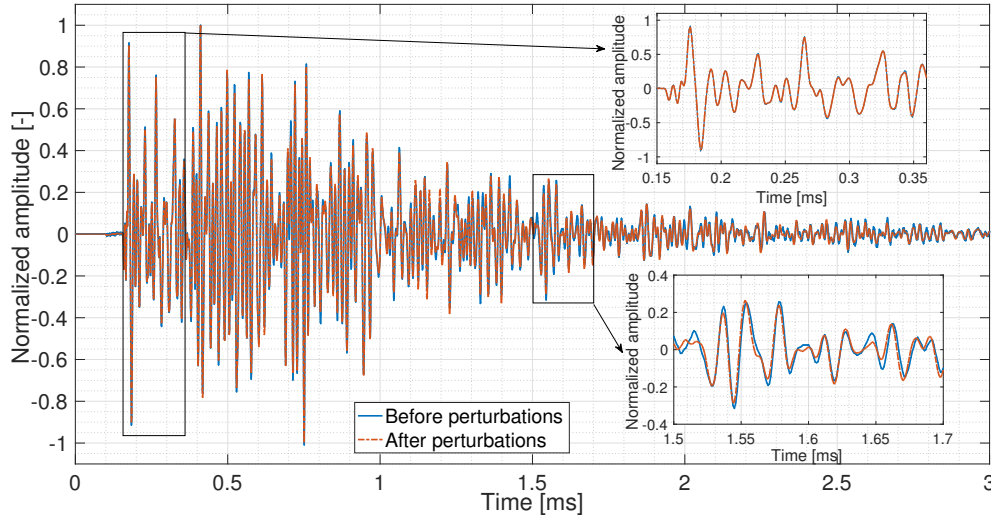
Figure 2. Signals recorded before and after perturbation in the medium [31].

The principle of CWI is to compare the coda waves recorded in two different states to monitor weak velocity variations and waveform modifications. As shown in Figure 2, two signals are

recorded before and after a perturbation. The first arrivals of the signals are almost the same (i.e., [0.16 ms, 0.35 ms]), while the coda wave (i.e., [1.5 ms, 1.7 ms]) shows a significant difference. For this reason, CWI is more sensitive to weak perturbation in the medium.

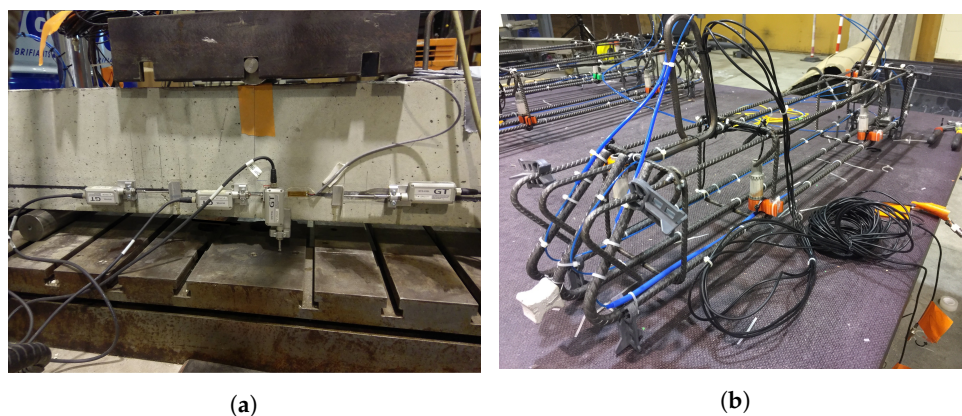
Figure 3. (a) front view of the loading arrangement and the beam instrumented with sensors before testing; (b) Ultra Sonics (US) and Distributed Fiber optics (DFO) sensors attached to the rebars before casting of concrete.

A $20 \times 20 \times 100$ cm reinforced concrete beam was tested under continuous three-point loading with a loading speed of 1 kN/min (Figure 3a). As shown in Figure 4a, the beam was reinforced with three $\phi 10$ longitudinal reinforcement bars (rebars) in the tension area and three $\phi 6$ rebars in the compression area, attached together by four $\phi 6$ stirrups. The beam was instrumented with SG (green color), LVDT (grey color), Ultra Sonic US (red color) and DFO (blue color) sensors. Before casting of concrete, four US sensors were attached to the stirrups while one optical cable was fixed over the length of four rebars (Figure 3b). After casting, the same optical cable was bonded to the surface of the beam by making a groove in the concrete at the same level of rebars and gluing the optical cable using a two components epoxy adhesive.

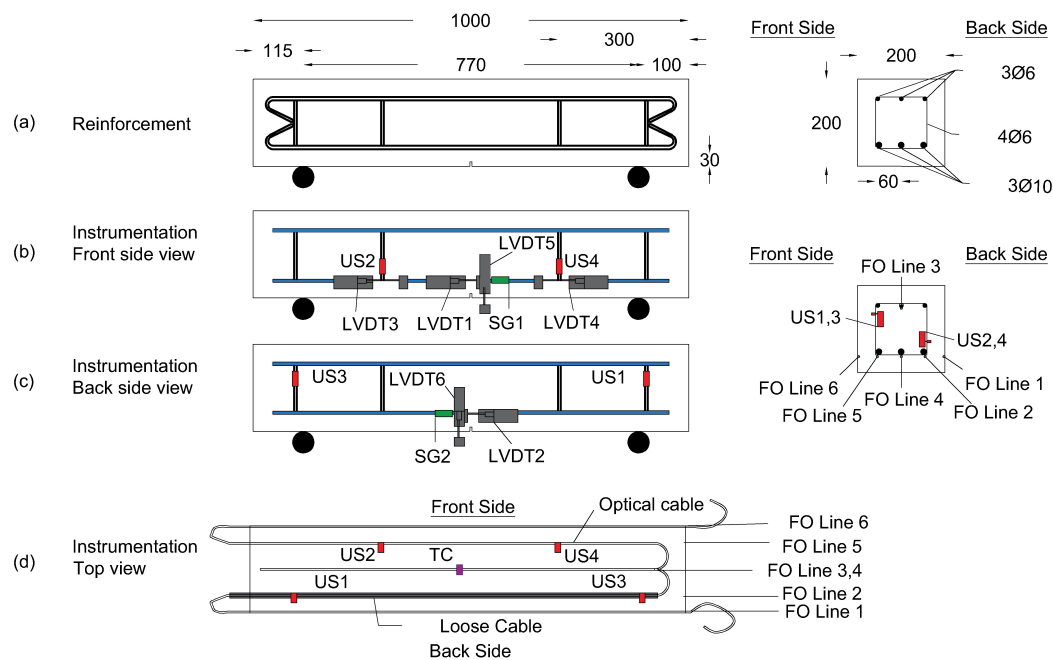
Figure 4. (a) dimensions of the beam and different rebars positions; (b) front view of sensors positions; (c) back view of sensors positions; (d) top view of sensors positions.

Figure 4 shows the top view of the optical cable trajectory while respectively:

- Glued on the front surface (Line 1).
- Attached to the front bottom rebar (Line 2). This line was surrounded by a tube to create a loose part for temperature compensation.
- Attached to the mid top rebar (Line 3).
- Attached to the mid bottom rebar (Line 4).
- Attached to the back bottom rebar (Line 5).
- Glued on the back surface (Line 6).

In addition, two LVDT sensors (one from each side) were measuring deflection at the center of the beam, while four other sensors were fixed at the level of rebars for displacement monitoring at specific locations as shown in Figure 4b,c. Moreover, two SG sensors (one from each side) were fixed 6 cm away from the central part of the beam. A thermocouple (purple color), fixed in the central part of the beam, followed low temperature variations (in the order of ± 0.1 °C) during the test in accordance with those measured all over Line 2 (Figure 4d).

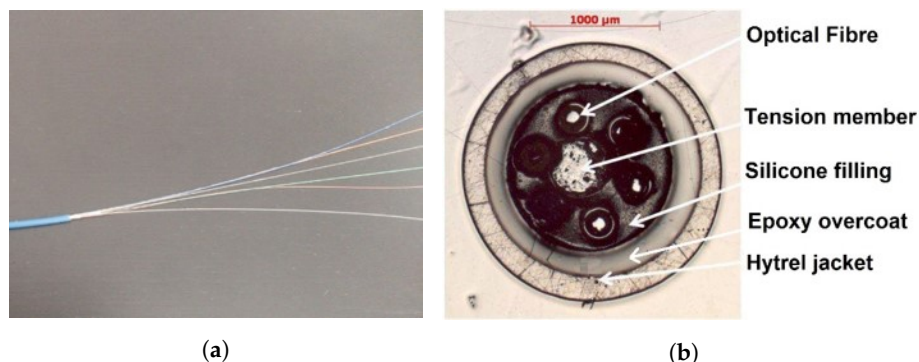
Figure 5. (a) Photo of the optical cable. (b) Micrograph of different constitutive layers of the optical cable [22].

ODISI-B interrogator (manufactured by Luna, Blacksburg, VA, United States) was chosen for this experiment. Based on Optical Backscattering Reflectometry (OBR) technique, this interrogator can reach a spatial resolution of 5.2 mm with a maximum strain repeatability of $\pm 10 \mu\text{m/m}$ and a strain accuracy of $\pm 25 \mu\text{m/m}$. Figure 5 shows the AFL optical cable (from Sensornet, Hertfordshire, United Kingdom) used as a sensor. As shown in Figure 5b, the cable holds six fibers wrapped around a central rod and embedded in a soft polymer matrix. One of the optical fibers was connected to the interrogator and used for performing the measurements.

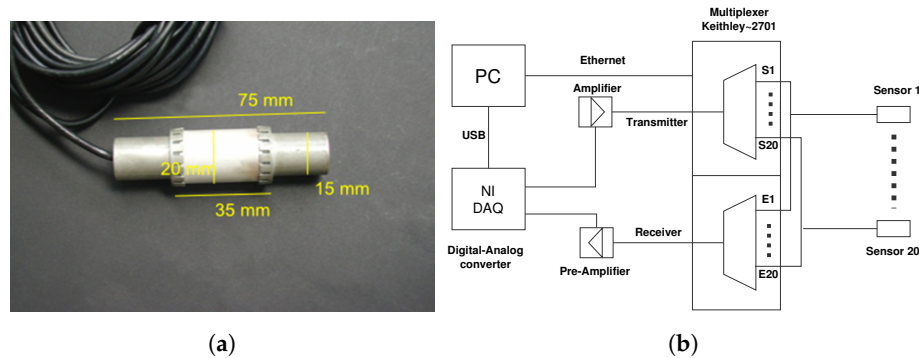
Figure 6. (a) dimensions of “SO807” [34]; (b) diagram of the data acquisition system.

A new embedded ultrasonic transducer “SO807” was used for this experiment. It was designed by Acoustic Control Systems ACS (Sarrebruck, Germany) in cooperation with and exclusively for BAM [34]. The main part of SO807 is a hollow piezo ceramic cylinder (Figure 6a) that can be both transmitter and receiver, and can be installed easily during the construction. The central frequency of this transducer is around 62 kHz. Contrary to classic ultrasonic sensors glued on the structure surface, SO807 is embedded inside the concrete material and thus records fewer surface waves

and is less influenced by near-surface changes (e.g., temperature influence). As shown in Figure 6b, a Keithley 2701 multiplexer (manufactured by Linktronix, Thalwil, Switzerland) was used to switch between different combinations S-E (transmitter-receiver) during the test. This data acquisition system allows autonomous continuous monitoring of the structure with a sampling frequency of 1 MHz.

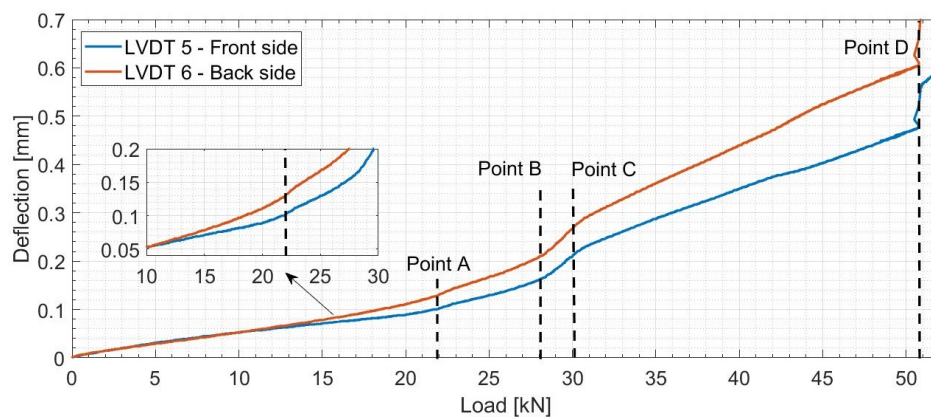
Figure 7. Variation of the vertical deflection in the central part of the beam measured by Linear Variable Differential Transformers (LVDT) sensors.

Back and front side vertical deflection values measured by LVDT sensors are plotted in Figure 7, in which the four marked points mark out each change in the curve shape and therefore a change in the behavior of the reinforced concrete beam.

Point A (load = 22 kN) marks the end of a linear elastic phase and the start of nonlinear behavior of the beam. This nonlinear behavior is due to the initiation of small micro cracks in the central part of the beam where the highest value of bending moment is located. Between Point B and Point C, the beam goes through a remarkable increase in deflection rate. Hence, this state marks a rapid reduction in the stiffness of the beam and therefore high deterioration problems. The jump in deflection observed when the load reached 51 kN (Point D) is believed to be due to the formation of a macro crack. Furthermore, distributed load and geometric imperfections of the beam could explain the difference in front and back side deflection values. This difference becomes more evident after the beam enters its nonlinear state.

Similar to the previous observations from deflection plots (Figure 7), four different points can be differed:

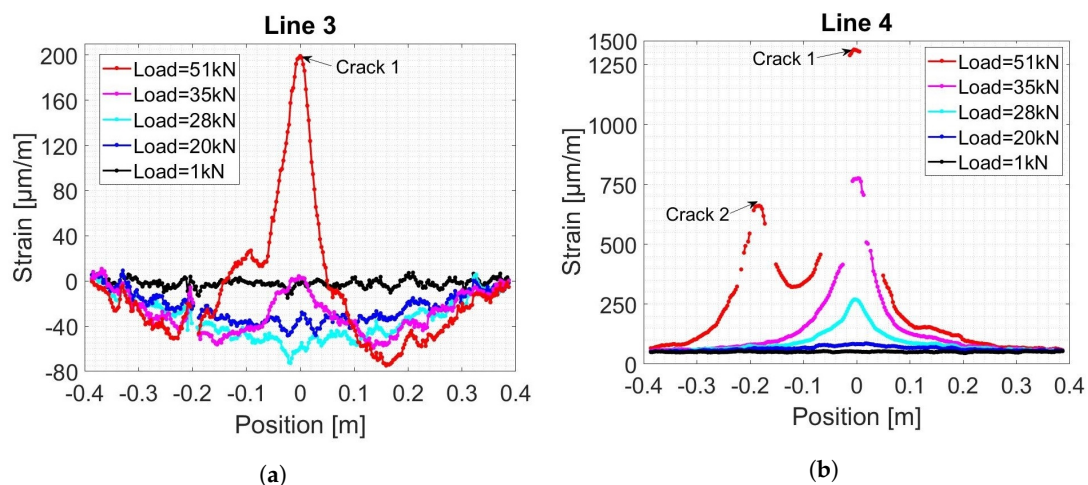
Figure 8. Spatial strain distribution in concrete measured by the DFOS system near the top (a) and bottom (b) rebars.

The DFO strain measurements were performed with a frequency rate of 10 Hz and then the moving average over ten consecutive measurements was calculated. The spatial strain distribution

over the length of FO Line 3 (near the top rebars) and Line 4 (near the bottom rebars) at five different load levels is plotted in Figure 8. Fixed at the level of the bottom rebars, Line 4 detects a micro crack when the load level increases from 20 kN to 28 kN. The strain profile evolves exponentially, indicating that a first crack, located near the central part of the beam, reaches the level of the bottom rebars. For regular concrete, the strain in the tension part does not exceed $100 \mu\text{m/m}$. With the increase in the crack opening, strain reigning in concrete material becomes therefore negligible when compared to the CIS that extends spatially to more than 40 cm of the length of the cable. On the other hand, FO Line 3 fixed at the top rebars shows the negative triangular strain distribution in the compression part of the beam. Strain profile at 35 kN load level shows higher values in its central part. The exponential shape indicates that the same crack propagates over the height of the beam until reaching top rebars. When the load reaches 51 kN, strain distribution in Line 4 shows another exponential increase indicating that a second micro crack appears around 20 cm from the center of the beam. While COD value increases, and due to rapid strain transitions near the crack location, a high number of dropouts are filtered by ODISI-B interrogator software (Version 5.2.2).

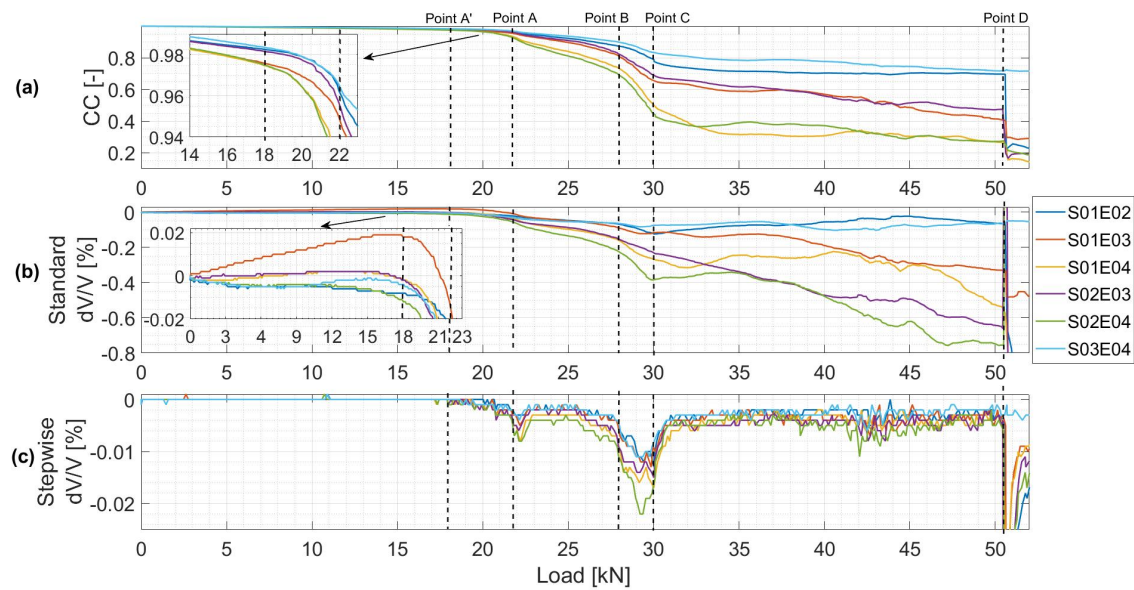
Figure 9. (a) CC plots for each $S_{xx}E_{yy}$ combination. (b) dV/V plots for each $S_{xx}E_{yy}$ combination. (c) Stepwise dV/V plots for each $S_{xx}E_{yy}$ combination.

The CC and dV/V values, calculated by standard and stepwise CWI for all different combinations of sensors $S_{xx}E_{yy}$ (transmitter xx and receiver yy), are plotted in Figure 9. A reference signal was chosen for standard CWI calculations before any load was applied. The CC values for all different combinations decrease as the load increases continuously during the test (Figure 9a). CC and deflection plots took a similar trend as they are related to the stiffness of the reinforced concrete beam. As micro cracks propagate over the height of the beam, the similarity between the ultrasonic signals reduces and is accompanied by a rapid decrease in CC values. Similarly, standard dV/V values decrease during the test depending on stress changes and positions of the sensors (Figure 9b). During the linear elastic state, these values vary between 0.02% and -0.01% for S01E03 and S02E04 combinations where the two sensors were positioned, respectively, in the upper and bottom part of the beam. While dV/V decreases for combination S02E04, S01E03 dV/V increases linearly with the increase in compression stresses in the upper part of the beam. Indeed, the stress–velocity variation coefficient changes between different combinations depending on the location and the distance between the two transducers [34]. Local velocity changes compared with the previous signal are observed clearly from stepwise dV/V (Figure 9c). The changes in stepwise dV/V plots help distinguishing four main remarkable load levels similar to those observed in the deflection plots. CWI results and their relation to damage propagation will be discussed and compared with other sensors in Section 5.1.3.

While Figure 9 presents the results of CC and dV/V calculated from US sensors measurements, Figure 11 shows the DFO strain measurements at the location of cracks 1 and 2 compared to displacements (crack openings) and strains measured respectively by LVDT (1, 2, 3) and SG (1, 2). Cracks 1 and 2 refer to the first crack detected at the center of the beam and the second one 20 cm away from the center (monitored by LVDT 3).

The formation of crack 1 is first detected by US and DFO sensors. When the load exceeded 18 kN, a first variation in velocity for S02E04 combination is observed from stepwise dV/V plot (Figure 9c). This decrease in dV/V followed shortly by other combinations is due to the propagation of the micro crack. The standard dV/V plots show that this fall in dV/V value is the highest between the two closest transducers located on the bottom part of the beam (combination S02E04). On the other hand, the smallest variations are observed for combinations S01E02 and S03E04 as the direct waves between these transducers do not bridge through the crack. CC plots follow a similar trend as dV/V plots.

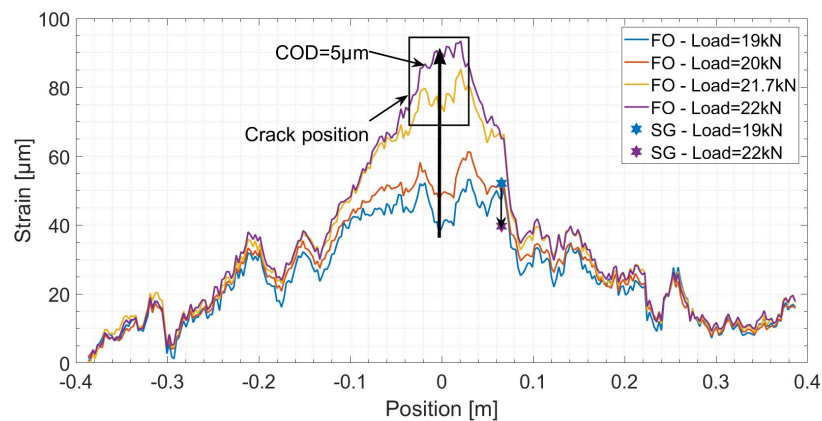
Figure 10. Spatial strain distribution over the length of Fiber Optics (FO) Line 1 before and after the creation of the first micro crack.

Figure 10 shows the measured strain versus the position for different load levels. For the specific (cable, glue, concrete) combination used in this experimentation, a crack opening of $5\text{ }\mu\text{m}$ resulted in an increase to 200% in the strain measured near the location of the crack. On the other hand, the strain measured by SG sensors decreased to 80% at 6 cm far from the crack location. If the crack location were closer to the SG sensors, a bigger rate of strain decrease would have been detected. However, if the crack bridged through the SG sensor, high strain values would have been measured. Since these two cases are rare when instrumenting real scale structures, crack detection using SG sensors is in most cases an indirect detection.

The shear lag parameter, estimated by fitting Equation (1) to the measured strain profiles, has a constant value that varies between 22 and 28 m^{-1} for each FO Line. Thus, the DFO system with a strain resolution (1 $\mu m/m$) and strain repeatability ($\pm 2 \mu m/m$) can therefore detect the change in CIS around 5–7 times less than $\frac{\beta}{2}$ value. While the latter corresponds to an increase of 1 μm in COD, LVDT sensors used in this experiment with a resolution of 1 μm , are therefore 5–7 times less sensitive to micro crack propagation than the DFO system.

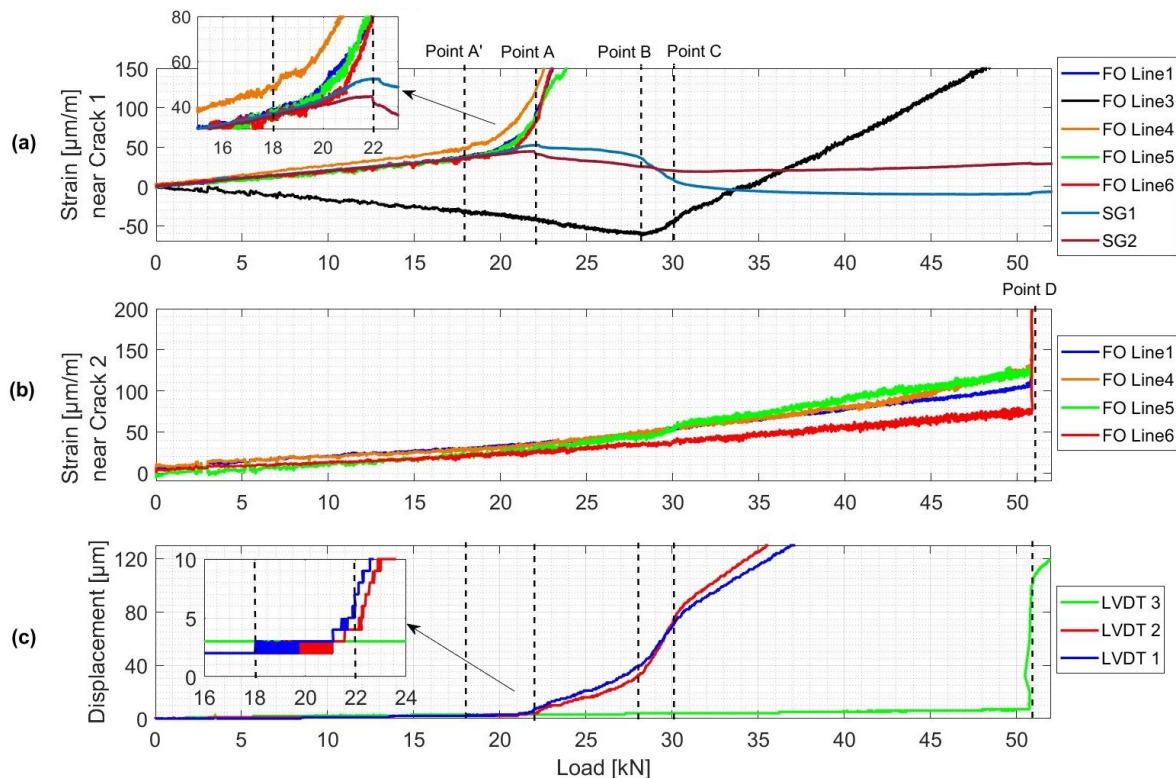
Figure 11. (a) Strain variations measured by FO lines and SG sensors near Crack 1. (b) Strain variations measured by FO lines near Crack 2. (c) Horizontal displacements measured by LVDT sensors.

- Point A': formation of Crack 1 in the center of the beam.
- Between Point B and C: Crack 1 reaching the top rebars level.
- Point D: formation of Crack 2 at 20 cm from the center of the beam.

Likewise, FO Line 1 and 4 present first an increase in strain variation near 18 kN, followed shortly by Line 5 and 6 near 20 kN (Figure 11a). However, the change in LVDT 1 and LVDT 2 measurements due to the crack opening occurred when the load reached 21 kN with higher values on the front side of the beam (Figure 11c). The creation of Crack 1 was the reason behind a strain release in concrete. This decrease in strain was detected by SG (1, 2) 6 cm from the crack location near 22 kN (Figure 11a). Finally, LVDT 3 did not show any change in measured displacement.

At about 28 kN, strain measured by FO Line 3 (attached to the top rebars) started increasing and therefore indicated the detection of Crack 1. A stable propagation of Crack 1 over the height of the beam, due to a load increase, is noticed from the linear decrease in dV/V and CC values between

18 kN and 28 kN. When Crack 1 approaches top rebars, a high dV/V and CC changing rates are observed signaling a rapid crack propagation between the top rebars level and the top of the beam until the load reached 30 kN. The beam is then divided into two parts and therefore dV/V values started increasing for combinations S01E02 and S03E04 (Figure 9b). The fact that the top rebars started working in tension near the crack introduced a sort of asymmetrical damage propagation in the beam. This can be observed from LVDT (1, 2) and SG (1, 2) measurement plots where the CODs and strains measured on the back side of the beam reached higher values than those on the front side between 28 kN and 31 kN (Figure 11c).

When load reached 51 kN, Crack 2 suddenly appeared at 20 cm from the center of the beam. The fact that the crack reached instantaneously a COD of 100 μm led to high variations in strain measured by FO Line (1, 4, 5, 6) (Figure 11b). For US measurement, the CC and dV/V for all combinations, except S03E04, changed significantly (Figure 9). Indeed, transducers (03, 04) are located on the other side of the beam and direct waves do not pass through the second crack. Another piece of compelling evidence is that the beam was separated into two parts.

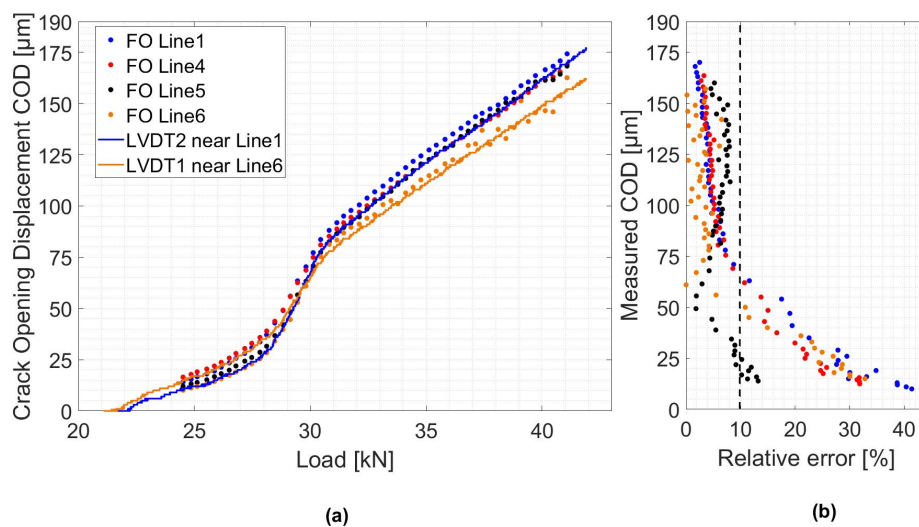
Figure 12. (a) Estimated crack openings compared to LVDT measurements. (b) Relative error compared to LVDT measurements.

As mentioned in Section 5.1.1, the CIS distribution (Equation 1) was fitted to the measured strain profiles using the least square method. δ and β were selected as variable parameters. Figure 12a shows a comparison between the estimated CODs from different FO Lines and those measured with LVDT sensors. The measured CODs near FO lines 4 and 5 are first determined by assuming a linear variation between the front and back sides values measured by LVDT 1 and 2. Then, the absolute relative error values for each FO Line are calculated (Figure 12b). For all different FO Lines, a relative error of less than 10% is achieved when the COD exceeds 65 μm . While a better accuracy is reached with the increase in the COD, the number of dropout points increases. As a result, and due to a lack of measurement values near the crack location, the fit does not converge for CODs exceeding 175 μm .

The estimated crack openings, compared to LVDT sensors working as crack meters, showed a small relative error in the order of 10%. On a real structure like a bridge, a crack map can be established and crack openings can be continuously monitored. However, in order to use a DFOS technique for crack opening monitoring, special laboratory experiments dedicated to single crack propagation case should be performed in order to study the shear lag parameter variations and search for the suitable cable configuration for concrete applications.
