Distributed fiber optics sensing and coda wave interferometry techniques for damage monitoring in concrete structures

Article

Distributed Fiber Optics Sensing and Coda Wave Interferometry Techniques for Damage Monitoring in Concrete Structures

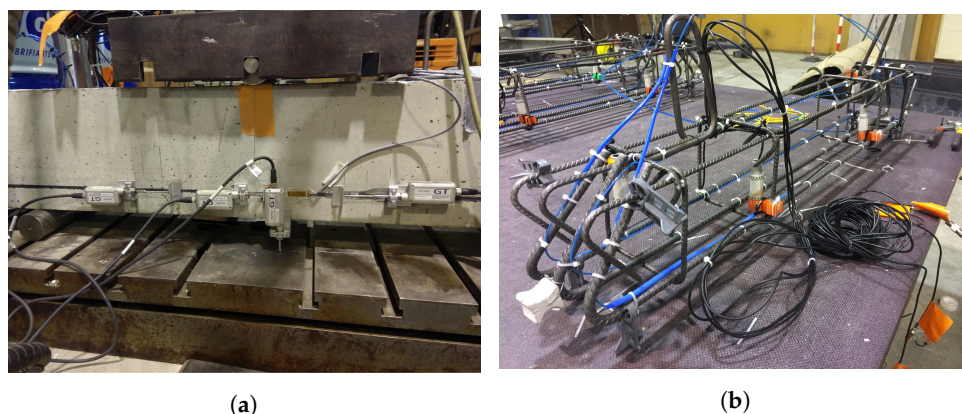
Figure 3. (a) front view of the loading arrangement and the beam instrumented with sensors before testing; (b) Ultra Sonics (US) and Distributed Fiber optics (DFO) sensors attached to the rebars before casting of concrete.

A $20 \times 20 \times 100$ cm reinforced concrete beam was tested under continuous three-point loading with a loading speed of 1 kN/min (Figure 3a). As shown in Figure 4a, the beam was reinforced with three $\phi 10$ longitudinal reinforcement bars (rebars) in the tension area and three $\phi 6$ rebars in the compression area, attached together by four $\phi 6$ stirrups. The beam was instrumented with SG (green color), LVDT (grey color), Ultra Sonic US (red color) and DFO (blue color) sensors. Before casting of concrete, four US sensors were attached to the stirrups while one optical cable was fixed over the length of four rebars (Figure 3b). After casting, the same optical cable was bonded to the surface of the beam by making a groove in the concrete at the same level of rebars and gluing the optical cable using a two components epoxy adhesive.

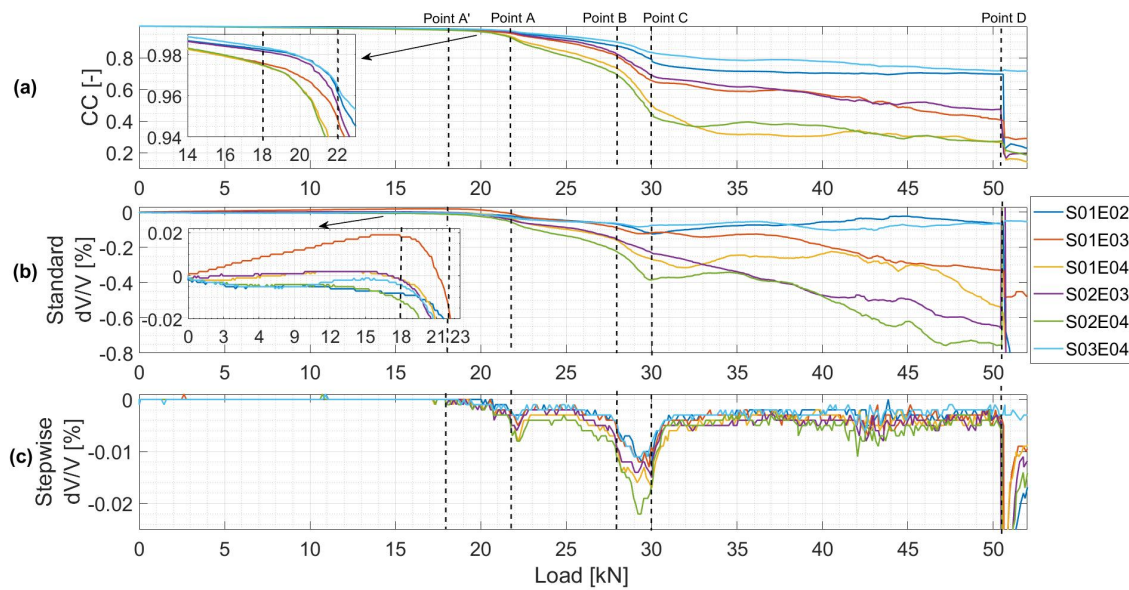
Figure 9. (a) CC plots for each $S_{xx}E_{yy}$ combination. (b) dV/V plots for each $S_{xx}E_{yy}$ combination. (c) Stepwise dV/V plots for each $S_{xx}E_{yy}$ combination.

The CC and dV/V values, calculated by standard and stepwise CWI for all different combinations of sensors $S_{xx}E_{yy}$ (transmitter xx and receiver yy), are plotted in Figure 9. A reference signal was chosen for standard CWI calculations before any load was applied. The CC values for all different combinations decrease as the load increases continuously during the test (Figure 9a). CC and deflection plots took a similar trend as they are related to the stiffness of the reinforced concrete beam. As micro cracks propagate over the height of the beam, the similarity between the ultrasonic signals reduces and is accompanied by a rapid decrease in CC values. Similarly, standard dV/V values decrease during the test depending on stress changes and positions of the sensors (Figure 9b). During the linear elastic state, these values vary between 0.02% and -0.01% for S01E03 and S02E04 combinations where the two sensors were positioned, respectively, in the upper and bottom part of the beam. While dV/V decreases for combination S02E04, S01E03 dV/V increases linearly with the increase in compression stresses in the upper part of the beam. Indeed, the stress–velocity variation coefficient changes between different combinations depending on the location and the distance between the two transducers [34]. Local velocity changes compared with the previous signal are observed clearly from stepwise dV/V (Figure 9c). The changes in stepwise dV/V plots help distinguishing four main remarkable load levels similar to those observed in the deflection plots. CWI results and their relation to damage propagation will be discussed and compared with other sensors in Section 5.1.3.

The formation of crack 1 is first detected by US and DFO sensors. When the load exceeded 18 kN, a first variation in velocity for S02E04 combination is observed from stepwise dV/V plot (Figure 9c). This decrease in dV/V followed shortly by other combinations is due to the propagation of the micro crack. The standard dV/V plots show that this fall in dV/V value is the highest between the two closest transducers located on the bottom part of the beam (combination S02E04). On the other hand, the smallest variations are observed for combinations S01E02 and S03E04 as the direct waves between these transducers do not bridge through the crack. CC plots follow a similar trend as dV/V plots.

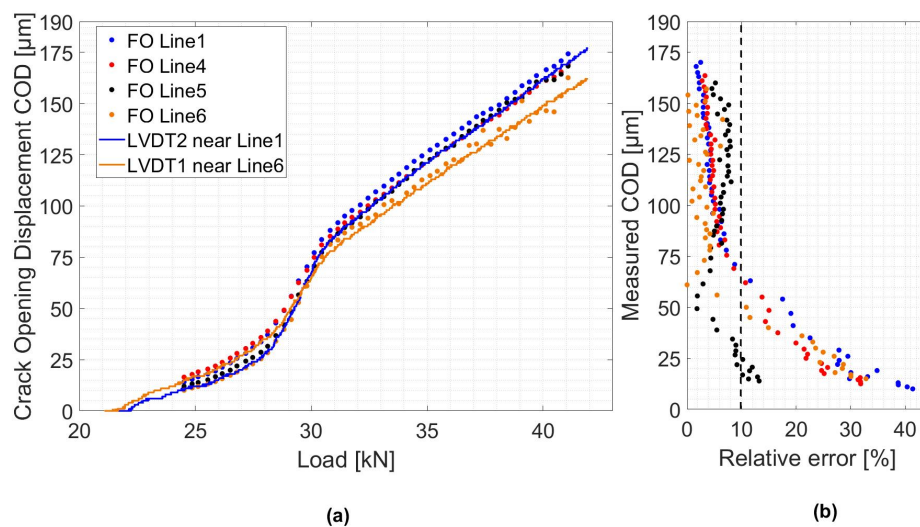
Figure 12. (a) Estimated crack openings compared to LVDT measurements. (b) Relative error compared to LVDT measurements.

As mentioned in Section 5.1.1, the CIS distribution (Equation 1) was fitted to the measured strain profiles using the least square method. δ and β were selected as variable parameters. Figure 12a shows a comparison between the estimated CODs from different FO Lines and those measured with LVDT sensors. The measured CODs near FO lines 4 and 5 are first determined by assuming a linear variation between the front and back sides values measured by LVDT 1 and 2. Then, the absolute relative error values for each FO Line are calculated (Figure 12b). For all different FO Lines, a relative error of less than 10% is achieved when the COD exceeds 65 μm . While a better accuracy is reached with the increase in the COD, the number of dropout points increases. As a result, and due to a lack of measurement values near the crack location, the fit does not converge for CODs exceeding 175 μm .
