Distributed fiber optics sensing and coda wave interferometry techniques for damage monitoring in concrete structures

Distributed Fiber Optics Sensing and Coda Wave Interferometry Techniques for Damage Monitoring in Concrete Structures

Abstract: The assessment of Coda Wave Interferometry (CWI) and Distributed Fiber Optics Sensing (DFOS) techniques for the detection of damages in a laboratory size reinforced concrete beam is presented in this paper. The sensitivity of these two novel techniques to micro cracks is discussed and compared to standard traditional sensors. Moreover, the capacity of a DFOS technique to localize cracks and quantify crack openings is also assessed. The results show that the implementation of CWI and DFOS techniques allow the detection of early subtle changes in reinforced concrete structures until crack formation. With their ability to quantify the crack opening, following early detection and localization, DFOS techniques can achieve more effective monitoring of reinforced concrete structures. Contrary to discrete sensors, CWI and DFOS techniques cover larger areas and thus provide more efficient infrastructures asset management and maintenance operations

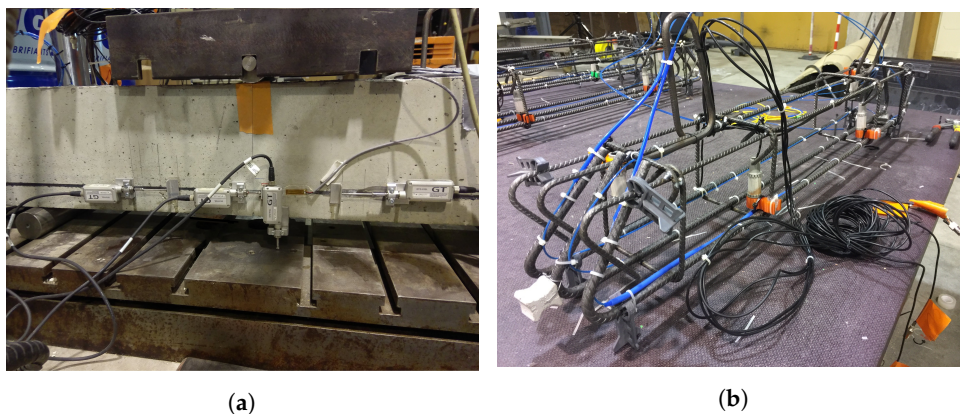
Figure 3. (a) front view of the loading arrangement and the beam instrumented with sensors before testing; (b) Ultra Sonics (US) and Distributed Fiber optics (DFO) sensors attached to the rebars before casting of concrete.

A $20 \times 20 \times 100$ cm reinforced concrete beam was tested under continuous three-point loading with a loading speed of 1 kN/min (Figure 3a). As shown in Figure 4a, the beam was reinforced with three $\phi 10$ longitudinal reinforcement bars (rebars) in the tension area and three $\phi 6$ rebars in the compression area, attached together by four $\phi 6$ stirrups. The beam was instrumented with SG (green color), LVDT (grey color), Ultra Sonic US (red color) and DFO (blue color) sensors. Before casting of concrete, four US sensors were attached to the stirrups while one optical cable was fixed over the length of four rebars (Figure 3b). After casting, the same optical cable was bonded to the surface of the beam by making a groove in the concrete at the same level of rebars and gluing the optical cable using a two components epoxy adhesive.

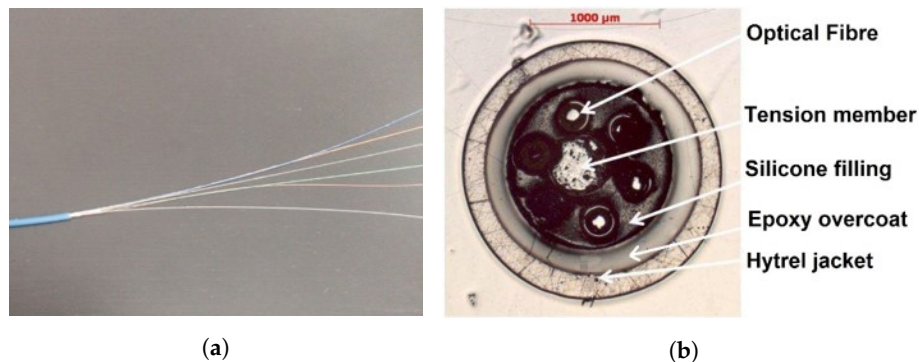
Figure 5. (a) Photo of the optical cable. (b) Micrograph of different constitutive layers of the optical cable [22].

ODISI-B interrogator (manufactured by Luna, Blacksburg, VA, United States) was chosen for this experiment. Based on Optical Backscattering Reflectometry (OBR) technique, this interrogator can reach a spatial resolution of 5.2 mm with a maximum strain repeatability of $\pm 10 \mu\text{m}/\text{m}$ and a strain accuracy of $\pm 25 \mu\text{m}/\text{m}$. Figure 5 shows the AFL optical cable (from Sensornet, Hertfordshire, United Kingdom) used as a sensor. As shown in Figure 5b, the cable holds six fibers wrapped around a central rod and embedded in a soft polymer matrix. One of the optical fibers was connected to the interrogator and used for performing the measurements.

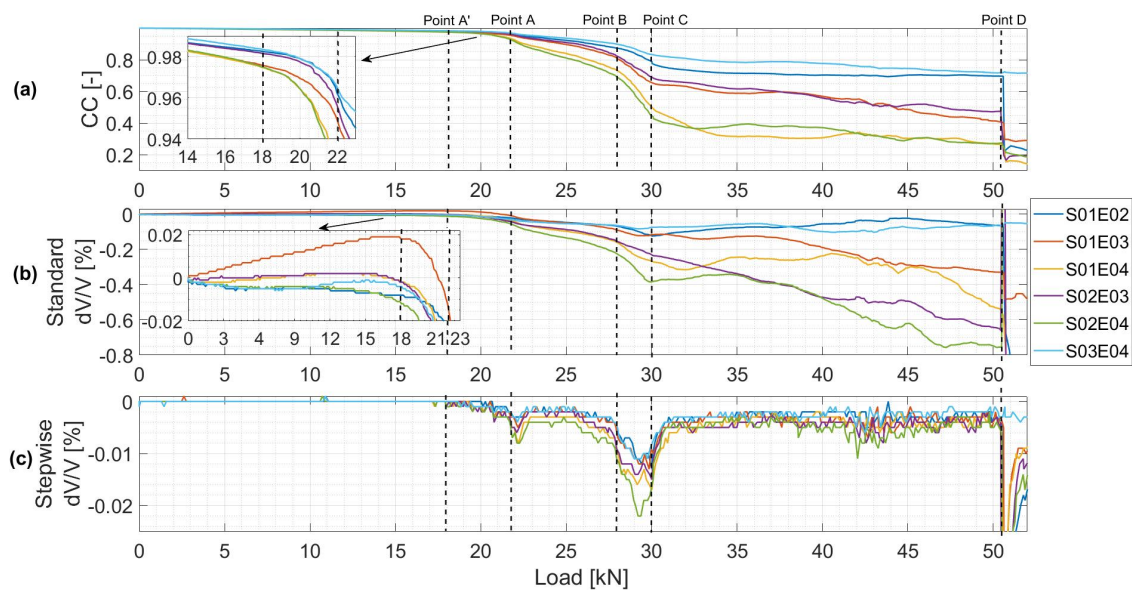
Figure 9. (a) CC plots for each $S_{xx}E_{yy}$ combination. (b) dV/V plots for each $S_{xx}E_{yy}$ combination. (c) Stepwise dV/V plots for each $S_{xx}E_{yy}$ combination.

The CC and dV/V values, calculated by standard and stepwise CWI for all different combinations of sensors $S_{xx}E_{yy}$ (transmitter xx and receiver yy), are plotted in Figure 9. A reference signal was chosen for standard CWI calculations before any load was applied. The CC values for all different combinations decrease as the load increases continuously during the test (Figure 9a). CC and deflection plots took a similar trend as they are related to the stiffness of the reinforced concrete beam. As micro cracks propagate over the height of the beam, the similarity between the ultrasonic signals reduces and is accompanied by a rapid decrease in CC values. Similarly, standard dV/V values decrease during the test depending on stress changes and positions of the sensors (Figure 9b). During the linear elastic state, these values vary between 0.02% and -0.01% for S01E03 and S02E04 combinations where the two sensors were positioned, respectively, in the upper and bottom part of the beam. While dV/V decreases for combination S02E04, S01E03 dV/V increases linearly with the increase in compression stresses in the upper part of the beam. Indeed, the stress–velocity variation coefficient changes between different combinations depending on the location and the distance between the two transducers [34]. Local velocity changes compared with the previous signal are observed clearly from stepwise dV/V (Figure 9c). The changes in stepwise dV/V plots help distinguishing four main remarkable load levels similar to those observed in the deflection plots. CWI results and their relation to damage propagation will be discussed and compared with other sensors in Section 5.1.3.

The formation of crack 1 is first detected by US and DFO sensors. When the load exceeded 18 kN, a first variation in velocity for S02E04 combination is observed from stepwise dV/V plot (Figure 9c). This decrease in dV/V followed shortly by other combinations is due to the propagation of the micro crack. The standard dV/V plots show that this fall in dV/V value is the highest between the two closest transducers located on the bottom part of the beam (combination S02E04). On the other hand, the smallest variations are observed for combinations S01E02 and S03E04 as the direct waves between these transducers do not bridge through the crack. CC plots follow a similar trend as dV/V plots.
