Review and analysis of historical leakages from storage salt caverns wells

Pierre Bérest, Arnaud Réveillère, David Evans, Markus Stöwer

Pierre Bérest, Arnaud Réveillère, David Evans, Markus Stöwer. Review and analysis of historical leakages from storage salt caverns wells. *Oil & Gas Science and Technology - Revue d'IFP Energies nouvelles*, 2019, 74, pp.27. 10.2516/ogst/2018093 . hal-02074777

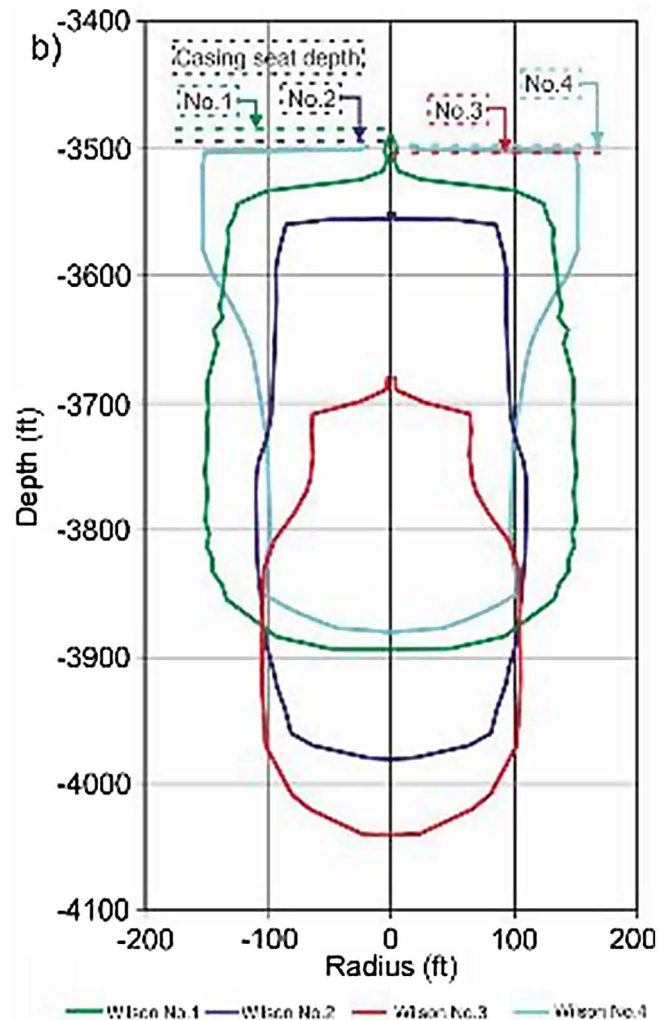
Fig. 9. General cross-sections of caverns, based on sonar data. From Osnes *et al.* (2007)

anchored much higher above the cavern roof and the well experienced no leak (Fig. 9). In both the Eminence and Boling cases, large vertical strains led to casing overstretching and failure.

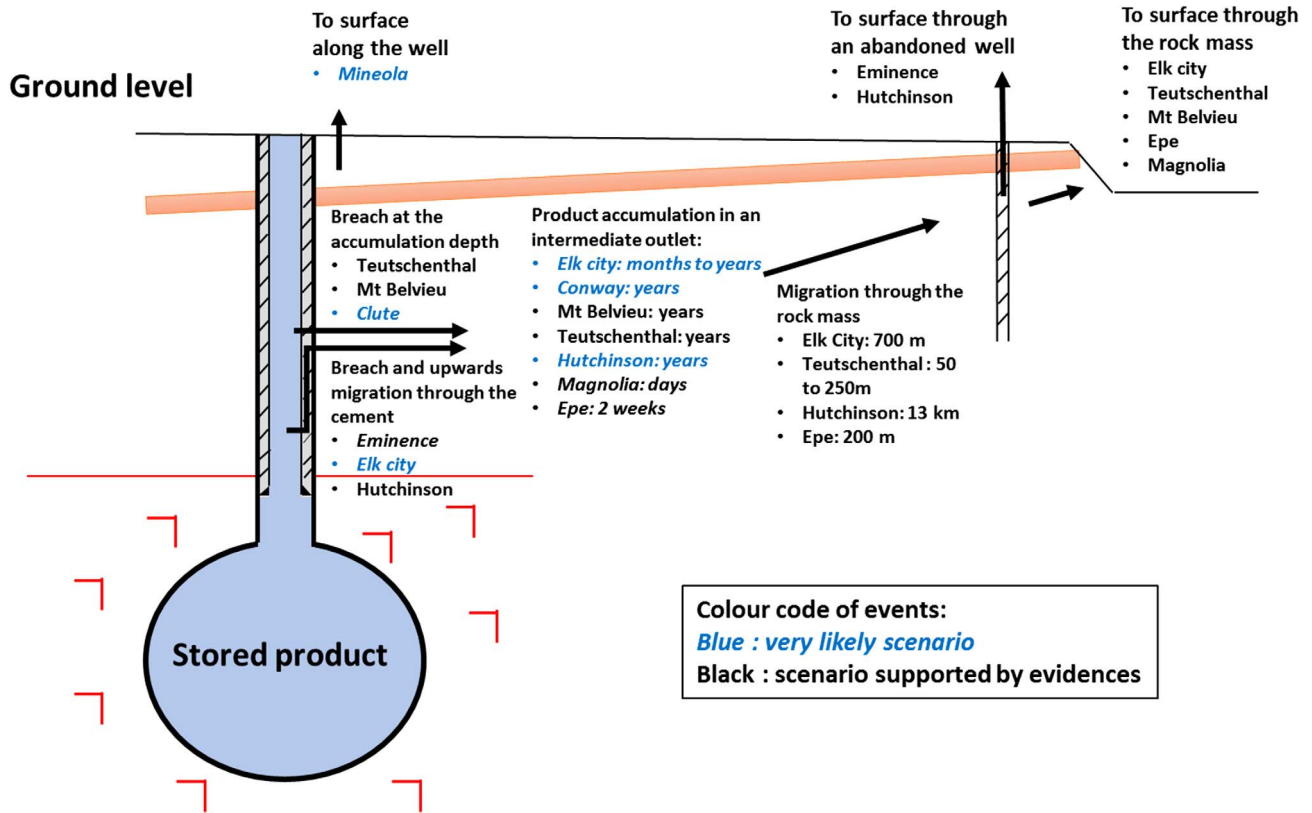
Fig. 13. Schematic of leakage development cases with an intermediate outlet accumulation.

The analysis of the leak mechanisms identified in the 11 cases previously analyzed enables to identify some common patterns. In the following the onset and nature of a breach ([Sect. 4.1](#)), the development of a leak ([Sect. 4.2](#)), consequences at ground level and monitoring-prevention are discussed ([Sect. 4.3](#)). These three successive steps are represented in [Figure 13](#).
