Review and analysis of historical leakages from storage salt caverns wells

Pierre Bérest, Arnaud Réveillère, David Evans, Markus Stöwer

Pierre Bérest, Arnaud Réveillère, David Evans, Markus Stöwer. Review and analysis of historical leakages from storage salt caverns wells. *Oil & Gas Science and Technology - Revue d'IFP Energies nouvelles*, 2019, 74, pp.27. 10.2516/ogst/2018093 . hal-02074777

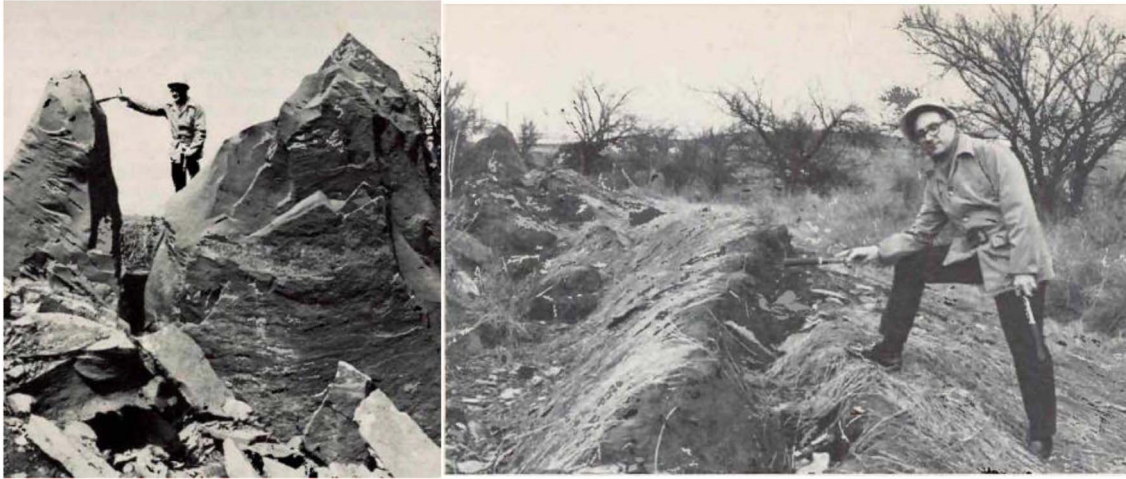
Fig. 2. Central crater (left, from [Fay, 1973a](#)) and one of the pressure cracks (right, from [Fay, 1973b](#)) discovered on February 23, 1973.

On February 23, 1973, the Oklahoma Geological Survey was informed that a central crater about 10 m by 15 m (30 ft by 50 ft) by 6 m (20 ft) deep, plus 20 m–50 m (160 ft–360 ft)-long pressure cracks radiating from the crater, had appeared in level grassland, about 8 km (5 miles) south of Elk City, Oklahoma. Siltstone blocks of 20–45 kg (50–100 pounds) were thrown as far as 23 m (75 ft) away, and several 30-ton boulders were lifted to an upright position (Fig. 2, left), and 5 m (15 ft) tall trees in the vicinity were tilted 45°. On March 1, 1973, gas samples were taken at the blow-out site. Analyses revealed 1% total hydrocarbons, of which 75% was propane, a result excluding any natural origin. A leak from a propane salt storage cavern leached out from the upper part of the Permian Blaine formation was suspected. Several investigations and tests were undertaken at that site. A 13-hour observation period with the cavern maintained at constant halmostatic pressure was performed (*i.e.*, with the inner tubing filled with saturated brine and opened at the surface). This test found a 30-gal/day (5 L/h) apparent leak in the cavern (such a test is not fully conclusive as phenomena other than a leak can explain such an outflow). The storage cavern was emptied, with the propane being displaced from the cavern by brine on March 28. The two inner strings were retrieved

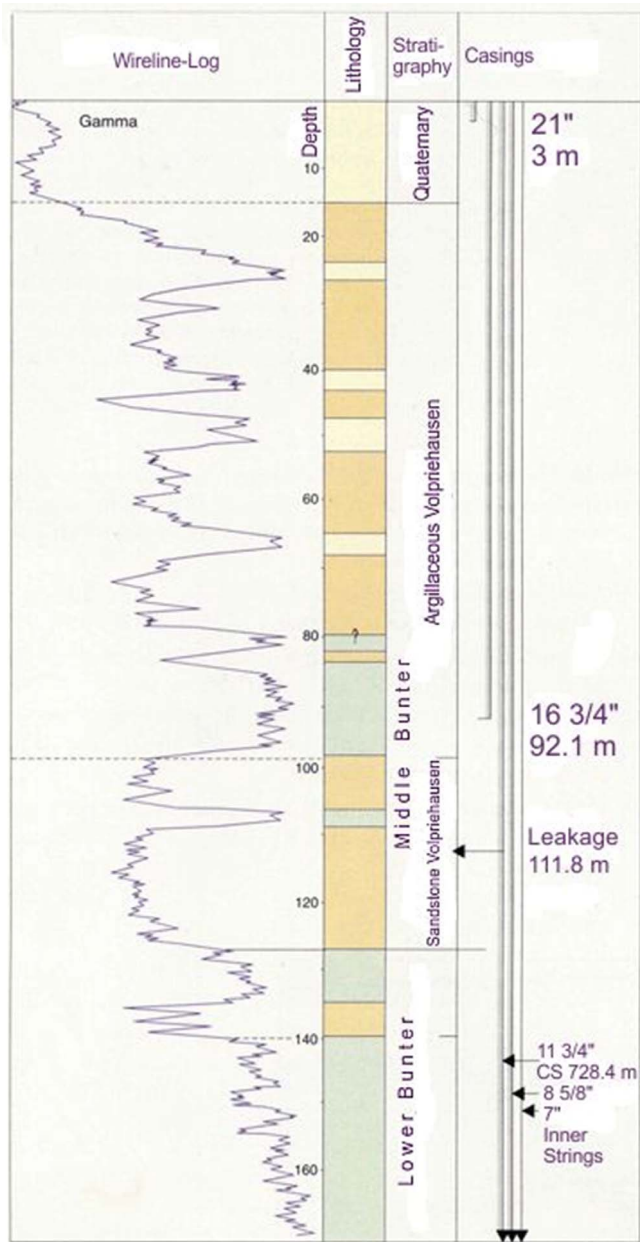
Fig. 7. Casing program and top-hole geology of Ug Lt 5/71. Based upon and modified from [Katzung et al. \(1996\)](#).

The Teutschenthal/Bad Lauchstädt storage site is located $\cong 40$ -km (26 miles) west of Leipzig, central Germany ([Fig. 6](#)), [Arnold et al. \(2010\)](#). Bedded rock salt (halite) deposits lie at a depth of 500 m–1000 m (1500–3000 ft), with the thickness of the halite increasing to the SE, from less than 50 m to more than 500 m. The overburden comprises 300 m (1000 ft) of argillaceous rocks overlain by a 110 m (360 ft) thickness of an alternating sandstone and mudstone sequence ([Fig. 7](#)).

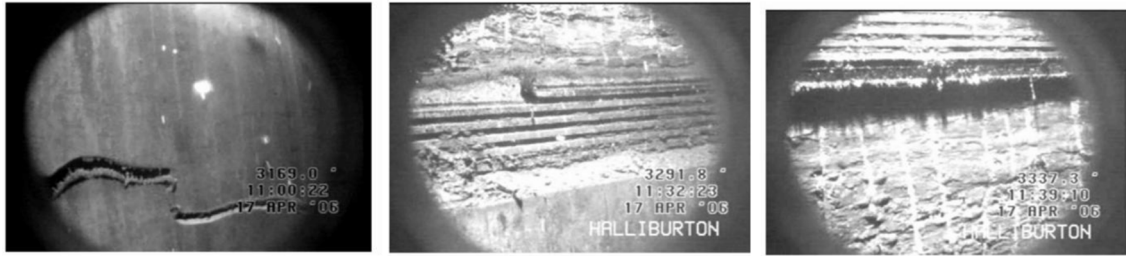
Fig. 10. Examples of failures detected by the video inspection. From left to right: Circumferential fracture of the pipe body, of the threaded coupling, and thread jump-out. From [Osnes et al. \(2007\)](#).

Detailed investigations into the incident were undertaken, including running downhole video camera logs, which identified casing collar and coupling partings for over 100 m above the casing shoe depth (Fig. 10). The video log revealed that the casing had failed at eight different locations, always near or at a connection. Failure often was a circumferential fracture. The casing being dragged down after it fractured, up to 60 cm height of cement could be observed in between the two parts of the fractured casing.

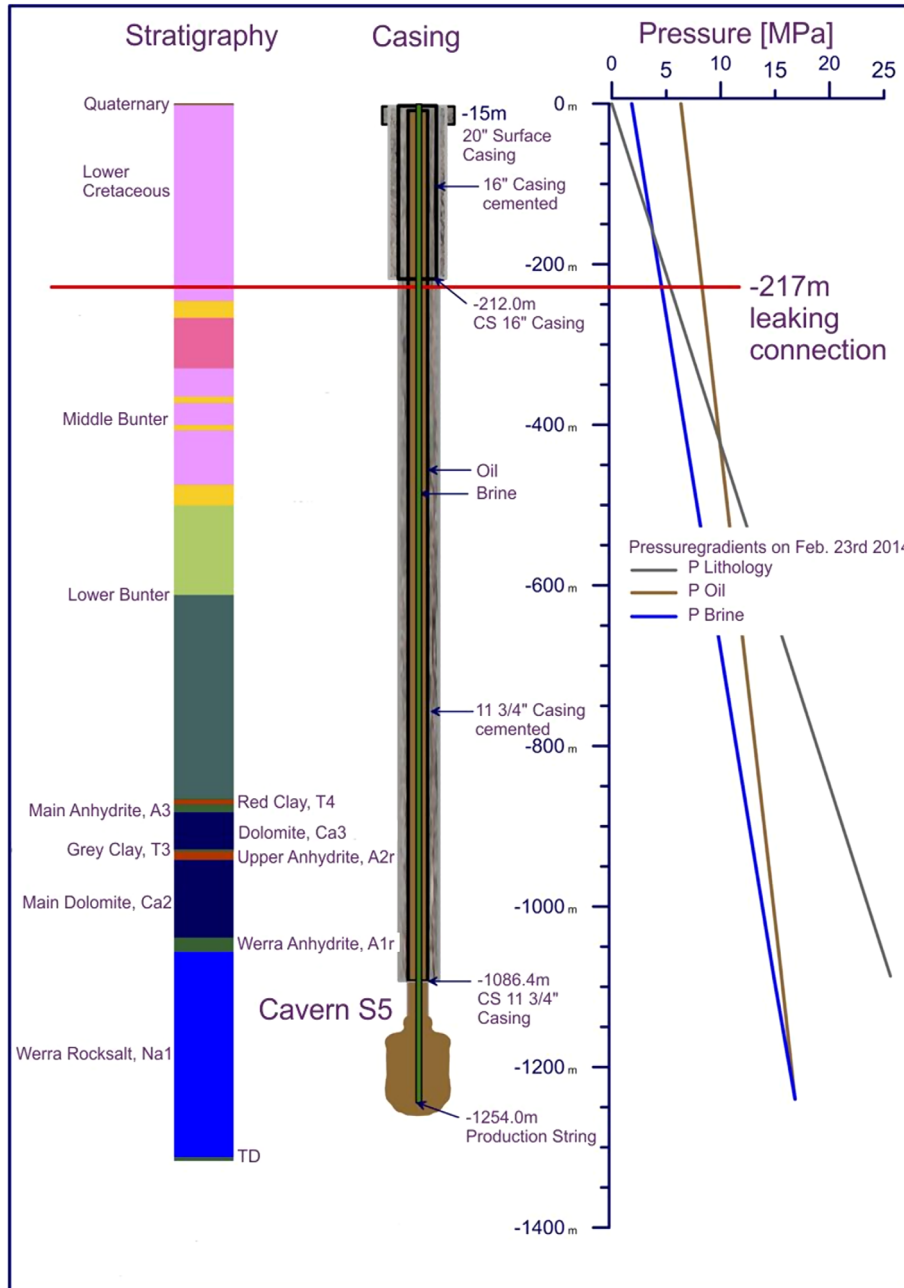
Fig. 12. Well scheme and pressure gradients of Epe S5 (Stöwer, in: Réveillère et al., 2017)
