Review and analysis of historical leakages from storage salt caverns wells

Pierre Bérest, Arnaud Réveillère, David Evans, Markus Stöwer

Pierre Bérest, Arnaud Réveillère, David Evans, Markus Stöwer. Review and analysis of historical leakages from storage salt caverns wells. *Oil & Gas Science and Technology - Revue d'IFP Energies nouvelles*, 2019, 74, pp.27. 10.2516/ogst/2018093 . hal-02074777

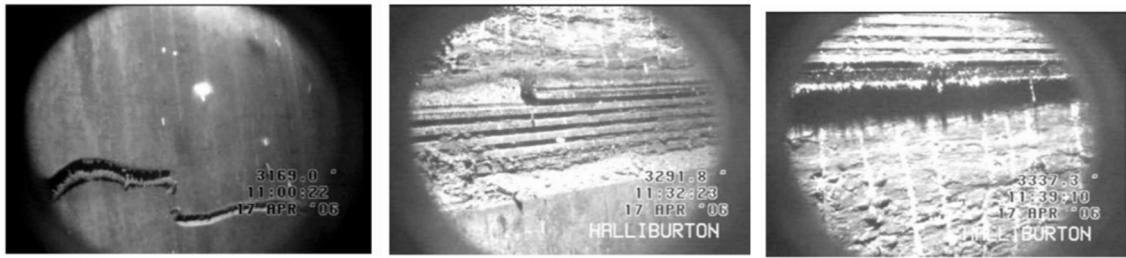
Detailed investigations into the incident were undertaken, including running downhole video camera logs, which identified casing collar and coupling partings for over 100 m above the casing shoe depth (Fig. 10). The video log revealed that the casing had failed at eight different locations, always near or at a connection. Failure often was a circumferential fracture. The casing being dragged down after it fractured, up to 60 cm height of cement could be observed in between the two parts of the fractured casing.

Fig. 10. Examples of failures detected by the video inspection. From left to right: Circumferential fracture of the pipe body, of the threaded coupling, and thread jump-out. From [Osnes et al. \(2007\)](#).

The well repair procedure for the three leaking wells included milling a 30 m (100 ft) section from the original 11-3/8" casing and cementing a 10-3/4" welded liner. The new casing shoe, 30 m higher than the original one, was therefore in a zone where simulations suggest the strain induced by the salt creep should stay below the casings strength, thanks to this new 30 m long cavern neck.
