Laurie Podesta, Bertrand Wattrisse, Félix Latourte, Laurent Waltz, Jean-Michel Muracciole. Imaging of 316H SENT creep sample subjected to oxidation at high temperature. International Conference on Creep And Fracture Engineering Materials And Structure - CREEP 2015, May 2015, Toulouse, France. hal-02080493

# Imaging of 316H SENT creep sample subjected to oxidation at high temperature

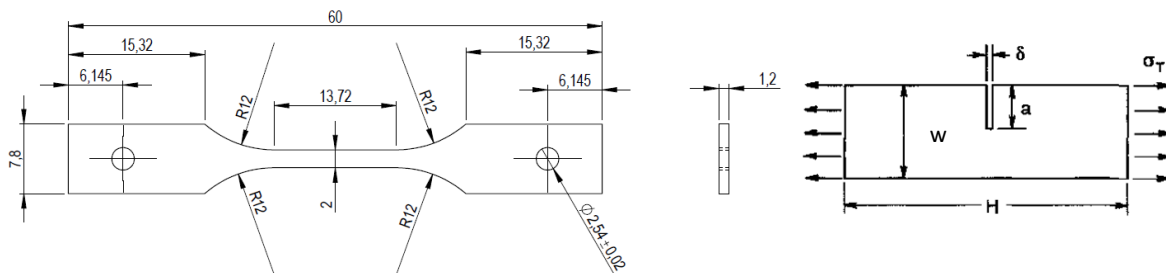
Figure 1: Single Edge Notched Tensile creep specimen drawing (metric unity: mm, crack length  $a$ , gage width  $w$ ).

At elevated temperature (550°C) in CO<sub>2</sub> environment, the 316H stainless steel is known to be sensitive to intergranular creep cracking [1]. In view of assessing creep crack growth from surfacic Digital Image Correlation measurements, the surface pattern stability of the creep specimen was assessed in this preliminary study. Monitoring the creep crack initiation and growth is conducted at the grain scale using scanning electron microscopy. Small Single Edge Notched Tensile specimens (SENT) have been machined using electric discharge machining (see Figure 1). In the tests, we plan to use  $a/w$  ratios close to 0.15.

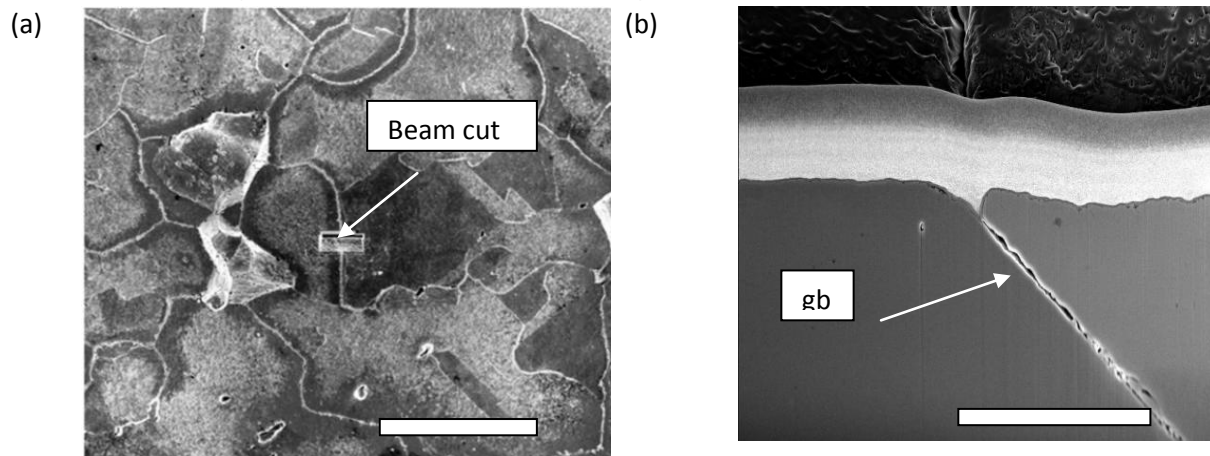
Figure 2: SEM image in SE mode of dual beam cut after etching (Quanta600 FEI) (a) (the scale bar is 100 µm in length) of a grain boundary (b) (the scale bar is 5 µm in length)

The oxidant atmosphere and the elevated temperature are likely to affect the surface pattern. Therefore a preliminar study aims at determining the optimal sample preparation to get a stable pattern. After a fine polishing (until OPS), several specimens have been subjected at 550°C in a furnace with air flow. After five weeks, ion beam sectioning and SEM observations have lead to quantify the thickness of the formed oxide (about 1  $\mu\text{m}$ ). The brittle oxide is detrimental to the pattern quality. Etching was then conducted to retrieve the oxide layer without damaging the

chromium-rich layer which confers to the material its good corrosion resistance. Etching conditions were HCl and HNO<sub>3</sub> solutions at room temperature with ultrasonication. The W pattern is then deposited on the etched surface and it is submitted to high temperature oxidation. Figure 3 shows the pattern after two weeks.

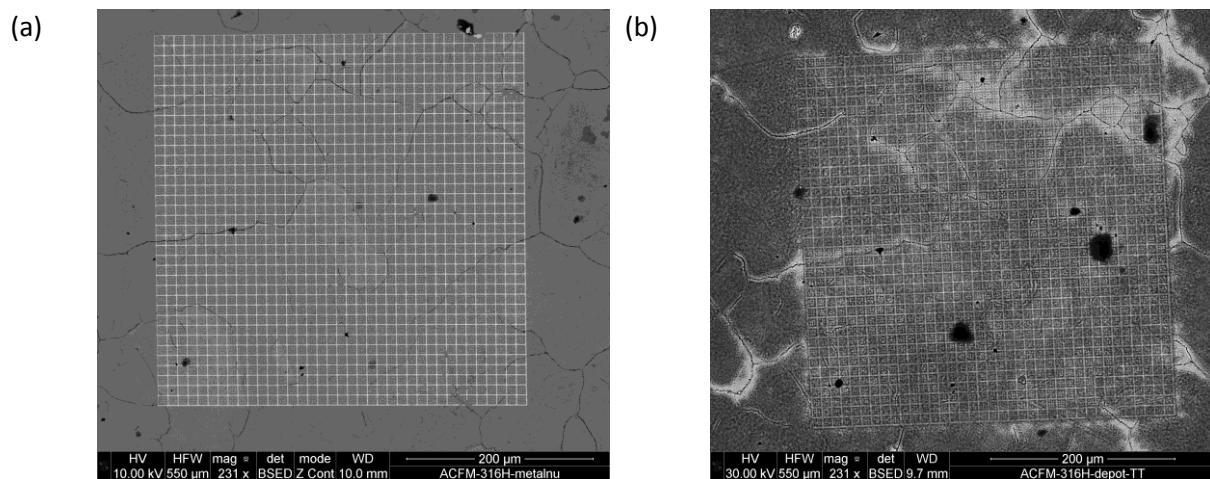
Figure 3: SEM image (BSE mode/Z contrast) of 316H patterned surface after etching and lithography (a) and after 2 weeks in air at 550°C (b).
