## Tribological Analysis of Bolted Joints Submitted to Vibrations

Komla Apélété Kounoudji, Guilhem Mollon, Mathieu Renouf, Yves Berthier

Komla Apélété Kounoudji, Guilhem Mollon, Mathieu Renouf, Yves Berthier. Tribological Analysis of Bolted Joints Submitted to Vibrations. Tribology Online, 2016, 11 (2), pp.255-263. 10.2474/trol.11.255 . hal-02093273

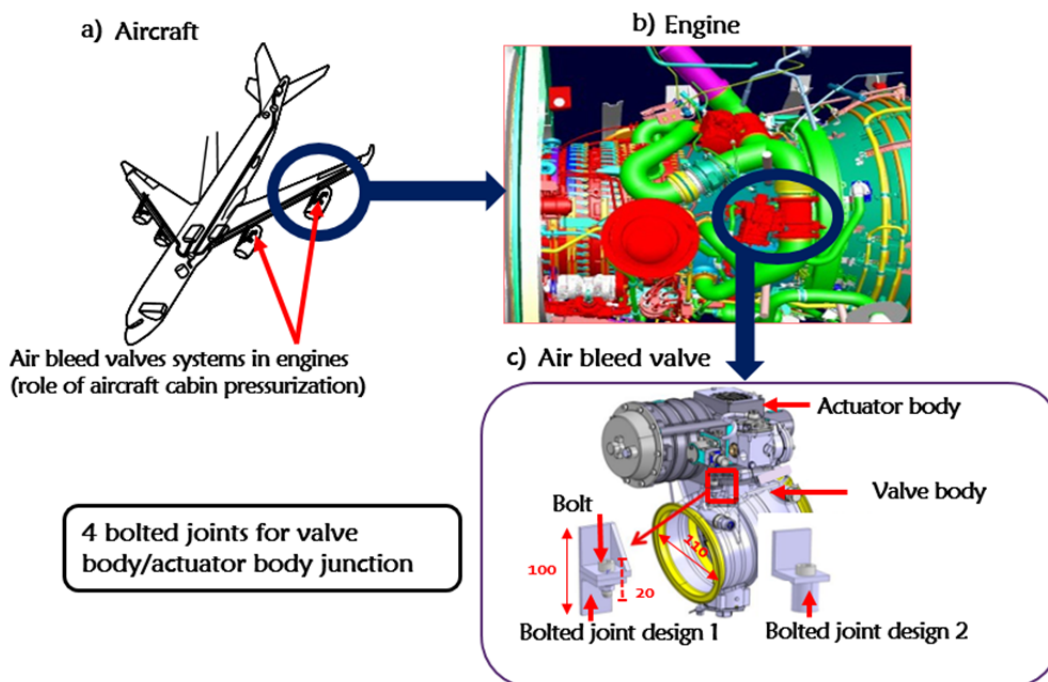
Fig. 1 Air bleed valve systems in aircraft engine

contact conditions between their various components. Thus, this study aims to well understand the service damage of bolted joints used in aircraft air bleed valve systems for their control. Indeed, the main role of air bleed valve is to ensure the pressurization of aircraft cabins. As shown on pictures of the Fig. 1, they are located in engines and are globally composed of actuator body and valve body assembled by bolts. Different designs of bolted joints are used in the junction technology of actuator body/valve body (cf. Fig. 1(c)). In service (i. e. operating on an aircraft), damages appear in bolted joints interfaces such as crack and surface degradation (cf. Fig. 2), which can limit lifetime of bleed valve systems. In extreme cases this can cause the depressurization of aircraft cabins leading to crashes. So it's crucial to well understand the causes of these damages. At this end, an experimental approach is adopted to identify local contact conditions of bolted joints loaded surfaces. The experimental stage is focused on a vibratory testing with DIC technique. Numerical processing of DIC measurements coupled with tribological observations of loaded surfaces after test has led to a numerical analysis by FEM.

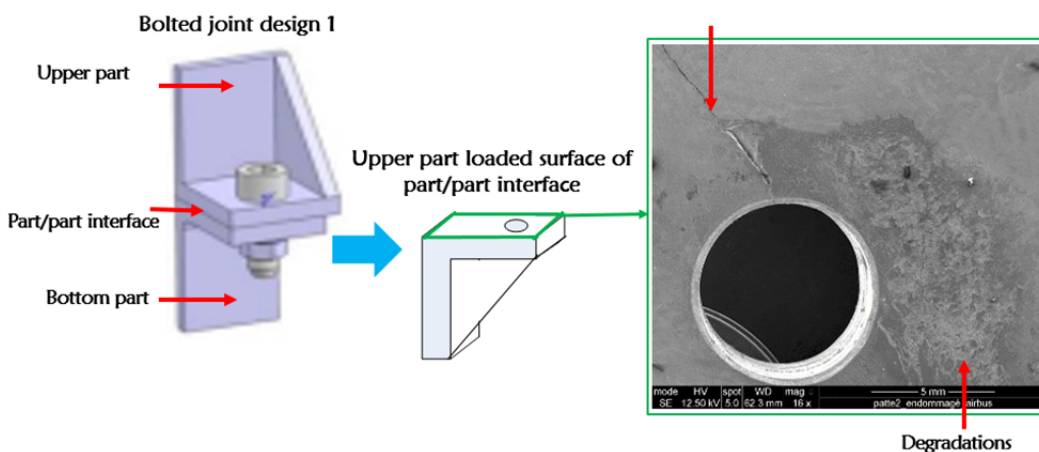
Fig. 2 Different damages on an air bleed valve having operated on an aircraft

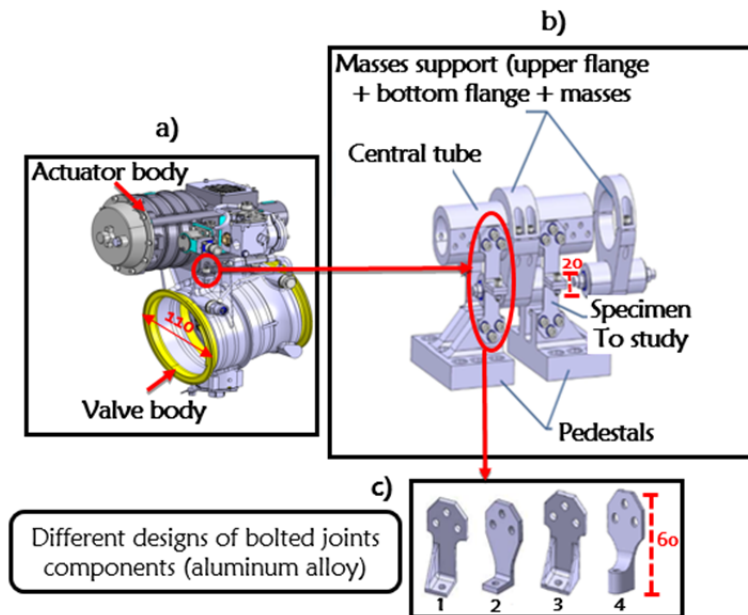
Fig. 3 (a) Real assembly of bleed valve, (b) Model experimental device, (c) Different designs of bolted joints components

In order to test many designs of actuator body/valve body junction, the performing test is not on a real bleed valve but on a model experimental device (cf. Fig. 3). It's representative of actuator body/valve body junction and is composed of a masses support adjustable in position, a central tube, four specimens and two pedestals (cf. Fig. 3(b)). The combination of the central tube and the masses support resembles geometrically to actuator body; but not the pedestals to the valve body. Indeed, they are designed like this to be able to fasten it on the test bench. Different combinations of different designs of specimens

- (i) an axial swaying mode (in this case the masses support keeps the position shown on Fig. 3(b));
- (ii) a torsional mode (masses support is rotated to 90 degrees).

Among these parameters (designs, vibration modes), only the results of the combination of bolted joint design 1 (cf. Fig. 3(c)), the commonly used in the junction technology of air bleed valves, with axial swaying mode is presented in the remainder of this study. The tests begin after assembling the central tube and the socles with four specimens (Fig. 3(b)). Testing conditions at room temperature on the vibratory test bench (cf. Fig. 4) are:

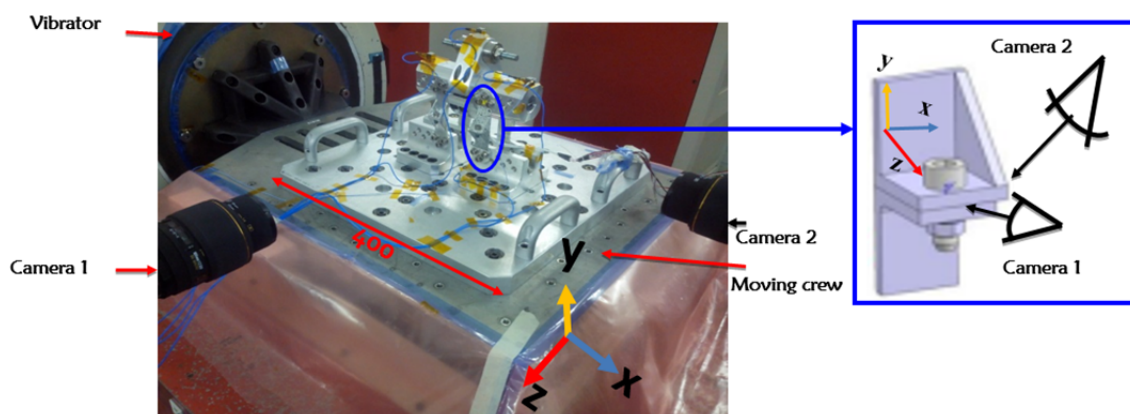
Fig. 4 Vibratory test bench with DIC technique

- (i) a sinusoidal excitation in the X-direction, referring to reference system of the test bench;
- (ii) a scanning frequency, ranging from 200 to 400 Hz

- (iii) test performing duration of 20 min with 8g of acceleration level and 236 Hz of first natural frequency.

Two cameras of high acquisition rate type “FASTCAM ultima APX-RS” are used for DIC measurements. The first one is located in X-Y plane and the second one in Y-Z plane. Note that the range of frequency vibration corresponds to the one occurring on bleed valves on an aircraft.

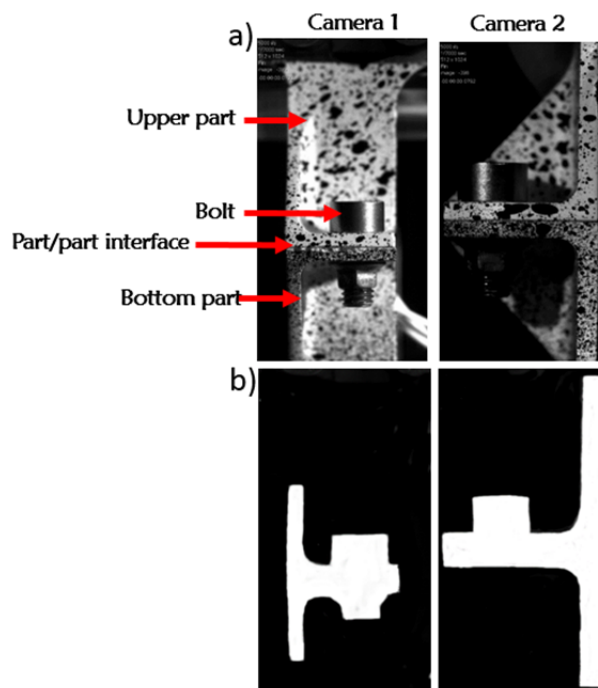
Fig. 5 (a) Reference speckle images for each camera, (b) Regions of interest defined from the reference images for each camera

[11], an open source 2D DIC Matlab program. This open source requires the definition of a region of interest, from the reference image or from one of the speckle images of the assembly at the loaded state according to applications. This region of interest should be colored in white and the other part of the image in black. In our study, the area of interest is defined from the reference speckle images as shown on the images of Fig. 5(a,b). Thus, the images of Fig. 6(b) and Fig. 7(b) are referred to the deformation field measurements in *Y*-direction measurements respectively on the camera 1 and camera 2. These results suggest that there is a local kinematic of the assembly at part/part interface, for example. In order to explore the local contact instabilities that would generate the involved deformation field, average relative displacements are measured at the interface. From the measurements, the interfacial displacements graphs were plotted by means of the scanned images (512 pixels by 256 pixels of definition) of the two cameras and multiblocks regions of interest. Indeed, the regions of interest have been defined separately for each component (block) of the studied assembly (bolt, upper part, bottom part) from the reference speckle images. All the blocks are then assembled as shown on the images in Figs. (8,9). Through a Matlab routine, each block is meshed in order to track down the mesh nodes at the interface (cf. Fig. 6(c) and Fig. 7(c)). From images of Fig. 6(d) and Fig. 7(d), one can observe that, at the local scale the instabilities are micro-slips and peeling-off type at the interface (part/part interface), where the relative displacements in the *X* and *Z*-directions are assigned to

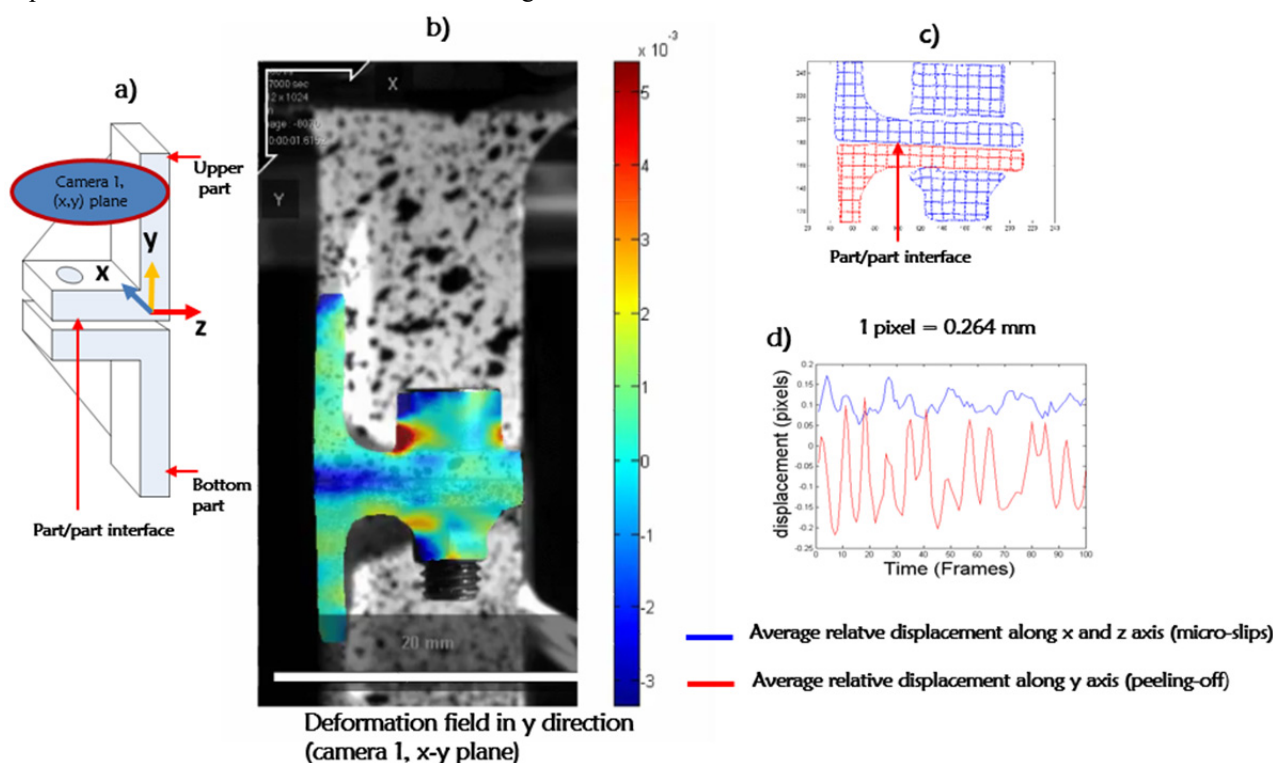
Fig. 6 (a) Bolted joint design 1 with camera 1 position, (b) Deformation field with camera 1 position, (c) Mesh of region of interest with camera 1, (d) Average relative displacements with camera 1

the blue plots while ones in the *Y*-direction to red plots. These displacements plots are in fact the average displacements of the mesh nodes at the interface. It should be clarified that all the degrees of freedom of the

nodes of bottom part are blocked at contrary to those of the upper part which nodes are left free; this allow to note the relative displacements of the interfacial nodes of the free part (upper part) compared to the blocked one. It is clear from this analysis that the interfacial relative displacements are cyclical and peeling-off instabilities are more pronounced than micro-sleeps ones (camera 2, Fig. 7) and are around 2.5 pixels of displacement (the scanned images are defined in pixels), the equivalent of 700 microns. The conclusion is that the assembly is solicited both globally and locally.

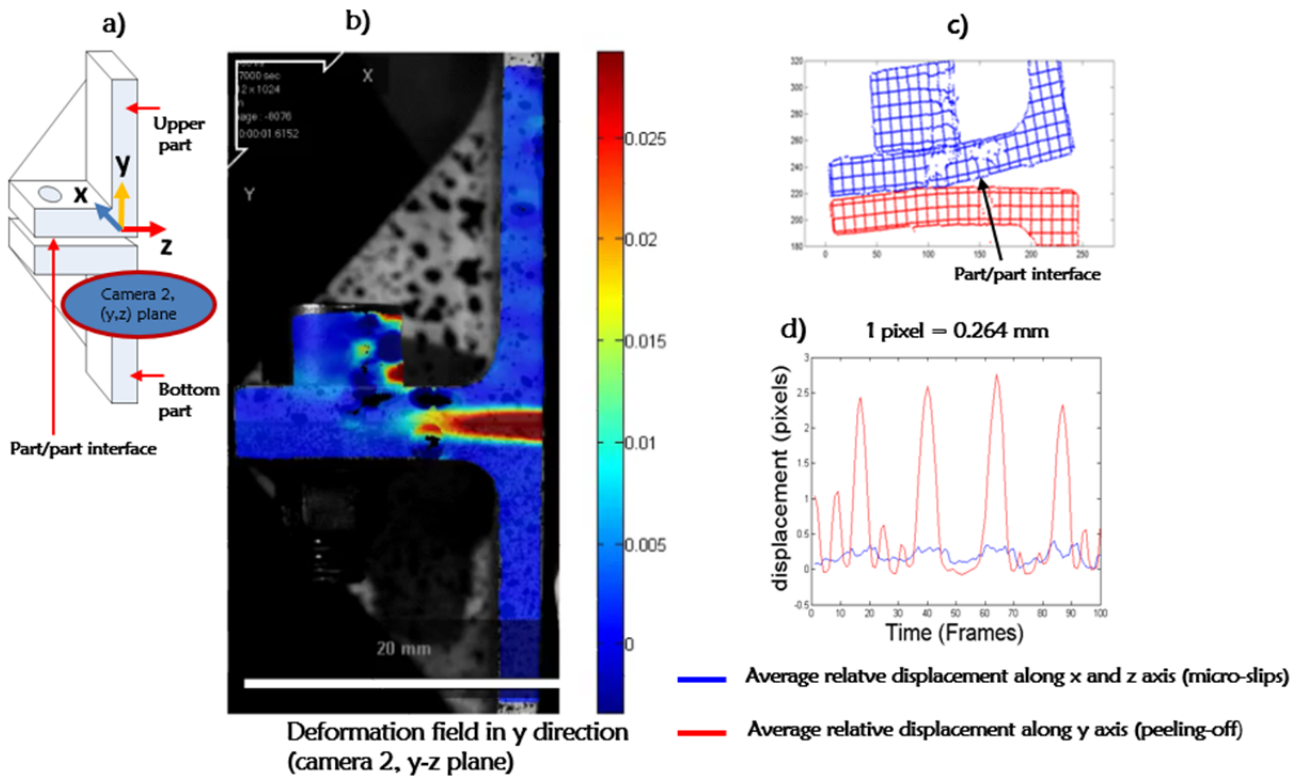
Fig. 7 (a) Bolted joint design 1 with camera 2 position, (b) Deformation field with camera 2 position, (c) Mesh of region of interest with camera 2, (d) Average relative displacements with camera 2

peeling-off instabilities (cf. Fig. 7(c));

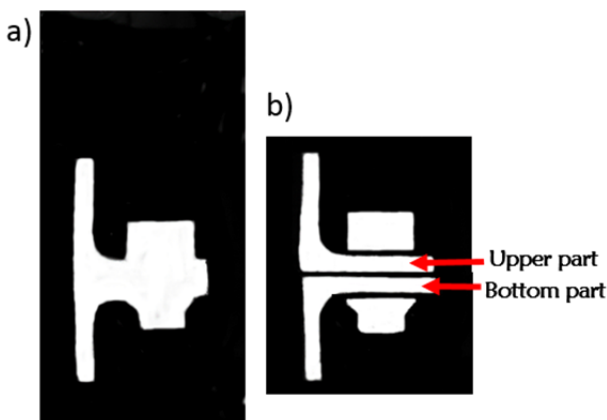
Fig. 8 (a) Monoblock region of interest (camera 1), (b) Multi-block region of interest (camera 1)

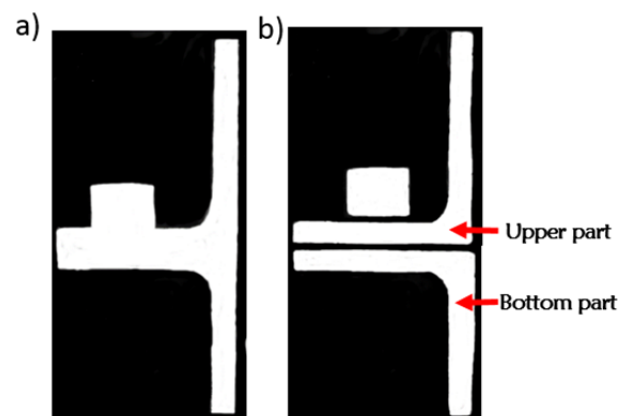
Fig. 9 (a) Monoblock region of interest (camera 2), (b) Multi-block region of interest (camera 2)

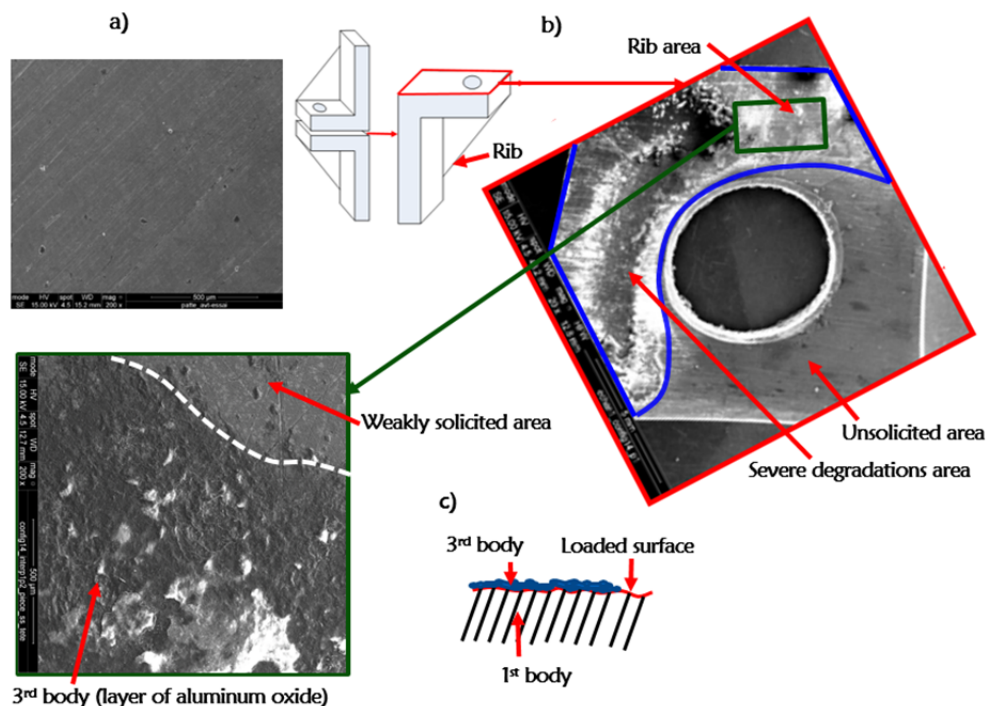
Fig. 10 (a) Surface before testing stage, (b) Surface after testing stage, (c) Sectional view

After test, the four specimens are disassembled and one of them is devoted to analyses. The involved surfaces are compared before and after testing stage in Fig. 10(a,b). In Fig. 10(b), the hole of the specimen used in the experiment seems to locate at the center of the surfaces; this is due to the cutting conditions for SEM analysis. In actual fact, the hole is not at the center (cf. Figs. 6,7). It appears on the surface post-testing, three areas according to the severity of local sollicitations (cf. Fig. 10(b)):

- (i) a severe degradations area showing a formed third body, which corresponds to the area of great

- (ii) a weakly solicited area (without third body) and a third body zone, both in the rib area of the structures (the two parts of the assembly);
- (iii) an unsolicited area which conserves the morphology of the surface before the tests.

Therefore, the involved interface is solicited according to its own dynamic. Looking for the morphology of the degraded region at the local scale, a thin layer of third body appears on the surface as shown on the sectional view (cf. Fig. 10(c)). This third body layer is composed for the main part of an alumina (aluminum oxide). This is explained by the fact that during sollicitations, aluminum particles are detached at the surface. Then, in contact with the oxygen of surrounding air, they are oxidized and form the alumina third body layer.

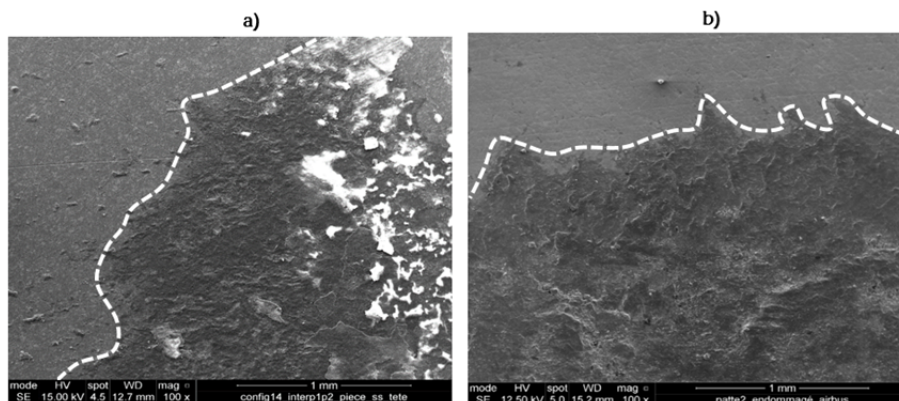
Fig. 11 (a) Degradations of the involved surface during testing stage, (b) Degradations of the involved surface during service stage

The degraded surface observed after the testing stage is compared to the same one of a bleed valve having operated on an aircraft (cf. Fig. 11). It can be found that the degradations are similar; the testing stage is allowed to reproduce the same tribological behavior that in service, although the pedestals don't resemble the valve body.

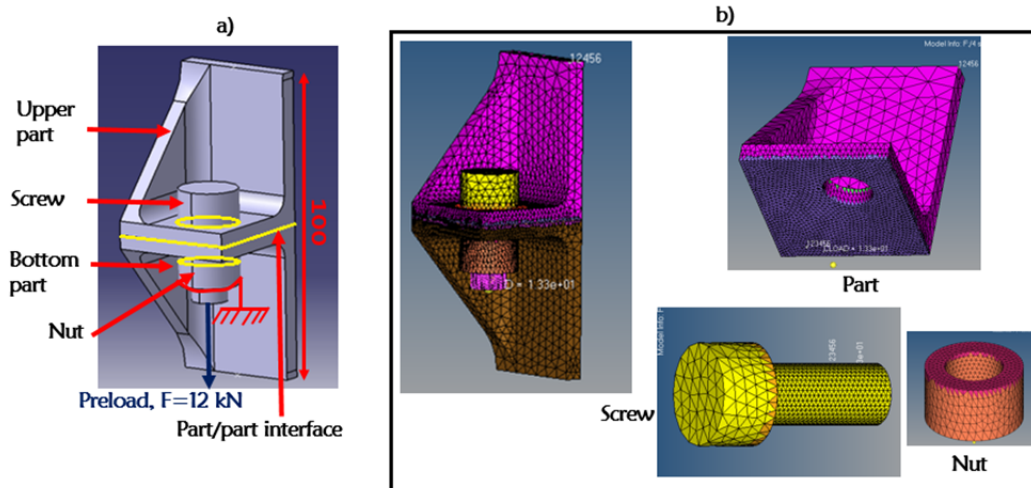
Fig. 12 (a) Simplified bolted joint model, (b) Mesh of different parts of bolted joint model

For this purpose, a finite element model is realized. Only the part/part interface is considered in the present study. Hence the bolt (screw and nut) is simplified (i. e. the threads are not represent). The bolted joint model and its mesh are shown at Fig. 12(a,b). The model is

composed of a total of 64130 elements. This step being dedicated to the simulation of tightening stage, as boundary conditions, the preload, an experimental value of 12 kN (from torque-preload test) is applied by pulling on the screw while blocking the bottom surface of the nut (cf. Fig. 12(a)). The bolt is in steel, and the interactions between surfaces are managed by a Coulomb friction law. The used values (cf. Table 1) are derived from

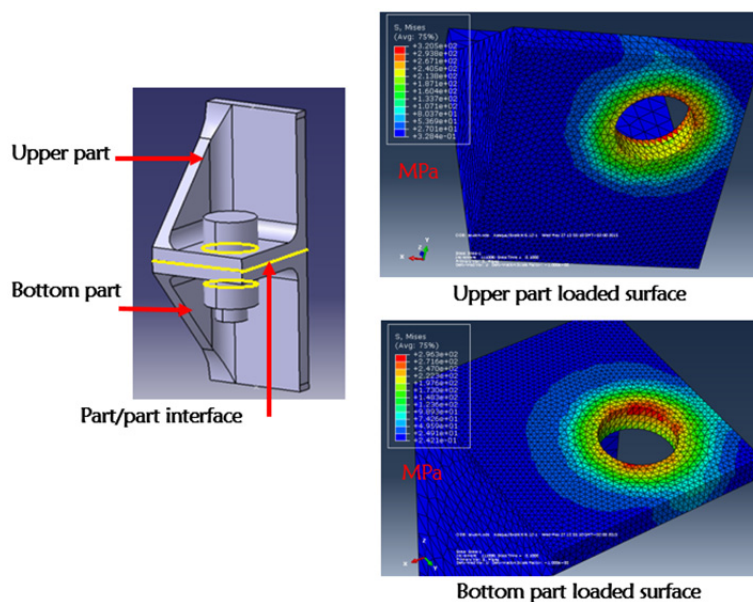
Fig. 13 Von Mises stress field in the involved interface

Von Mises stresses fields corresponding to the involved contact surfaces (part/part interface) are evaluated at the end of the calculation as represented in Fig. 13. According to these numerical results, only the region of the bolt is the most loaded during tightening stage, and not all the contact area (cf. Fig. 14(a)). Moreover, this loading is not so high to damage the region of the bolt if referring to the experimental model (cf. Fig. 14(b)). This means that degraded area is referred to peeling-off and micro-slip phenomena due to vibrations. The only contribution of the tightening stage would be the activation (increasing the reactivity) of surfaces.

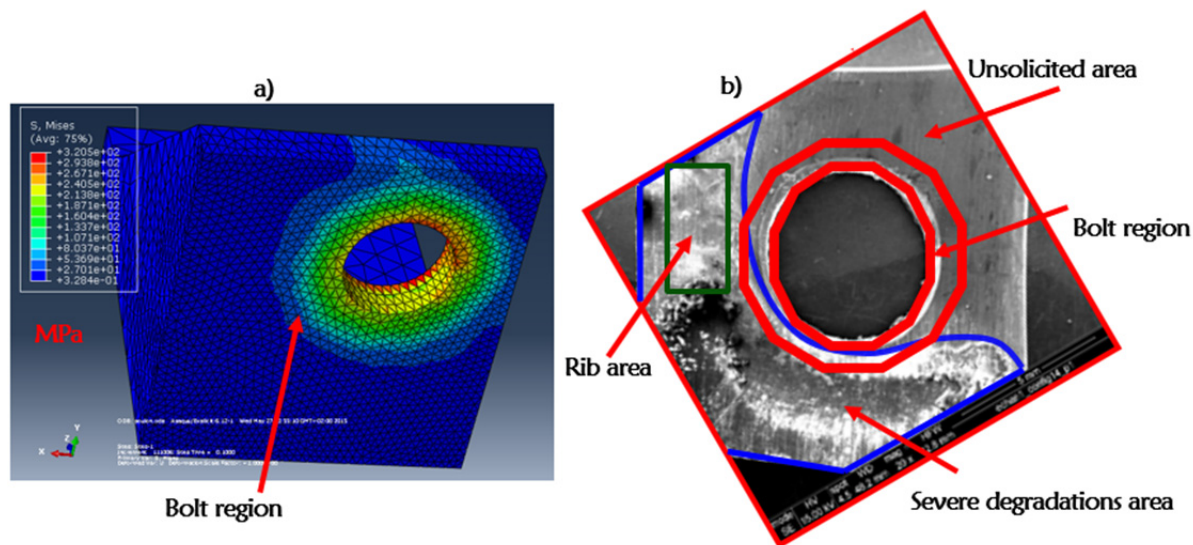
Fig. 14 (a) Numerical model, (b) Experimental model
