Experimental investigation of compression and compression after impact of wood-based sandwich structures

John Susainathan, Florent Eyma, Emmanuel de Luycker, Arthur Cantarel, Christophe Bouvet, Bruno Castanié

John Susainathan, Florent Eyma, Emmanuel de Luycker, Arthur Cantarel, Christophe Bouvet, et al.. Experimental investigation of compression and compression after impact of wood-based sandwich structures. Composite Structures, 2019, 220, pp.236-249. 10.1016/j.compstruct.2019.03.095. hal-02104770

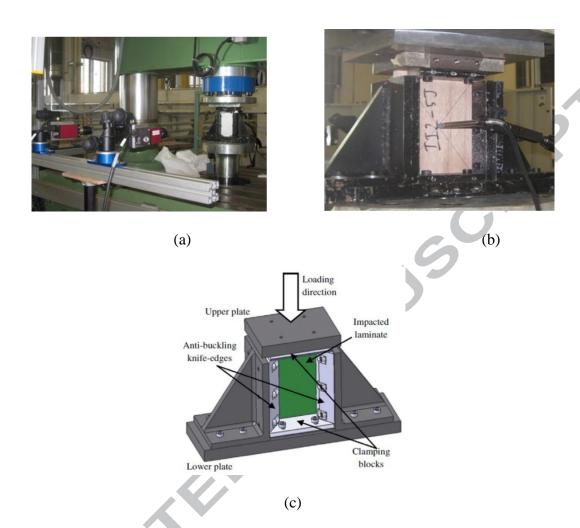
Fig. 1: Drop-weight impact test set-up,

Impact tests were performed using a drop weight apparatus (*Fig. 1*) followed by tomographic analysis [33, 35]. Low velocity impact tests were carried out at three energy levels (5 J, 10 J and 15 J), corresponding to energy levels generally encountered in industry, to simulate tools falling onto a floor. The principle of the falling weight is to drop an instrumented mass and guide it in a tube onto a sample plate held by a support window.

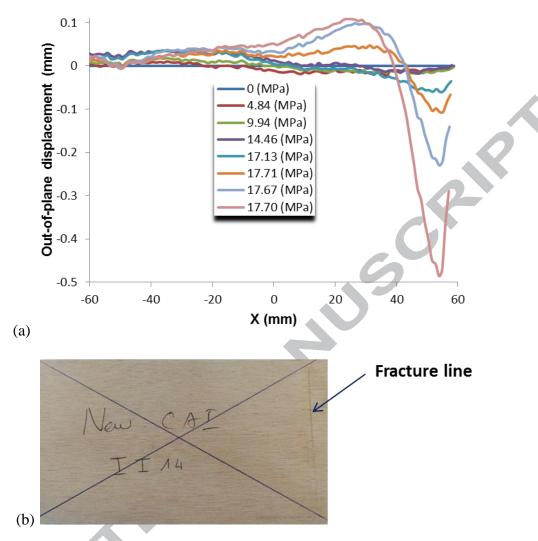
Figure 7: Out of plane displacement of pristine specimen of plywood A (a) along compression direction (X) and vs load, and (b) final failure pattern.

The load/displacement curves obtained for plywoods A and B are shown Fig. 5 (a) and (b). The evolution of residual strength, structural failure and residual stiffness are given Fig. 6. In general, plywood (A) had better mechanical properties than plywood (B). The degradation of the mechanical characteristics was more progressive and the residual strength reductions were 28% and 32.6% respectively. It can also be noted that, in the pristine state, plywood A had a very long plateau (Fig. 5 (a)) of practically 3 mm. This mechanical characteristic could be of interest in a crash. For plywood B in new condition, the length of the plateau was only 0.5 mm because the test was stopped prematurely. The compression failure scenarios of the two new plywoods were quite different. Plywood A gradually deformed out of plane following a mode II (in the sense of Euler beam theory), see Fig 7 (a)

and the upper fold of okoume at 0° ended up breaking in traction at the tip of wrinkle (Fig. 7 (b)).

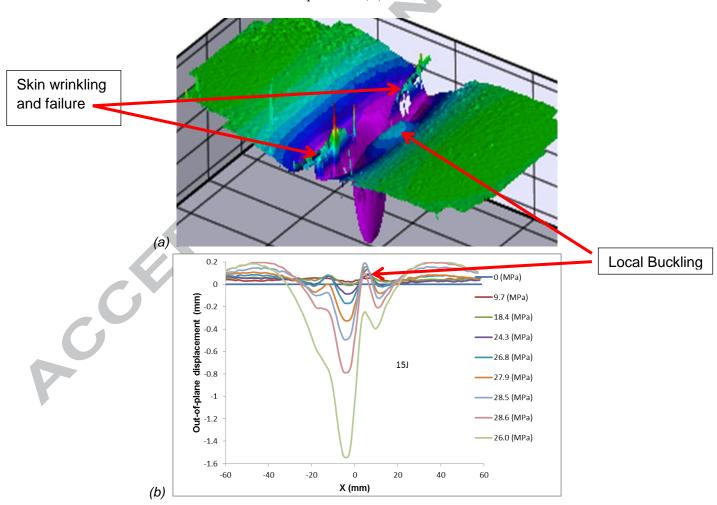
Figure 12: Skin buckling for the pristine specimen (a) and failure pattern for impacted specimen (b)

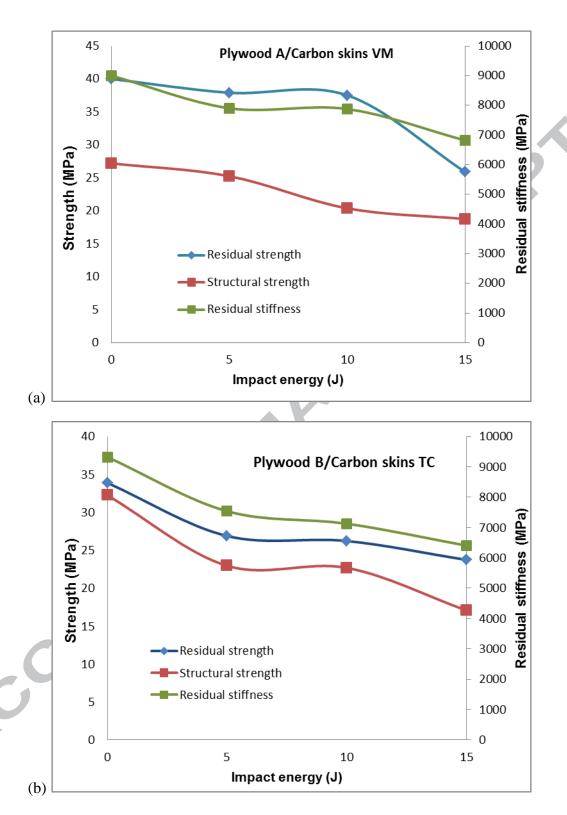
Figure 14: Tests results for sandwiches of plywoods A (a) and B (b), with carbon skins.

The overall load/displacement results and the strength reduction vs impact energy are shown in Figures 14 and 15, respectively, for the two types of sandwich, i.e. plywood A + carbon skins Vacuum Molded (VM) and plywood A + carbon skins obtained by Thermo-Compression (TC). The behavior is almost the same for pristine specimens and for

impacted specimens, with nearly linear behavior followed by a sudden drop. The plywood A specimen impacted at 15 J has different behavior with a large plateau area - probably because of the large extent of the damage. The residual strength falls by 30 % for plywood B/ carbon skins TC and by 35 % for plywood A/ carbon skins VM. It is noticeable that this drop remains limited in comparison to the reference sandwich (up to 70%) and may be interesting in terms of sizing, despite the heavier weight. Also, the sensitivity to the manufacturing process highlighted in [32] is not found here.

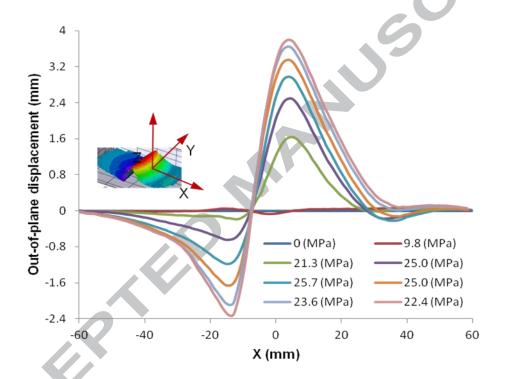
Figure 16: Typical local skin buckling for plywood with carbon skins.

After the impact, the carbon skin is delaminated due to its high stiffness and has strong spring-back, so the permanent indentation is slight. Nevertheless, the wood is still crushed below the skin and the skin becomes unsupported [33]. This failure pattern is very similar to that in impacts on sandwich structures with Nomex honeycomb cores and carbon skins, where the honeycomb is crushed under the residual dent [38, 39]. So the behavior is almost the same as described in [13, 14] and explains the shape of the curves in Figure 14 and the local skin buckling visible in Figure 16. The only significant difference is the shape of the buckling found for the 15 J impact of plywood A with carbon skin (see Fig. 17) where the load/displacement curve has a plateau. The buckling is so large that a second mode appears (in an Euler beam sense), which is probably due to a large crushing area combined with debonding (due to a poor manufacturing process) between carbon skin and plywood after the impact.

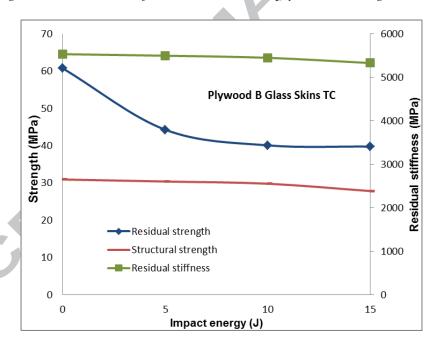
Figure 18: Test results for sandwiches with plywood B and glass skins.

The overall load/displacement results and the strength reduction vs impact energy are shown in Figures 18 and 19 respectively. Unlike the other configurations, this one experiences a rapid drop in strength, even for the 5 J impact, which also reaches 35 %. The loss in stiffness and in structural failure is nearly inexistent. The failure scenario is a local bucking of

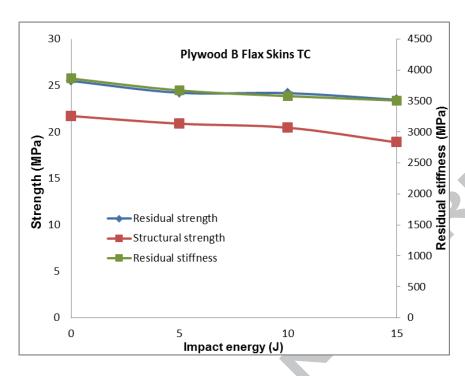
Figure 21: Tests results for sandwiches with plywood B and flax skins.

The overall load/displacement results and the strength reduction vs impact energy are shown in Figures 21 and 22, respectively. These sandwiches exhibit an exceptional and unexpected behavior with a drop in strength and in stiffness limited to less than 10 %, even for the 15 J impact. Moreover, as for the plywood with aluminum skins, a plateau area is observed. The failure scenario is also similar to that found in [13, 14] with a final brittle failure of the flax skin.

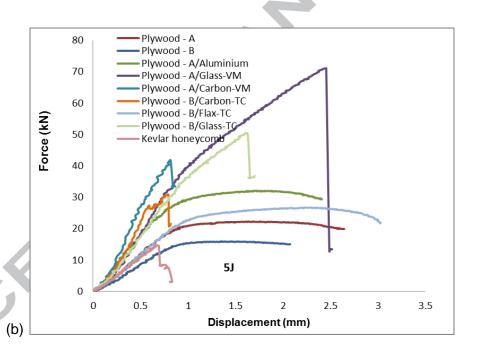
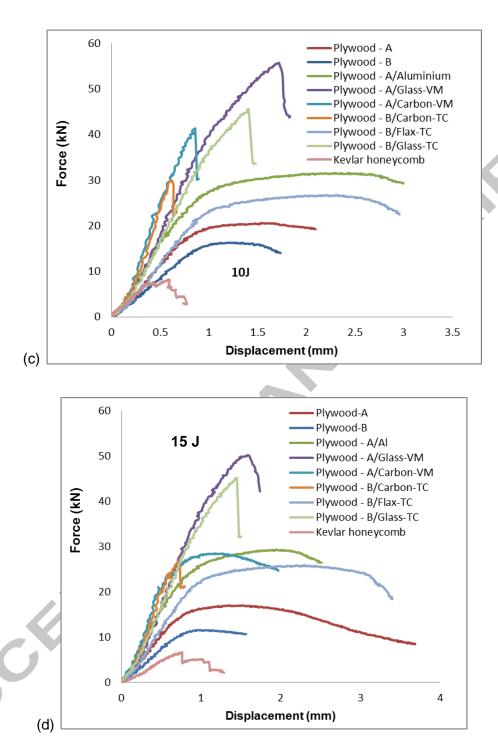
Figure 23: Overall compression force vs displacement curves for the nine configurations of sandwiches when pristine (a) or impacted at 5 J(b), 10 J(c) or 15 J(d)

Compression After Impact tests results are presented in Figure 23 a, b, c & d in terms

of force-displacement response for the nine different structures when pristine and after 5 J, 10 J and 15 J impact. Their main interest is that they enable comparisons to be made between the values at failure and the various behaviors) Strength reduction and normalized specific strength are presented for the nine different structures in Table 4 and Figure 24 a and b.

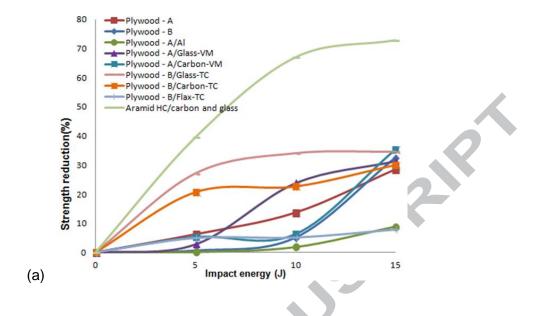
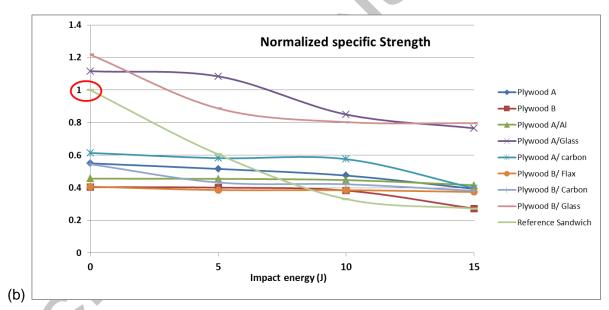
Figure 24: Strength reduction and specific performance of the nine sandwich configurations.

Conversely, the reference sandwich, except in pristine condition, almost always has the lowest compressive strength, even compared to plywood alone. However, this can be explained by a density that is half that of the plywood specimens. Another peculiarity is that, at 15 J, the strength drop reaches 70% for this sandwich (Fig 24 a) and, from this point of view, this material is very poor.

In Fig. 24 (b), the specific characteristics have been normalized with respect to the reference sandwich in the pristine state (see Table 4 calculations) and the results in this form are very interesting since the fiberglass skin sandwiches have a specific resistance 20% higher than the reference sandwich in compression in the pristine state. In this configuration, the other sandwiches are, on the other hand, about half as efficient. However, by 10 J, all sandwiches with a core in plywood become more efficient than the reference sandwich. Here, we find an intrinsic performance of the wood under this stress [40, 41] provided that it is confined, a role that is probably performed by the skins of the sandwich.
