On the optimization of the cutting conditions for an improved corrosion resistance of OFHC copper

Procedia CIRP 77 (2018) 413-416

8th CIRP Conference on High Performance Cutting (HPC 2018)

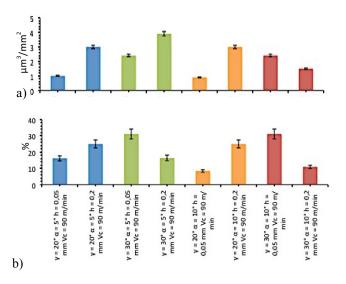
Fig. 3. (a) Mean in-depth degradation induced by oxidation at the end of the aging test under saline atmosphere, and (b) percentage of the oxidized surfaces at the end of the aging test under saline atmosphere.

To explain degradation under the green surface, in-depth topography is measured under the oxide once it is removed. The removed volume per surface unit reflects the mean indepth degradation under the oxide. Results are represented in Figure 3.

Comparing the percentage of oxidized surface at the end of the aging test under saline atmosphere (cf. Figure 3b), the following remarks can be drawn: i) The least covered surface by atacamite is the least damaged under the green oxide ($\gamma = 20^{\circ}$; $\alpha = 10^{\circ}$; h = 0.05 mm; $V_c = 90$ m/min); ii) The most covered surface by oxides is not necessarily the one knowing the worst in-depth degradation ($\gamma = 30^{\circ}$; $\alpha = 5^{\circ}$; h = 0.05 mm; $V_c = 90$ m/min).

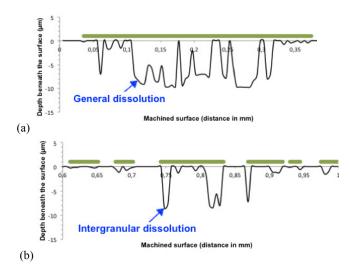
Fig. 4. Profiles under the green zones for surfaces obtained by the conditions $\gamma = 30^{\circ}$, $\alpha = 5^{\circ}$, h = 0.2 mm and $V_c = 90$ m/min. Part of the analyzed profile presenting generalized dissolution (a) and intergranular corrosion (b).

A unidirectional profile measured in the oxidized region was taken from every analyzed surface to identify the shape profile under the oxide. It was measured only under the green areas (represented by the green lines in Figure 4 as an example). The used in-depth resolution is 78 nm and the horizontal resolution is 5 μ m. According to the obtained profiles, it is remarkable that under the green areas two types of cavities can prevail: large cavities with plate valleys (corresponding to generalized dissolution, cf. Figure 4.a) and thin and deep cavities (corresponding to intergranular corrosion cf. Figure 4.b) in the borders of the green area.

The cavities depth varies under the surfaces covered by the green oxide, what witnesses a non-uniform dissolution happening on the same surface. These observations under the oxides allow the corrosion process analysis explaining the surface damage in the presence of saline atmosphere as follows [12]. Inside the droplets, copper dissolution leads to the formation of the ions Cu⁺ or Cu²⁺ in aqueous solution. Associated to anions Cl already present in the droplet, they constitute the green compound CuCl. With high chloride concentration, they can even produce the ions of CuCl²⁻. On the other side, cations Cu2+ can be hydrolyzed to form atacamite Cu₂(OH)₃Cl. This reaction, consuming molecules of H₂O, produces protons H⁺, decreasing the pH. As the droplet stagnates in the surface, the pH diminishes with the generation of atacamite. A previous study [11] has demonstrated that pH lower than the limit of copper dissolution can be rapidly reached leading to a generalized dissolution and to intergranular corrosion. The electrons issued from the dissolution reduce the oxygen inside the droplet. As the solubility of oxygen inside water is high, the cathodic reaction continues, and the dissolution evolves into cavities. Then, what makes a machined surface more active than the other just by manipulating the cutting conditions?
