Study of Post-World War II French Aeronautical Aluminium Alloy and Coatings: Historical and Materials Science Approach

Magali Brunet, Audrey Cochard, Christophe Deshayes, Chantal Brouca-Cabarrecq, Luc Robbiola, Jean-Marc Olivier, Philippe Sciau

Study of post-World War II French aeronautical aluminium alloy and coatings: historical and materials science approach.

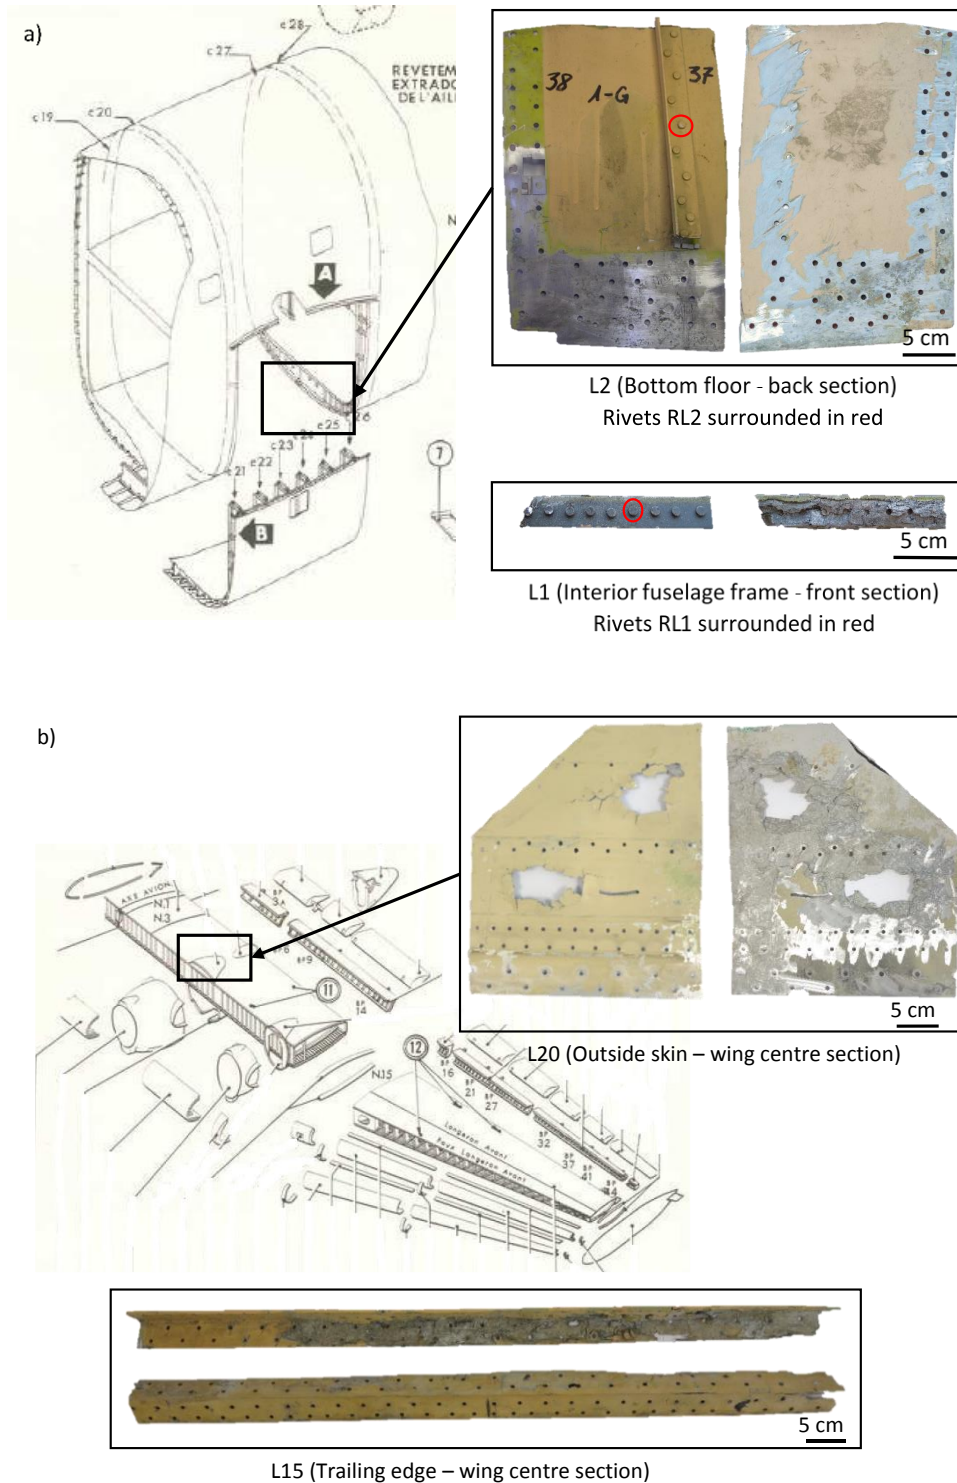
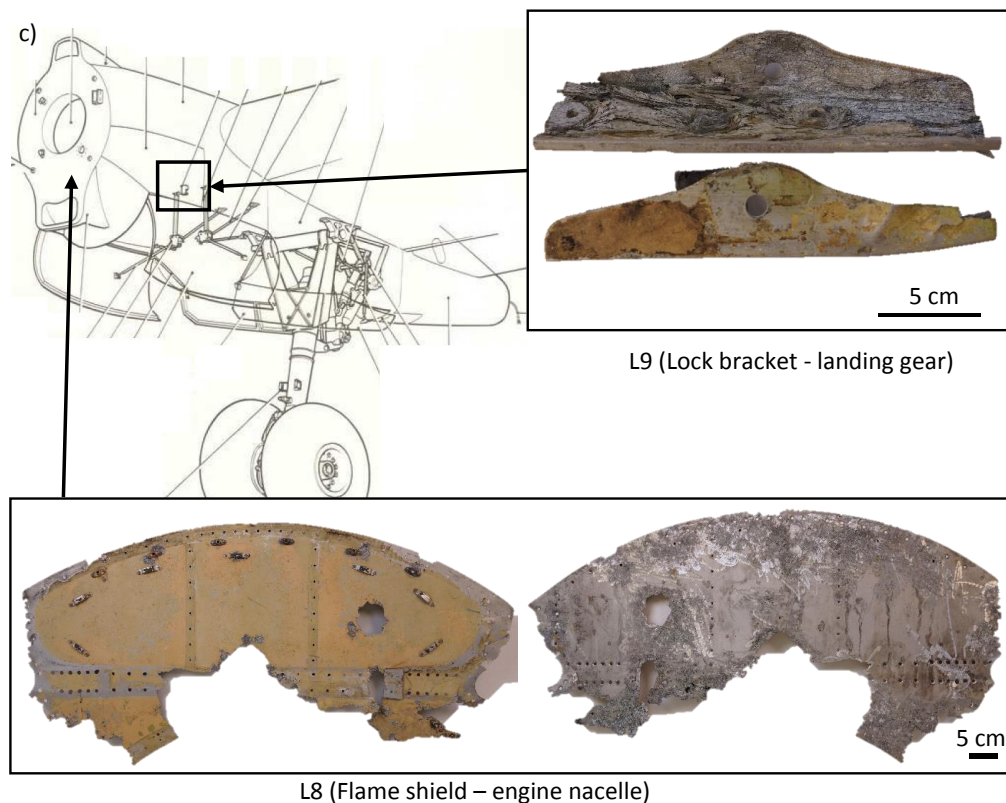
Figure 1. Photographs of collected parts (front and back side) from Breguet 765 airplane with localization on original plans (Breguet n.d.); a) Plate L2 (2 mm thick) with RL2 rivets (5 mm diameter) and profile L1 with RL1 rivets (4 mm diameter), b) Plate L20 (3 mm thick) and profile L15 (4 mm thick); c) Plate L8 (1.6 mm thick) and bracket L9 (5 mm thick).

During the renovation of the Breguet 765, some partly corroded parts are removed by members of the association for replacement. For this study, representative parts were collected inside or outside the aircraft as shown in Figure 1 (Breguet n.d.):

- Three plates (L2, L8, L20) with different roles and locations: L2 is from the primary structure, a reinforcement plate underneath the bottom floor inside; L8 is a cladding plate near the engine used as a flame shield and L20 is a plate from the upper surface of the wing centre section also called skin (thus an outside part);
- Two structural parts: L9 is a lock bracket from inside the landing gear and L15 is a profile¹ from the trailing edge of the wing centre section. Both these parts are very much stressed during the aircraft lifetime;
- Rivets previously studied (A. Cochard *et al.* 2013) are included in the corpus for comparison purposes between the different selected metallic parts. RL1, from a stringer (called L1) has a diameter of 4 mm and RL2 from the plate L2 has a diameter of 5 mm.

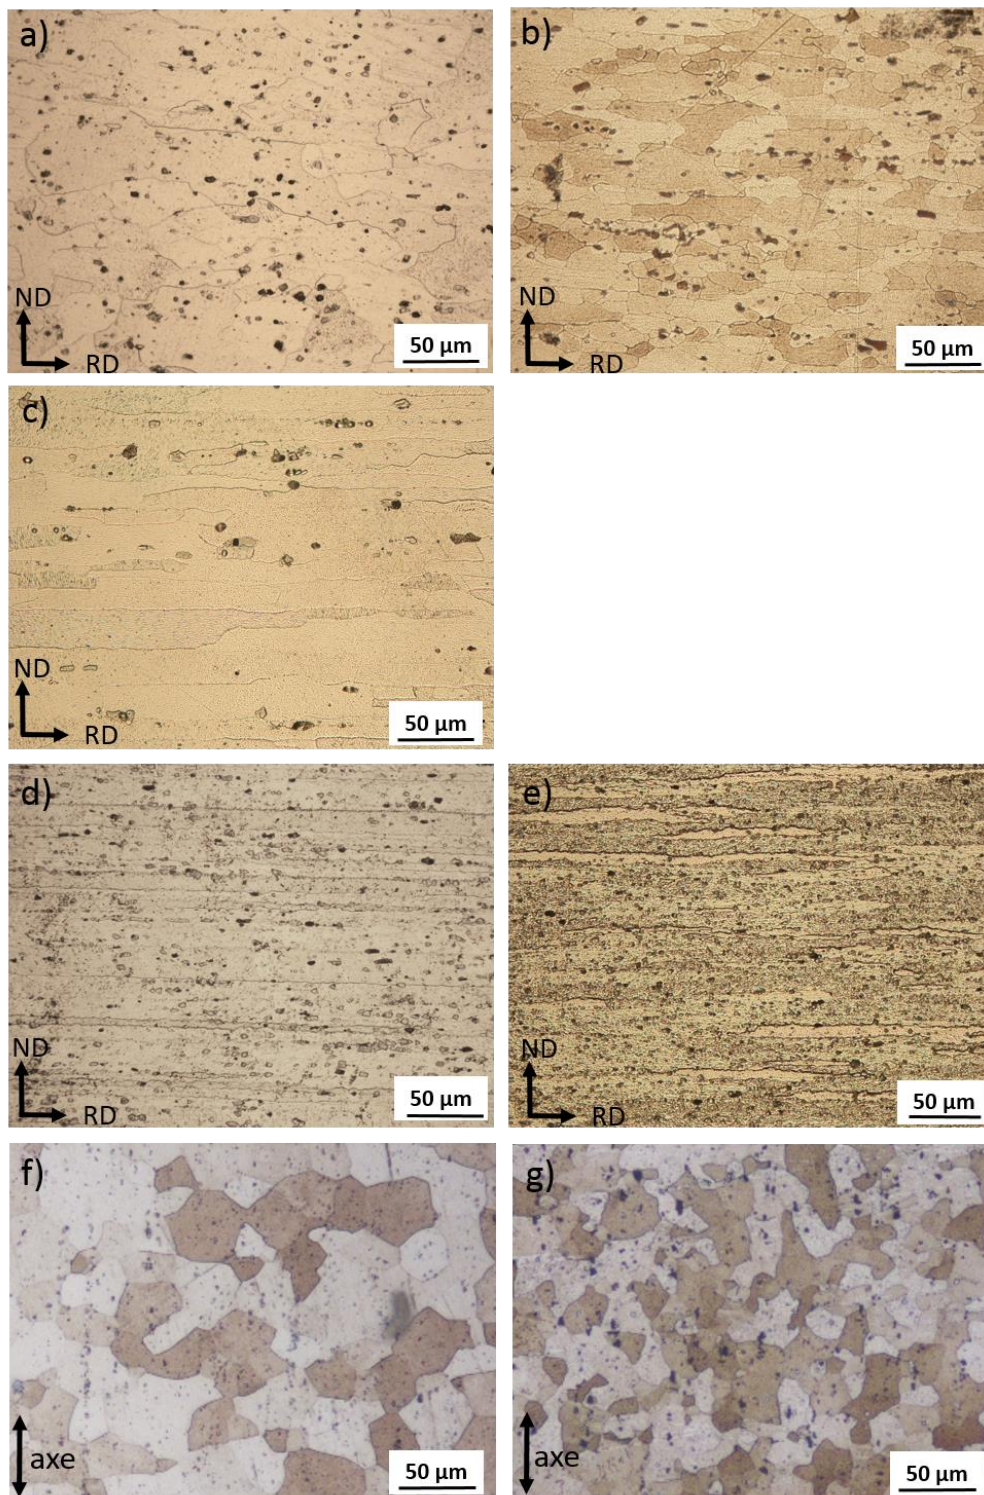
Figure 2. Optical microscopy images after Keller etching of collected parts in the plane normal to the rolling direction. a) L2 (A-U4G1), b) L8 (A-U4G), c) L20 (A-U4G1), d) L9 (A-U4G1), e) L15 (A-U4G1), f) RL1 (A-U3G), g) RL2 (A-U4G). For the rivets, the images were acquired in the shank. ND: normal direction / RD: rolling direction.

Figure 2 shows metallographic structure of the studied parts, from optical microscopy performed after a Keller metallographic attack. Grains of the different alloys are this way revealed. Full report of metallographic structures for L2 (Figure 2a) and L8 (Figure 2b) can be found in previous publication (A.

Cochard *et al.* 2017). Here, only one orientation (normal plane) is shown and commented. L2, L8 and L20 plates (Figures 2.a.b.c) show grains with a preferential orientation (anisotropy in shape). The size and the shape of the grain depends mainly on the manufacturing process, in particular the thermomechanical treatments applied. For the plates, the preferential orientation is the signature of a rolling process followed by recrystallization steps. L20 (Figure 2.c) exhibits longer grains (average length equal to $117 \pm 19 \mu\text{m}$) than L2 ($69 \pm 35 \mu\text{m}$) and L8 ($46 \pm 15 \mu\text{m}$). As the three plates don't have the same thickness (3 mm, 2 mm and 1.6 mm respectively), they probably received different number of rolling passes and/or different recrystallization treatments leading to different grain size and shape.

Bracket L9 (Figure 2.d) and profile L15 (Figure 2.e) have also a microstructure with preferential orientation but grains are very long, thin and crushed. This specific microstructure is produced during extrusion generating severe plastic deformation (Hérenghuel and Lelong 1958). For rivets RL1 (Figure 2.f) and RL2 (Figure 2.g), grains are equiaxed. Rivets were also fabricated by extrusion but a heat treatment for recrystallization generally was done before the formation of the head (Penel 1950) which transformed the grains shape. Furthermore, it is observed that A-U3G rivets have larger grains (average diameter equal to $47 \pm 25 \mu\text{m}$) than A-U4G rivets (average diameter equal to $29 \pm 15 \mu\text{m}$) (A. Cochard *et al.* 2013). This particular point will be discussed below after a deeper look at the precipitation at the nanoscale. Overall, the microstructures of the two rivets are comparable with those reported in 1955 for similar rivets (Tournaire and Renouard 1956).

In all the collected parts (plates, bracket, profile and rivets), particles in the micron range are observed (See Figure 2). These coarse particles (> 1µm) are intermetallic phases generally encountered in this type of Al-alloys (Hughes *et al.* 2013) (Mondolfo 1976). Analysed with EDS, particles in A-U4G and A-U4G1 alloys are composed of Al-Cu-Mn-Fe-Si, Al-Cu, Al-Cu-Mg and/or Al-Mg-Si. For the A-U3G alloy, only Al-Cu-Fe particles were found. Such coarse intermetallic particles are normally deleterious for mechanical properties: they can cause cracks as well as corrosion. It is thus, important to document them in terms of size and density for understanding the possible alteration of historic alloys.

nanometres to a few hundred nanometres and homogeneously distributed. Formed during the homogenisation heat treatment and always containing manganese in Duralumin, the dispersoids are partly responsible for the hardness of the material by limiting the size of the grains in the alloy. In A-U4G1, the dispersoids are rod-shaped (Figure 3.a L2 plate) and their composition is AlCuMn, whereas in A-U4G, their forms are ovoid (Figure 3.b L8 plate and 3.d RL2 rivet) with AlMnSi composition. In A-U3G, there is hardly any dispersoids (Figure 3.c RL1 rivet) due to the absence of manganese in the alloy composition. This explains the larger grain size in this rivet observed in Figure 2.f.

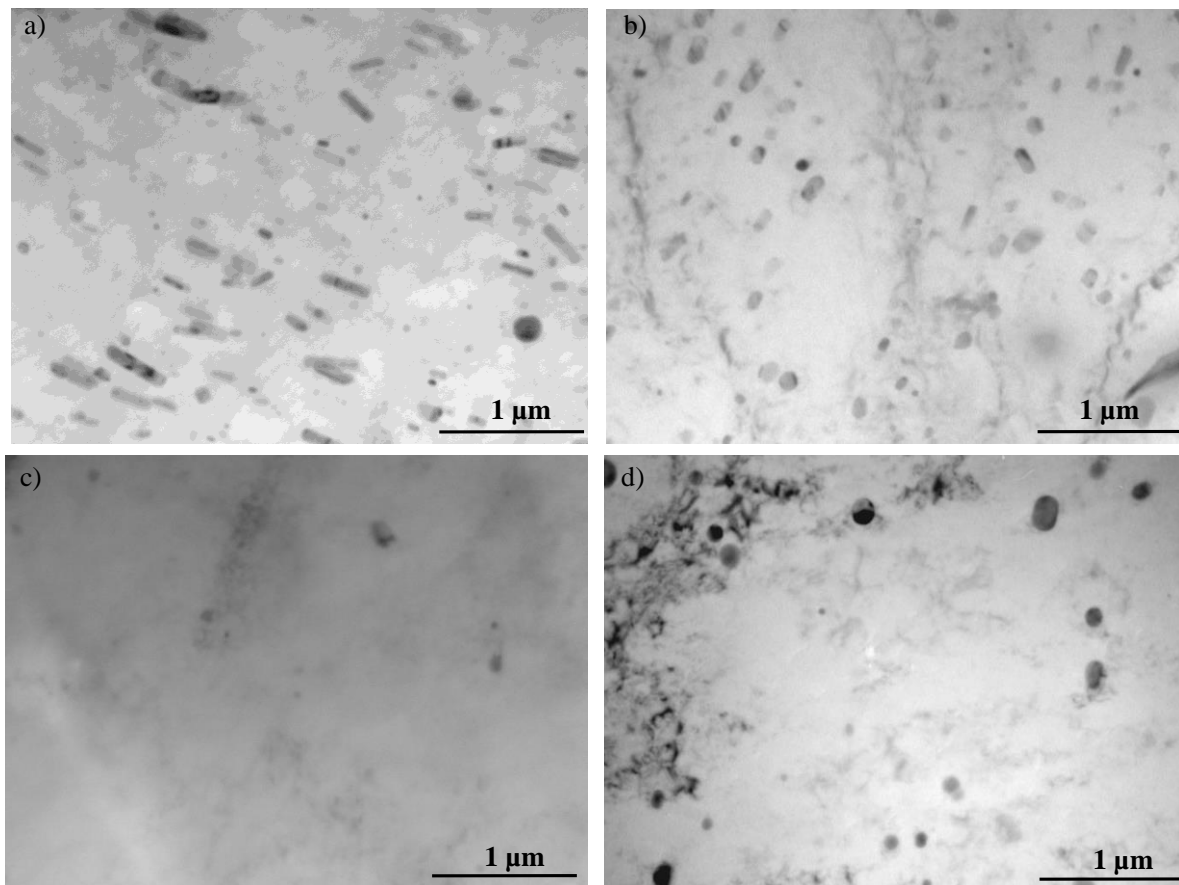
Figure 3. Observations by TEM of dispersoids in top row (bright field observation): a) plate L2 (A-U4G1), b) plate L8 (A-U4G), c) rivet RL1 (A-U3G) and d) rivet RL2 (A-U4G).

At a higher scale, Figure 3 shows TEM images (Bright field) of the concerned alloys. One can see dispersoids, particles of about ten

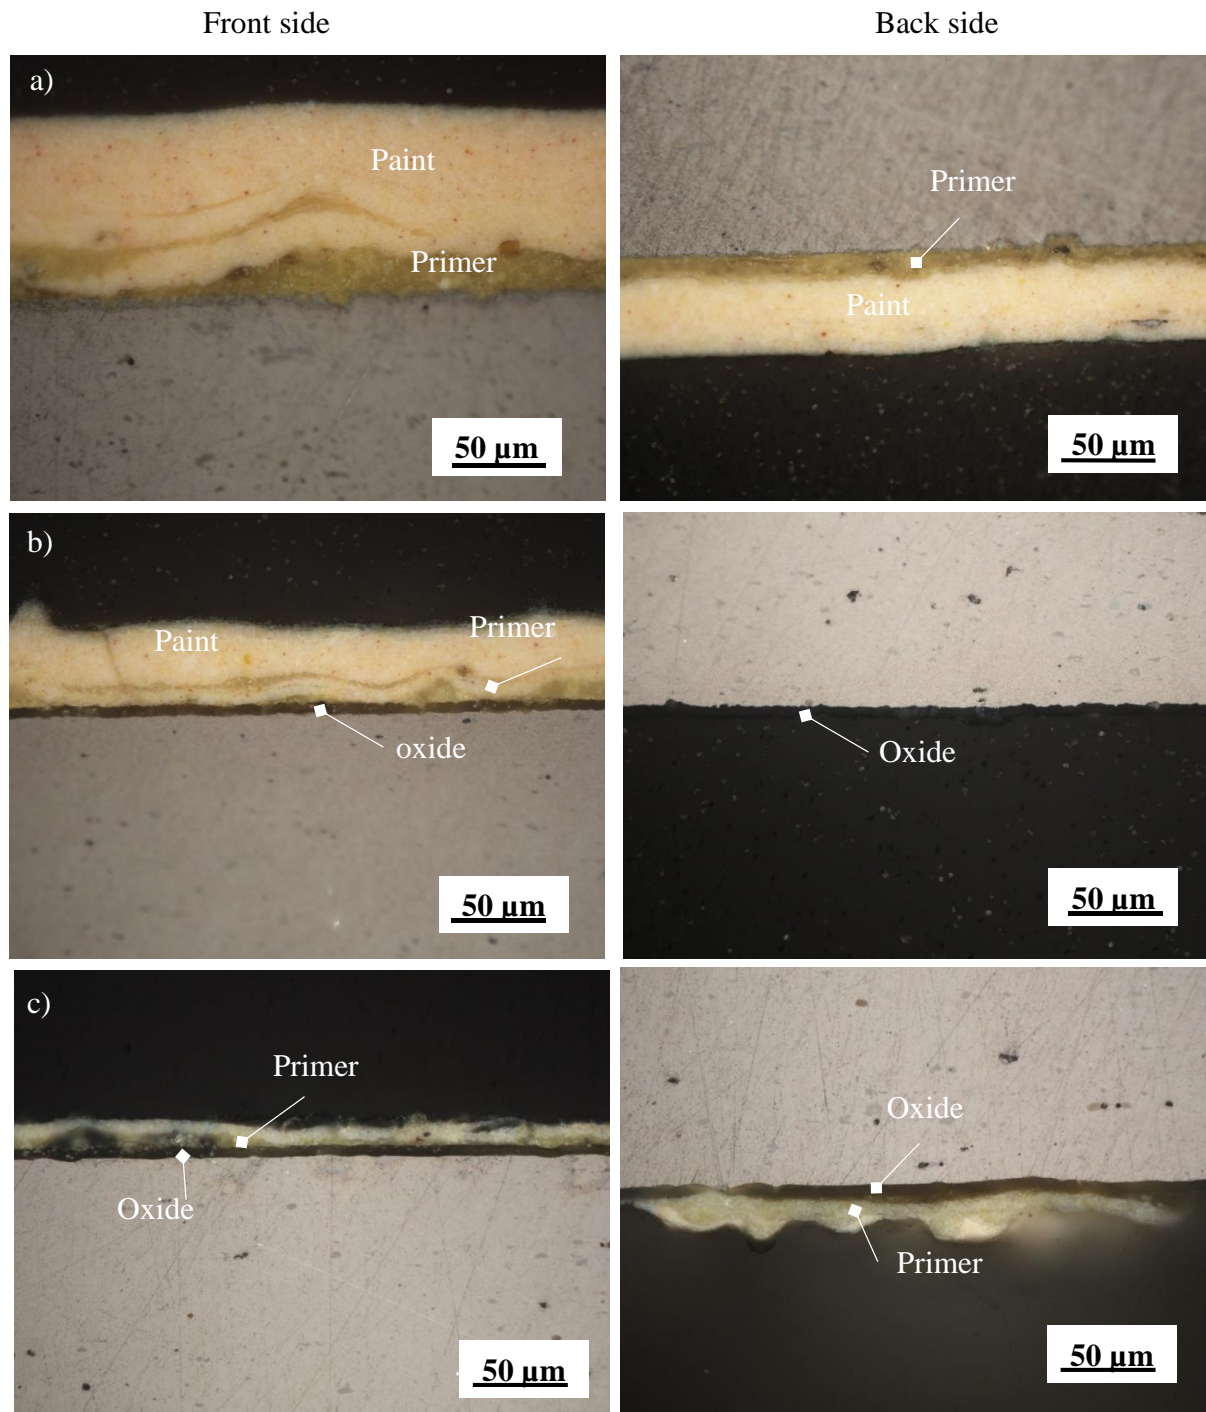
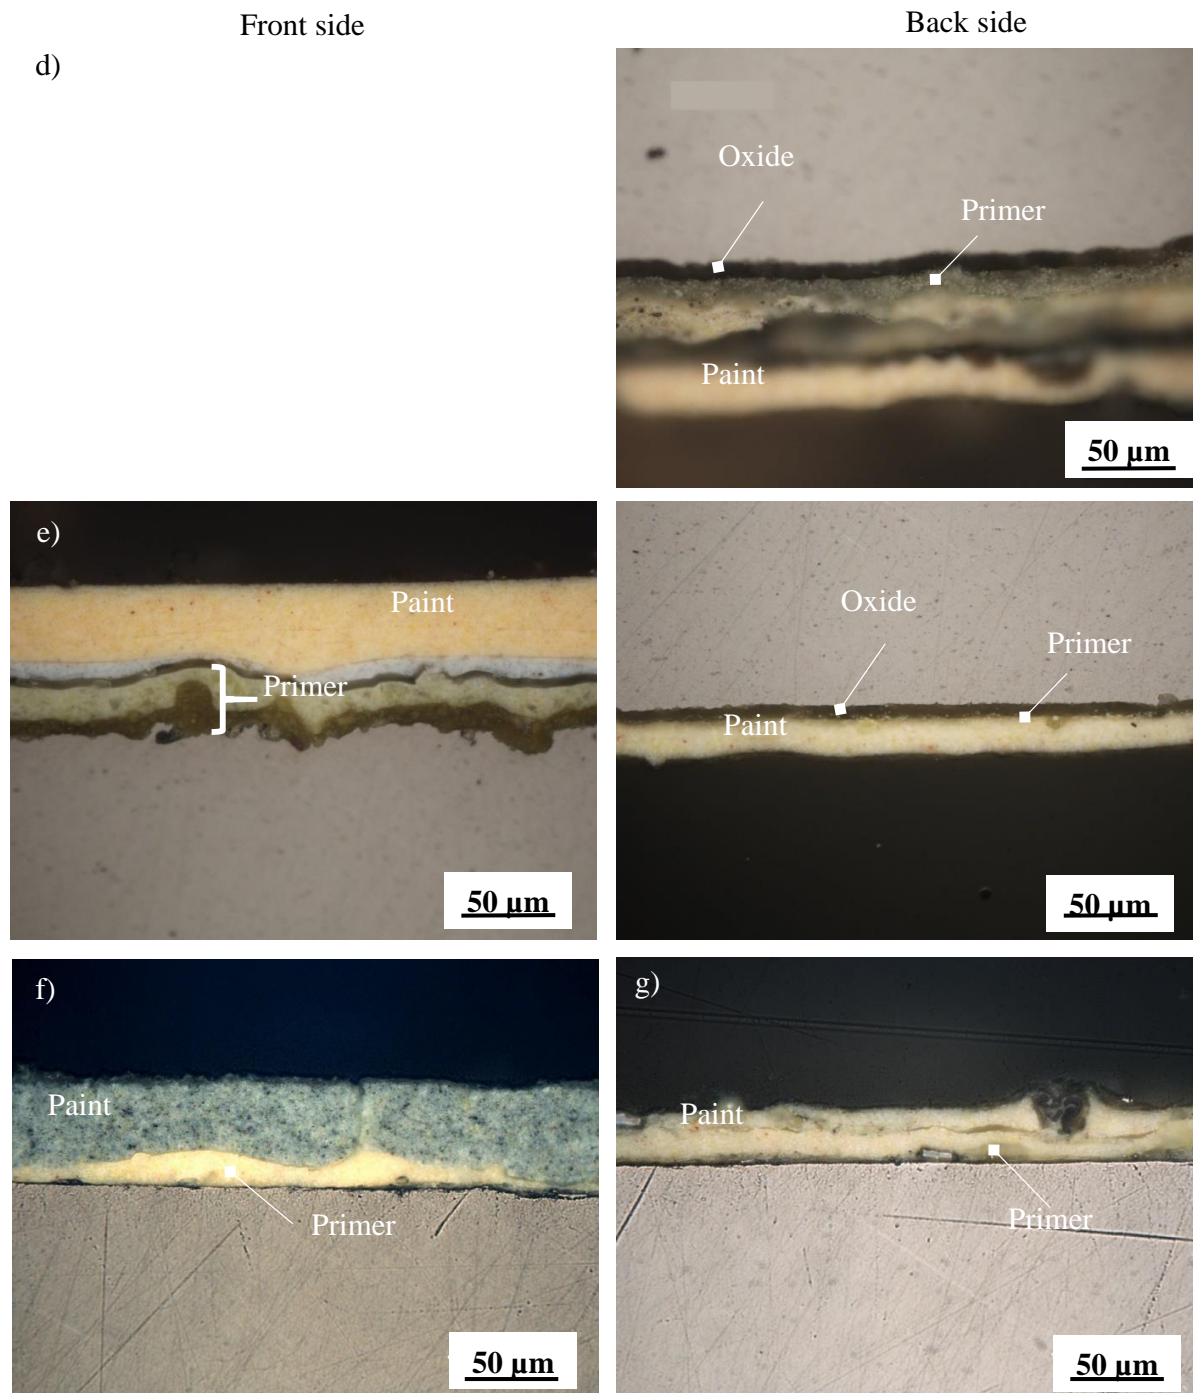
Figure 4. Optical microscope images (dark field mode) of protective coatings for both sides: a) L2, b) L8, c) L20, d): L9, e) L15, f) RL1, g) RL2. For L9, the front side was completely corroded and the coating no longer existed

For each selected metallic part, the two surface sides were observed and analysed: the front side and the back side. The front side is defined here as the accessible or visible side when the part is still assembled on the aircraft, while the back side is in contact with another part when assembled, therefore non-accessible. Representative sections for all the coatings are reported in Figure 4 with possible identification. The nature of each layer was determined thanks to SEM-EDS analysis and XRD. On the bracket L9, the front side is too much altered by corrosion to detect any protective coating left. As seen in Figure 4, the protective coatings are quite different between the collected parts and between sometimes the front side and the back side for a same part. Nevertheless, some similarities exist. The transparent layer directly on the surface of the aluminium, detected on both sides of L8, L20 and on the backside of L9 and L15, is identified as an aluminium oxide with traces of sulphur. This oxidation layer is between 6 and 9 μm thick depending on the investigated part. On the plate L2 and on the rivets RL1 and RL2, no oxide layer is detected. Then, the light green layer on top of the oxide, seen on L9, L2, L8, L20, RL1, RL2 and on the backside of L15 is an organic layer containing chromium, zinc and phosphorous. XRD pattern collected on the light green layer (on L2 and L8 samples) allowed us to identify a zinc chromium oxide hydrate of formulae $Zn_2CrO_5 \cdot H_2O$ (PDF 11-0277) mixed with ZnO (PDF 89-0510) and TiO_2 rutile (PDF 89-0554). On the profile L15, the front side appears very different from the back side and to the other parts (see Figure 4.e). On the front side indeed, no oxide is found (as opposed to the back side) and the primer is composed of two layers of different colours: a darker green layer at the surface of the aluminium and a light green layer on top as revealed from the EDS maps in Figure 5.

This double-layer, thicker and more resistant than the primer found on the other collected parts seems to have a similar nature but with a different composition. As shown in Table 2, it has a much higher phosphorus content (about 9 wt.% in the dark green) compared with 1 to 2

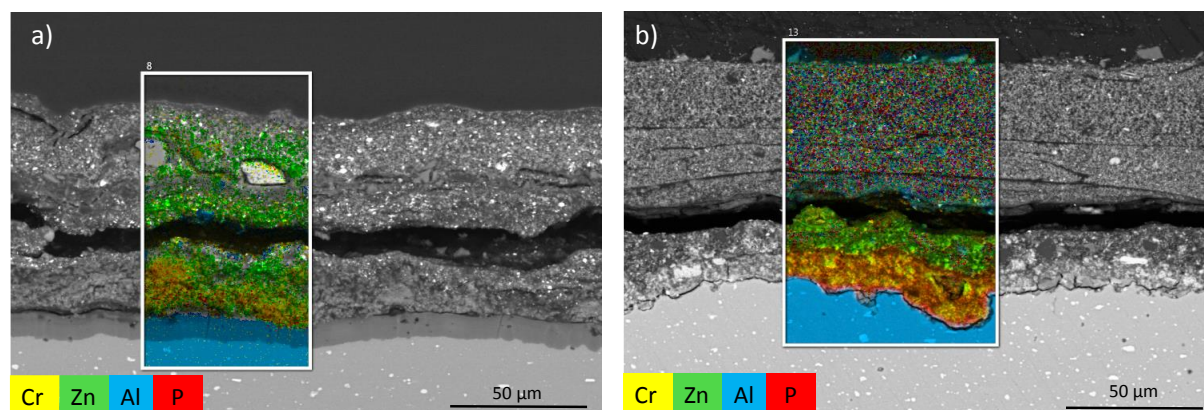
Figure 1. Coating detected in L9 (back side) and L15 (front side) with SEM: backscattering image and EDS maps. Only Zn, P, Cr and Al are shown. In blue: Al-alloy, green: zinc, yellow: chrome and red: phosphorus.
