## **Evaluation of thirty eight cemented pegged glenoid components with variable backside curvature: two-year minimum follow-up**

# Evaluation of thirty eight cemented pegged glenoid components with variable backside curvature: two-year minimum follow-up

## Abstract

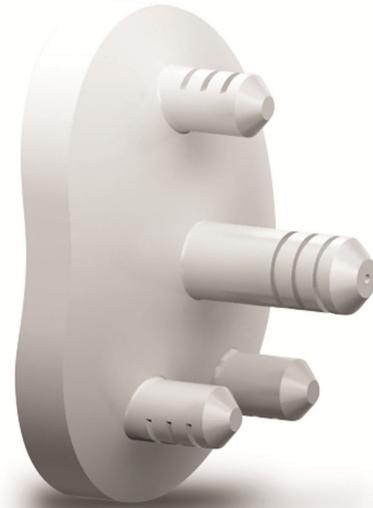
**Fig. 1** The PERFORM™ pegged glenoid component

The PERFORM™ pegged glenoid component (Wright-Tornier, Inc., Edina, MN, USA) has been used in our institution since 2012. This implant has a convex back, with a long central peg, and three peripheral pegs, one superiorly and two inferiorly, all for cement fixation (Fig. 1). Available sizes include five radii of curvature (30, 35, 40, 50, 60 degrees), and two sizes per radius (small/medium for 30°; small/medium for 35°; small/medium for 40°; large/extra-large for 40°; large/extra-large for 50°; and large/extra-large for 60°) or 12 components. The radial mismatch between the radius of curvature and the humeral head is variable according to the size of the humeral head and the glenoid component.

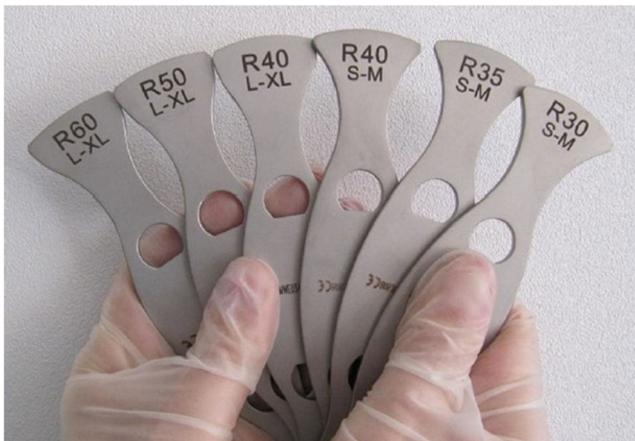
**Fig. 2** The six different gauges used to evaluate the glenoid curvature

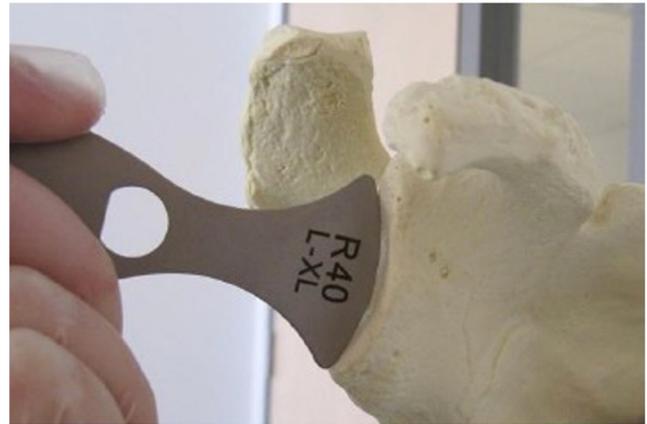
**Fig. 3** The glenoid radius of curvature was identified

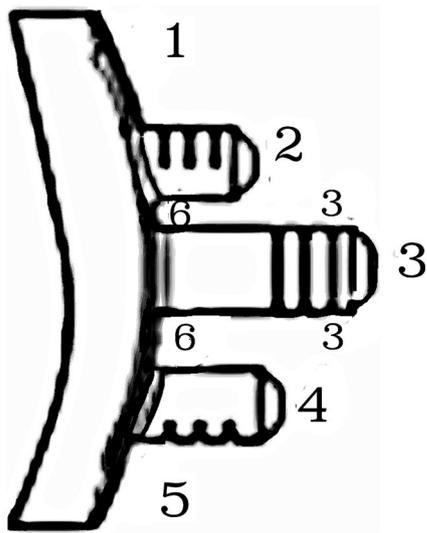
**Fig. 4** The six zones defined around the component to evaluate the incidence of RLL

Post-operatively, specific attention was focused on the presence of radiographic lucent lines (RLL) around the glenoid component according to the six zones described around the component (Fig. 4). Using the system described by Molé et al. [13], score ranged from 0 point for no radiolucency, to 18 points for RLL exceeding 2 mm in the six zones (Table 2). Correct seating of the glenoid component on the glenoid surface was also evaluated according to the method of Lazarus et al. on a scale of A to E [9] (Table 3). Finally, the presence or absence of penetration of the pegs through the scapula cortex was also noted. A resident (FD) and a fellowship-trained shoulder surgeon (JL), who were familiar with the grading systems and who were not involved in the surgery or the post-operative care of these patients, evaluated the radiographs.

than 1-mm thickness and very limited. Localization of the lucent lines were mainly in zone 6 in 62.5% of the cases, and in zone 3 in 50%. According to Molé [13], the average RLL score was  $0.36 \pm 0.8$  points (0 to 3). At the last follow-up, RLL were observed around the glenoid component in 16 cases (42%). Localization were essentially in zone 3 in 75% of the cases, and in zone 6 in 56% of the cases. However, the RLL score was only  $1.3 \pm 2$  (0 to 10) ( $p < 0.001$ ). In one case, RLL score reached 10, but with an asymptomatic patient. Radiographic results are summarized in Table 3 (Fig. 5).

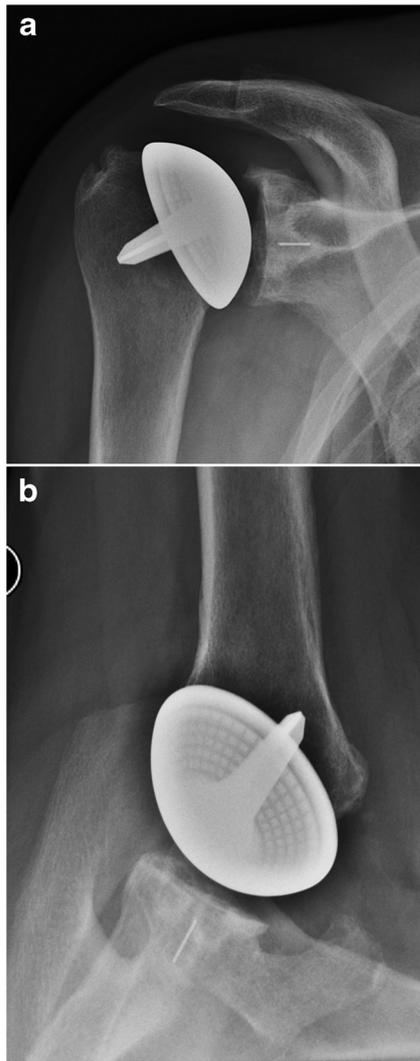
**Fig. 5** Anterior posterior view (a) and axillary view (b) of a resurfacing shoulder prosthesis with a perfectly seated and centered PERFORM™ pegged glenoid component

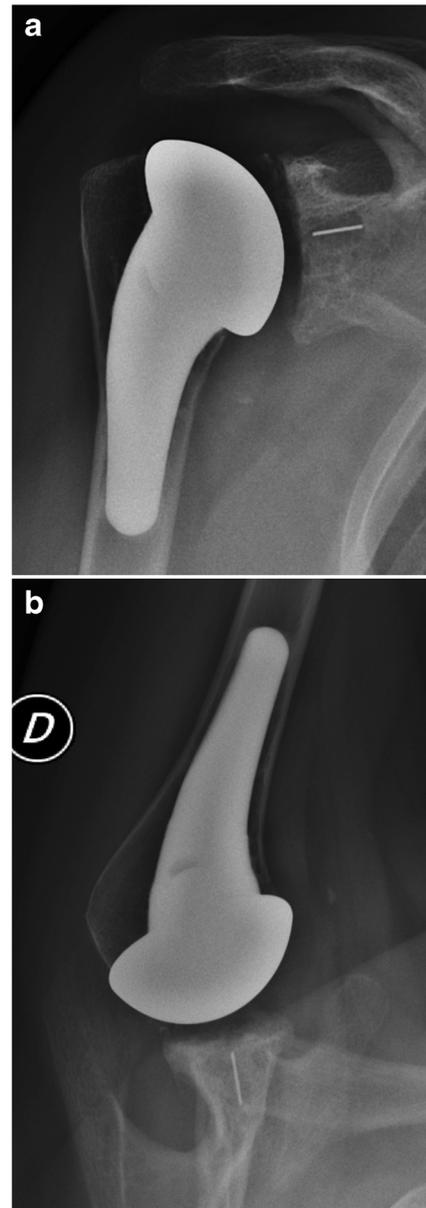
**Fig. 6** Anterior posterior view (a) and axillary view (b) of a short stem uncemented prosthesis with a perfectly seated and centered PERFORM™ pegged glenoid component

According to the Lazarus grading system, 29 components were staged grade A, two grade B, five grade C, and two grade D. There was no grade E in our study. No correlation could be found between glenoid seating and aetiology, pre-operative range of motion, type of glenoid wear, and type of humeral

prosthesis used. However, it was correlated with the post-operative RLL score ( $p < 0.05$ ) (Fig. 6).
