Entire Life Time Monitoring of Filament Wound Composite Cylinders Using Bragg Grating Sensors: III. In-Service External Pressure Loading

Hilario Hernández-Moreno, Francis Collombet, Bernard Douchin, Dominique Choqueuse, Peter Davies. Entire Life Time Monitoring of Filament Wound Composite Cylinders Using Bragg Grating Sensors: III. In-Service External Pressure Loading. *Applied Composite Materials*, 2009, 16 (3), pp.135-147. 10.1007/s10443-009-9082-x . hal-02139772

This article is the third of three papers describing a study of the monitoring of filament wound composite cylinders for underwater applications. Part I described the technological issues and the development of specimens instrumented with embedded gratings and thermocouples, with the aim of monitoring the temperature and strain changes during the cylinder manufacturing presented in Part II. Residual strains are not negligible, over 1,000 axial micro-strain at the end of the curing cycle. Part III describes the response of these cylinders to hydrostatic pressure loading. The same embedded fiber optical Bragg gratings (FBGs) used for parts I and II of the study are here used as strain gauges. Their response is compared t

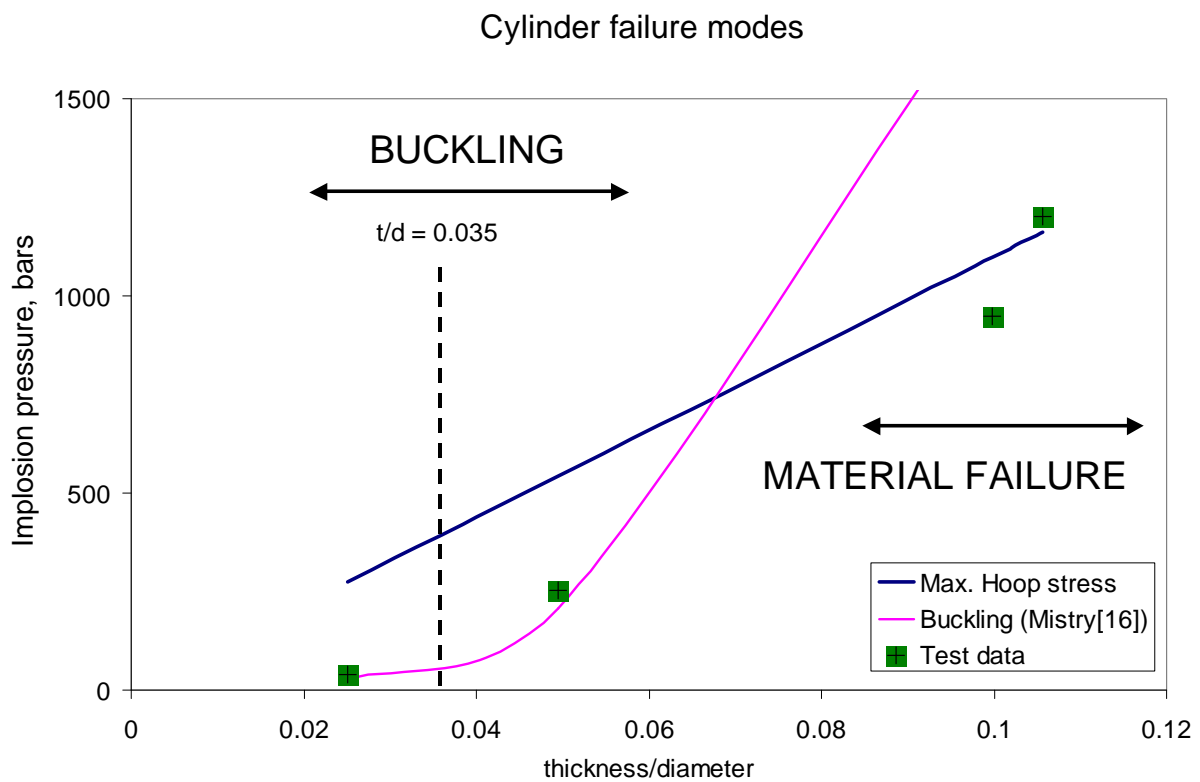
Figure 1. Implosion pressure versus thickness to mean diameter (t/d) ratio, showing transition between buckling and material failure modes.

Several recent publications have described the response of glass/epoxy composite cylinders to external pressure [11-14]. Two failure modes can occur; buckling, usually associated with thin walled tubes, and material failure in compression observed in thicker cylinders. Figure 1 shows the two failure regions, together with some IFREMER data for $\pm 55^\circ$ glass/epoxy cylinders. The limit between the two modes depends on the choice of failure criteria, both for buckling and material failure, and there is still considerable debate over the appropriate choice for this type of loading [15]. An analytical expression for buckling proposed by Mistry et al. [16] is plotted in Figure 1, together with a simple maximum hoop stress criterion for which the critical value is taken as 500 MPa for material failure. Given the uncertainty in predicting implosion pressures most applications rely on qualification testing. This is performed in pressure vessels, on tubes which are closed by metallic end plates. The design of these end closures, which determine the test boundary conditions, is particularly important when thick wall tubes are tested if premature failure is to be avoided [17] [18]. In a test cylinder, strain sensors (strain gages) are placed on the structure at the moment when the specimen is being prepared for testing, so the initial strain within the material is unknown, though sometimes it can be estimated. One aim of the present study is to include the specimen residual strain, which is measured during fabrication, in the design of the pressure vessel. For this it was necessary to demonstrate that the same Bragg gratings could be used to follow both manufacturing and pressure testing.

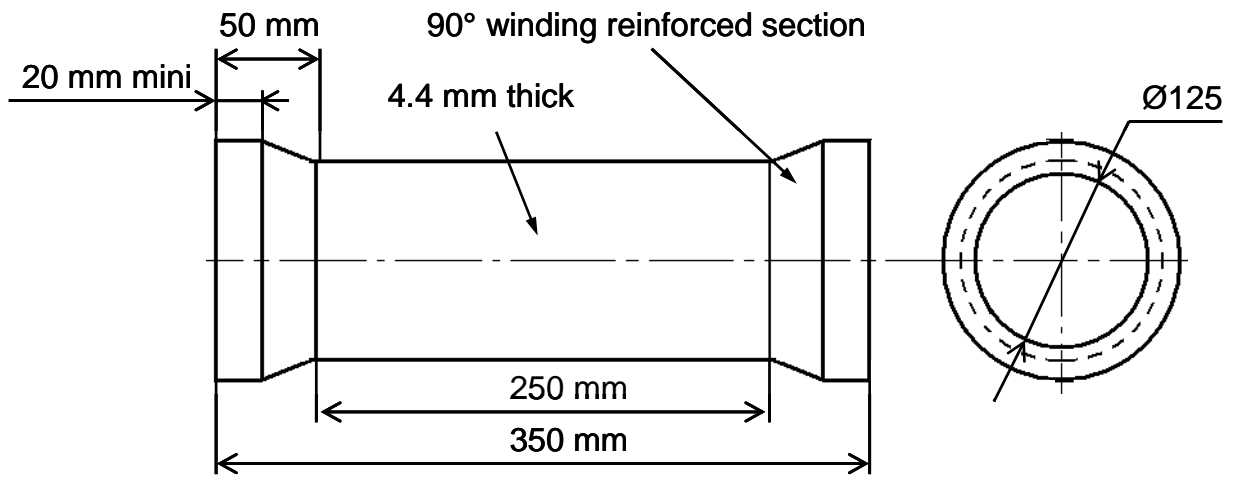
Figure 2. General dimensions of specimen with machined ends.

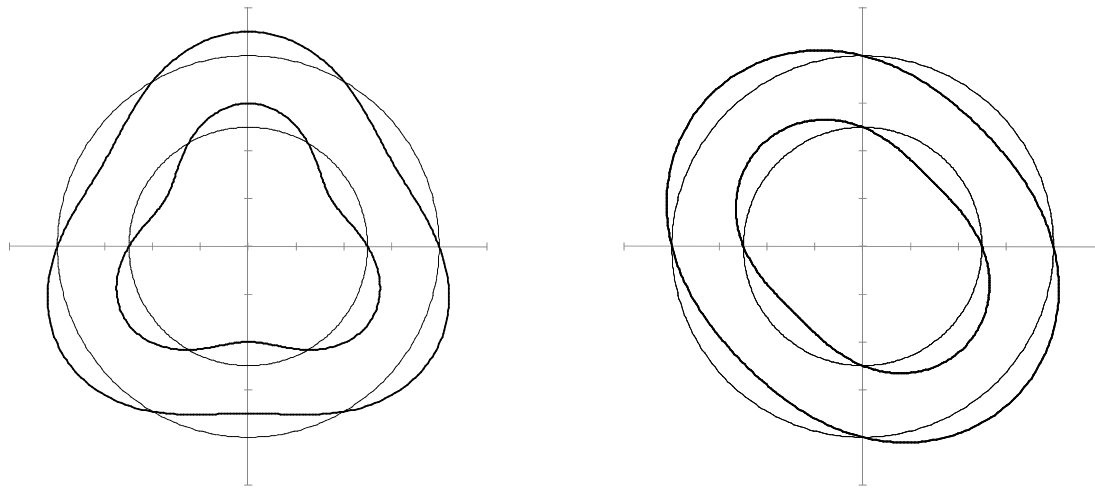
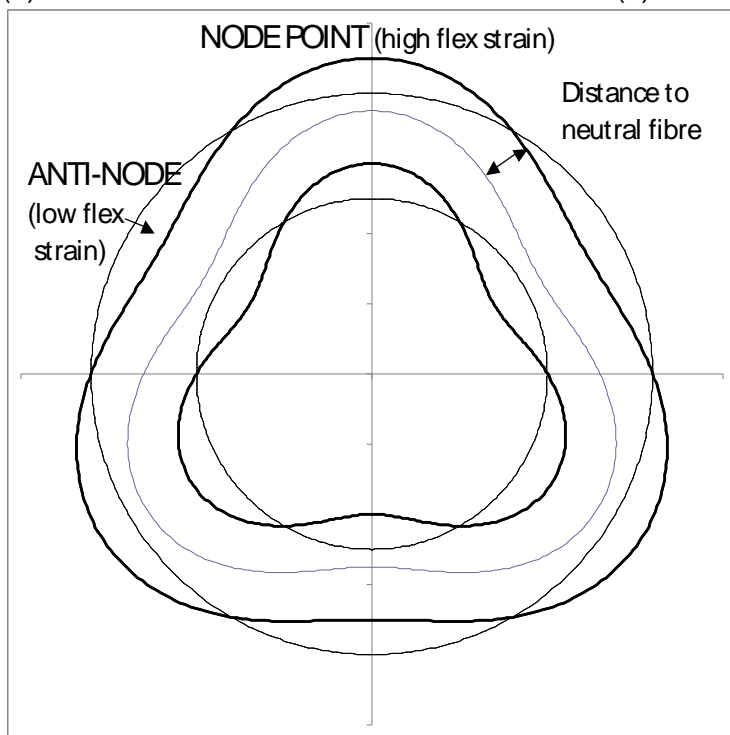
Figure 3. a) Mode 2, b) Mode 3 mode-shapes and c) Strain sensitivity at different points.

Taking into account the failure mode of cylinders under pressure (buckling) the sensor must be placed on the structure at the adequate location in order to be sensitive to the resulting deformation. The sensor was therefore placed in the mid-section of the cylinder, between the first and the second ply of the structure. In plane deformations of the central part of the cylinder correspond to the sum of the global compression deformation of the structure and the flexural deformation induced by the buckling mode of the structure. The flexural deformations of the ring induced by the buckling of the structure for the more common mode-shapes (modes 2 and 3) are shown in figure 3a and 3b. This indicates that the flexural deformation depends on:

The response to flexural deformation of a sensor will be zero if it is placed at a node point of the mode-shape and maximum at the anti-node point, Figure 3c. In the same way the sensor placed on the surface of the material (outer or inner) will have the maximum sensitivity to the flexural deformation while a sensor placed at the mid thickness of the material will not measure any bending strain. In this initial study to validate the use of embedded optical sensors the cylinder was equipped with two Bragg gratings, one placed in the axial direction and the second lying along the circumference, as shown in Figure 4a. Results from fabrication monitoring indicated the presence of residual strains. Residual strains at 21°C for this cylinder at the end of manufacturing were: in the axial direction $-1025 \mu\epsilon$, in the circumferential direction $70 \mu\epsilon$. For this test, one end closure was provided with a sealed passage tube, in order to connect the optical fibers to the chamber cover. In order to monitor strains during the entire service life of the structure (up to 10 years for some underwater applications) the optical fiber must be carefully protected from the external environment. The main objectives are:

When pressure-strain diagrams are analyzed (Figures 12 and 13), a critical pressure can be observed around 5.5 MPa (the pressure at which the pressure versus strain plot becomes non-linear). Beyond this point, a Bragg grating hysteresis response is observed, which is not detected by the strain gages. The reasons for this hysteresis are not clear, more tests are required to investigate its origins. Observing each diagram between 0 and 5 MPa (before pressure reaches a critical value), the Bragg grating strain response follows a very similar slope to that of the strain gages, within the variations between the strain gages (due to different flexural strains at different points on the mode-shape as indicated in Figure 3c).

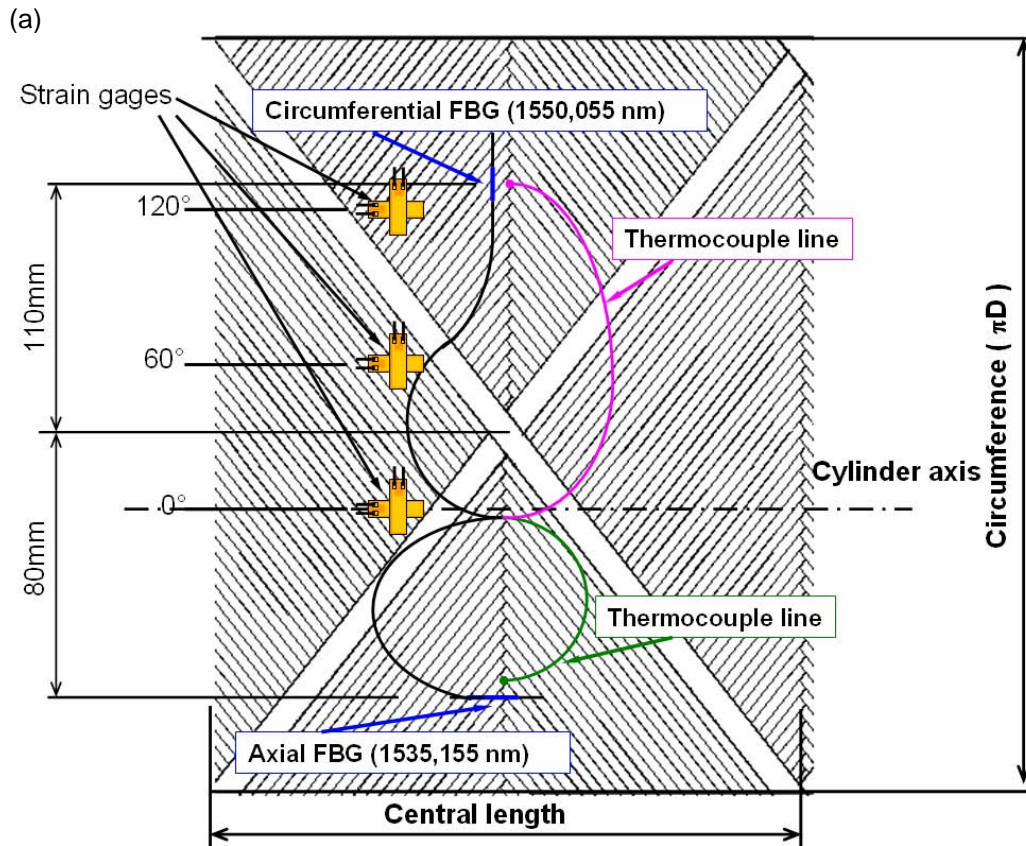
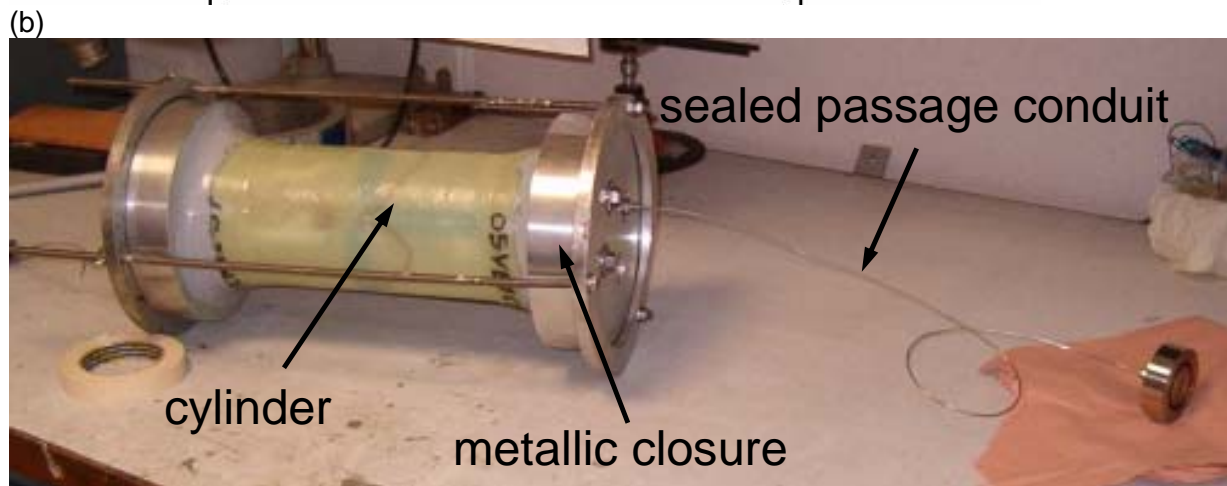
Figure 4. Instrumented cylinder with a) Strain and temperature measurement points, b) Complete cylinder and closure system before external pressure testing in hyperbaric chamber.

This cylinder was also instrumented with strain gages to compare with the Bragg grating results. These were bonded on the inner surface of the cylinder, three in the circumferential direction and three in the axial direction, but only one of the latter functioned correctly during the test. These are also shown on Figure 4a. The conditioned cylinder before testing is shown in figure 4b. The test was performed using the 1000 bar capacity hyperbaric testing chamber shown in figure 5.

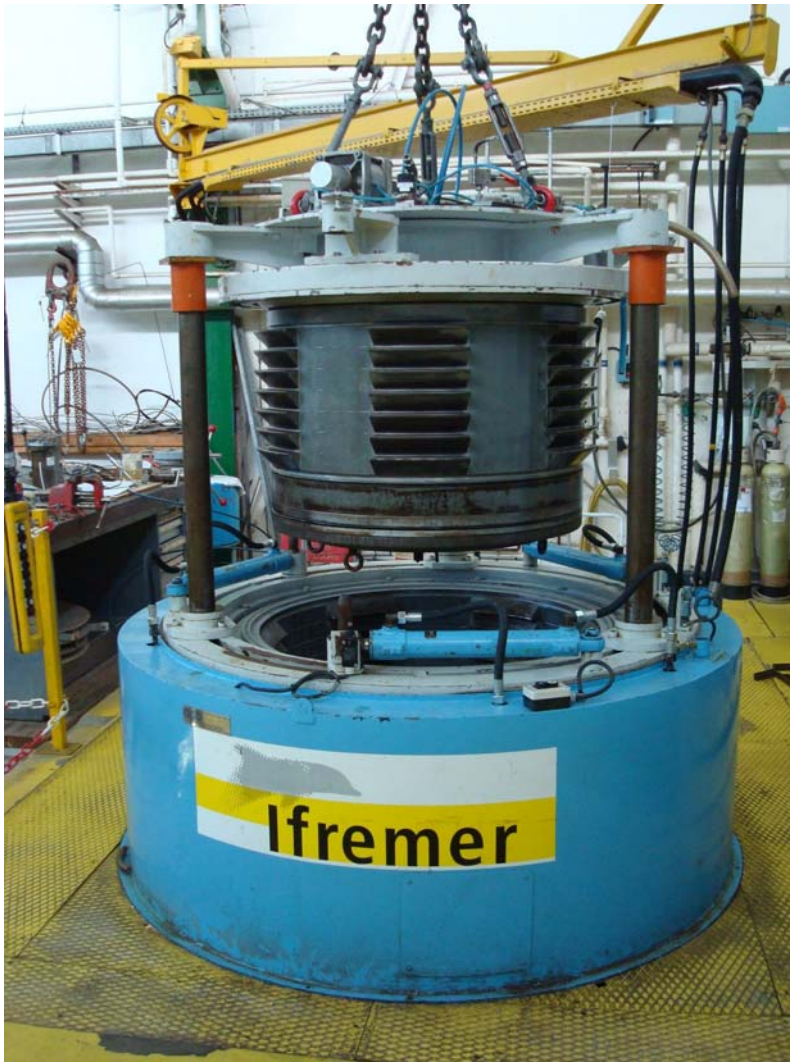
Figure 5. 1000 bar hyperbaric pressure testing chamber.

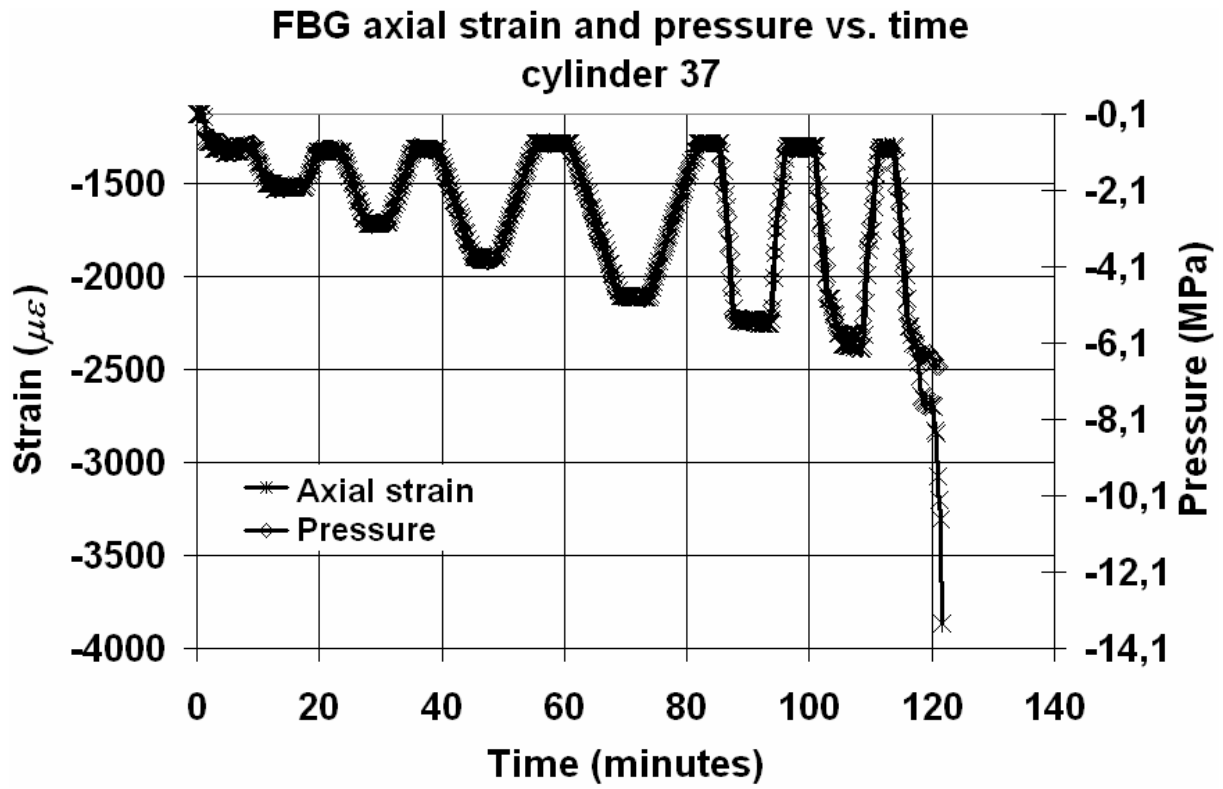
Figure 6. Axial strain from Bragg grating and pressure vs. time.

Loading and unloading pressure cycles were applied, Figures 6 and 7, with pressure increments of 10 bar, starting at 10 bar. Once the pressure had stabilized at 10 bars, the first loading – unloading cycle was composed of a pressure ramp until 20 bar, followed by a constant pressure segment lasting 5 minutes and an unloading ramp to 10 bars. Subsequent cycles have the same shape, but each time the final value is higher by 10 bar. The loading and unloading rate was 1 MPa/min for the first 4 cycles (up to 5 MPa) then increased to 3 MPa/min for the last 3 cycles (up to collapse). During the entire test, strain responses from gages and pressure signals are recorded with a data acquisition system, with a sampling frequency of 4 readings per minute. This sampling frequency is limited by the data acquisition program available, which was developed to interrogate a large number of strain gages inside the pressure vessel via a single connecting cable. Central Bragg grating wavelengths were recorded continuously using a different acquisition system with a higher frequency of 5 Hz. Bragg grating wavelengths are transformed into strains following the

The Bragg grating strain response is initially proportional to pressure (Figures 6 and 7), but for the last three cycles there is a slight deviation, which may indicate a change in shape due to buckling or damage initiation. Bragg grating data is recorded for slightly longer than the pressure data at rupture due to the difference in sampling periods, 15 s for the pressure gage and 0.2 s for Bragg gratings, indicating the functionality of the latter until the last moments of the specimen life.

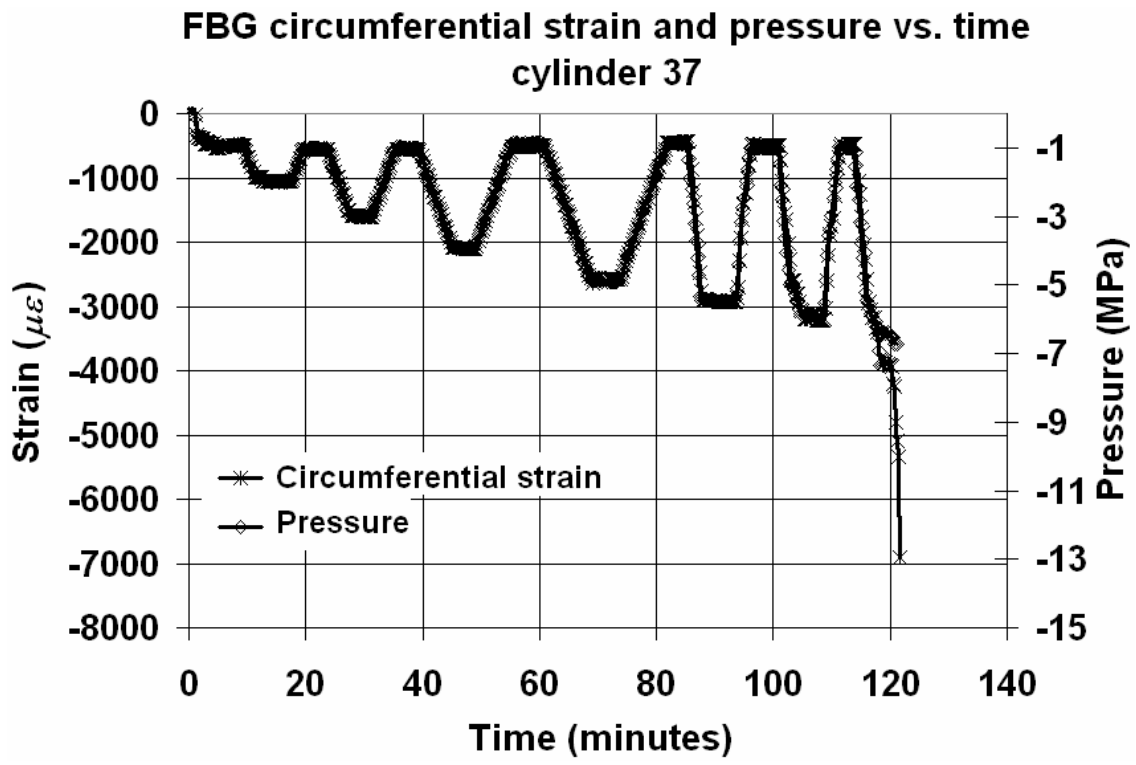
Figure 7. Circumferential strain from Bragg grating and pressure vs. time.

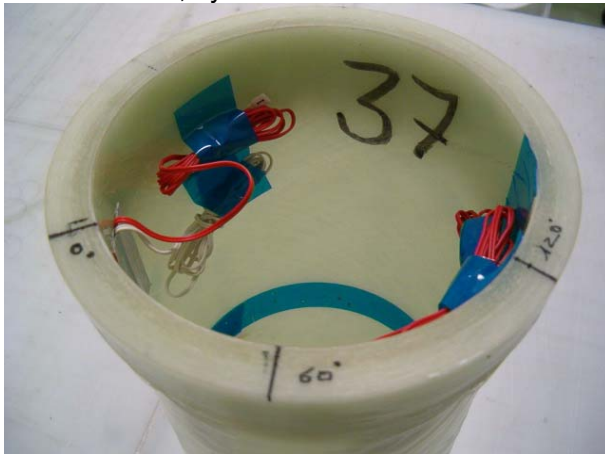
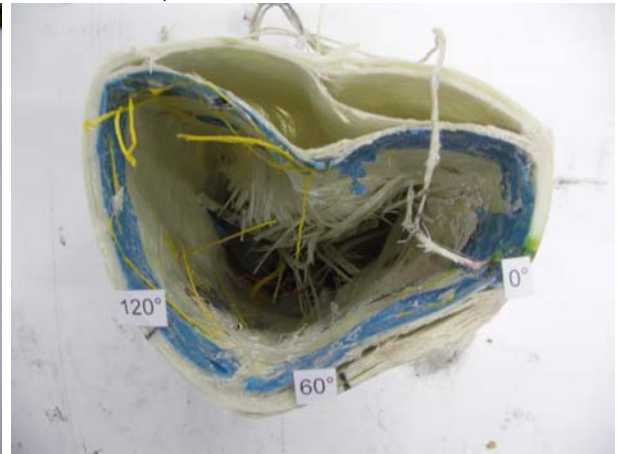
a. Before test, cylinder end

b. After test, mid-section

Figure 8. a) Cylinder before test, b) Cylinder mid-section after implosion, buckled mode $n=3$.

Results from the five initial tests to failure indicated a mean value of implosion pressure of 6.5 MPa, with a standard deviation of 0.4 MPa (Table 2), as described previously [19]. In all but one case the cylinders buckled with a 3-lobe circumferential failure mode. The implosion pressure for the test on the cylinder with the Bragg grating was 6.7 MPa, which is within one standard deviation of the mean value obtained on non-instrumented specimens, and showed the same 3-lobe buckling failure mode, Figure 8. This result indicates that the embedded instrumentation has no significant influence on mechanical strength at implosion.

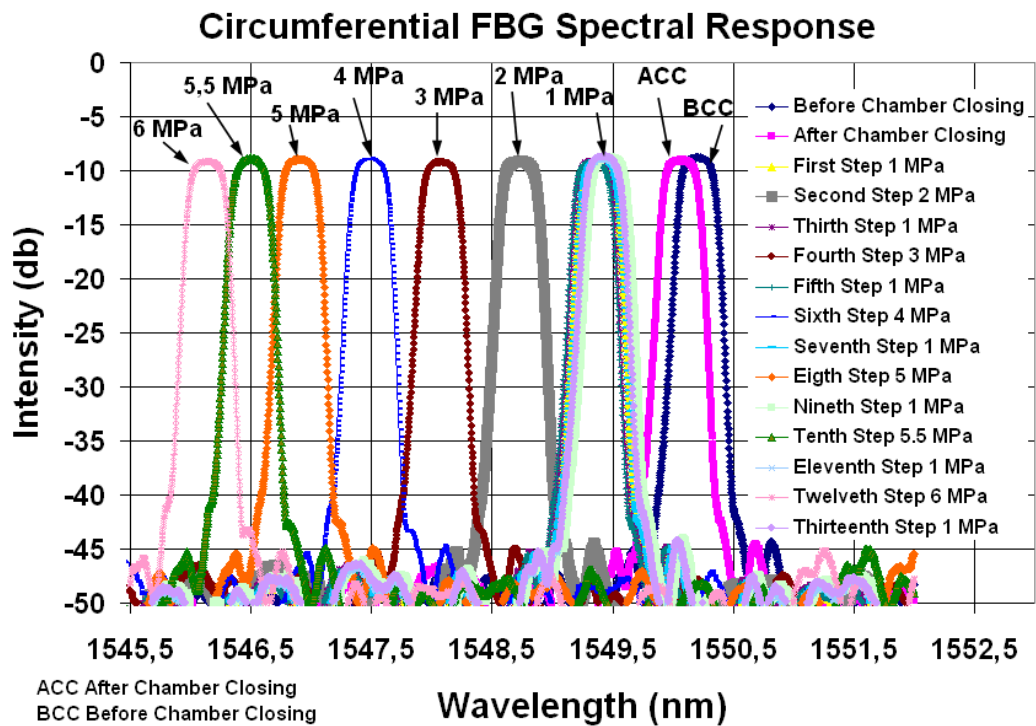
Figure 9. Circumferential FBG spectra during pressure test cycles.

Spectral response of both gratings (axial and circumferential) were recorded at specific points during the test, specifically before and after pressure vessel closure and at the different pressure steps (10, 20, 10, 30, 10, 40, 10, 50, 55, 60, 10 Bar), in order to check for any spectrum shape variation. Examples of circumferential grating spectra are shown in Figure 9, the axial spectra are very similar. Analyzing spectral response it can be seen that throughout the test, the shape of spectra does not vary, this means that loads transverse to the optical fiber axis do not influence the grating response significantly, so the grating response is solely due to membrane strains and temperature (in this case the latter is almost constant).

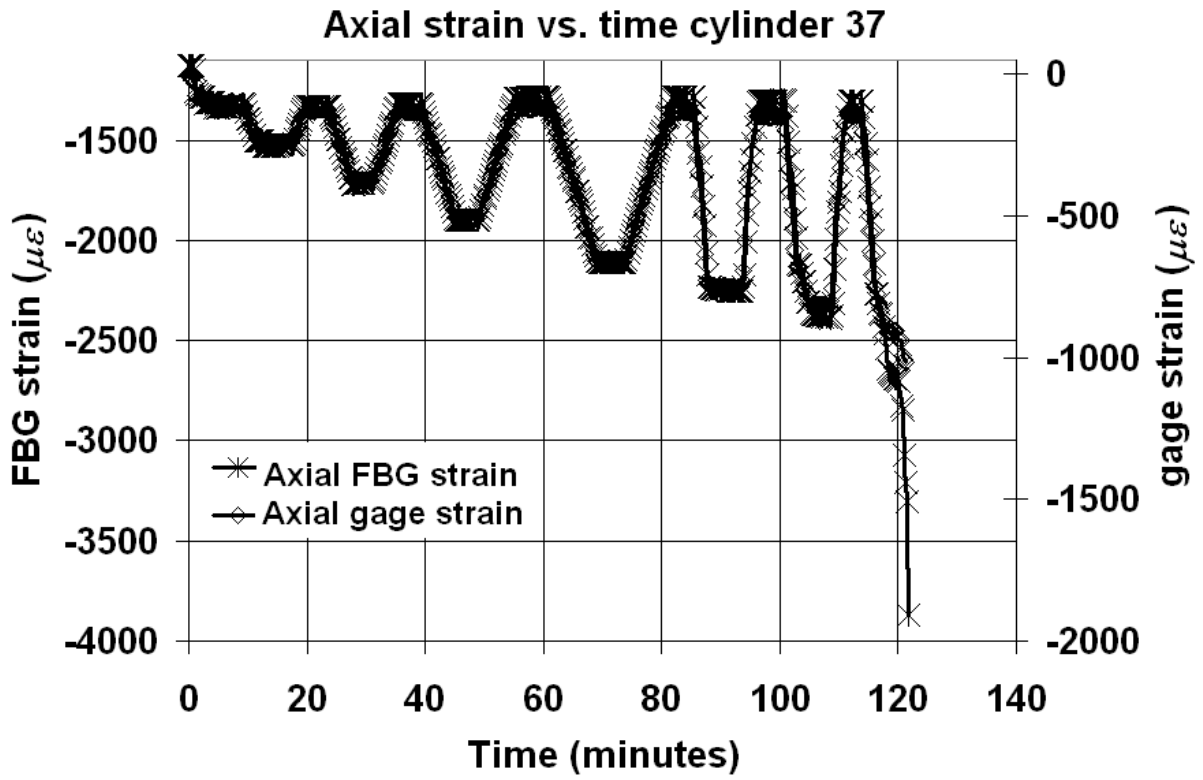
Figure 10. Bragg grating strain response and strain gage placed in axial direction.

The Bragg grating and strain gage responses show similar behavior (see Figures 10 and 11). As noted with respect to pressure, the Bragg grating strain during the last three cycles shows a small deviation compared with the strain gage values. As previously noted the absolute values measured will depend on the location of the measurement points with respect to the buckled shape. As the lobes develop some regions are more highly strained while others are unloaded, due to the induced local flexure. Only three strain gages were bonded round the circumference in this test, and this is not sufficient to represent the evolution of the buckled shape accurately. In order to be sure to capture the buckling mode correctly a larger number of strain gages are needed, and in some large cylinder tests over 100 can be used. In the axial direction the strain gage begins with an almost zero value while the Bragg grating already has $1128\mu\epsilon$ (Figure 8). This is due to the fact that the Bragg grating followed the strain evolution from fabrication including residual strain. In the circumferential direction (see Figure 7), this difference is not obvious because the residual strain indicated by the Bragg grating at the beginning is only $21\mu\epsilon$. It is important to note that these residual strains evolved very little (by around 100 micro-strain) in the time between the end of manufacture and the start of the pressure test (6 months). This indicates that these are indeed permanent residual strains, which must be taken into account in cylinder design.

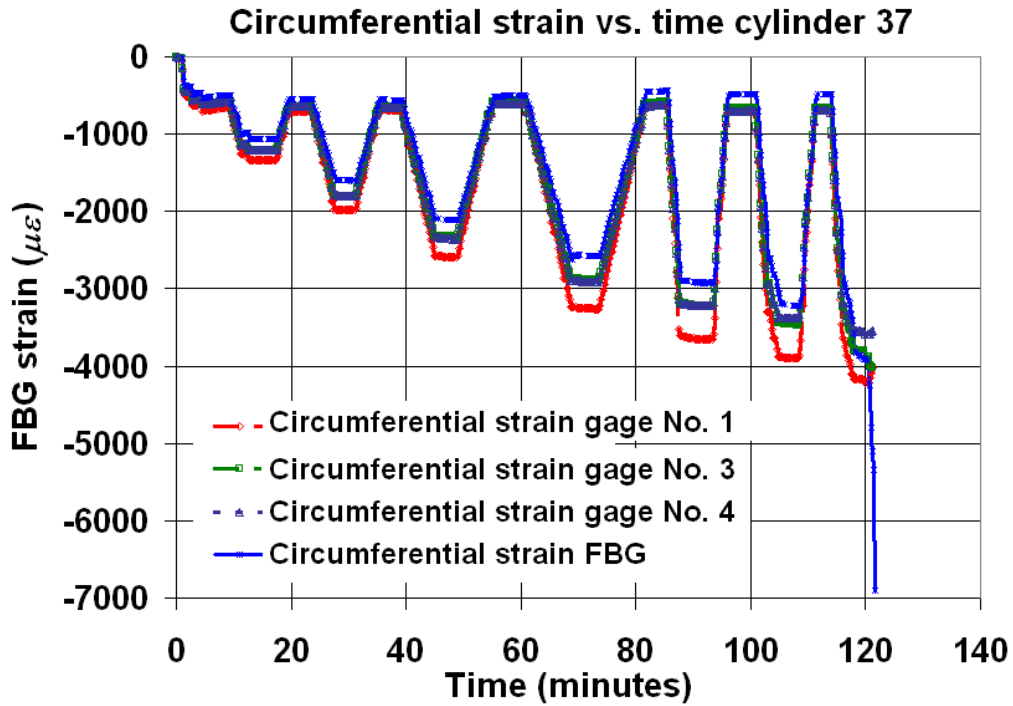
Figure 11. Bragg grating and strain gage response in circumferential direction.

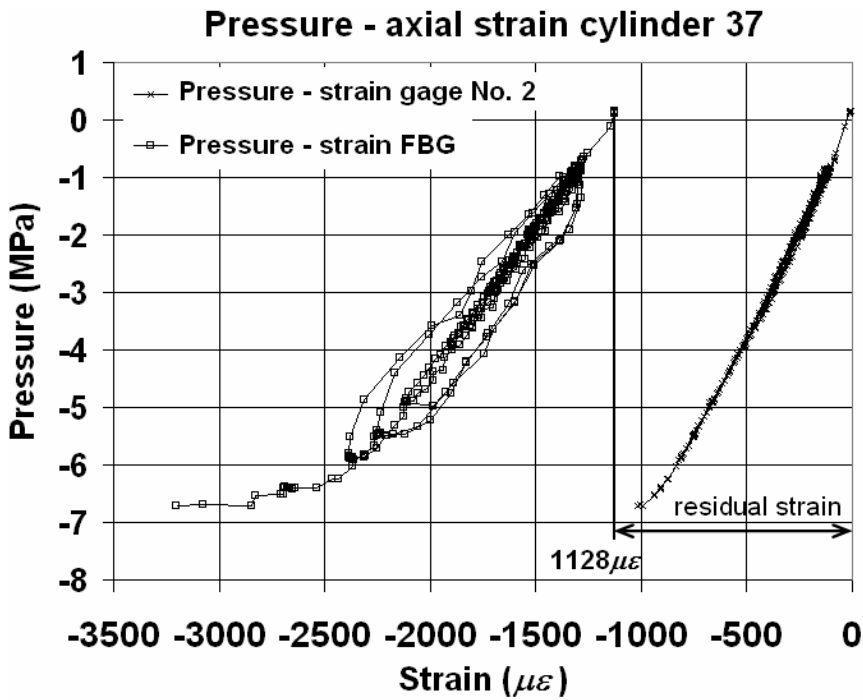
Figure 12. Axial pressure-strain plots.

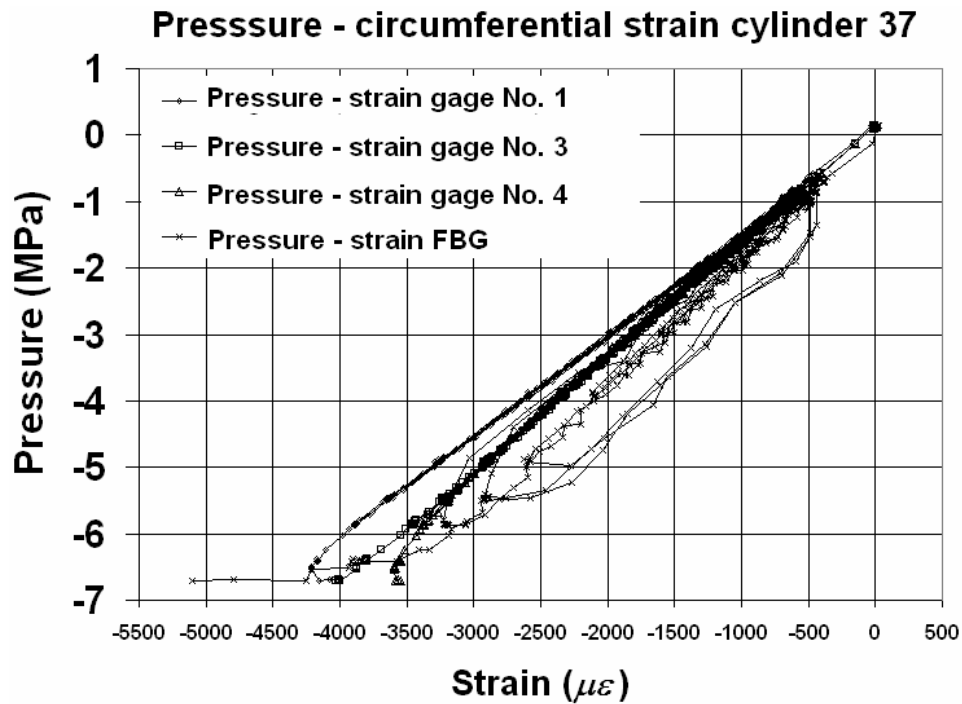
Figure 13. Circumferential pressure-strain plots.
