Anterolateral ligament injuries in knees with an anterior cruciate ligament tear: Contribution of ultrasonography and MRI

Marie Faruch Bilfeld, Etienne Cavaignac, Karine Wytrykowski, Olivia Constans, Franck Lapègue, Hélène Chiavassa Gandois, Ahmed Larbi, Nicolas Sans

Anterolateral ligament injuries in knees with an anterior cruciate ligament tear: Contribution of ultrasonography and MRI. (2017) *European Radiology*, 28 (1). 58-65. ISSN 0938-7994

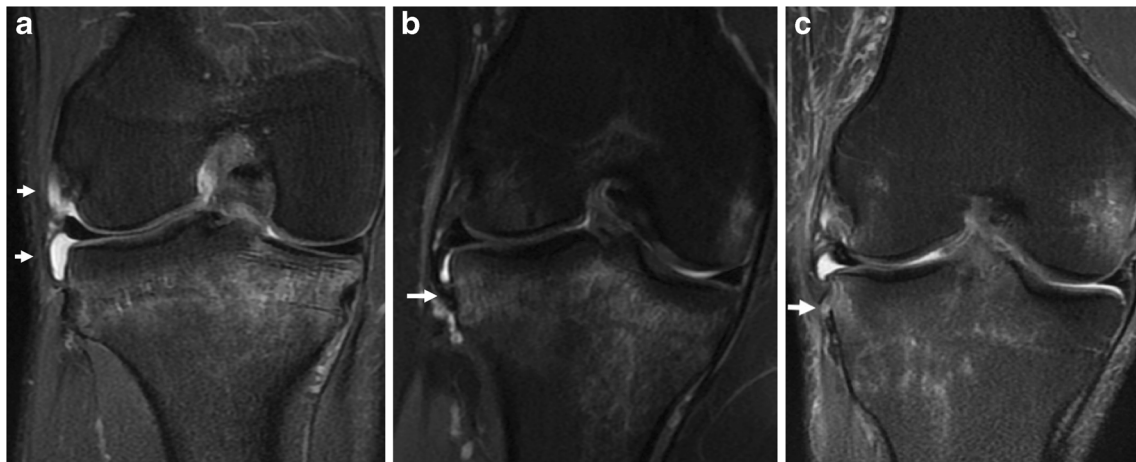
Fig. 1 Appearance of anterolateral ligament (ALL) on MRI. Anterolateral ligament of the knee in the coronal plane in fat saturated proton density weighted sequences. (A) Normal ALL. (B) Injured ALL:

hyperintensity at tibial insertion and increased thickness. (C) Segond fracture: bone avulsion at tibial enthesis combined with hyperintensity at thickened tibial insertion

The ALL was considered normal if a low-intensity linear structure was visible between the femoral epicondyle and tibial plateau [16, 17, 19, 23, 24]. The ALL was considered injured if it was torn or had high signal intensity with irregular contours [19]. Avulsion of the ALL at its tibial insertion was considered a Segond fracture [5, 23, 24]. The presence of bone oedema at the tibial enthesis was labelled grade 1 if it was less than 5 mm in diameter at its widest point, and grade 2 if it was more than 5 mm in diameter [25]. Figure 1 shows examples of normal and injured ALLs on MRI.

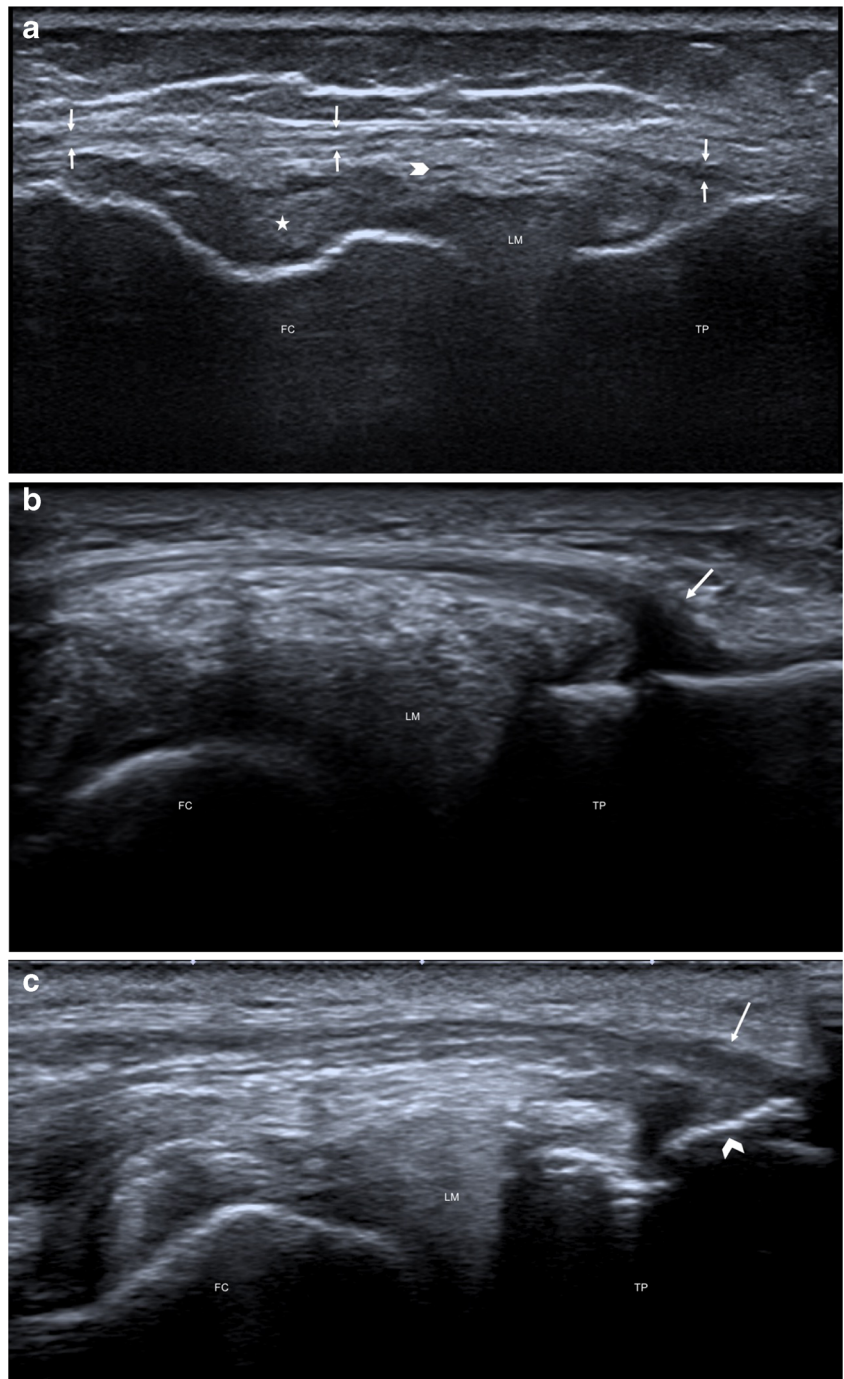
Fig. 2 Appearance of anterolateral ligament (ALL) on ultrasonography. Major axis of the anterolateral ligament of the knee; coronal plane image showing the ligament in the major axis. **(A)** Ultrasonography of normal ALL (arrows): hypoechoogenic, fibrillar, thin structure crossing superficially the inferior genicular artery (arrow head) and popliteal tendon (star). **(B)** Ultrasonography of injured ALL: the tibial insertion is hypoechoogenic and thickened (arrow) with fluid accumulation in the soft tissues around the ligament. **(C)** Ultrasonography of injured ALL: the tibial insertion is hypoechoogenic and thickened (arrow) and there is a bone avulsion at the tibial enthesis (arrow head), i.e. Segond fracture. *FC* femoral condyle, *LM* lateral meniscus, *TP* tibial plateau

ALL was considered normal if a fibrillar anisotropic structure was visible [18]. The ALL was considered injured if it was torn, stretched or hypoechogenic with irregular contours and fluid accumulated around the ligament. The thickness of the ALL was measured in the injured and contralateral knees at the level of the tibial plateau. Avulsion of the ALL at its tibial insertion was considered a Segond fracture and labelled an 'ultrasonographic Segond' [5, 24, 26]. Figure 2 shows examples of normal and injured ALLs on US. Figure 3 shows an example of different findings on ultrasound and MRI.

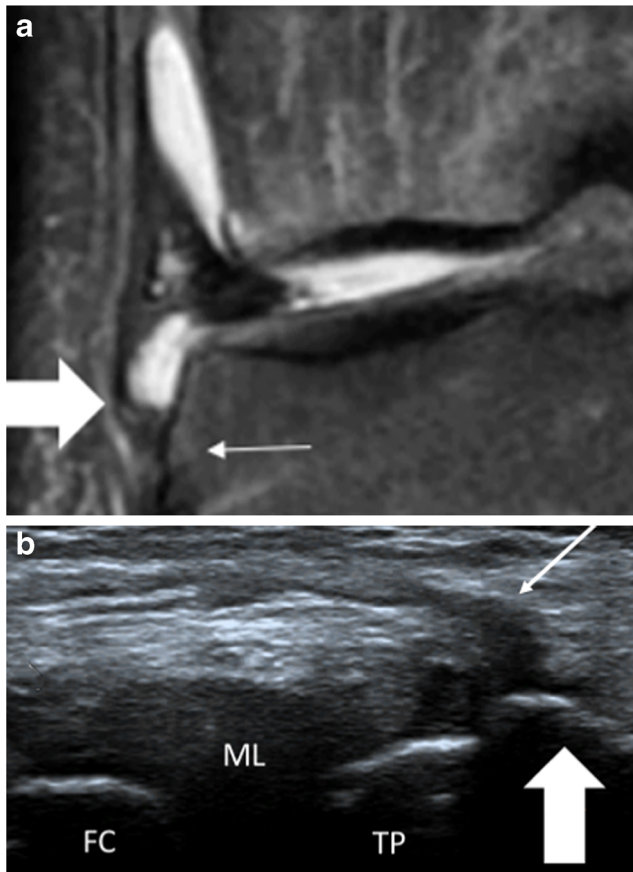
Fig. 3 Example of different findings on ultrasound and MRI. MRI coronal PD Fat Sat sequence (A) shows thickening at the anterolateral ligament (ALL)'s tibial insertion (thick arrow) without damage to the bone cortex at its enthesis, which is the site of grade 1 oedema. Ultrasound in the coronal plane (B) shows thickening at the ALL's tibial insertion (thin arrow) and a discontinuity in the cortex (thick arrow) at its enthesis. FC femoral condyle, LM lateral meniscus, TP tibial plateau
