## Crushing of composite tubular structures and energy absorption for aircraft seat development

Jean-Emmanuel Chambe, Olivier Dorival, Christophe Bouvet, Jean-François Ferrero

Jean-Emmanuel Chambe, Olivier Dorival, Christophe Bouvet, Jean-François Ferrero. Crushing of composite tubular structures and energy absorption for aircraft seat development. 18th European Conference on Composite Materials, Jun 2018, Athènes, Greece. hal-02149149

# CRUSHING OF COMPOSITE TUBULAR STRUCTURES AND ENERGY ABSORPTION FOR AIRCRAFT SEATS DEVELOPMENT

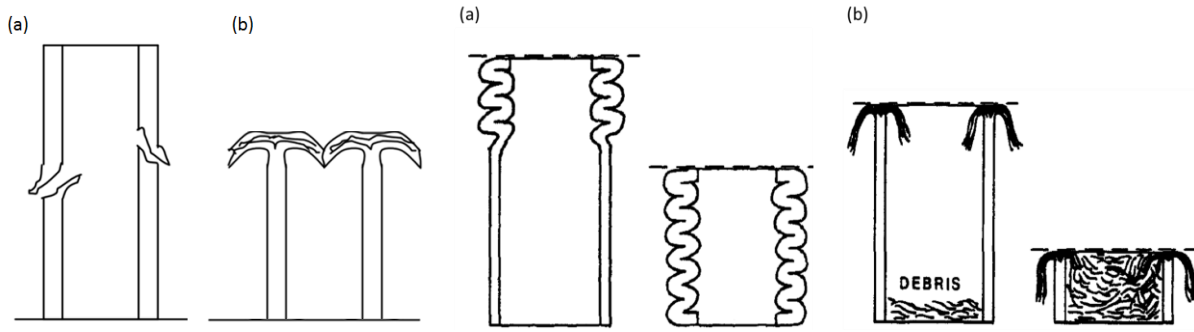
**Figure 1.** Catastrophic (a) and progressive (b) failure [2], progressive folding (c) and crushing (d) [3].

Two main failure mechanisms for composite tubular structures have been identified as either catastrophic or progressive failure [1, 2]. (Figure 1). For the latter failure mode, a distinction can be made as the composite tube may undergo progressive folding or progressive crushing [3]. (Figure 1). During the first case, composite tube walls progressively fold under successive local buckling (similar to shell buckling) when loaded in axial compression. The extremity of the tube yields in buckle mode, leading to hinge formation and progressive folding; the folded zone then grows progressively down the tube wall. For the second case, the tube collapses as a result of successive brittle fractures. The extremity of the tube breaks leading to the splaying of the tube wall and fragmentation. Local fracture occurs at the crush front; splaying and micro-fractures then propagate down the tube [3]. Such rupture tends to generate random sized debris.

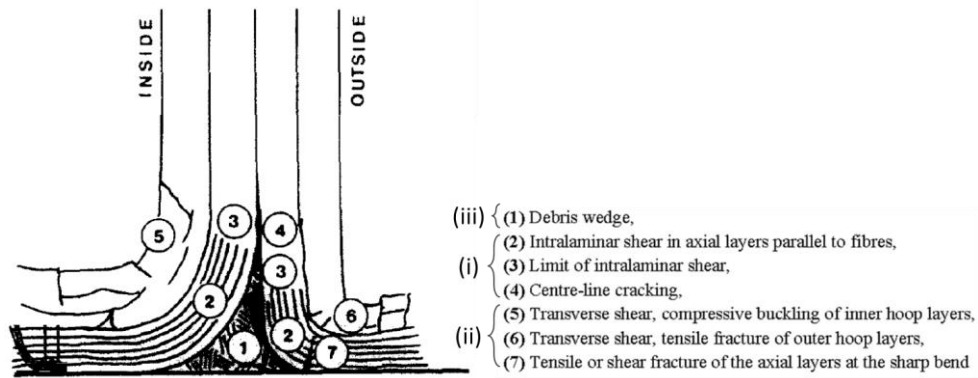
**Figure 2.** Main features and major damage mechanisms occurring at the crush zone (adapted from [3]).

In progressive crushing mode, damage mechanisms may be summed up into three types: (i) splaying, (ii) fragmentation and (iii) debris creation and accumulation [4]. (Figure 2).

Fragmentation might occur at two levels: under the tip of the plies (due to micro-buckling of fibers for 0° plies and to multiple shear micro-cracks for 90° plies) or within the plies as intra-laminar failure, fiber breakage and matrix cracks (due to a combination of compression, bending and shear) [4]. (Figure 2). The localized fragmentation at the tip of the plies is pointed as the mechanism leading to the definition of the ply Mean Crushing Stress (MCS) [4].

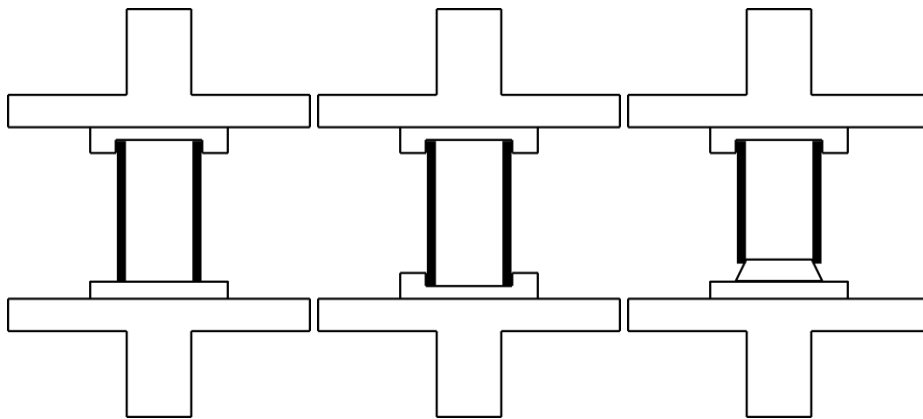
**Figure 3.** Experimental set-ups with one end free (a), encased (b) and on a conic plug initiator (c).

Quasi-static crushing tests were carried out using a 250 kN Schenck hydraulic testing machine in compression testing mode, through a constant loading speed of  $0.2 \text{ mm}\cdot\text{s}^{-1}$ . Several configurations were tested for crushing initiation and hopeful enhancement. Tubular structures were clamped and encased at one end, while several options were tested for the other. For instance, they were (a) let free on a plane surface, (b) also encased, (c) positioned on a conic plug initiator. Figure 3 presents these three configurations.

Although some specimens underwent catastrophic failure, breaking down from a midpoint zone of their wall length and not from their extremity, none underwent progressive folding, the majority following a progressive crushing scheme. Nevertheless, a clear difference was observed in the spreading array of damaged wall parts depending on the tests configurations (cf. Figure 3).

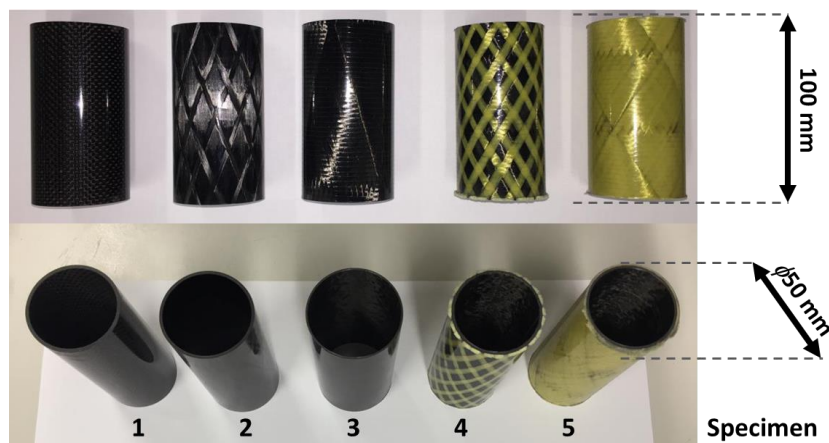
**Figure 4.** Picture of the five tube specimens with dimensions.

Five specimens with different structure and of different composition were tested in various crushing modes. Structural and material basis for the specimens include 12K HR carbon fibers and polymer Epoxy resin. Fibers orientation and laminate stratification differ from one specimen to another as shown in Figures 4 and 5 and summarized in Table 1. Provided tubular structures were machined and shaped in tubes of 100 mm length as pictured in Figure 4. Outer diameter was set at an average of 50 mm, with inner diameter varying from one sample to another due to stratification differences. Stratification layout and tube wall thickness are summarized in Table 1 for each sample.

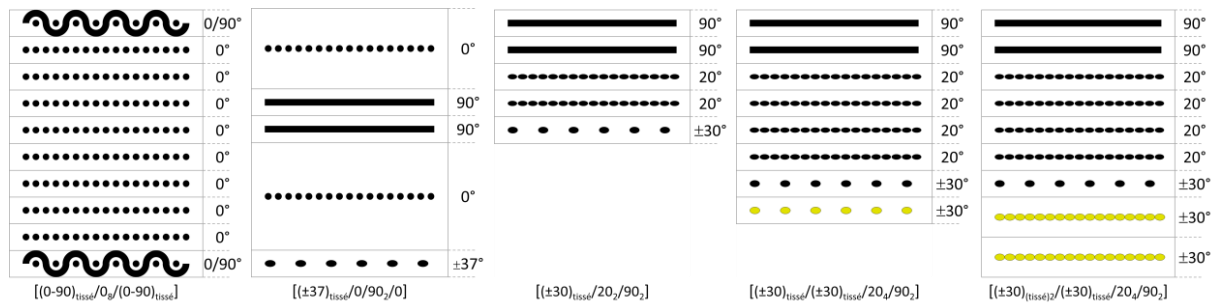
**Figure 5.** Schematic representation of the five tube specimens by their stratification.

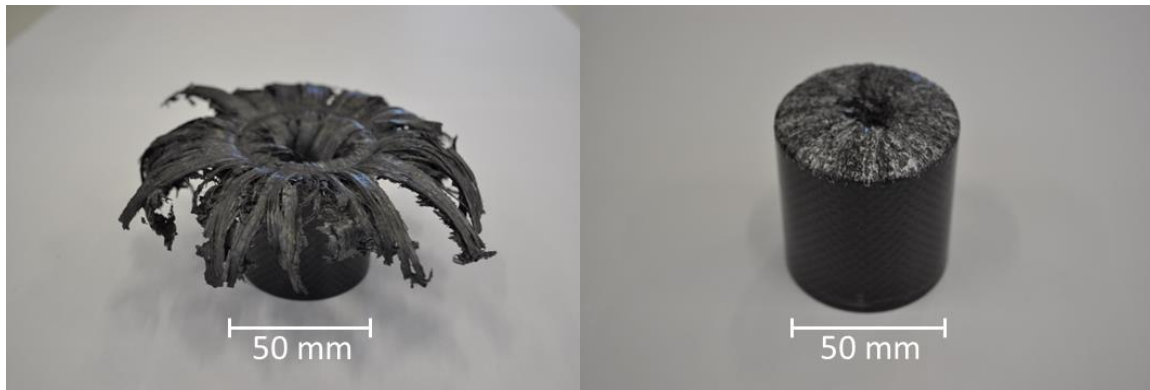
**Figure 6.** Crushed CFRP tubes showing outer spreading (left) and inner folding (right).

As an example, the pictures in Figure 6 present the difference in crushing behavior for the same CFRP tube specimen submitted to axial crushing under the first two different configurations presented in Figure 3. Both underwent progressive crushing. The first (left) corresponding to configuration type (a) presents inner and outer spreading of splayed parts, whereas the second (right) corresponding to configuration (b), have the whole bundle of splayed parts that folds towards the inside of the tube.

Configuration type (c), with a cone-shaped plug initiator, does not differ much from configuration type (a) apart from the fact that the entire splayed bundle spreads on the outside.

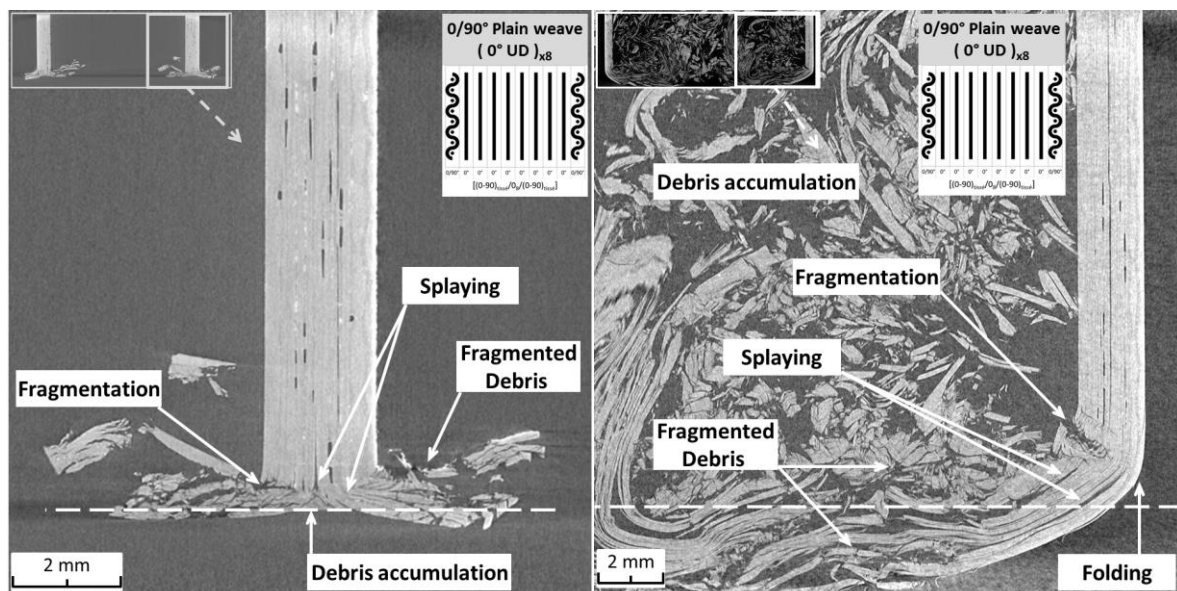
**Figure 7.** Tomographic images of crushed CFRP tubes showing major damage for two configurations.

Figure 7 highlights major occurring damage resulting from progressive crushing instigated by quasi-static axial compression load for specimen 1 through the means of tomographic imaging for two different crushing modes ((a) and (b) when referring to Figure 3). Inner (a, b) and outer (b) splaying of fragmented or un-fragmented parts are clearly visible, as well as debris accumulation.

The crushing plane surface is schematized by a discontinued line on both pictures on Figure 7. It is strongly suspected that for each tube samples, folded plies at the end of the tube walls between the sane part of the tubes and the crushing surface moved back downward when the crushing force was unloaded, due to a spring back effect. Hence an estimated positioning of the crushing surface appearing to be situated within the tube and entering inside the tube structure.

For the first configuration, a pyramidal-shaped debris accumulation can be observed at the center under the tube wall, between the tube section and the crushing surface, where the laminate plies spread towards the inside or the outside of the tubular structure. This debris accumulation forms from the void created by the plies splaying from the center under the tube wall then subsequently helps further and heighten this splaying.

For the second test configuration, damage mechanisms are similar in type and classification, but are all shifted toward the inside of the tube, since the outer wall is encased, leaving no leeway for splayed plies to spread that way. Incidentally, although major occurring damage are the same, their origin varies somewhat. Bending and folding resulting from the compression generate the splaying of the composite plies, and therefore the fracture and fragmentation for those sustaining a higher stress. Fragmentation still generates an important number of debris that varies in forms and shape, but those are freely evacuated from the crushing zone under the tube section to the inside of the tube. They do not form a tip that parts the laminate wall and split it, as observed with the pyramidal debris accumulation on the first configuration.

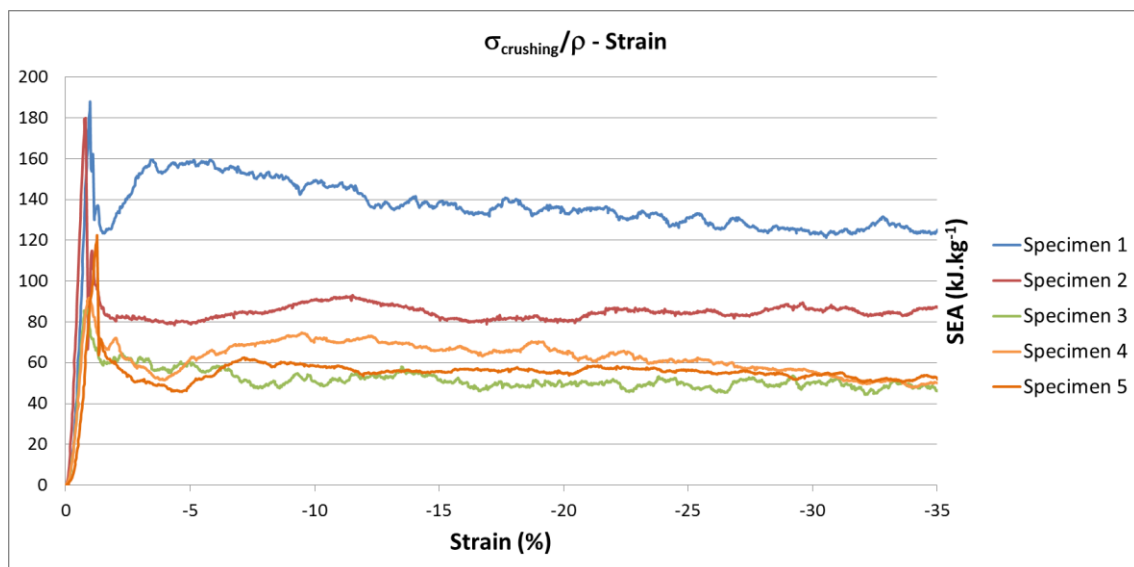
**Figure 8.** SEA evolution for 5 CFRP tube specimens submitted to pure axial crushing.

The Specific Energy Absorption was calculated after each crushing test for each specimen for every configuration. Results are presented in Figure 8, which highlights the benefit of specimen 1 in terms of energy absorption with a SEA value well above the others, at around  $140 \text{ kJ.kg}^{-1}$ , and the good performance of specimen 2, with a SEA value of around  $80 \text{ kJ.kg}^{-1}$ . It can be seen that specimens 3, 4 and 5 have a similar behavior and identical energy absorbing capability, but lesser than the others.

Similarity in behavior and energy absorbing capability for specimen 3, 4 and 5 are not incoherent when referring to Table 1 which shows the same basis structure for these specimens. Outer aramid covering does not improve or worsen the general behavior or energy absorbing capability.

For each axial compression tests, a stiff peak can be observed on the load-displacement curves or the stress/density-strain curves as showed on Figure 8, when the structure yields before it starts collapsing by progressive crushing at a stable and constant load, as reflected by the continuous plateau level. Ideally the gap between the peak and plateau value has to be reduced to a minimum, as a small gap and constant plateau level means an optimized dissipation of energy for a fixed and given load value.

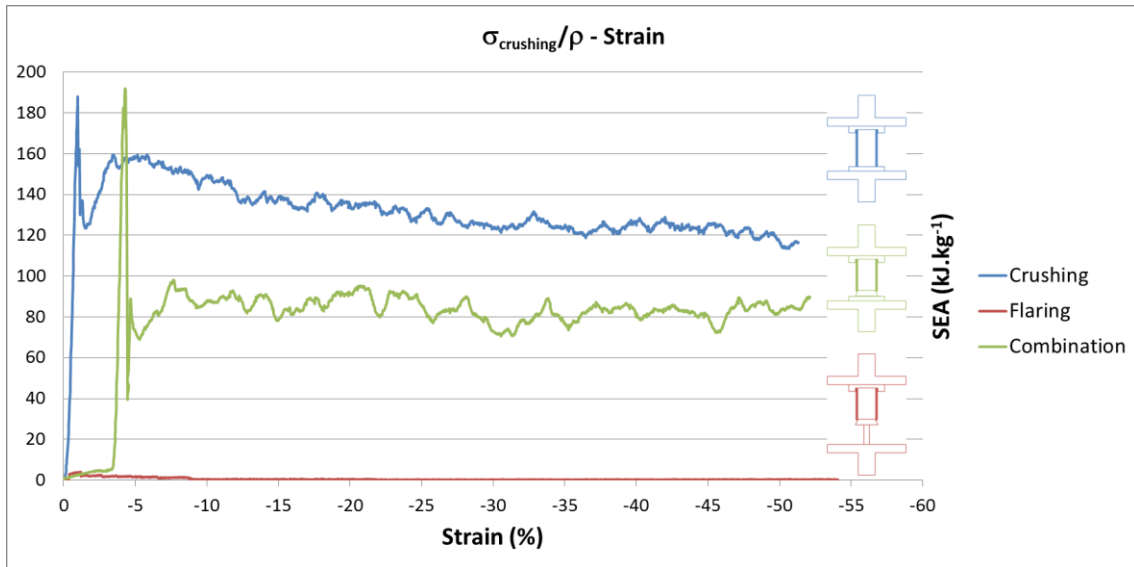
**Figure 9.** SEA evolution for 3 crushing configurations for the same CFRP tube specimen (n°1).

The use of a conic plug initiator to introduce a radial flaring of the tube structure before it is submitted to crushing does not improve the energy absorbing capability, compared to pure and plain crushing, as it is shown in Figure 9. Moreover, this configuration worsens the energy absorbing capability as it significantly lowers the SEA value. At last, the use of the conic plug alone, passing through the tube along its whole length, hardly dissipate any energy.

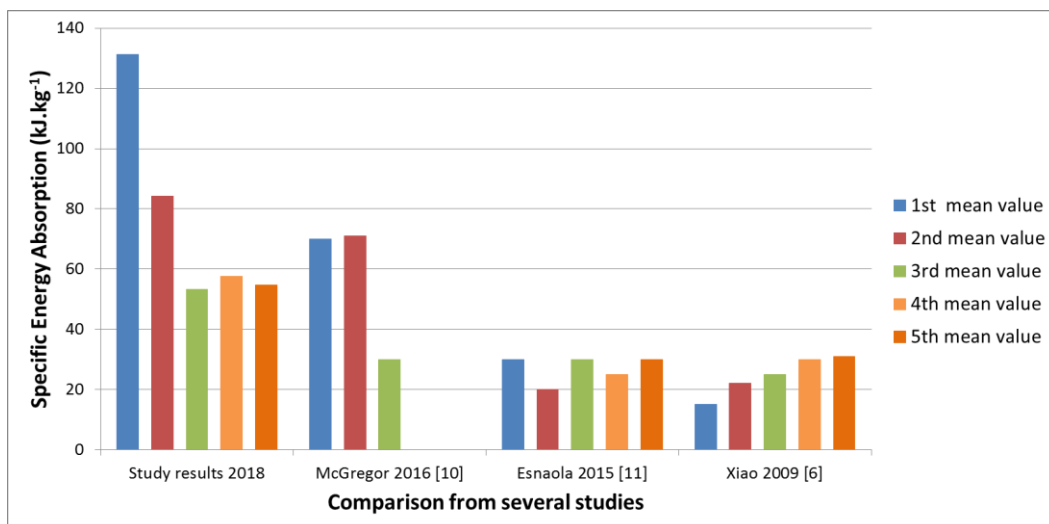
**Figure 10.** SEA values comparison from different studies.

SEA values up to 140 kJ.kg<sup>-1</sup> were obtained, achieving better than most instances from the literature, averaging around 30 kJ.kg<sup>-1</sup> and reaching up to around 80 kJ.kg<sup>-1</sup>. (Figure 10).
