# Strength measurement and rupture mechanisms of a micron thick nanocrystalline MoS2 coating using AFM based micro-bending tests

G. Colas <sup>1,2</sup>, P. Serles <sup>1</sup>, A. Saulot <sup>3</sup>, T. Filleter <sup>1</sup>

#### **Abstract**

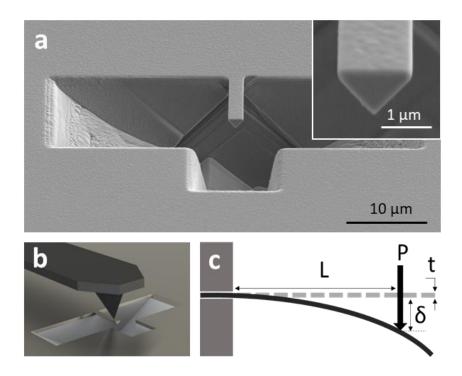
Figure 1 - (a) SEM image of a  $MoS_2$  micro-cantilever beam FIB milled in the 1.1  $\mu$ m thick  $MoS_2$  coating, the inset is a zoomed in image on the beam cross section. (b) 3D schematic representation of the bending test using AFM, at scale. (c) schematic of the deflection test performed on the beam using AFM.

MoS<sub>2</sub> micro-cantilever beams were prepared using a Hitachi NB5000 high precision dual-beam FIB and SEM. In order to achieve micro-cantilever beams consisting of freestanding MoS<sub>2</sub>, the FIB-milling was performed without the protective metallic layer on the MoS<sub>2</sub> coating which is commonly used during FIB-milling. The beams were milled using a high-voltage Ga<sup>+</sup> gun in a three-stage process allowing for the creation of free-standing triangular cantilever beams as seen in Figure 1a. First, 3 rectangular volumes are removed using a high energy beam (40 kV, 19.5 nA) creating a rectangular structure of MoS<sub>2</sub> coating with one end connected to the bulk of the coating. Second, the undercut was performed at angles of either 45° or 58° on each side with a medium ion beam energy (40 kV, 3.8 nA). At this stage, re-deposition of material, primarily made of Si and Ga, accumulates on the undercut side of the micro-cantilever beam, therefore, a third low-energy (40 kV, 0.8 nA) slow cleaning cut was performed to remove this re-deposited layer (cf. SI 1). These beam energies were carefully selected to minimize the FIB induced damage and amorphization of the coating [40–43] (SI 2). In total 11 micro-cantilever beams were successfully characterized with dimensions varying from 9 to 15 µm in length, 1.4 to 2.2 µm in width, and 0.6 to 1.3 µm in height.

Microbeam bending tests were performed using an Atomic Force Microscope (MFP-3D, Oxford Instruments; Asylum Research Ltd.) with sharp-tip (<10 nm tip radius) silicon probes (cantilever with 42 N/m spring constant, calibrated geometrically) from Nano Sensors as represented in Figure 1b. The microbeams were first imaged in tapping mode AFM to position the cantilever after which the deflection tests were performed in a static deflection mode. On each MoS<sub>2</sub> cantilever beam, the bending tests were performed in at least 3 different positions along the length of the beam, as recommended in [24]. The tip was positioned along the longitudinal axis at distances from the clamped end from 6 μm to 13 μm to ensure the validity of the Euler-Bernoulli deflection theory

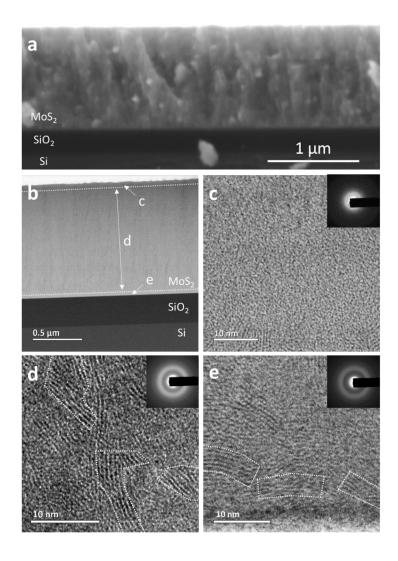
Figure 2 - (a) SEM image of the fractured cross-section of  $MoS_2$  coating. (b) to (e) TEM images of the coating cross-section; (b) low magnification dark filed image of the entire coating thickness with a small portion of the wafer substrate; (c) high magnification image of the coating top surface showing an amorphous structure; (d) high magnification image of the coating bulk showing vertically aligned crystallites; and (e) high magnification image showing the horizontally aligned crystallites at the bottom interface with the  $SiO_2$  layer.

The SEM image of the fractured coating cross-section (Figure 2a) shows a dense microstructure with roughly vertically oriented grains. These grains appear to be in accordance with the dark field STEM micrograph (Figure 2b) where large light gray vertically oriented regions of similar magnitude are delimited by thin dark frontiers. The high-resolution STEM images (Figure 2 c,d,e) show three distinct phases vertically distributed within the coating. The surface  $47 \pm 5$  nm exhibits a purely amorphous phase (Figure 2c) while the central bulk of the coating exhibits a nanocrystalline phase embedded in an amorphous matrix (Figure 2d). These bulk nanocrystals are vertically oriented within  $\pm 28^{\circ}$  of the vertical axis and represent approximately 35% of the total volume. Across 10 micrographs studied, a total of 189 nanocrystals were identified with widths of  $13.1 \pm 1.1$  atomic layers ( $8.1 \pm 2$  nm;  $c_{MoS_2} = 6.15$  Å [50]) in the [001] direction and lengths of  $12 \pm 4$  nm in the [100] or [010] directions. The third phase exists as the bottom interface of the coating with a height of  $17 \pm 4$  nm and consists of similarly sized nanocrystals in an amorphous matrix as in the bulk, but horizontally oriented within  $\pm 22^{\circ}$  of the horizontal axis as seen in Figure 2e.

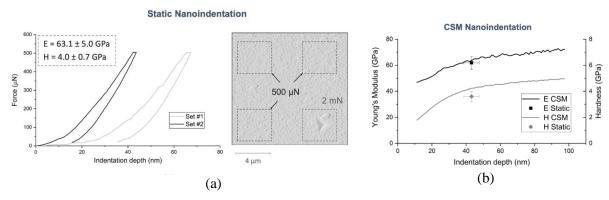
Figure 3 – (a) Examples of static mode indentation curves from the  $1^{st}$  and  $2^{nd}$  set of 25 indents and AFM image of the surface after indentation; inset on the indentation curve gives the calculated values of E and H over the 50 indents. (b) Example of CSM data obtained on pristine MoS<sub>2</sub>, average value from the  $2^{nd}$  set of 25 indents from static mode indentation is shown for comparison.

with no significant difference between the two measurement sets. The indentation loading curves show a plateau when the load is maintained constant at 500  $\mu$ N for 10s (Figure 3a). This plateau is the effect of stress-induced creep which can be linked to viscoelasticity or viscoplasticity in the material [18]. During unloading, the curve demonstrates hysteresis with a different slope as compared to the loading curve (Figure 3a). However, surprisingly, the AFM topographic study of the indented regions shows no significant indent (Figure 3b). To ensure proper location, one indent at 2 mN load was performed at known distances from the 500  $\mu$ N indents. Note that no significant material pile-up or sink-in is detected in and around the high load indent (Figure 3b). The two sets of 25 indentations which were performed show differences that are attributed to rounding of the Berkovich tip between the measurements as evidenced by changes in the calibrated tip function (cf. SI 3).

The indentations performed in CSM mode (Figure 3b) were considered only up to an indentation depth of 100 nm (<10% coating thickness) and the first 10 nm of indentation was negated due to noise from the woodpecker effect. Interestingly, the MoS<sub>2</sub> sample shows an increasing trend for E and H values with respect to the indentation depth, in particular at depths below ~ 45 nm. As well,

for E there exists a transition from nonlinear to linear which corresponds with approximately 45 nm of depth. In comparison to the second set of static indentations (same tip function as in CSM mode), at 43 nm of depth (corresponding to 500  $\mu$ N load) both the E and H values are consistent with the static mode values as reported in the inset of the graph on Figure 3a.

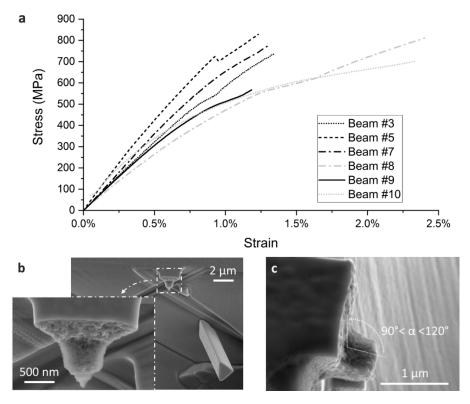
Figure 4 - (a) Stress/strain curves up to fracture of the beams on which rupture strength has been measured, (b) & (c) fracture surface of the beam at the clamped end

The rupture strength (Rm) values for the five micro-cantilever beams that were successfully fractured as well as the values of Young's modulus (E) measured from nine beams are presented in Table 1. The results show very consistent E values across the beams giving  $E = 64.5 \pm 4.0$  GPa. Beam #10 demonstrated an AFM tip-sliding event (cf. SI 4) which might have modified the tip/beam interface (e.g. transfer of material to the tip). This may explain the strong non-linearity observed during the first 1% strain and consequently the outlier E value of  $81.7 \pm 4.5$  GPa; beam #10 was thus removed from the E average. As discussed in SI 5, contrary to E, the Rm of beam #5 does not appear to be as sensitive to the redeposition. Rm indeed stays within the range of values defined by the other beams. Considering this additional Rm value to the five presented in **Table 1**, the average value is  $Rm = 728 \pm 88$  MPa. Although both E and Rm exhibit values within a reasonably narrow range across the six beams considered, two groups tend to be observed if the strain to rupture is considered. Indeed, four beams (#3, #5, #7 and #9) exhibit a strain to rupture in the 1.2% - 1.3% range while beams #8 and #10 exhibit a strain to rupture higher than 2.4% as seen in Figure 4a.

Regarding the fracture mode, the stress/strain curves (Figure 4a) demonstrate that the coating is brittle as the beams exhibit no plasticity prior to fracture, which is confirmed by the HRSEM images of the fractured surface (Figure 4b & c). While the stress/strain curve of beam #10 shows strong non-linearity over the first 1% strain, the fracture surface is identical to the fracture surface shown in Figure 4b which furthers the assumption that Rm is independent of E for these beams. All the fracture surfaces show a multi-faceted structure within the coating bulk; the fracture plane is not a single shear plane but rather made of many smaller fracture surfaces. Additionally, a different contrast between the top 50 nm and the bulk of the coating within the beam is clearly observable in SEM as shown on Figure SI 2 which demonstrates a change in the coating structure locally within that thickness, consistent with TEM observations. Finally, there exists a clear transition in the topography of the fracture surface with a step at approximately half of the height from the top surface. There is a  $90^{\circ} < \alpha < 120^{\circ}$  shift in propagation direction of the cracks over

The multi-facetted morphology shown in the HRSEM images of the fracture surfaces (Figure 4b) is consistent with the idea of a nanocrystalline structure within the coating; the crack propagation within the coating would follow an intergranular fracture pattern along the variably oriented nanocrystallites thus providing a multi-facetted morphology as seen herein. Additionally, the general direction of fracture isn't straight but presents two fracture directions oriented at  $90^{\circ} < \alpha < 120^{\circ}$  to each other. The transition between the two directions is a clear step located approximately half of the thickness below the top surface of the beam. This location is slightly
