Strength measurement and rupture mechanisms of a micron thick nanocrystalline MoS₂ coating using AFM based micro-bending tests

G. Colas^{1,2}, P. Serles¹, A. Saulot³, T. Filleter¹

Abstract

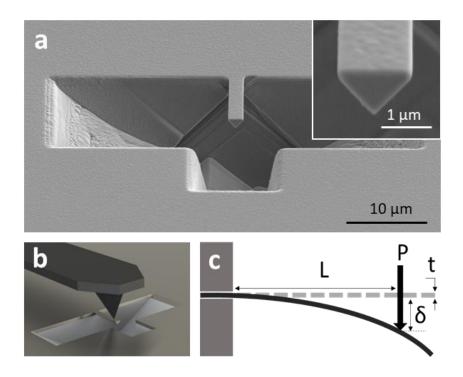
Figure 1 - (a) SEM image of a MoS_2 micro-cantilever beam FIB milled in the 1.1 µm thick MoS_2 coating, the inset is a zoomed in image on the beam cross section. (b) 3D schematic representation of the bending test using AFM, at scale. (c) schematic of the deflection test performed on the beam using AFM.

MoS₂ micro-cantilever beams were prepared using a Hitachi NB5000 high precision dual-beam FIB and SEM. In order to achieve micro-cantilever beams consisting of freestanding MoS₂, the FIB-milling was performed without the protective metallic layer on the MoS₂ coating which is commonly used during FIB-milling. The beams were milled using a high-voltage Ga⁺ gun in a three-stage process allowing for the creation of free-standing triangular cantilever beams as seen in Figure 1a. First, 3 rectangular volumes are removed using a high energy beam (40 kV, 19.5 nA) creating a rectangular structure of MoS₂ coating with one end connected to the bulk of the coating. Second, the undercut was performed at angles of either 45° or 58° on each side with a medium ion beam energy (40 kV, 3.8 nA). At this stage, re-deposition of material, primarily made of Si and Ga, accumulates on the undercut side of the micro-cantilever beam, therefore, a third low-energy (40 kV, 0.8 nA) slow cleaning cut was performed to remove this re-deposited layer (cf. SI 1). These beam energies were carefully selected to minimize the FIB induced damage and amorphization of the coating [40–43] (SI 2). In total 11 micro-cantilever beams were successfully characterized with dimensions varying from 9 to 15 µm in length, 1.4 to 2.2 µm in width, and 0.6 to $1.3 \,\mu\text{m}$ in height.

Microbeam bending tests were performed using an Atomic Force Microscope (MFP-3D, Oxford Instruments; Asylum Research Ltd.) with sharp-tip (<10 nm tip radius) silicon probes (cantilever with 42 N/m spring constant, calibrated geometrically) from Nano Sensors as represented in Figure 1b. The microbeams were first imaged in tapping mode AFM to position the cantilever after which the deflection tests were performed in a static deflection mode. On each MoS_2 cantilever beam, the bending tests were performed in at least 3 different positions along the length of the beam, as recommended in [24]. The tip was positioned along the longitudinal axis at distances from the clamped end from 6 µm to 13 µm to ensure the validity of the Euler-Bernoulli deflection theory

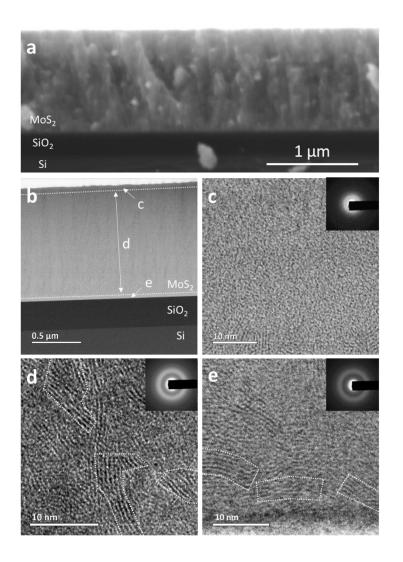
Figure 2 - (a) SEM image of the fractured cross-section of MoS_2 coating. (b) to (e) TEM images of the coating cross-section; (b) low magnification dark filed image of the entire coating thickness with a small portion of the wafer substrate; (c) high magnification image of the coating top surface showing an amorphous structure; (d) high magnification image of the coating bulk showing vertically aligned crystallites; and (e) high magnification image showing the horizontally aligned crystallites at the bottom interface with the SiO₂ layer.

The SEM image of the fractured coating cross-section (Figure 2a) shows a dense microstructure with roughly vertically oriented grains. These grains appear to be in accordance with the dark field STEM micrograph (Figure 2b) where large light gray vertically oriented regions of similar magnitude are delimited by thin dark frontiers. The high-resolution STEM images (Figure 2 c,d,e) show three distinct phases vertically distributed within the coating. The surface 47 ± 5 nm exhibits a purely amorphous phase (Figure 2c) while the central bulk of the coating exhibits a nanocrystalline phase embedded in an amorphous matrix (Figure 2d). These bulk nanocrystals are vertically oriented within ±28° of the vertical axis and represent approximately 35% of the total volume. Across 10 micrographs studied, a total of 189 nanocrystals were identified with widths of 13.1 ± 1.1 atomic layers (8.1 ± 2 nm; $c_{MoS_2} = 6.15$ Å [50]) in the [001] direction and lengths of 12 ± 4 nm in the [100] or [010] directions. The third phase exists as the bottom interface of the coating with a height of 17 ± 4 nm and consists of similarly sized nanocrystals in an amorphous matrix as in the bulk, but horizontally oriented within ±22° of the horizontal axis as seen in Figure 2e.

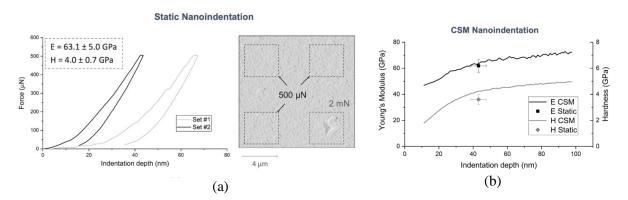
Figure 3 – (a) Examples of static mode indentation curves from the 1^{st} and 2^{nd} set of 25 indents and AFM image of the surface after indentation; inset on the indentation curve gives the calculated values of E and H over the 50 indents. (b) Example of CSM data obtained on pristine MoS₂, average value from the 2^{nd} set of 25 indents from static mode indentation is shown for comparison.

with no significant difference between the two measurement sets. The indentation loading curves show a plateau when the load is maintained constant at 500 μ N for 10s (Figure 3a). This plateau is the effect of stress-induced creep which can be linked to viscoelasticity or viscoplasticity in the material [18]. During unloading, the curve demonstrates hysteresis with a different slope as compared to the loading curve (Figure 3a). However, surprisingly, the AFM topographic study of the indented regions shows no significant indent (Figure 3b). To ensure proper location, one indent at 2 mN load was performed at known distances from the 500 μ N indents. Note that no significant material pile-up or sink-in is detected in and around the high load indent (Figure 3b). The two sets of 25 indentations which were performed show differences that are attributed to rounding of the Berkovich tip between the measurements as evidenced by changes in the calibrated tip function (cf. SI 3).

The indentations performed in CSM mode (Figure 3b) were considered only up to an indentation depth of 100 nm (<10% coating thickness) and the first 10 nm of indentation was negated due to noise from the woodpecker effect. Interestingly, the MoS₂ sample shows an increasing trend for E and H values with respect to the indentation depth, in particular at depths below ~ 45 nm. As well,

for E there exists a transition from nonlinear to linear which corresponds with approximately 45 nm of depth. In comparison to the second set of static indentations (same tip function as in CSM mode), at 43 nm of depth (corresponding to 500 μ N load) both the E and H values are consistent with the static mode values as reported in the inset of the graph on Figure 3a.

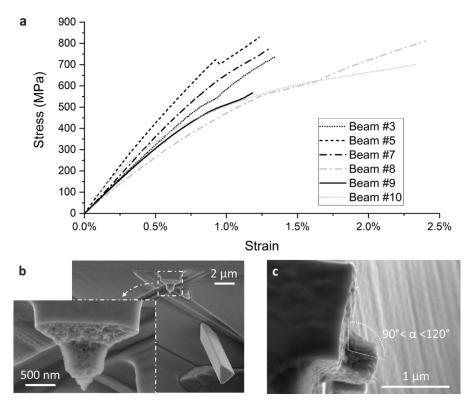
Figure 4 - (a) Stress/strain curves up to fracture of the beams on which rupture strength has been measured, (b) & (c) fracture surface of the beam at the clamped end

The rupture strength (Rm) values for the five micro-cantilever beams that were successfully fractured as well as the values of Young's modulus (E) measured from nine beams are presented in Table 1. The results show very consistent E values across the beams giving $E = 64.5 \pm 4.0$ GPa. Beam #10 demonstrated an AFM tip-sliding event (cf. SI 4) which might have modified the tip/beam interface (e.g. transfer of material to the tip). This may explain the strong non-linearity observed during the first 1% strain and consequently the outlier E value of 81.7 ± 4.5 GPa; beam #10 was thus removed from the E average. As discussed in SI 5, contrary to E, the Rm of beam #5 does not appear to be as sensitive to the redeposition. Rm indeed stays within the range of values defined by the other beams. Considering this additional Rm value to the five presented in **Table 1**, the average value is Rm = 728 ± 88 MPa. Although both E and Rm exhibit values within a reasonably narrow range across the six beams considered, two groups tend to be observed if the strain to rupture is considered. Indeed, four beams (#3, #5, #7 and #9) exhibit a strain to rupture in the 1.2% - 1.3% range while beams #8 and #10 exhibit a strain to rupture higher than 2.4% as seen in Figure 4a.

Regarding the fracture mode, the stress/strain curves (Figure 4a) demonstrate that the coating is brittle as the beams exhibit no plasticity prior to fracture, which is confirmed by the HRSEM images of the fractured surface (Figure 4b & c). While the stress/strain curve of beam #10 shows strong non-linearity over the first 1% strain, the fracture surface is identical to the fracture surface shown in Figure 4b which furthers the assumption that Rm is independent of E for these beams. All the fracture surfaces show a multi-faceted structure within the coating bulk; the fracture plane is not a single shear plane but rather made of many smaller fracture surfaces. Additionally, a different contrast between the top 50 nm and the bulk of the coating within the beam is clearly observable in SEM as shown on Figure SI 2 which demonstrates a change in the coating structure locally within that thickness, consistent with TEM observations. Finally, there exists a clear transition in the topography of the fracture surface with a step at approximately half of the height from the top surface. There is a $90^{\circ} < \alpha < 120^{\circ}$ shift in propagation direction of the cracks over

The multi-facetted morphology shown in the HRSEM images of the fracture surfaces (Figure 4b) is consistent with the idea of a nanocrystalline structure within the coating; the crack propagation within the coating would follow an intergranular fracture pattern along the variably oriented nanocrystallites thus providing a multi-facetted morphology as seen herein. Additionally, the general direction of fracture isn't straight but presents two fracture directions oriented at $90^{\circ} < \alpha < 120^{\circ}$ to each other. The transition between the two directions is a clear step located approximately half of the thickness below the top surface of the beam. This location is slightly
