## Quantification of the morphodynamics and ecological functionality of a Mediterranean river

Margot Chapuis, Amine Ait Elabas, Katia Souriguère, Franck Compagnon,  
Vincent Mayen, Benoit Terrier

Margot Chapuis, Amine Ait Elabas, Katia Souriguère, Franck Compagnon, Vincent Mayen, et al.. Quantification of the morphodynamics and ecological functionality of a Mediterranean river. River Flow 2018 - Ninth International Conference on Fluvial Hydraulics, Sep 2018, Lyon-Villeurbanne, France. hal-02181626

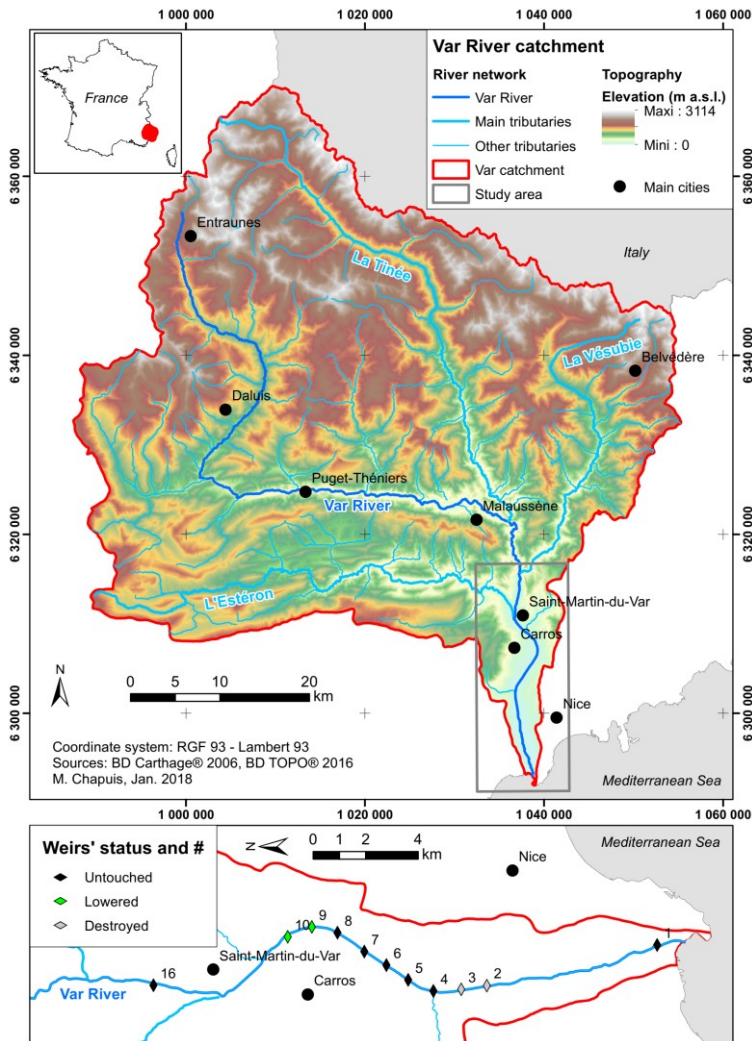
**Fig. 1.** Var River catchment and location of the study reach in the downstream part of the river. On the 11 weirs built within this reach, two were destroyed during the 1993 flood and two others are already lowered because of the ongoing restoration project.

The Var River is a 110-km long gravel-bed river, ending in the Mediterranean Sea near Nice. The downstream floodplain is only 25 km long since the river exits steep gorges few kilometres before its last significant tributary (the Estéron River, fig. 1). The Var upper catchment (total area: 2822 km<sup>2</sup>) is located in the Southern French Alps and is thus characterized by steep slopes, but the downstream reach slope is only of 1 to 5 ‰ with a braiding pattern. Such braiding prevents accurate measurement of water discharge: maximal estimated flood is 3000 m<sup>3</sup>/s, while mean annual flow is estimated of 50 m<sup>3</sup>/s.

The downstream reach is thus characterized by heavy channelization that reduced active width from 1000 m to 250 m (fig. 2), and longitudinal profile stabilization (because of gravel mining) through several weirs (initially 11 weirs were built, but weirs #2 and #3 were destroyed during the 1993 flood in the downstream end of the study reach).

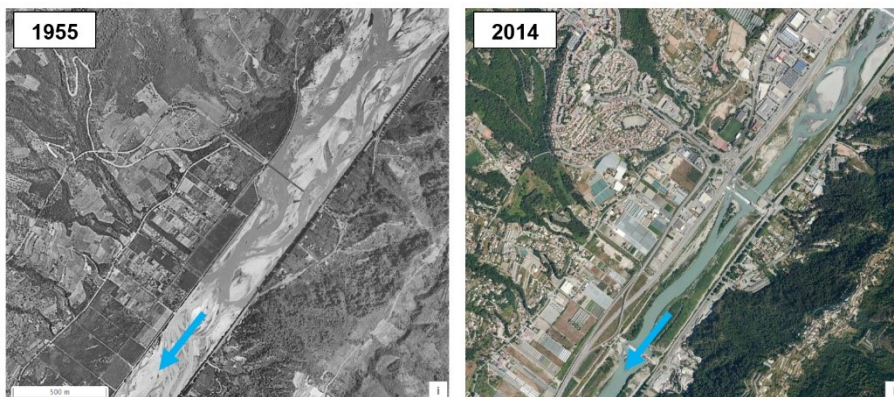
**Fig. 2.** Var River catchment and location of the study reach in the downstream part of the river (modified from: <https://remonterletemps.ign.fr>).

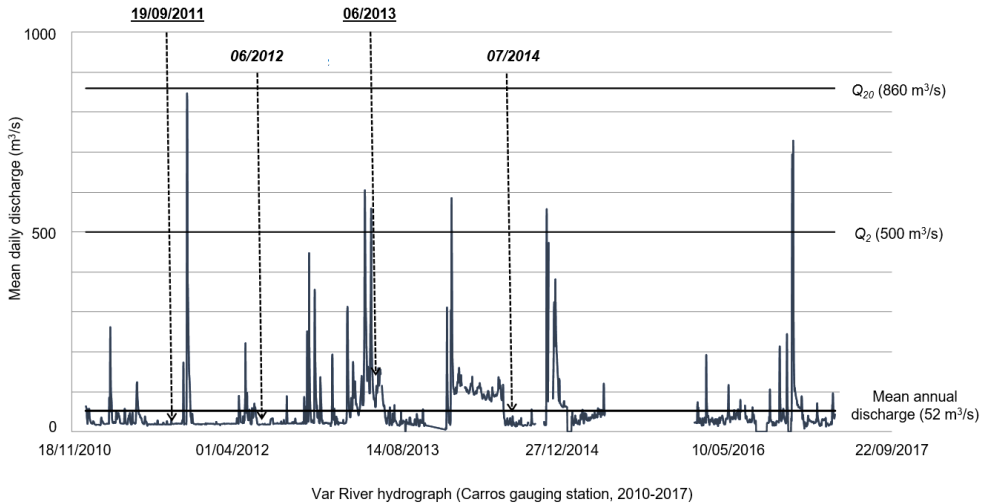
**Fig. 3.** Var River mean daily discharge during the 2010–2017 period.  $Q_i$  refers to the return period associated with values in brackets. Dates of data acquisition are also indicated: dates for LiDAR campaigns are underlined and bold vs. dates for orthophoto campaigns are in italic and bold.

Early in the analysis process, we stressed the importance of using LiDAR and orthophotos datasets that correspond to a unique field campaign, in order to prevent misinterpretation of morphological units during the digitization process (fig. 3). This shall be considered for future planning of data acquisition campaigns.

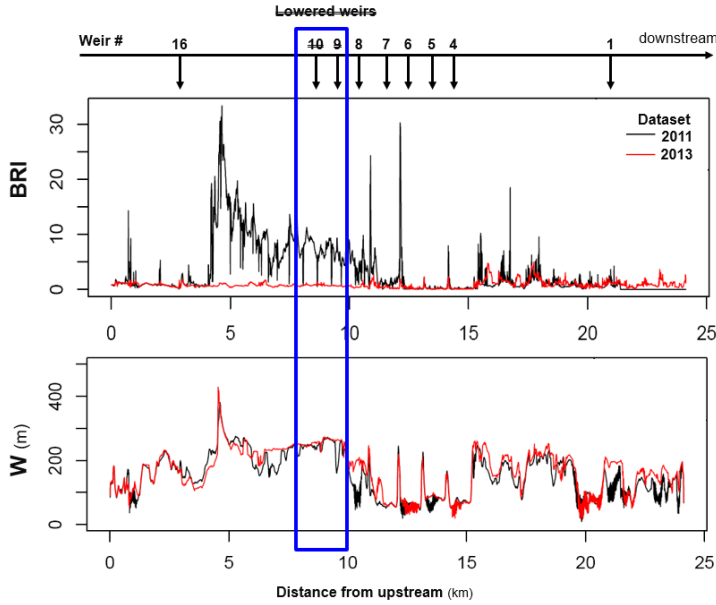
**Fig. 4.** Temporal analysis of river indicators: Bed Relief Index ( $BRI$ ) and active width ( $W$ ). Lowered weirs in the restoration project area are indicated (weirs #9 and #10). The  $BRI$  enables to discriminate between ‘restored’ reaches (upstream weir #10) and ‘unrestored’ reaches.

The lower Var River is an active system that quickly recovers its sediment continuity from upstream thanks to the weirs lowering restoration project (fig. 4). Indeed the 2011 dataset (before the lowering of weir #10) shows a different *BRI* pattern compared to the 2013 dataset: this last one show very low values of *BRI*, indicating low rugosity within the cross-sections and thus an active braiding pattern.

For the 2013 dataset, active width ( $W_{restored} = 242 \pm 19$  m vs. values ranging from  $103 \pm 53$  to  $163 \pm 53$  m for ‘unrestored’ reaches) and normalized bed relief index values ( $BRI^*_{restored} = 0,003 \pm 0,001$  vs.  $0,003 \pm 0,003$  to  $0,007 \pm 0,004$  for ‘unrestored’ reaches) indicate a combination of low rugosity and wide active width (fig. 5). Similar trends would be observed for the 2011 dataset, according to fig. 4. Thus the ‘restored’ reach shows a different set of  $BRI^*$  and  $W$  indices compared to adjacent ‘unrestored’ reaches: the ‘restored’ reach shows a specific pattern with high value of  $W$  and narrow standard deviations for both  $BRI^*$  and  $W$ .

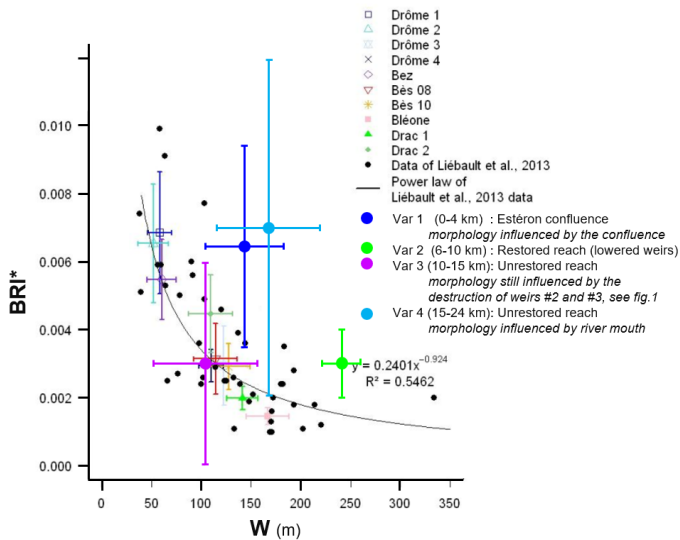
**Fig. 5.** Normalized Bed Relief Index ( $BRI^*$ ) and active width ( $W$ ) of the Var River reaches compared to other braiding river systems that are not channelized (modified from [2]).
