Margot Chapuis, Amine Ait Elabas, Katia Souriguère, Franck Compagnon, Vincent Mayen, et al.. Quantification of the morphodynamics and ecological functionality of a Mediterranean river. River Flow 2018 - Ninth International Conference on Fluvial Hydraulics, Sep 2018, Lyon-Villeurbanne, France. hal-02181626

Quantification of the morphodynamics and ecological functionality of a Mediterranean river

Abstract. The Var River (South-Eastern France) is currently undergoing an ambitious restoration project that aims at restoring its 'natural' active braiding pattern ('Mediterranean facies') on the channelized downstream reach of the river. As part of the ongoing feedback evaluation of such project, this study aims at: (1) quantifying the morphological evolution of the bed that is recovering from sediment discontinuity; (2) identifying and/or developing hydromorphological and ecological indicators which vouch for improvement of the Mediterranean river system, from a hydrosedimentary and ecological point of view. We used LiDAR and orthophoto datasets and performed analyses described in the literature for unchannelized braiding rivers [1, 2]. Active width ($W_{restored} = 242 \pm 19$ m vs. va

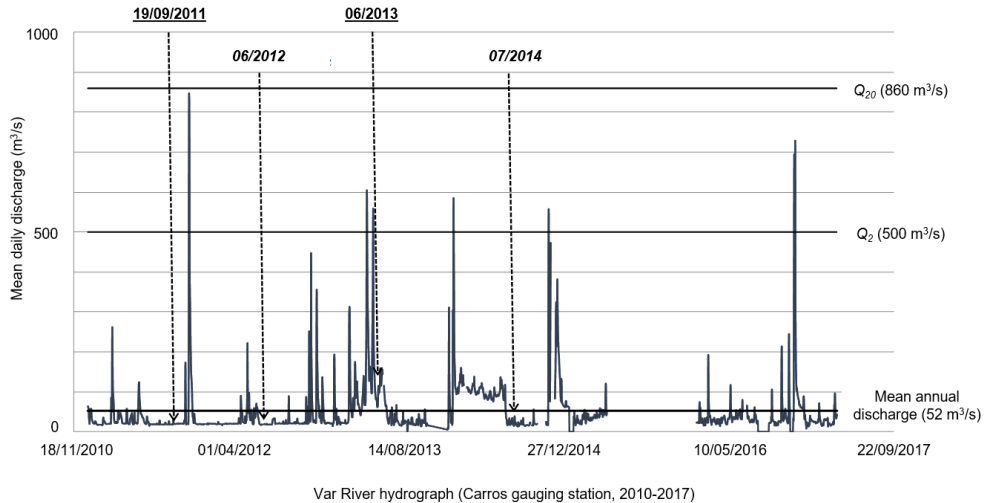
Fig. 3. Var River mean daily discharge during the 2010–2017 period. Q_i refers to the return period associated with values in brackets. Dates of data acquisition are also indicated: dates for LiDAR campaigns are underlined and bold vs. dates for orthophoto campaigns are in italic and bold.

Early in the analysis process, we stressed the importance of using LiDAR and orthophotos datasets that correspond to a unique field campaign, in order to prevent misinterpretation of morphological units during the digitization process (fig. 3). This shall be considered for future planning of data acquisition campaigns.
