A French experience of continuous scour monitoring on real sites

A FRENCH EXPERIENCE OF CONTINUOUS SCOUR MONITORING ON REAL SITES

Keywords: Scour, field study, monitoring

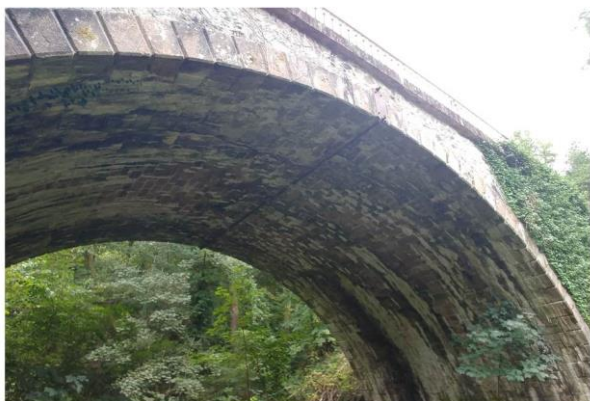
a) view of the bridge masonry

Figure 1. .View of the site in August 2018

In this paper we focus on this latter site that is located on the railway line linking Limoges to Angoulême in the southwest of France. Traffic consists of commuter trains and freight trains, including those from a quarry that provides ballast, particularly for bullet train lines. The bridge is a masonry rail one built about 1880 (Figure 1a). Due to the meandering course of the river, the left bank is in an extrados situation (Figure 1b). At the foot of the abutment, we measured a scour of 1.7 m long and 0.5 m deep. The pearl is collapsed and many of the blocks at the bottom of the river come from it.

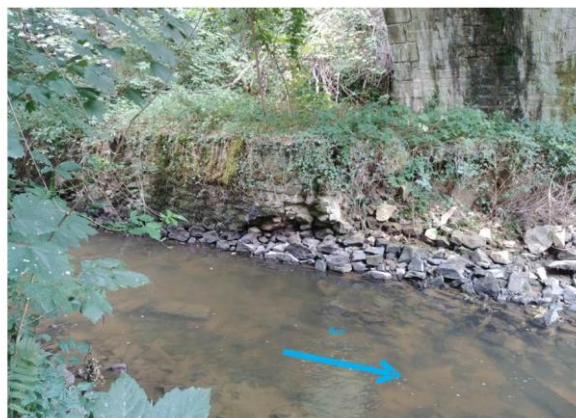
b) flow and abutment scour
