The role of slip transfer at grain boundaries in the propagation of microstructurally short fatigue cracks in Ni-based superalloys

Keywords: X-ray synchrotron radiation; Grain boundary; High Cycle Fatigue; Superalloy; Microstructurally short crack propagation

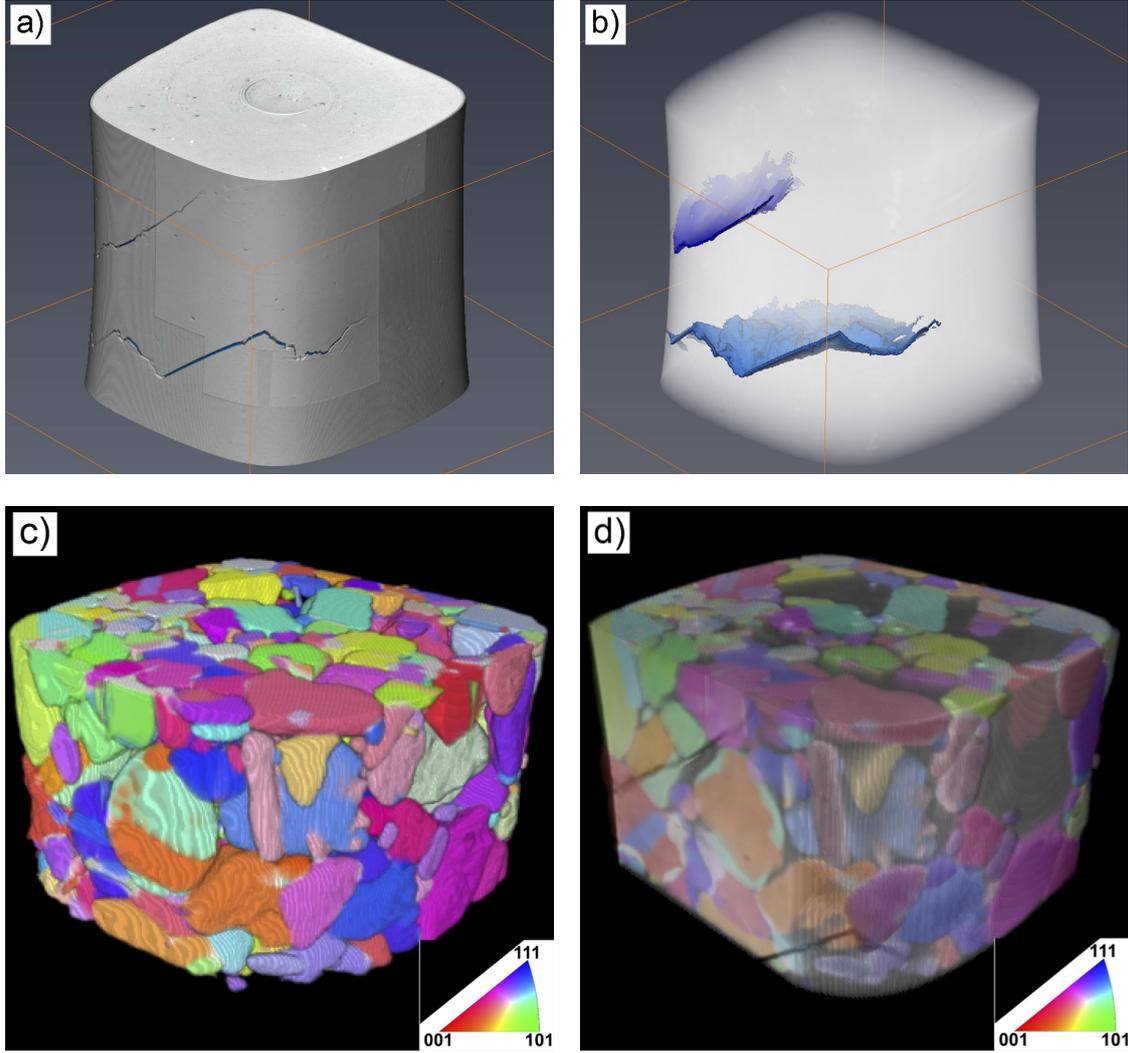
Figure 1: Reconstructed volumes of: a) PCT after 100,000 cycles. Cracks can be seen on the surface. b) PCT after 100,000 cycles with segmented cracks. c) DCT. d) Interior slice of the DCT overlapped with the PCT after 100,000 cycles, showing the interaction of the cracks with the specimen microstructure in 3D. Orientations are referred to the load (vertical) axis. The side length of the specimen is $600\mu\text{m}$.

The PCT volumes showed high quality reconstructions and clear images of the cracks (figures 1a and 1b). The DCT volume is shown in figure 1c. About 80 % of the sample volume could be indexed and reconstructed. The indexing and reconstruction process is affected by the presence of extended orientation related domains (c.f. large fraction of Sigma 3 boundaries), which give rise to systematic diffraction spot overlaps. Figure 1d shows the overlay of both, the PCT and DCT volumes. Cracks could be clearly tracked and confronted with the local microstructure, allowing the identification of the individual grains that led to crack initiation, the crystallographic planes along which the cracks propagated and the change in crack plane when the cracks were transmitted across a GB.

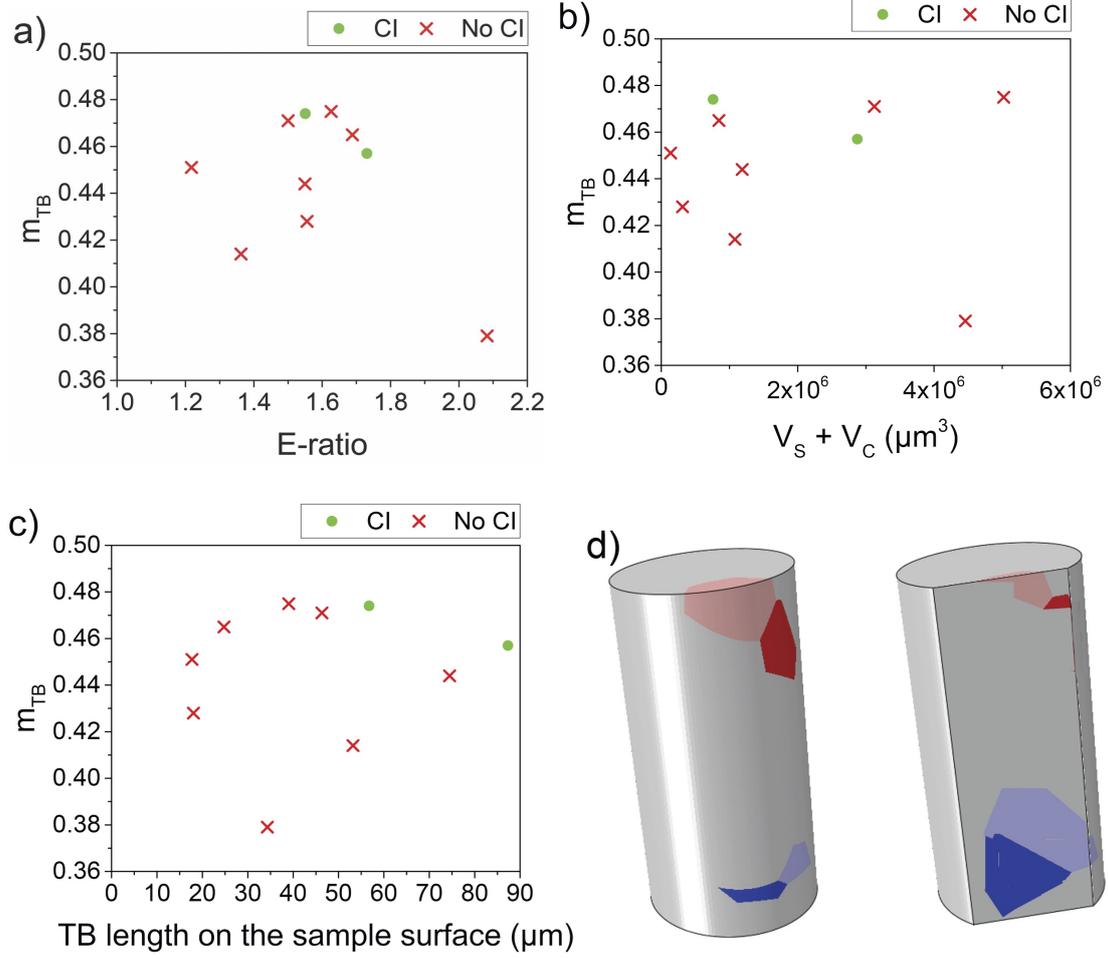
Figure 2: The applied Schmidt factor on all pre-existing CTBs found at the specimen surface is plot against different factors that can potentially lead to fatigue crack initiation. Green circles represent those CTBs that led to fatigue crack initiation (CI), while the red crosses stand for the ones that did not (No CI). a) E-ratio = E_1/E_2 . b) Sum of volumes of the grains at both sides of the TB. c) Length of the TB along the specimen surface. d) Schematic illustration of the influence of the volume of grains and length of the CTB on the surface. A long CTB on the surface that separates a small pair of grains (red grains) is more prone to crack initiation than a shorter CTB on the surface that separates two bigger grains (blue grains).

and the length of the CTB on the specimen surface. Figure 2 summarizes the results, where the green circles represent those CTBs that led to crack initiation and the red crosses those that did not. It is clear that for the cases where crack initiation occurred, a large applied Schmidt factor and a large E-ratio of 1.7 was found (figure 2a), implying that in those grains well oriented for slip a large elastic incompatibility across the CTB can explain the local stress concentration that leads to damage nucleation. However, large E-ratios and Schmidt factors are two necessary, but not sufficient conditions for the nucleation of cracks, as for instance a pre-existing CTB with a E-ratio=2.1 did not lead to crack initiation. It is also expected that larger grains will be softer and therefore more prone to damage than small ones, but figure 2b shows that this is not the most important factor because the largest grains did not lead to crack initiation. On the contrary, figure 2c shows that the length of the CTB, rather than the volume of the grains, is the most relevant characteristic size leading to crack initiation: the longer the intersection of the TB with the surface, the more likely it is to initiate a crack. This is explained by the more relaxed constraint of the slip plane parallel to the CTB on the surface, which facilitates the formation of the PSBs. As shown schematically in figure 2d, larger grains for which the intersection of the CTB with the surface is short (for instance, the blue pair of grains) are less susceptible to initiate cracks than smaller grains that display a larger CTB on the surface (the red pair of grains). Even though the current observations in a single specimen are limited, the conclusions are in full agreement with those reported using conventional testing [3], but with the advantage that the tomography results allow measuring the sub-surface shape and size of the grains and orientation of the nucleated cracks,

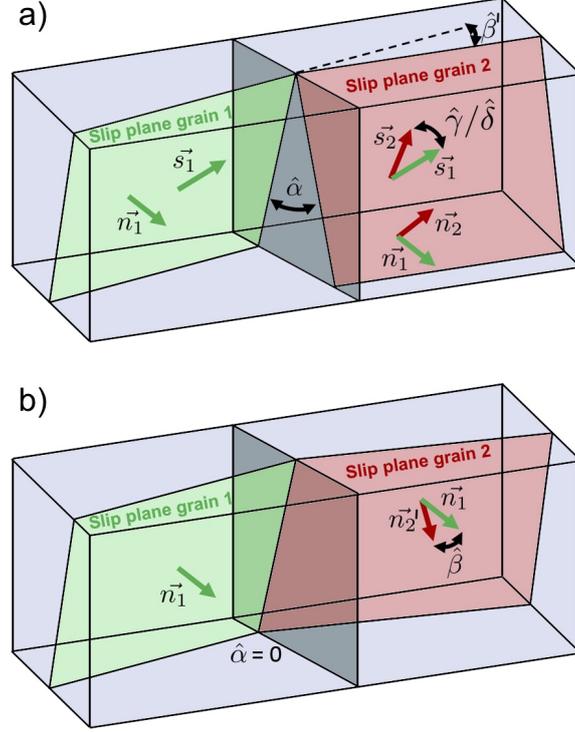
Figure 3: Definition of a) twist angle $\hat{\alpha}$ (angle between the traces of the slip/crack planes on the GB), $\hat{\gamma}$ angle (angle between the incoming slip direction and the direction with maximum SF of the outgoing plane) and $\hat{\delta}$ angle (minimum angle between the incoming slip direction and outgoing slip directions for each possible outgoing plane). b) tilt angle $\hat{\beta}$ (angle between slip/crack planes normals after rotating the outgoing slip plane around the vector normal to the GB until the twist angle $\hat{\alpha}$ is reduced to 0).

Regarding crack propagation across GBs, contrary to previous surface observations [12], the current measurements provide full access to all relevant geometrical parameters that define the propagation of cracks across each GB, including the real GB orientation below the surface: the real twist angle, in figure 3a, is measured as the angle between the intersection of the two slip/crack planes with the GB plane; and the real tilt angle $\hat{\beta}$, in figure 3b, as the angle between the two slip/crack plane normals, once the outgoing slip/crack plane is rotated around the GB normal to remove the twist. Moreover, since in Stage-I, the cracks propagate parallel to a slip plane in each grain, for each incoming slip/crack plane on an individual GB, there are four potential outgoing slip planes and three potential slip directions, and the experimental data can be used to evaluate the role of slip transferability at the GB in front of the crack tip on the selection of the outgoing slip/crack plane. To account for this, starting from the initial grain, two geometrical parameters were computed for each of the four potential slip/crack planes at each of the 12 GBs encountered by the crack: $\hat{\gamma}$, which is the angle between the incoming slip direction and the slip direction with the highest Schmidt factor for each potential outgoing slip/crack plane, and $\hat{\delta}$, which is the minimum angle between the slip direction of the incoming plane and the best aligned slip direction of each outgoing plane. The first one accounts for how well the outgoing slip system is oriented with respect to the externally applied load, while the second one evaluates how the geometrical alignment between the incoming and outgoing slip systems affects crack propagation

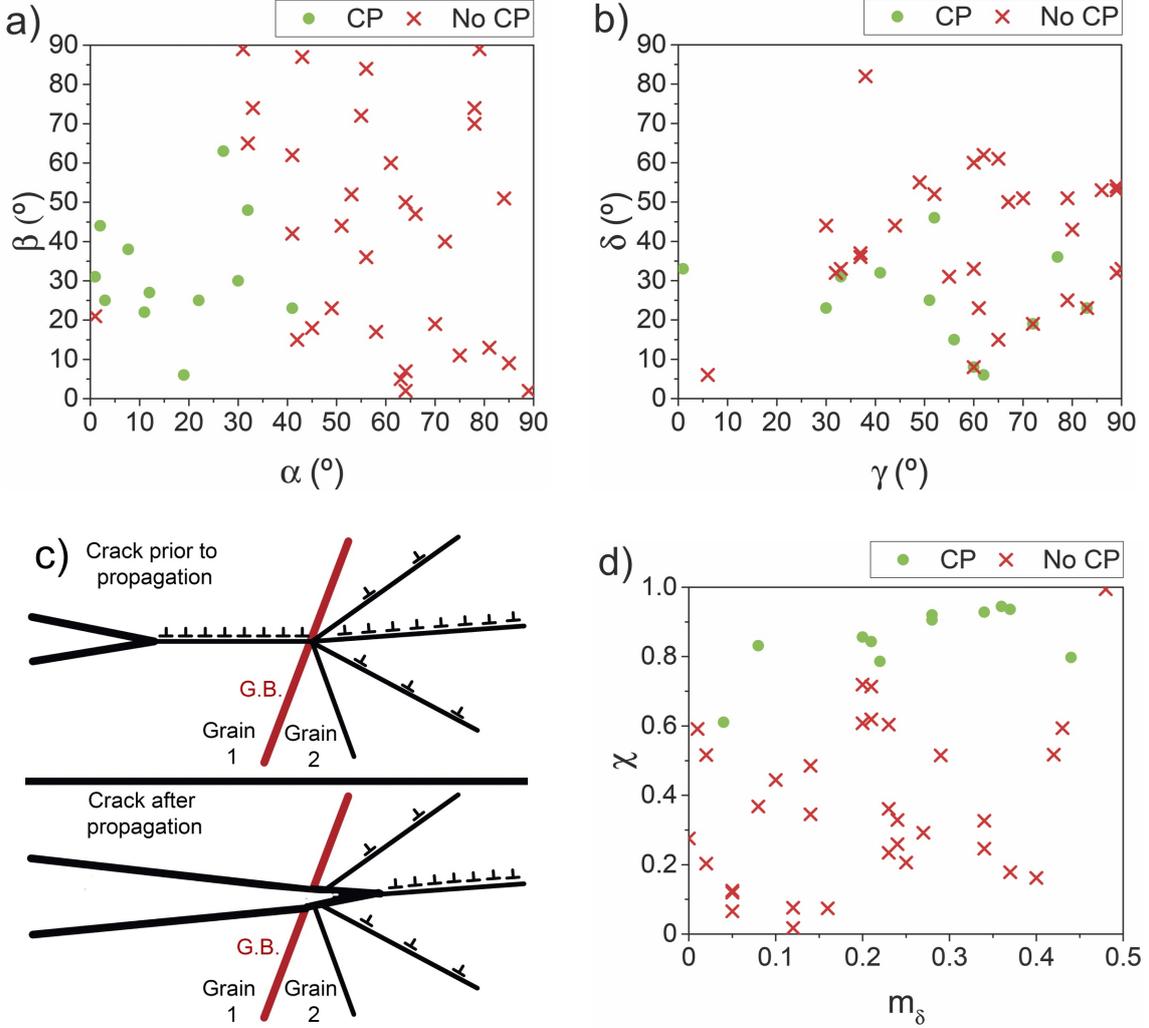
Figure 4: Analysis of crack propagation across GBs. Green circles represent the conditions for which crack propagation occurred (CP) and the red crosses represent other potential crack paths that were not observed (No CP). a) Values of the angles $\hat{\alpha}$ and $\hat{\beta}$. b) Values of the angles $\hat{\delta}$ and $\hat{\gamma}$. c) Schematic illustration of how slip transfer associated with a growing fatigue crack can determine the crack propagation path across a GB in Stage-I. d) Value of the χ factor versus the applied Schmidt factor.

Figure 4a plots the $\hat{\alpha}$ and $\hat{\beta}$ angles of all potential slip/crack planes for each analyzed GB impinged by the fatigue crack, with the green full circles representing actual observed crack paths and the red crosses, potential planes at which the cracks did not propagate. It is clear that crack propagation occurred predominantly for slip planes displaying a small twist angle, $\hat{\alpha} < 45^\circ$, while the tilt angle, $\hat{\beta}$, did not seem to influence significantly the crack path. The predominant influence of $\hat{\alpha}$ on crack propagation across GBs is in full agreement with previous observations [12], and it is reasonable because the lower the value of $\hat{\alpha}$, the smaller is the GB surface that the crack has to break through in order to propagate to the adjacent grain. Similarly, figure 4b plots the $\hat{\delta}$ and $\hat{\gamma}$ angles for all observed (green circles) and potential slip/crack planes (red crosses) for each analyzed GB impinged by the fatigue crack. It is clear that planes with a small $\hat{\delta}$, $< 45^\circ$, were always preferred propagation paths, whereas the impact of $\hat{\gamma}$ was found negligible. Therefore, both a small twist angle, $\hat{\alpha}$, and a small angle between the incoming and outgoing slip directions, $\hat{\delta}$, are key determining the crack path across GBs. Interestingly, both are geometrical parameters associated with easy slip transmission across GBs [23]. Therefore, the results allow concluding that crack propagation in stage-I is facilitated by slip transmission, as schematically illustrated in figure 4c. In other words, the plasticity induced at the crack tip in the incoming grain, predominantly parallel to the growing fatigue crack, activates outgoing slip systems in adjacent grains that are well oriented for slip transfer, and that dictate the crack path across the GB.

The χ factor, ranges between 0 and 1, with 1 implying the best possible geometrical alignment between the incoming and outgoing slip systems and 0 the worst one. Figure 4d clearly shows that

the observed CP planes correspond to slip systems with a χ factor close to 1, regardless the applied Schmidt factor on the outgoing slip system, m_{TB} . In other words, the fatigue crack propagates along directions of easy slip transfer, irrespective of their orientation with respect to the applied load. Interestingly, it was found that in the few cases where the crack did not follow a path with a high χ factor, this was associated to either bifurcation events at a given GB, due to the existence of two slip transfer paths with a high χ factor, or to cases where the incoming crack impinged on a pre-existing CTB, in which case the crack propagated along it, until impinging in the next GB.
