The role of slip transfer at grain boundaries in the propagation of microstructurally short fatigue cracks in Ni-based superalloys

Abstract

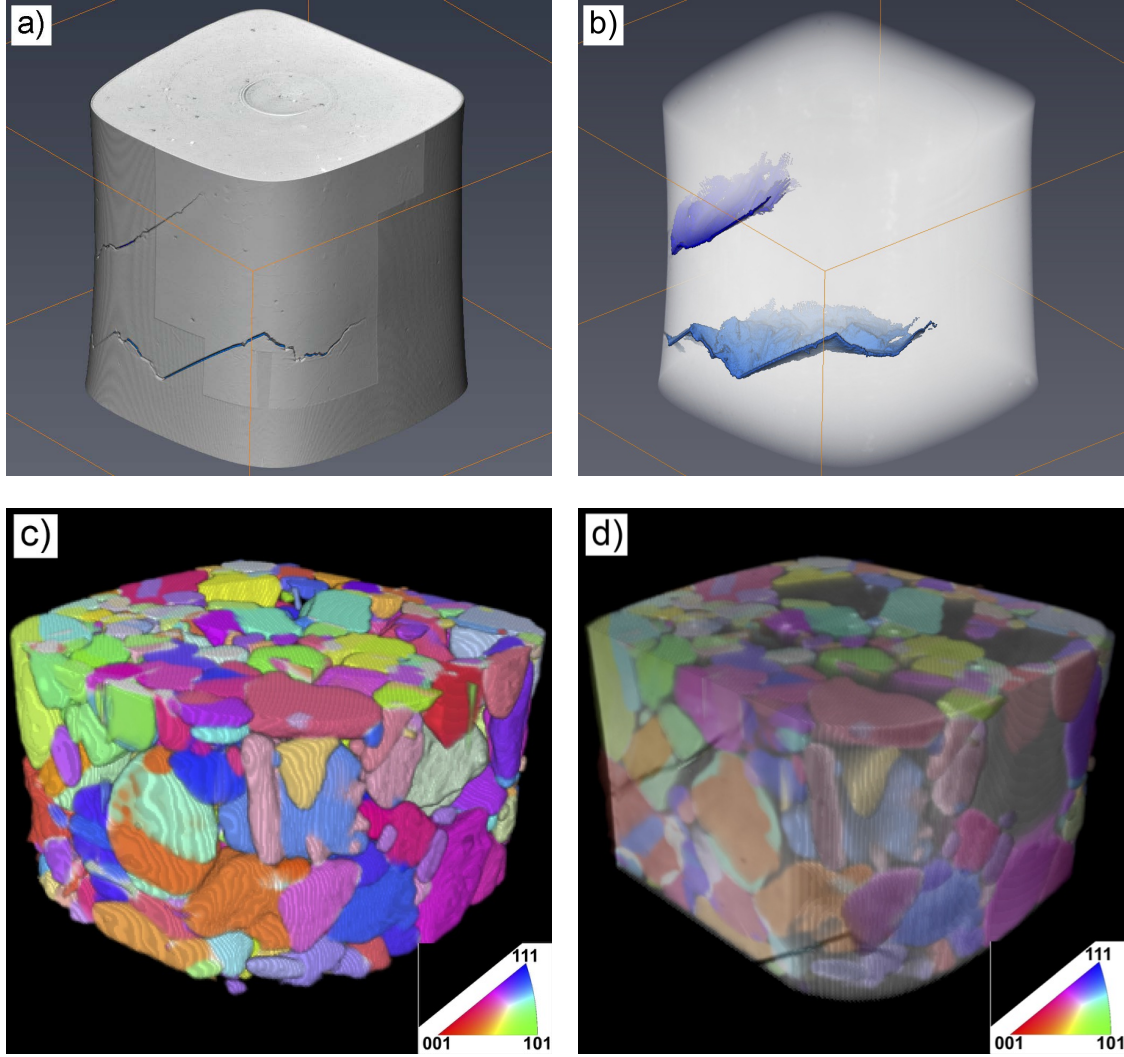
Figure 1: Reconstructed volumes of: a) PCT after 100,000 cycles. Cracks can be seen on the surface. b) PCT after 100,000 cycles with segmented cracks. c) DCT. d) Interior slice of the DCT overlapped with the PCT after 100,000 cycles, showing the interaction of the cracks with the specimen microstructure in 3D. Orientations are referred to the load (vertical) axis. The side length of the specimen is $600\mu\text{m}$.

The PCT volumes showed high quality reconstructions and clear images of the cracks (figures 1a and 1b). The DCT volume is shown in figure 1c. About 80 % of the sample volume could be indexed and reconstructed. The indexing and reconstruction process is affected by the presence of extended orientation related domains (c.f. large fraction of Sigma 3 boundaries), which give rise to systematic diffraction spot overlaps. Figure 1d shows the overlay of both, the PCT and DCT volumes. Cracks could be clearly tracked and confronted with the local microstructure, allowing the identification of the individual grains that led to crack initiation, the crystallographic planes along which the cracks propagated and the change in crack plane when the cracks were transmitted across a GB.

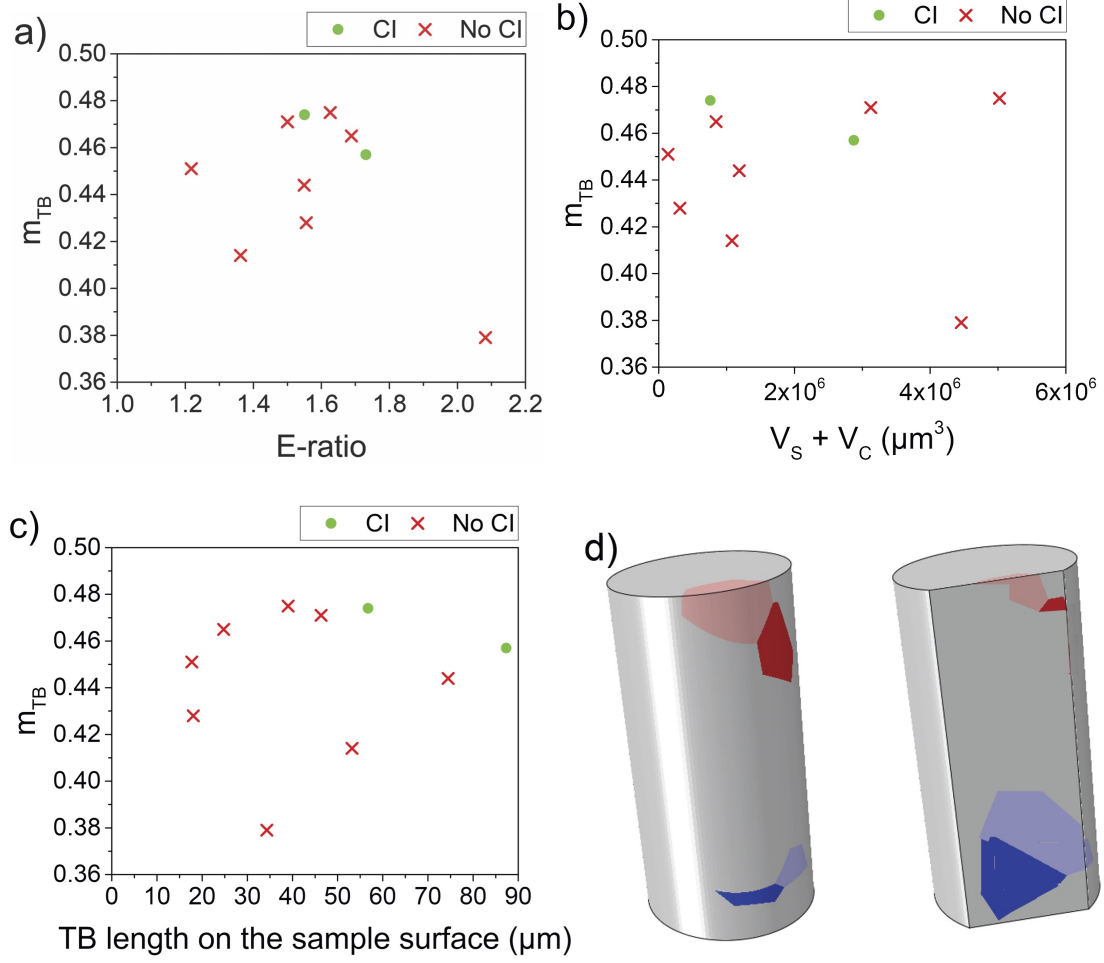
Figure 2: The applied Schmidt factor on all pre-existing CTBs found at the specimen surface is plot against different factors that can potentially lead to fatigue crack initiation. Green circles represent those CTBs that led to fatigue crack initiation (CI), while the red crosses stand for the ones that did not (No CI). a) E-ratio = E_1/E_2 . b) Sum of volumes of the grains at both sides of the TB. c) Length of the TB along the specimen surface. d) Schematic illustration of the influence of the volume of grains and length of the CTB on the surface. A long CTB on the surface that separates a small pair of grains (red grains) is more prone to crack initiation than a shorter CTB on the surface that separates two bigger grains (blue grains).

and the length of the CTB on the specimen surface. Figure 2 summarizes the results, where the green circles represent those CTBs that led to crack initiation and the red crosses those that did not. It is clear that for the cases where crack initiation occurred, a large applied Schmidt factor and a large E-ratio of 1.7 was found (figure 2a), implying that in those grains well oriented for slip a large elastic incompatibility across the CTB can explain the local stress concentration that leads to damage nucleation. However, large E-ratios and Schmidt factors are two necessary, but not sufficient conditions for the nucleation of cracks, as for instance a pre-existing CTB with a E-ratio=2.1 did not lead to crack initiation. It is also expected that larger grains will be softer and therefore more prone to damage than small ones, but figure 2b shows that this is not the most important factor because the largest grains did not lead to crack initiation. On the contrary, figure 2c shows that the length of the CTB, rather than the volume of the grains, is the most relevant characteristic size leading to crack initiation: the longer the intersection of the TB with the surface, the more likely it is to initiate a crack. This is explained by the more relaxed constraint of the slip plane parallel to the CTB on the surface, which facilitates the formation of the PSBs. As shown schematically in figure 2d, larger grains for which the intersection of the CTB with the surface is short (for instance, the blue pair of grains) are less susceptible to initiate cracks than smaller grains that display a larger CTB on the surface (the red pair of grains). Even though the current observations in a single specimen are limited, the conclusions are in full agreement with those reported using conventional testing [3], but with the advantage that the tomography results allow measuring the sub-surface shape and size of the grains and orientation of the nucleated cracks,

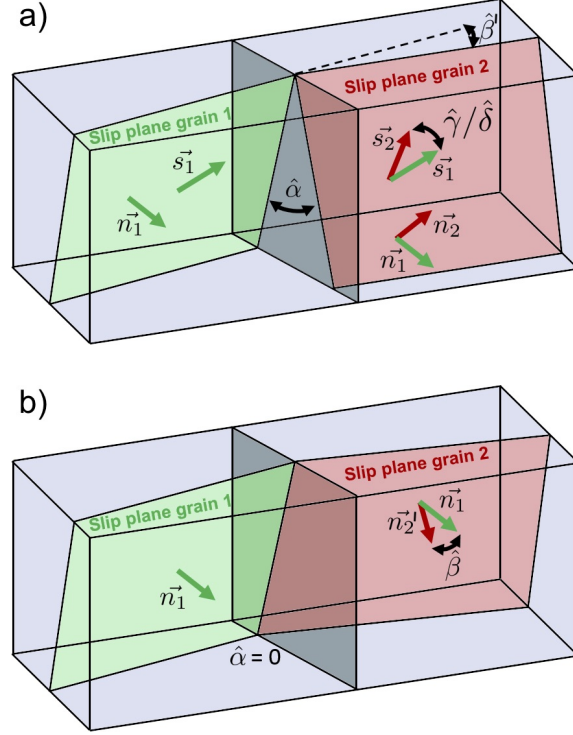
Figure 3: Definition of a) twist angle $\hat{\alpha}$ (angle between the traces of the slip/crack planes on the GB), $\hat{\gamma}$ angle (angle between the incoming slip direction and the direction with maximum SF of the outgoing plane) and $\hat{\delta}$ angle (minimum angle between the incoming slip direction and outgoing slip directions for each possible outgoing plane). b) tilt angle $\hat{\beta}$ (angle between slip/crack planes normals after rotating the outgoing slip plane around the vector normal to the GB until the twist angle $\hat{\alpha}$ is reduced to 0).

Regarding crack propagation across GBs, contrary to previous surface observations [12], the current measurements provide full access to all relevant geometrical parameters that define the propagation of cracks across each GB, including the real GB orientation below the surface: the real twist angle, in figure 3a, is measured as the angle between the intersection of the two slip/crack planes with the GB plane; and the real tilt angle $\hat{\beta}$, in figure 3b, as the angle between the two slip/crack plane normals, once the outgoing slip/crack plane is rotated around the GB normal to remove the twist. Moreover, since in Stage-I, the cracks propagate parallel to a slip plane in each grain, for each incoming slip/crack plane on an individual GB, there are four potential outgoing slip planes and three potential slip directions, and the experimental data can be used to evaluate the role of slip transferability at the GB in front of the crack tip on the selection of the outgoing slip/crack plane. To account for this, starting from the initial grain, two geometrical parameters were computed for each of the four potential slip/crack planes at each of the 12 GBs encountered by the crack: $\hat{\gamma}$, which is the angle between the incoming slip direction and the slip direction with the highest Schmidt factor for each potential outgoing slip/crack plane, and $\hat{\delta}$, which is the minimum angle between the slip direction of the incoming plane and the best aligned slip direction of each outgoing plane. The first one accounts for how well the outgoing slip system is oriented with respect to the externally applied load, while the second one evaluates how the geometrical alignment between the incoming and outgoing slip systems affects crack propagation

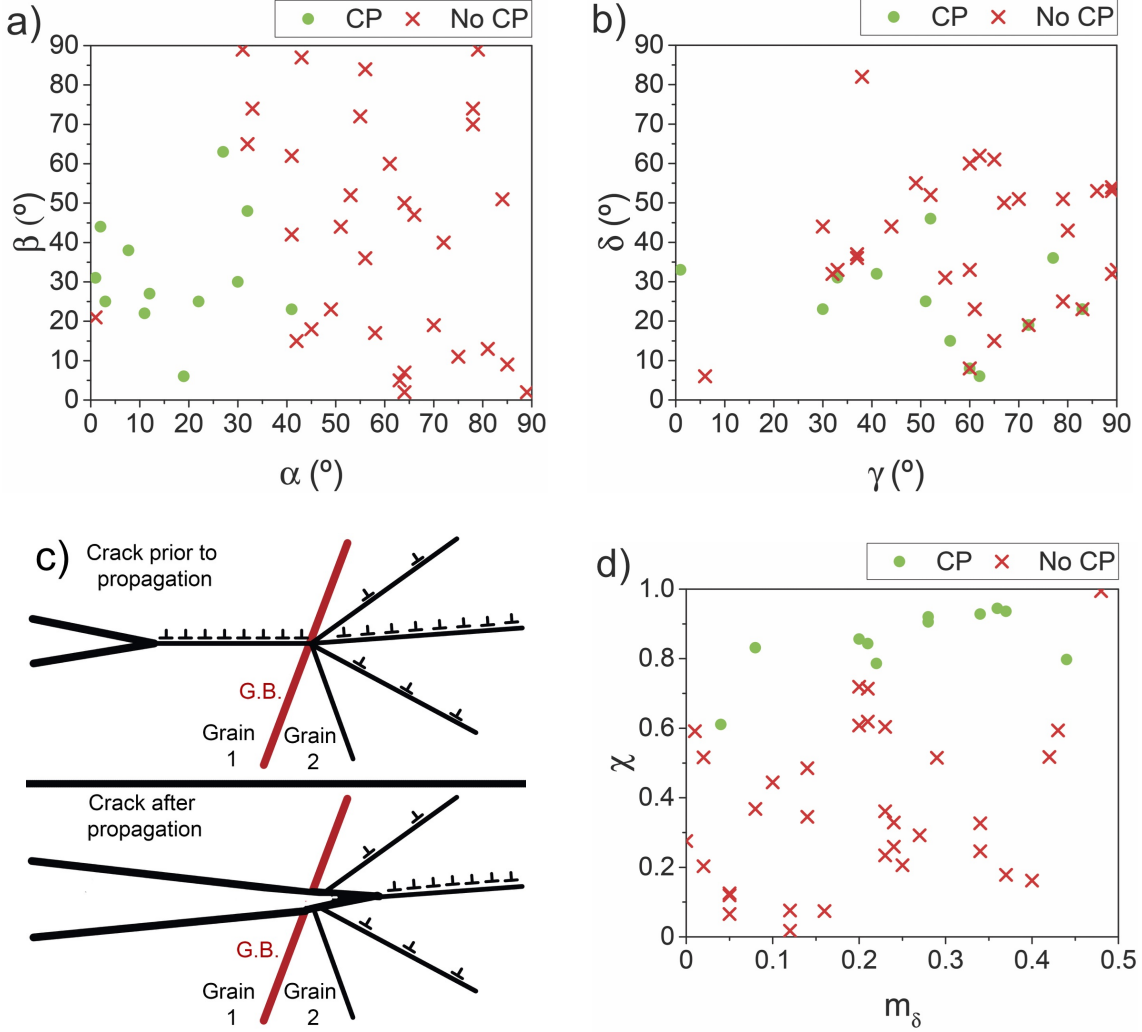
Figure 4: Analysis of crack propagation across GBs. Green circles represent the conditions for which crack propagation occurred (CP) and the red crosses represent other potential crack paths that were not observed (No CP). a) Values of the angles $\hat{\alpha}$ and $\hat{\beta}$. b) Values of the angles $\hat{\delta}$ and $\hat{\gamma}$. c) Schematic illustration of how slip transfer associated with a growing fatigue crack can determine the crack propagation path across a GB in Stage-I. d) Value of the χ factor versus the applied Schmidt factor.

Figure 4a plots the $\hat{\alpha}$ and $\hat{\beta}$ angles of all potential slip/crack planes for each analyzed GB impinged by the fatigue crack, with the green full circles representing actual observed crack paths and the red crosses, potential planes at which the cracks did not propagate. It is clear that crack propagation occurred predominantly for slip planes displaying a small twist angle, $\hat{\alpha} < 45^\circ$, while the tilt angle, $\hat{\beta}$, did not seem to influence significantly the crack path. The predominant influence of $\hat{\alpha}$ on crack propagation across GBs is in full agreement with previous observations [12], and it is reasonable because the lower the value of $\hat{\alpha}$, the smaller is the GB surface that the crack has to break through in order to propagate to the adjacent grain. Similarly, figure 4b plots the $\hat{\delta}$ and $\hat{\gamma}$ angles for all observed (green circles) and potential slip/crack planes (red crosses) for each analyzed GB impinged by the fatigue crack. It is clear that planes with a small $\hat{\delta}$, $< 45^\circ$, were always preferred propagation paths, whereas the impact of $\hat{\gamma}$ was found negligible. Therefore, both a small twist angle, $\hat{\alpha}$, and a small angle between the incoming and outgoing slip directions, $\hat{\delta}$, are key determining the crack path across GBs. Interestingly, both are geometrical parameters associated with easy slip transmission across GBs [23]. Therefore, the results allow concluding that crack propagation in stage-I is facilitated by slip transmission, as schematically illustrated in figure 4c. In other words, the plasticity induced at the crack tip in the incoming grain, predominantly parallel to the growing fatigue crack, activates outgoing slip systems in adjacent grains that are well oriented for slip transfer, and that dictate the crack path across the GB.

The χ factor, ranges between 0 and 1, with 1 implying the best possible geometrical alignment between the incoming and outgoing slip systems and 0 the worst one. Figure 4d clearly shows that

the observed CP planes correspond to slip systems with a χ factor close to 1, regardless the applied Schmidt factor on the outgoing slip system, m_{TB} . In other words, the fatigue crack propagates along directions of easy slip transfer, irrespective of their orientation with respect to the applied load. Interestingly, it was found that in the few cases where the crack did not follow a path with a high χ factor, this was associated to either bifurcation events at a given GB, due to the existence of two slip transfer paths with a high χ factor, or to cases where the incoming crack impinged on a pre-existing CTB, in which case the crack propagated along it, until impinging in the next GB.
