Field-based gravel fluxes measurements in a wandering river to assess sediment mobility downstream a dam (Durance River, Southern French Alps)

Kélian Lagrèvre, Margot Chapuis, Lylia Kateb, S. Dufour, Bernard Couvert,
Christian Doddoli, Mireille Provansal

Kélian Lagrèvre, Margot Chapuis, Lylia Kateb, S. Dufour, Bernard Couvert, et al.. Field-based gravel fluxes measurements in a wandering river to assess sediment mobility downstream a dam (Durance River, Southern French Alps). RCEM 2017- 10th Symposium on River, Coastal and Estuarine Morphodynamics, Sep 2017, Trente, Italy. RCEM 2017- 10th Symposium on River, Coastal and Estuarine Morphodynamics, 2017. hal-02417369

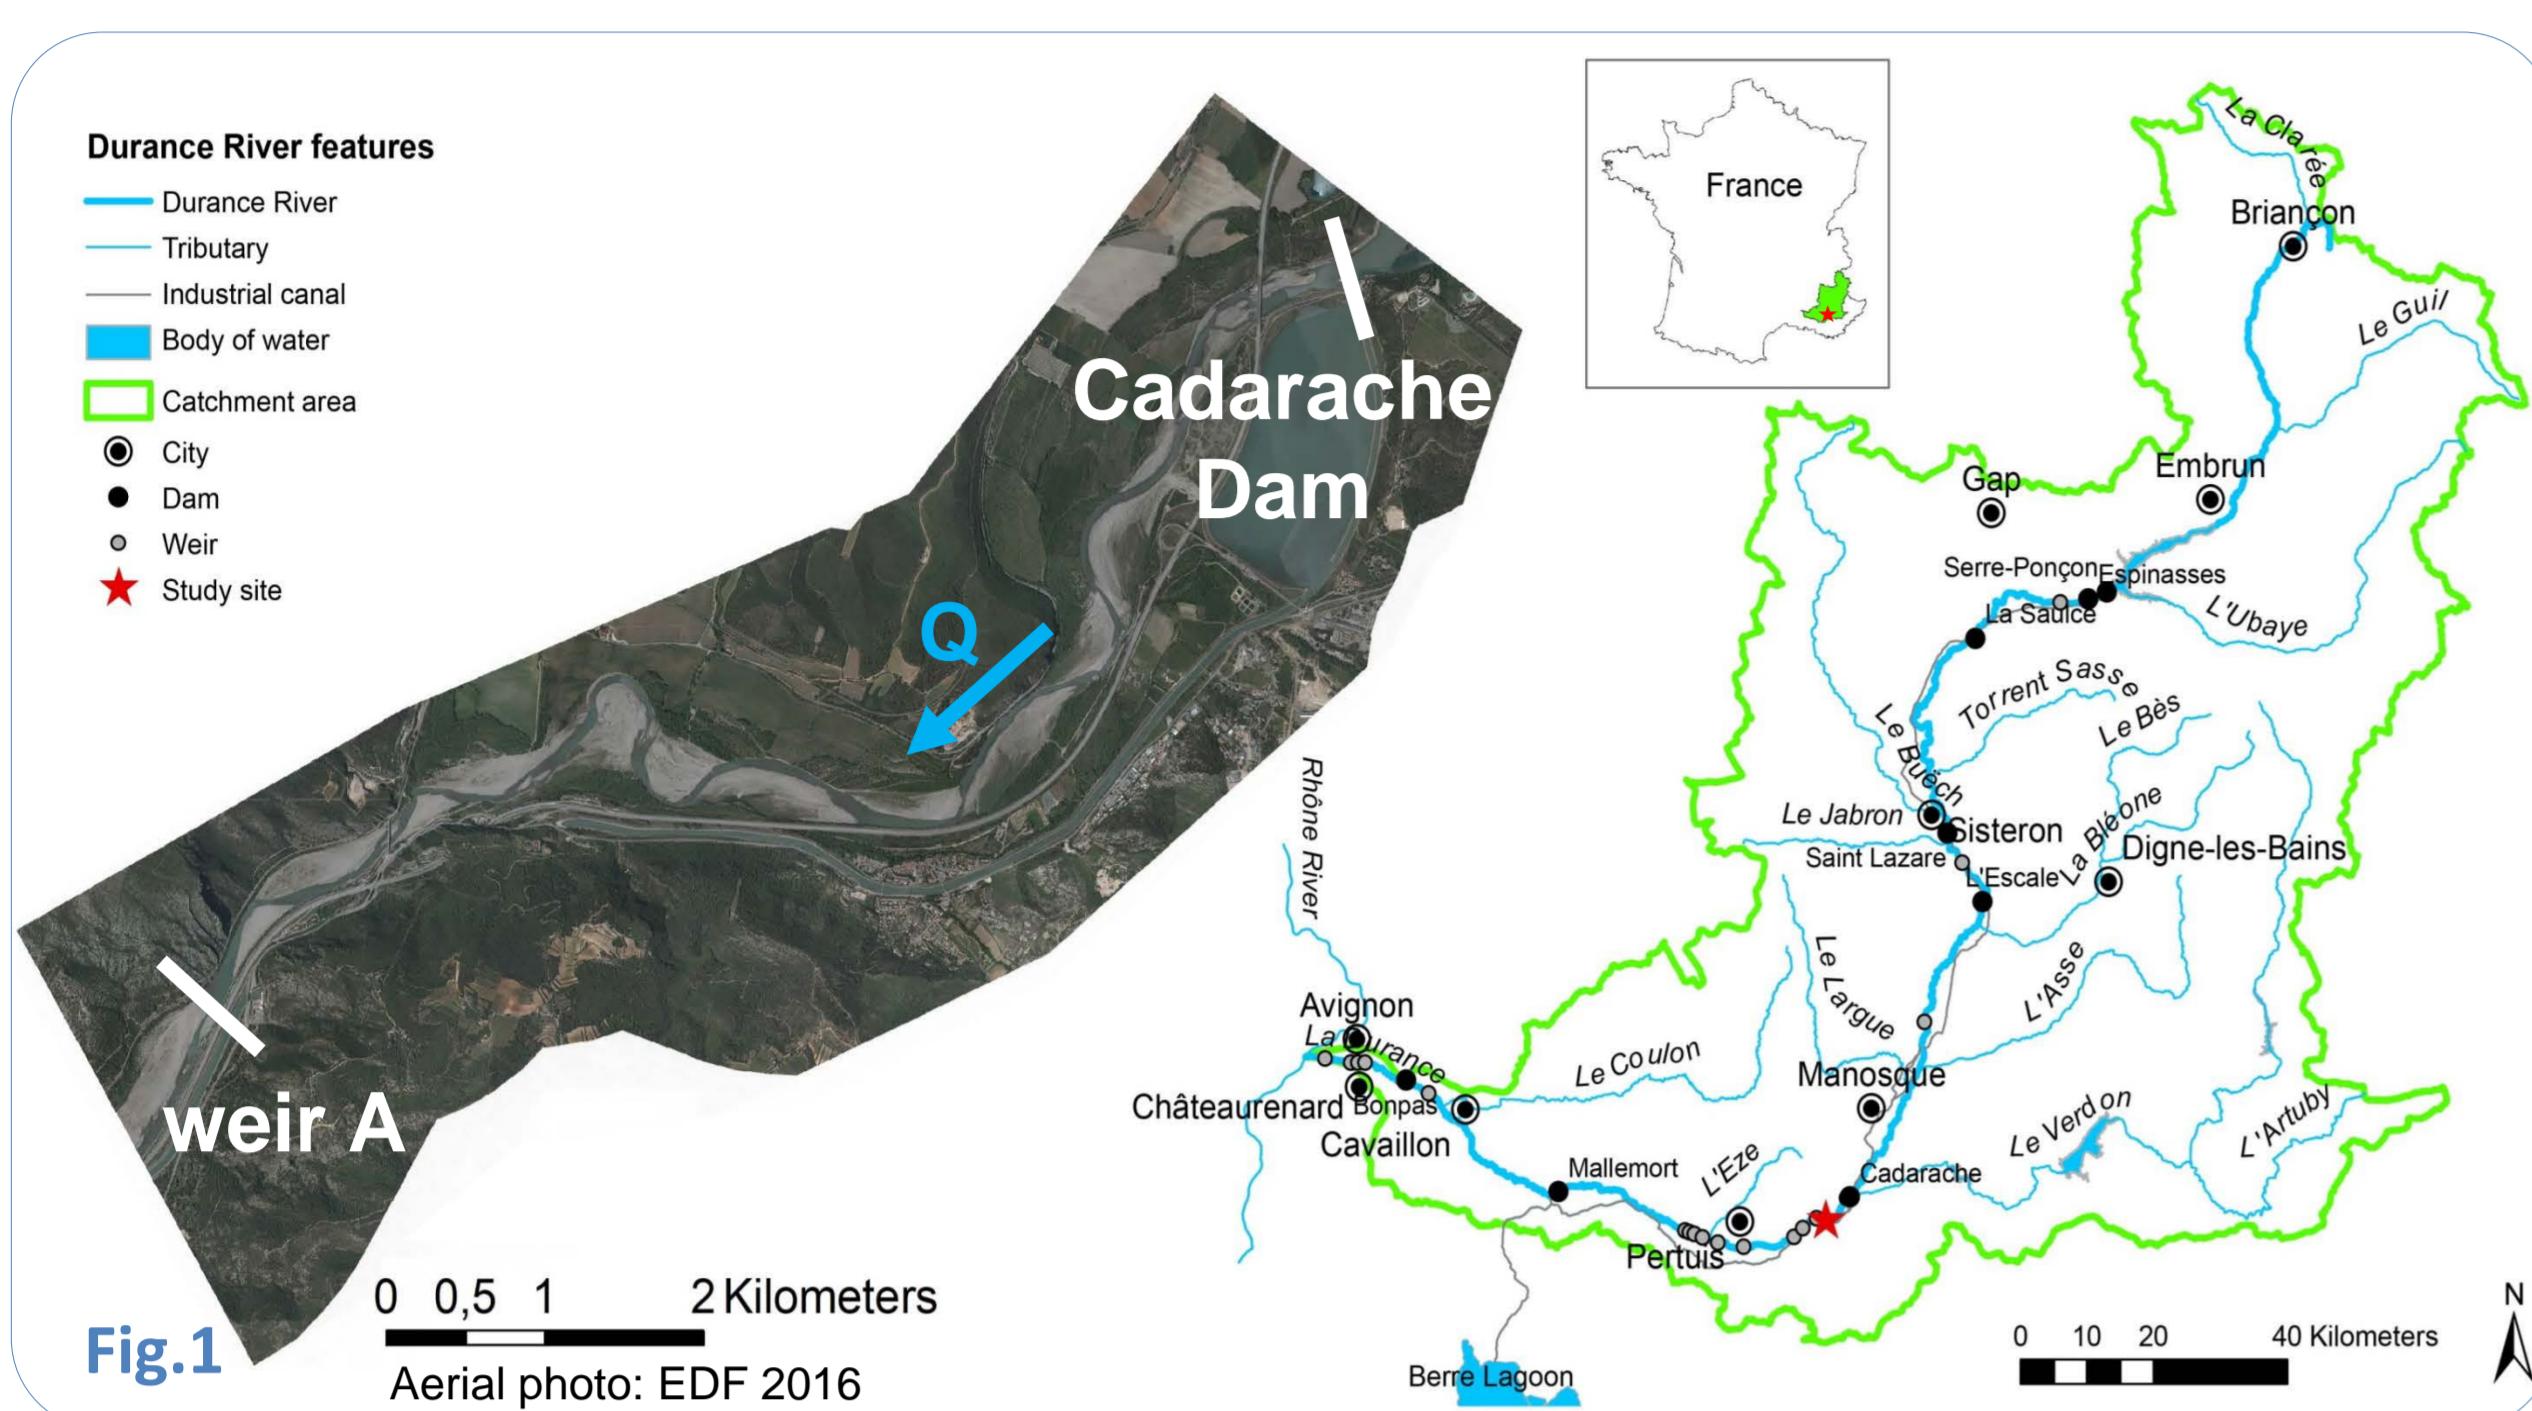
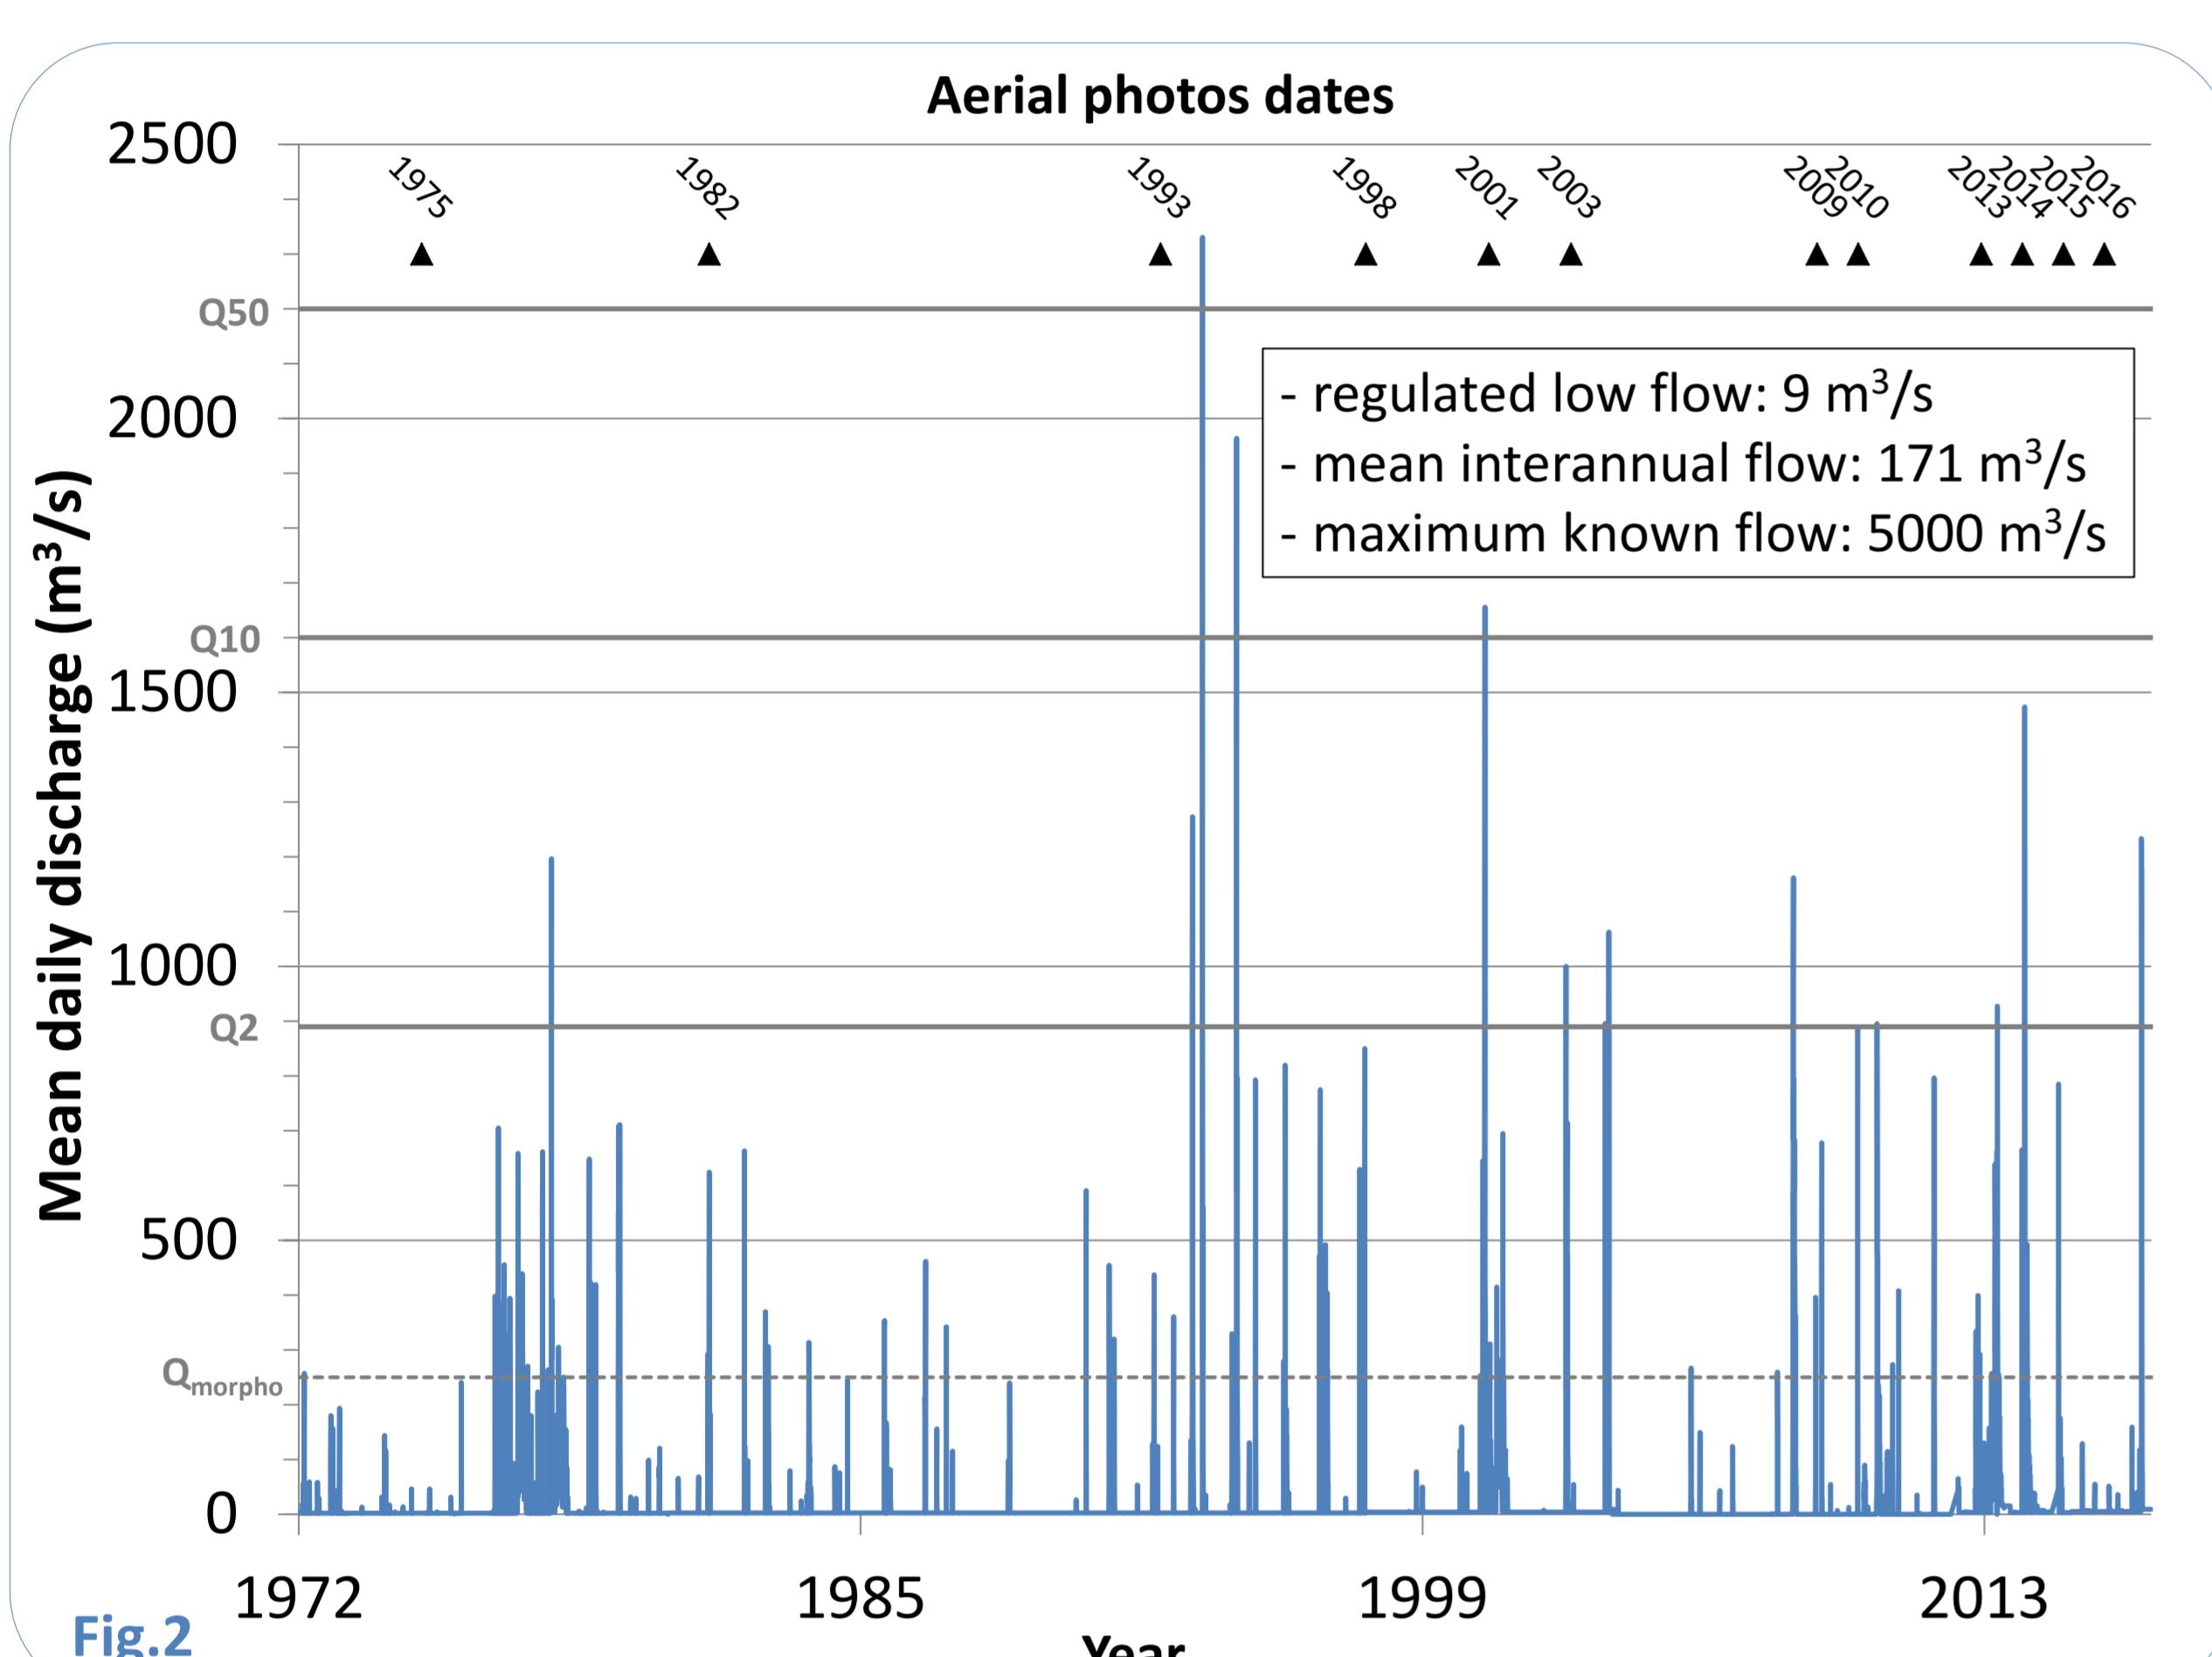
4. Study site – Fig.1 & Fig.2

- Large (mean width: 240 m) and steep (mean slope: 0.23%) wandering river
- 10 km-long reach located in the lower part of the Durance River (Southern French Alps), downstream Cadarache Dam
- Intense planning within the floodplain since 1960 (dam, highway, diversion canal)
- Peculiar hydrological regime: both Mediterranean and alpine influences → intense and short floods
- Bed material: gravel and fine matrix (coarse fraction: D₅₀ = 40 mm ; sand and silt fraction: D₅₀ = 33 µm)
- Since 2008, new management procedures at the dam: sediment transport is allowed when flooding above 500 m³/s → sediment continuity

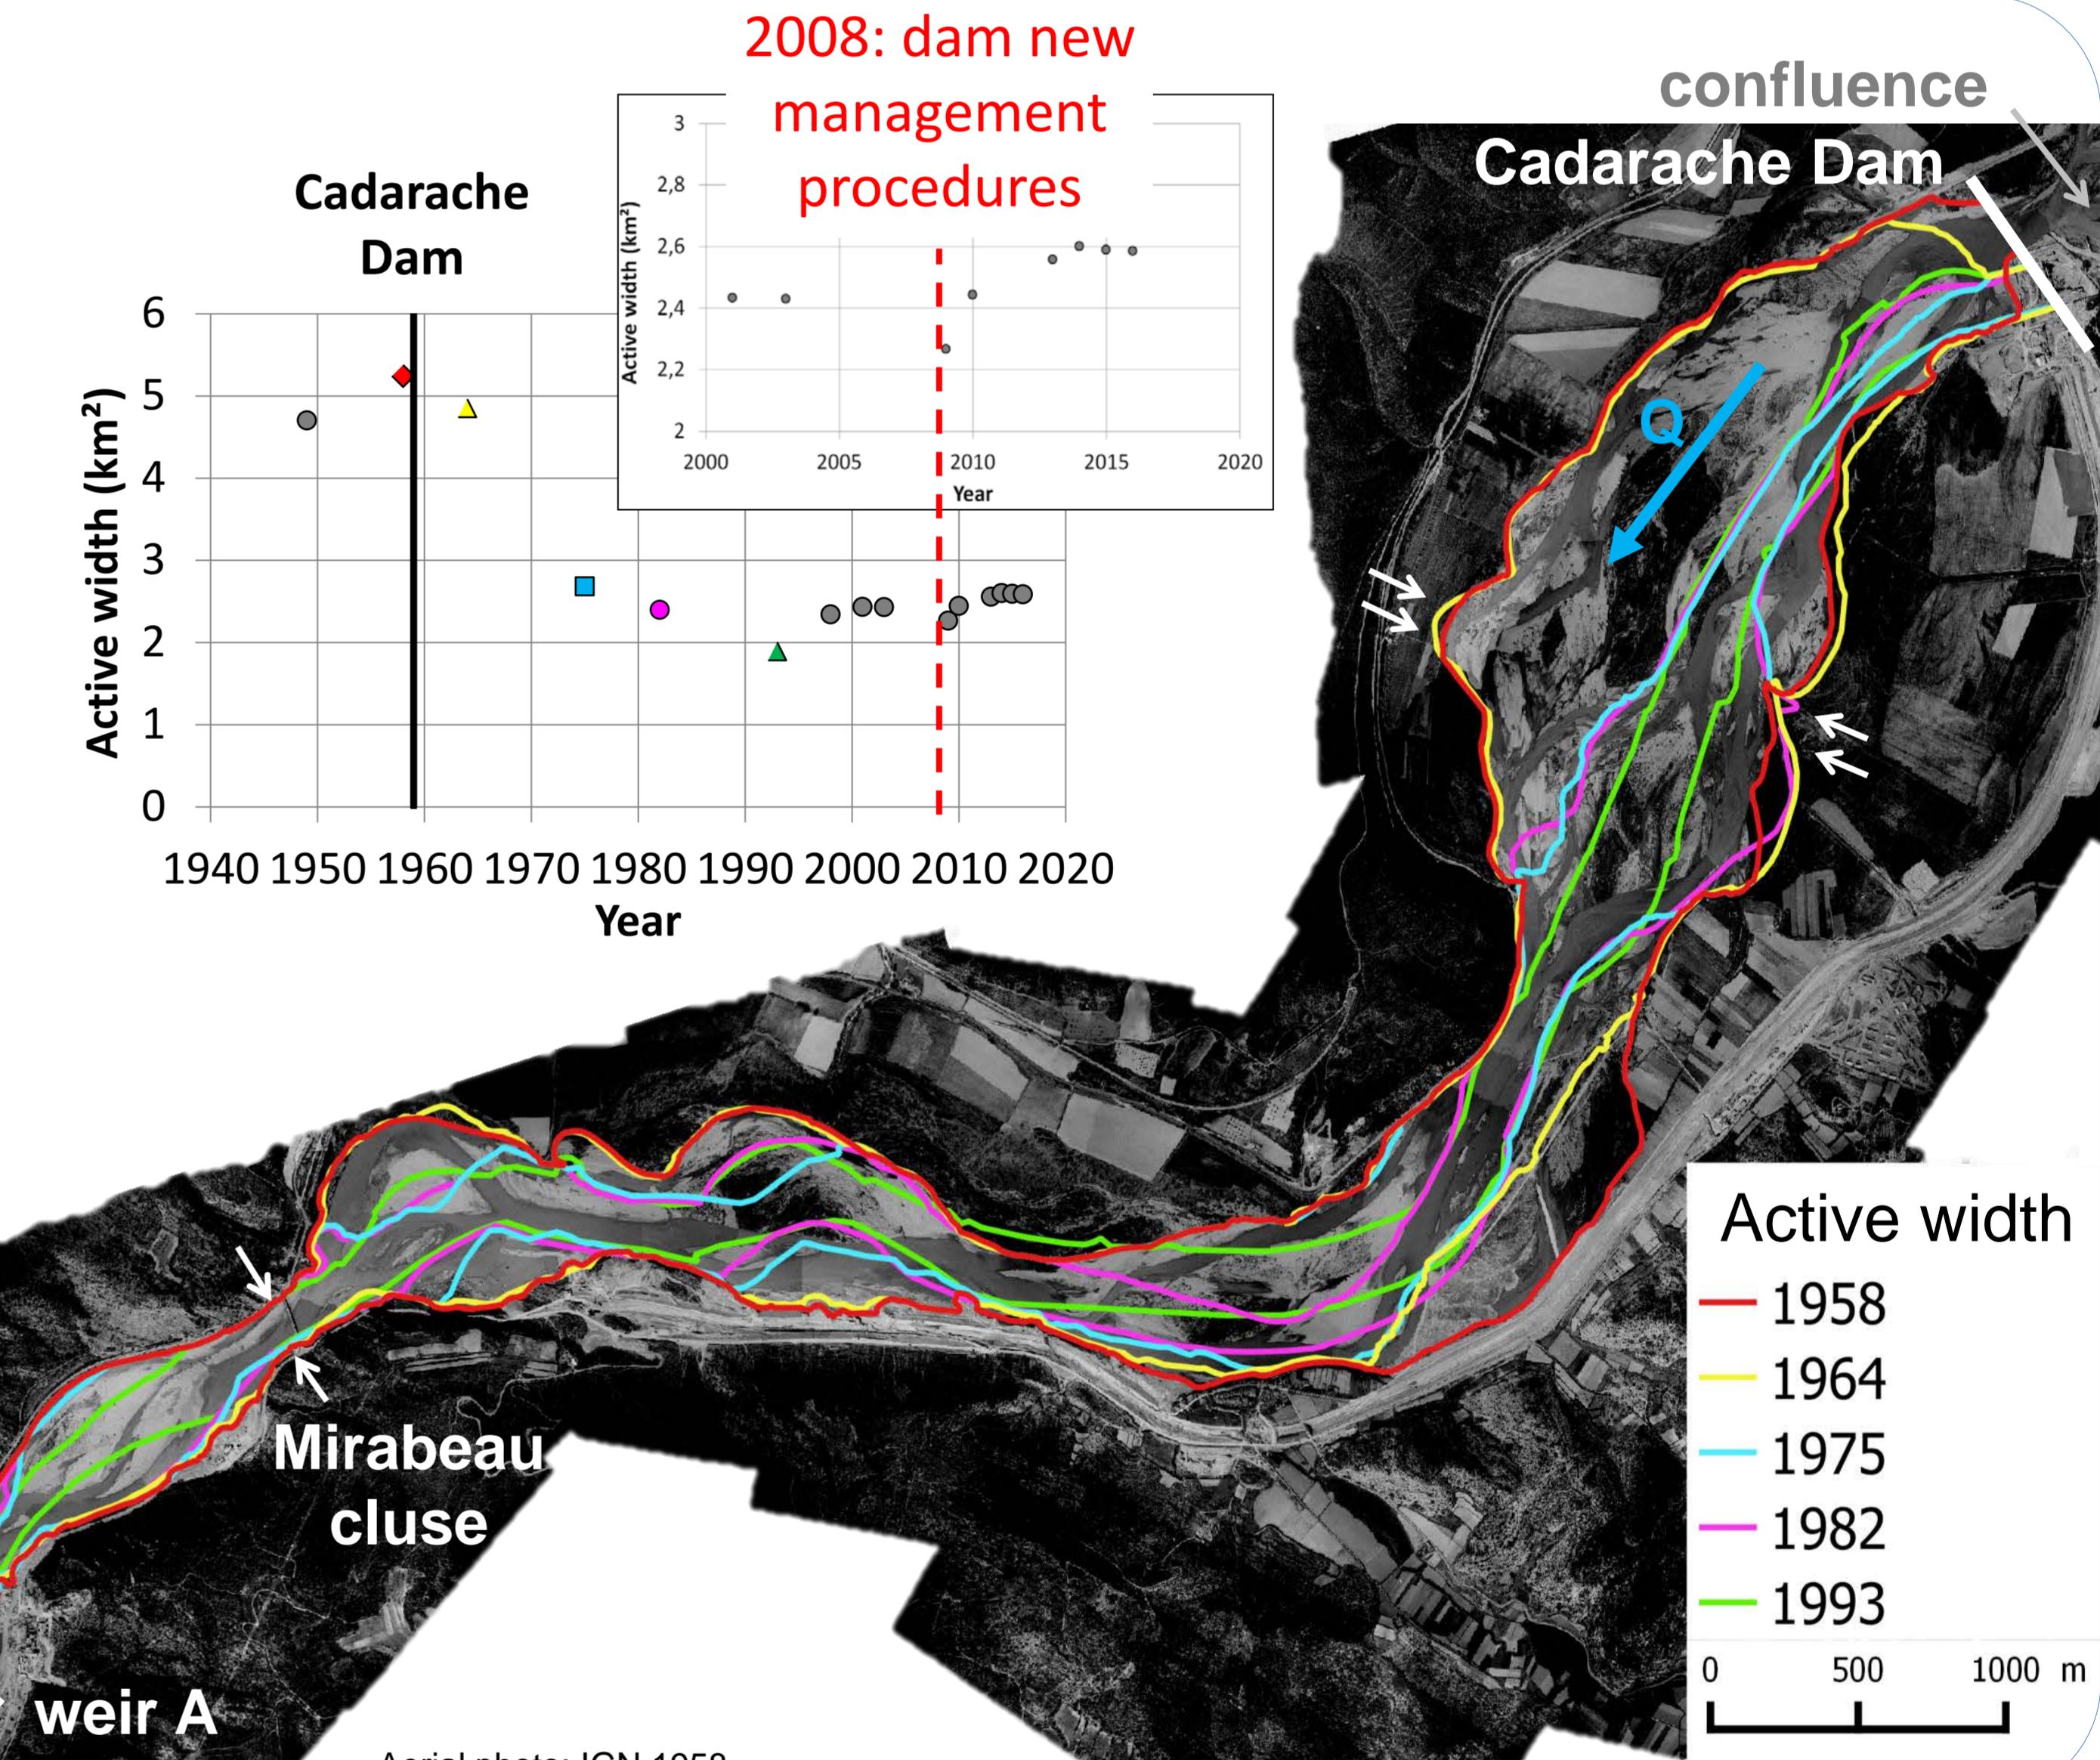
5a. Active width and lateral mobility – Fig.3

Before dam (1958)

- Lateral mobility controlled by geologic structure (confluence, cluse)

After dam (after 1959)

- 1958–1993: reduction of active width (64%), also linked to low hydrological regime
- 1994–2016: increase in active width (11%), linked to:
 - intense hydrological regime (9 floods > 900 m³/s)
 - new dam management procedures (discharge and sediment continuity)

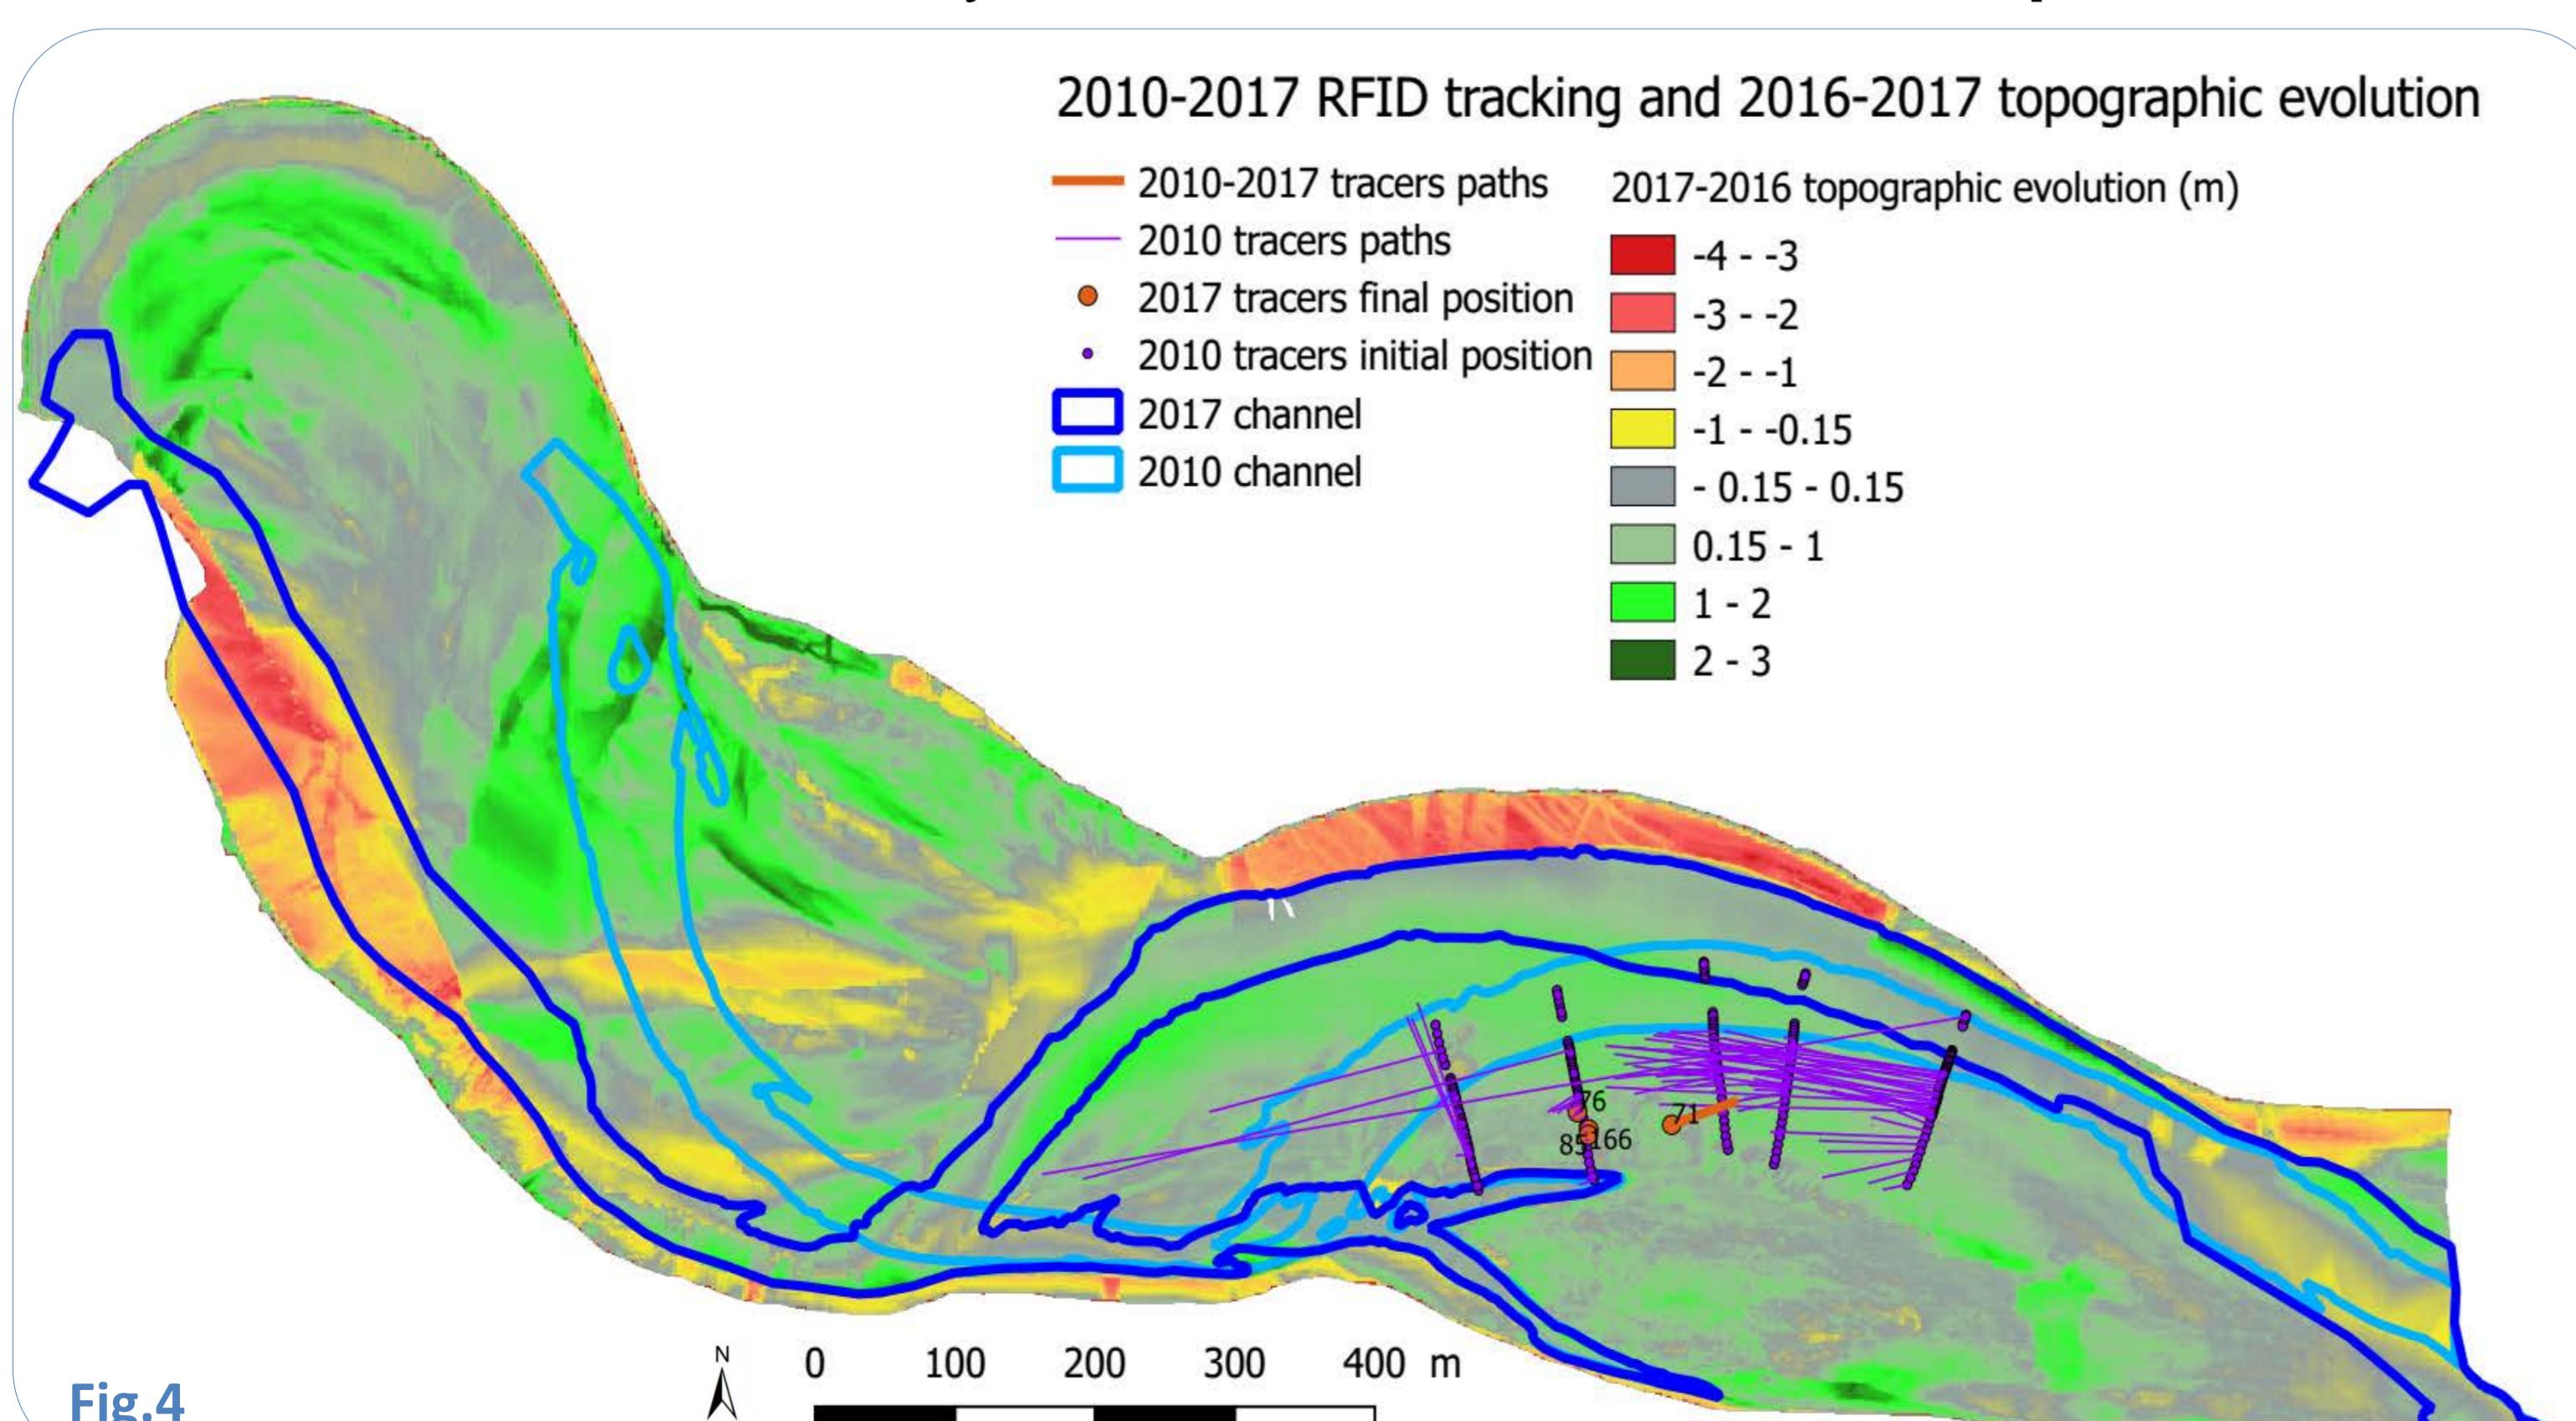
5b. Bed topographic evolution and RFID tracking – Fig.4

2009–2017 period

- Bed reworking (erosion vs. deposition phases) linked to hydrology
- Local general trend: deposition
- Outer banks translations by bank erosion → sediment input downstream

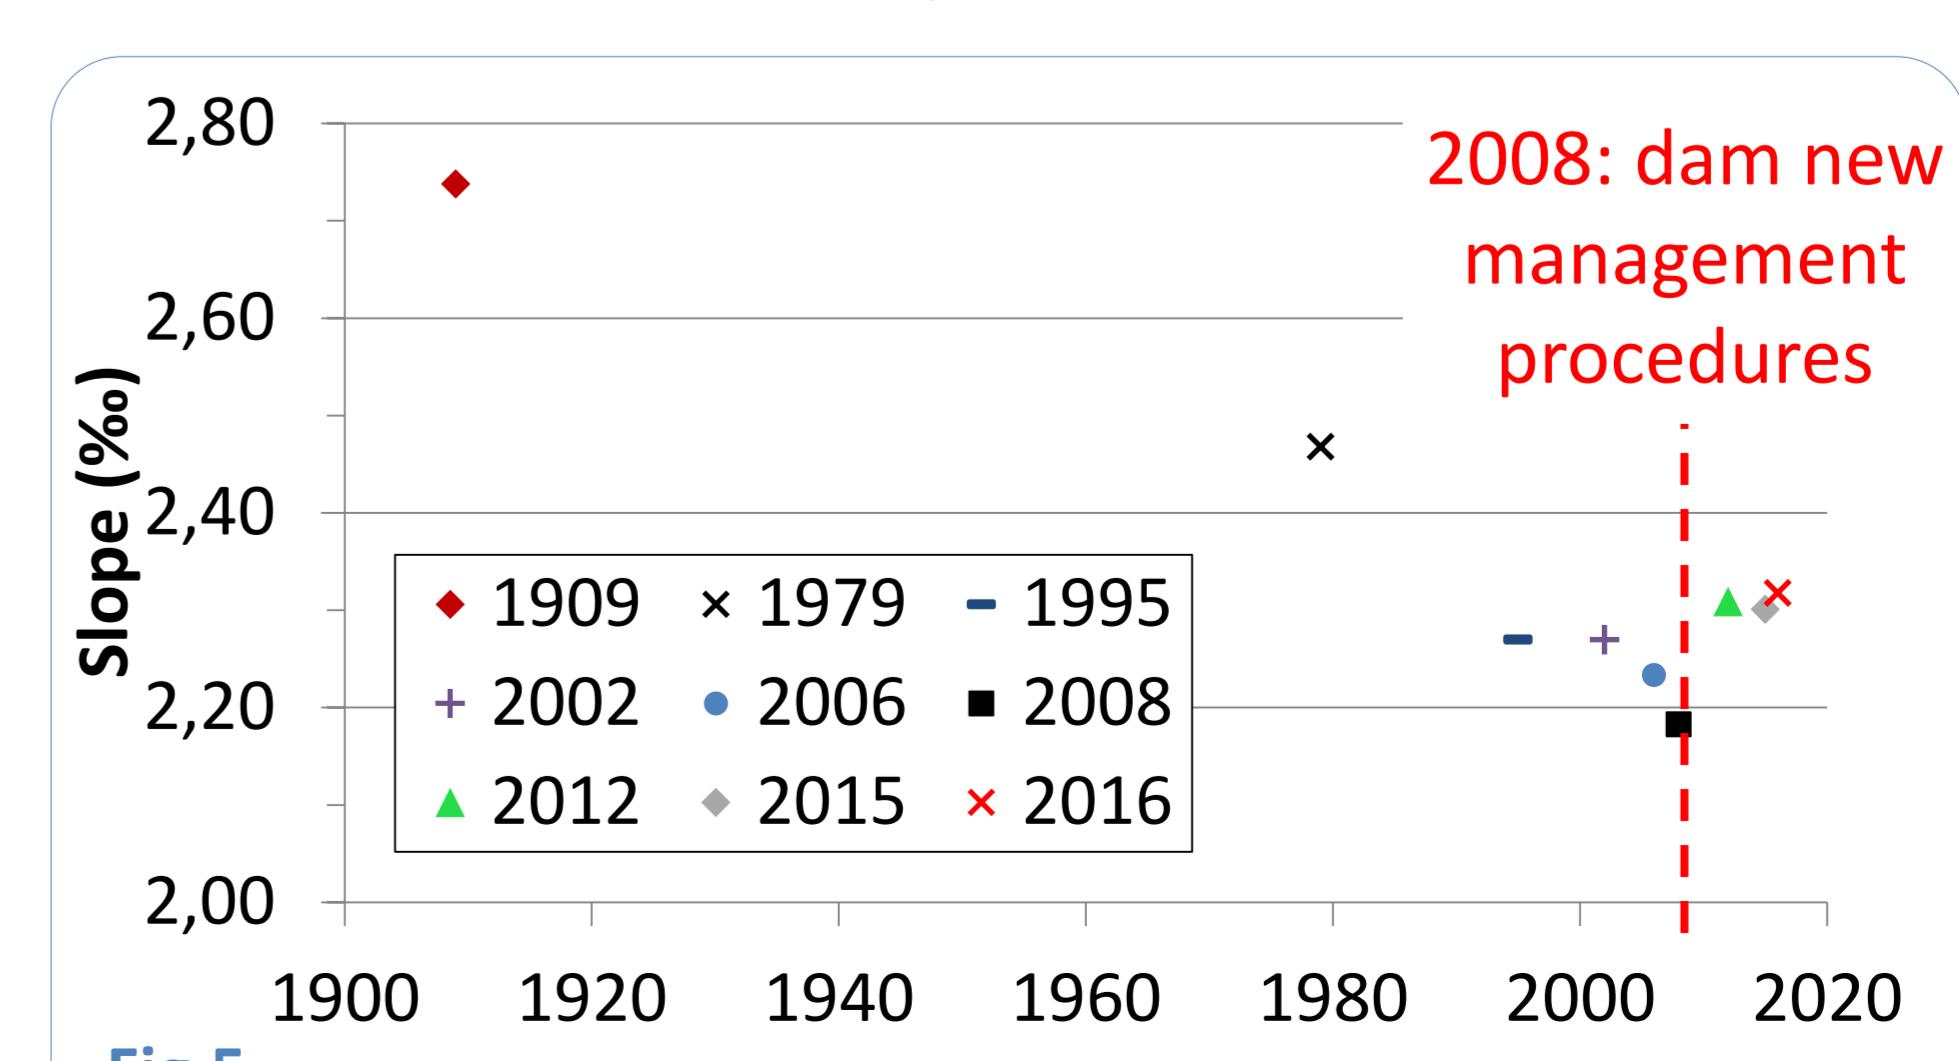
5c. Longitudinal profile – Fig.5

1909–2008 period

- Direct consequence of the dam: incision up to 2 m (Chapuis et al., 2015)
- Decrease in bed slope: adjustment to sediment discontinuity due to the dam (downstream erosion)

2008–2016 period

- Increase in bed slope to adjust from dam new management procedures: validation of the « equilibrium slope » to match transport capacity and upstream bedload supply (see hypothesis in Lefort, 2007, p.13) → reactivation of sediment dynamics
