# Non-destructive Evaluation of Concrete Damages of Containment Walls in Nuclear Power Plants

**ABSTRACT.** This paper is focused on the part of the project ANR ENDE that concerns the damage and crack characterization by means of NDT. The tests are done in 3 or 4 points bending in order to study the cracks' generation, their propagation, as well as their opening and closing. The main ultrasonic techniques developed concern linear or non-linear acoustic: acoustic emission [SBA 2015], Locadiff [LAR 2015], energy diffusion, surface wave's velocity and attenuation, DAET [3]. The recorded data contribute to providing the mapping of the investigated parameters, either in volume, in surface or globally. Digital image correlation is an important additional asset to validate the coherence of the NDT results.

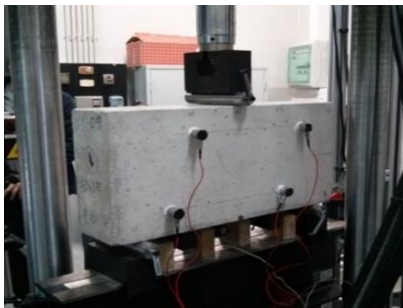
Figure 1. Three points bending test.

Follow-up testing of diffuse damage and its transition to continuous damage as well as that of interface cracks is carried out on 50x25x12 cm<sup>3</sup> specimens (Fig. 1a).

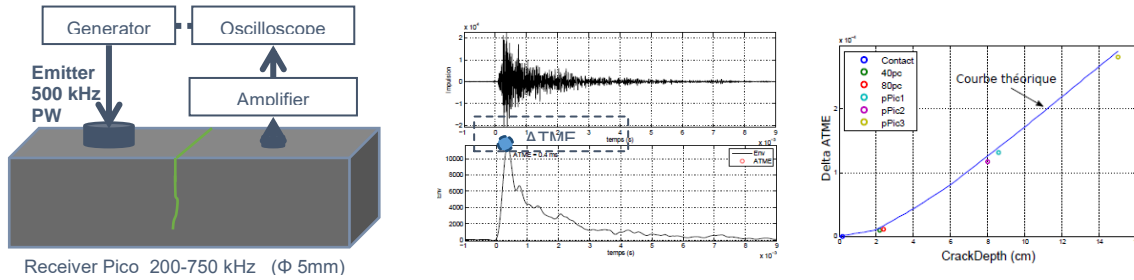
**Figure 4.** a) Diffused Waves analysis b) ATME c) Link between ATME and the crack depth

The Diffused Waves technique [QUI 2012] analyzes the wave energy transportation through the sample with a crack (Fig. 4a). One of the Non-Destructive Parameters used is the Arrival Time of the Maximum of the Energy (ATME) shown in Fig. 4b by the blue point. We can follow the increase of the crack depth through a simple model as presented in (Fig. 4c).

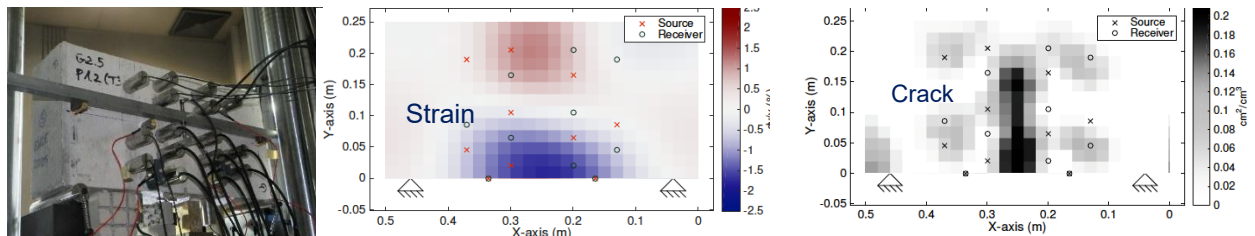
**Figure 5.** a) Transducers distribution b) Strain before the peak c) Crack propagation after the peak.

The Locadiff technique [LAR 2015] uses the evolution of the diffused waves obtained from a transducers network (Fig. 5a: 10 emitters, 10 receivers). A small perturbation in a material with multiple scattering is identified. This technique allows evaluating the strain state of the sample by the relative variation of velocity and estimating the damage and the crack by decorrelation of the wave forms. The results show the strain (Fig. 5b) and the crack length (Fig. 5c). The size of the voxels is  $2 \times 2 \times 2 \text{ cm}^3$ .

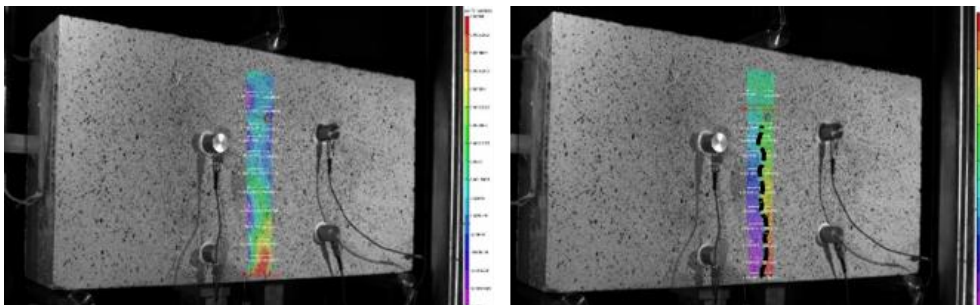
**Figure 6.** a) Strain distribution, b) Crack way and opening

The Digital Image Correlation (DIC) works with the displacement measurement of the points of a speckle pattern (Fig. 6a), [TAH 2010]. It allows evaluating the strain state of the sample (Fig. 6a) and also by the way, the length (Fig. 6c) and the opening of the crack. From a theoretical point of view, the crack opening corresponds to the displacement jump between two points located from either side of the future crack path. This holds particularly in the case of a visible and wide-opened macro crack (more than a few micrometers).

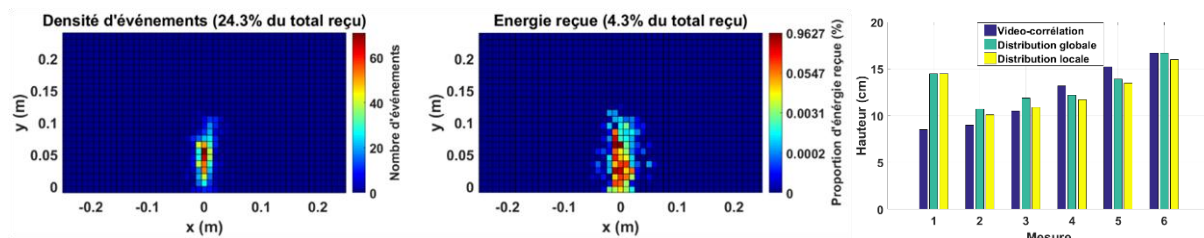
**Figure 7.** Density distribution (a) and energy (c) of EA events, (c) comparison of crack length measurement with EA and DIC.

The Acoustic Emission [SBA 2015] is a passive technique that allows following all the events that occurs in the sample with 8 receivers (transducers frequency of 150 kHz). These events correspond to the generation of micro cracks of damage or to the propagation of the crack(s). The events are recorded by the transducers and counted following a cumulative or instantaneous process. Each event, under conditions, is positioned by using the information from all the transducers (Fig. 1a). The results of a continuous auscultation of one of the samples can give us the density of the damage (Fig. 7a) and or the density of the energy close to the crack (Fig. 7b). The length of the crack is also extracted based on the events density distribution. A comparison between AE results and DIC show good correlation (Fig. 7c).
