Tool wear analysis and improvement of cutting conditions using the high-pressure water-jet assistance when machining the Ti17 titanium alloy

Yessine Ayed, Guénaël Germain, Amine Ammar, Benoit Furet

Yessine Ayed, Guénaël Germain, Amine Ammar, Benoit Furet. Tool wear analysis and improvement of cutting conditions using the high-pressure water-jet assistance when machining the Ti17 titanium alloy. *Precision Engineering*, 2015, 42, pp.294-301. 10.1016/j.precisioneng.2015.06.004 . hal-02486151

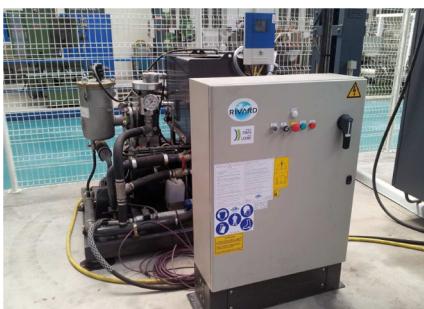
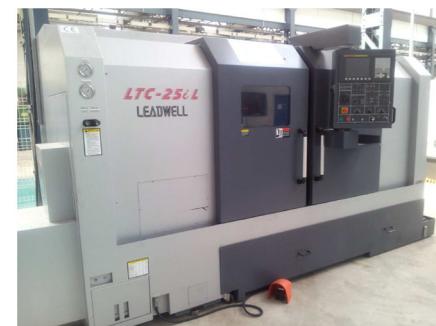
Fig. 2. (a) High-pressure pump, (b) CNC lathe.

All machining operations have been carried out with a “LEADWELL LTC25iL” CNC lathe (Fig. 2). A high-pressure pump has been used to supply the high-pressure jet (400 bar, 38 l/min). The pump tank is filled with 200 L of lubricant consisting of 95% water and 5% soluble oil. The experimental setup is illustrated by Fig. 3
