In Situ tensile tests to analyze the mechanical response, crack initiation, and crack propagation in single polyamide 66 fibers

Alba Marcellan, Anthony Bunsell, Roland Piques, Lucien Laiarinandrasana. In Situ tensile tests to analyze the mechanical response, crack initiation, and crack propagation in single polyamide 66 fibers. *Journal of Polymer Science Part B: Polymer Physics*, 2019, 57 (11), pp.680-690. 10.1002/polb.24823 . hal-02486413

***In Situ* Tensile Tests to Analyse the Mechanical Response, Crack Initiation and Crack Propagation in Single Polyamide 66 Fibres.**

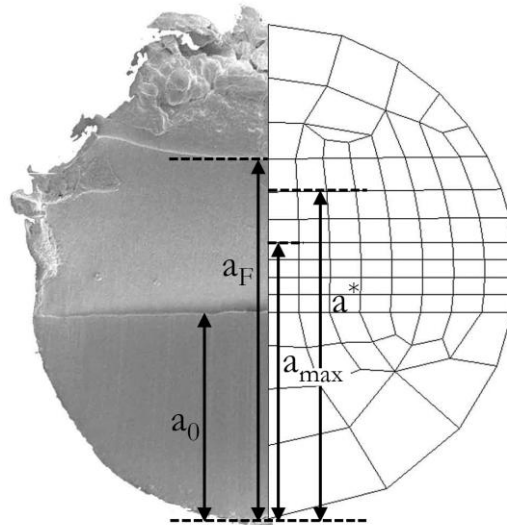
Concerning the pre-cracked fibre, the fracture toughness should be calculated for a crack depth corresponding to the onset of the brittle failure. As mentioned in Table 3, the extreme crack depths measured *in situ* from side views a_{\max} , were less than those measured from the *post-mortem* fracture surfaces by SEM. The purpose of the first part of the numerical simulation was then to determine the appropriate crack depths resulting in final brittle failure at the maximum load, using the compliance (inverse of the stiffness) method assisted by FE modelling. The compliance of the cracked specimen depends on the crack depth ratio. If the constitutive model is relevant, the FE simulated load versus δ curve should be in line with the experimental one by fixing the crack depth value. To this end, the remaining ligament was meshed for each of the geometries so as to make appear three crack depths, respectively a_0 , a_{\max} and a_F (Table 3). For simplification purposes, the crack front was assumed to be straight. Figure 10 details the top views of the afore-mentioned 3D meshes.

FIGURE 10. FE mesh of the remaining ligaments of MF fibres. This mesh corresponds to MF4 test. (Crack depths are defined in Table 3).

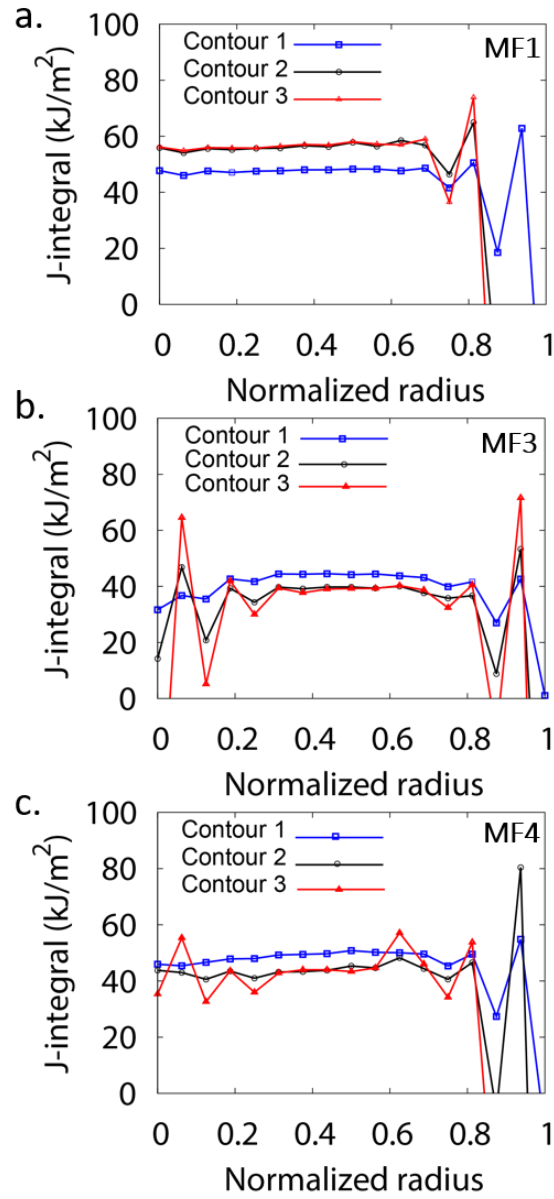
FIGURE 13. Profiles of J -integral along the crack fronts for a) MF1, b) MF3 and c) MF4 geometries.

Figure 13 plots the J -integral values obtained by FE simulations according to 3 contours around the crack tip node along the crack front.

Although oscillations of the J -integral appeared when the element was near a surface, a well-stabilized value of the J -integral could be observed elsewhere. This stabilized value was encountered from the second contour of elements around the crack front (Contours 2 and 3). The fracture toughness was taken to be the value of the J -integral at the maximum load and corresponded to a^* as the crack depth. The average value deduced from Figure 13 was $(47 \pm 7) \text{ kJ.m}^{-2}$, which is a rather high in comparison with other estimates using linear elastic fracture mechanics (about $15\text{-}30 \text{ kJ.m}^{-2}$).^{32,36} So as to check the relevance of the J -integral computed by FE in fully 3D, the value obtained using experimental curve as suggested by Ramsteiner *et al.*³⁴ was used:
