Building material and production analysis of the industrial lime kiln (19 th C.) excavated in the valley of La Panouse, Marseilles

Anne-Marie d'Ovidio, Annick Riani, Philippe Bromblet. Building material and production analysis of the industrial lime kiln (19 th C.) excavated in the valley of La Panouse, Marseilles. 4th Historic Mortars Conference - HMC 2016, Oct 2016, Santorin, Greece. hal-02548434

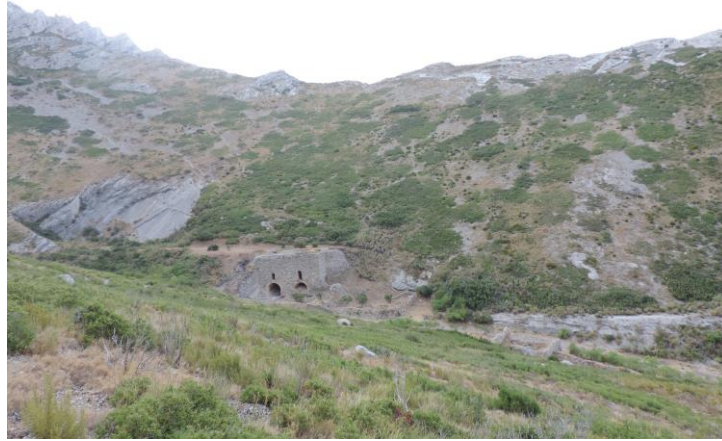
Fig. 1 Valley of the Panouse: quarry, lime kiln and grappier (cl. D'Ovidio A-M)

The lime kiln site of the valley of the Panouse is a major industrial complex set in the hills of Saint-Cyr Carpiagne in the National Park of the Calanques in Marseilles. The valley contains the industrial furnace, the oldest temporary furnaces, quarry, combustible, cooking residues: slag and grappier and annexes : house-tank and stables (Fig. 1).

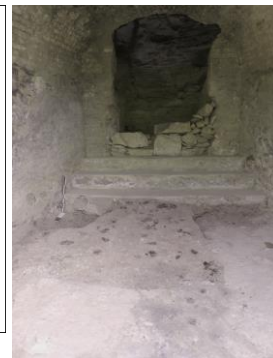
Fig. 3 Draw arch with layer of coal (cl. D'Ovidio A-M)

A thick layer of angular blocks of coal was spread in the draw arche of the kiln. It might have been pulled out the furnace before calcination and is a testimony of the end of the kiln use. The volatile matter content of 41% and the amount of carbon (68-72% At) (59 to 61% Wt) evoke the use of lignite. The transition from coal to wood is a key driver of the move towards industrialization of lime manufacture. That corresponds to the period where “new mining companies engage in industrialization methods of extraction and transport of local lignite until Marseille industries”[2].

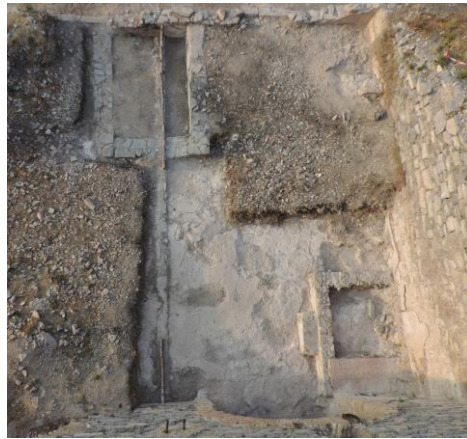
Fig. 4 Hangar excavation : technical room, lime extinction basin and brick wall
(cl. D'Ovidio A-M)

can be the cause of changes observed in the hangar. It was divided into three areas by hollow brick walls and received a finishing plaster. The eastern brick wall destroyed the lime extinction bassin. Overmore, a small technical room was built (Fig. 4). Upper windows were pierced in the front of the kiln.

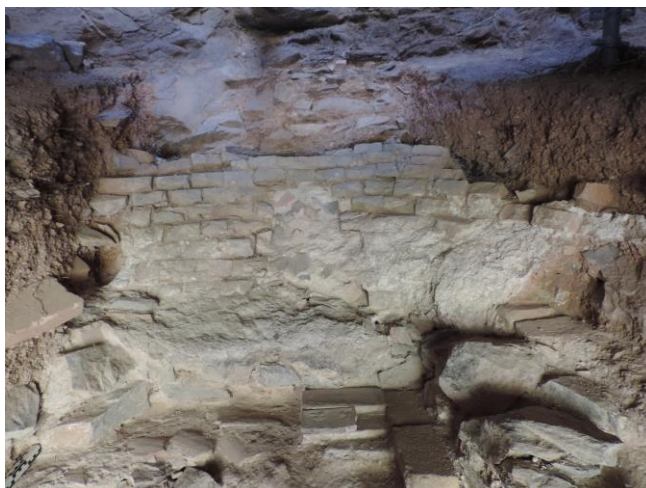
Fig. 6 Gypsum plaster restorations in the bottom of the furnace (cl. D'Ovidio A-M)

The mortar study also reveals old restorations, especially at the furnace whose high temperature fluctuations require ongoing maintenance. Two materials are identified for restorations: hydraulic lime and white gypsum plaster. At the top of the furnace, the original bricks of the mark Carbonel lining the wall were replaced by brick Uzes David. They are not sealed to the clay but with hydraulic lime. Louis David factory did not exist at the time of construction of the kiln. It was built shortly after in 1859 and was closed in 1913. The restoration of the furnace is to be considered in this period of time 1859 - 1913. However, in the bottom of the furnace, the bricks were restored with gypsum plaster (Fig 6). The gypsum plaster can withstand high temperatures. The draw arch of the furnace is backfilled from the 1920s, so these restorations are previous.

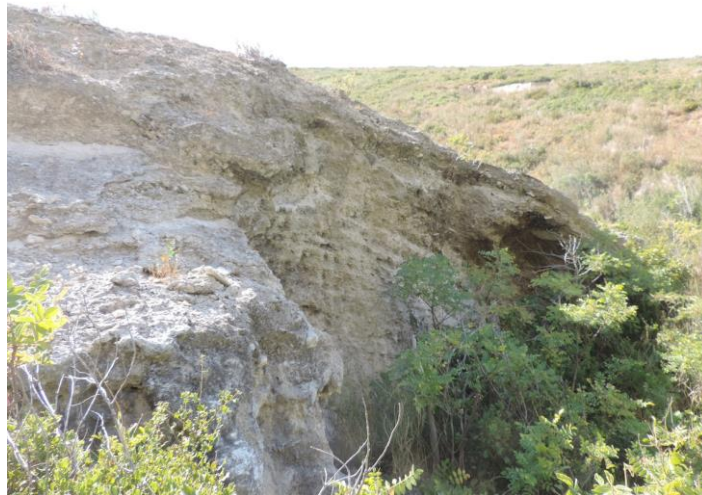
Fig. 8 The grappier (cl. D'Ovidio A-M)

Two kinds of industrial pollution mark the environment of the kiln: the grappier and slag. A whitish embankment of 72 m long and 12 m wide, 6 m high, with a volume of around 2000 m³ is the grappier. It was formed by the accumulation of cooking residue, of unburnt and overcooked materials. It contains

small grayish limestone not fully transformed into lime, brick fragments collapsed from walls of the furnace and slag. The analysis of samples taken in the grappier gives interesting results. For example, the presence of cristobalite reveals a high cooking temperature. The presence of the gehlenite evokes the production of a hydraulic lime. More systematic sampling from each stratum deposit should be performed to specify the production phasing. Moreover, traces of picket with a pick or crowbar were noticed in the grappier (Fig.8). They could evoke its reuse as cement grappier. This is a technique invented by the french ciment producer Lafarge that appears to have been developed in the second half of the 19th century until the World War I.
