Lessons learnt from the reconstruction of the destroyed mausoleums of Timbuktu, Mali

Thierry Joffroy, Ben Essayouti

Thierry Joffroy, Ben Essayouti. Lessons learnt from the reconstruction of the destroyed mausoleums of Timbuktu, Mali. HERITAGE2020 (3DPast | RISK-Terra) International Conference, Sep 2020, Valencia, Spain. pp.913-920, 10.5194/isprs-archives-XLIV-M-1-2020-913-2020 . hal-02928898

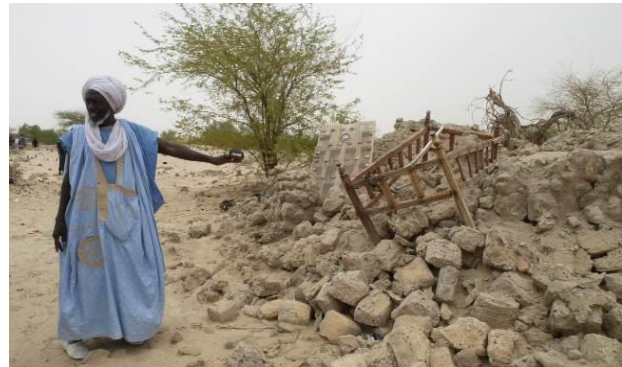
Figure 1. Mausoleum of Cheik Sidi Ben Amar, destroyed on June 30, 2012 © Joffroy T. CRATERre.

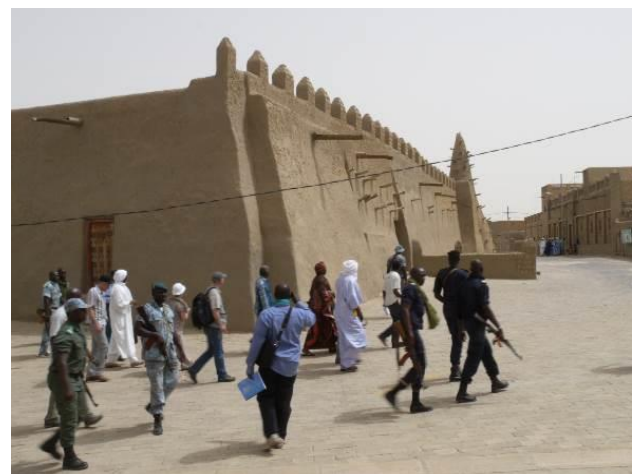
Figure 2. Inspection of Djingarey-ber mosque on June 6, 2013
© Joffroy T. CRAterre.

Therefore, UNESCO¹⁰ decided to organise several missions, first with a group of national experts (architects and heritage specialists) from May 28, and later involving international experts¹¹. This first international assessment mission took place on June 6 (Figure 2).

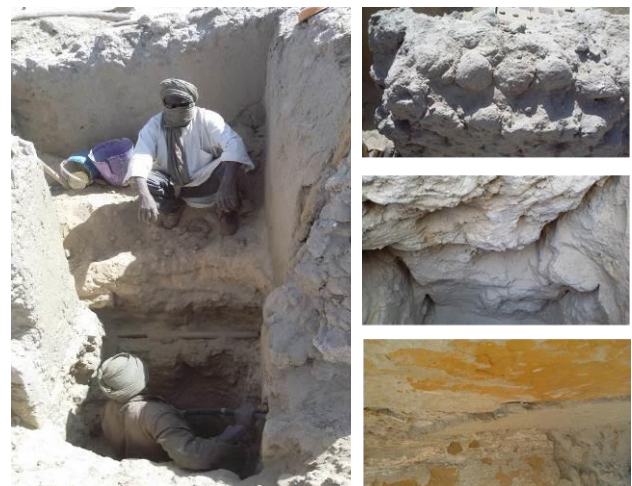
Figure 3. One of the archaeological digs and samples of strata observed © Yamoussa F. DNPC.

Several archaeological digs – limited to exploratory pits located beside the gate, as authorized by the custodians – were also undertaken¹⁴. These showed that some of the mausoleums had a very long history¹⁵ with both continuity and rupture. The stratification observed inside the excavated mausoleums revealed that these had already been prone to several – if not many – deterioration / repair cycles. Some of the findings at some strata gave clear evidence that the roof had collapsed and had been rebuilt without trying to re-use or remove the collapsed elements¹⁶. It was also observed that the walls had been raised above the original structures and that this had been done on several occasions. As a result, the buildings that we knew before their destruction by the armed groups in 2012 were in fact located far above the original ones. Explorations only went 3m deep as going further would have involved digging larger pits and installing struts, something which the traditional custodians would not have been willing to accept (Figure 3).

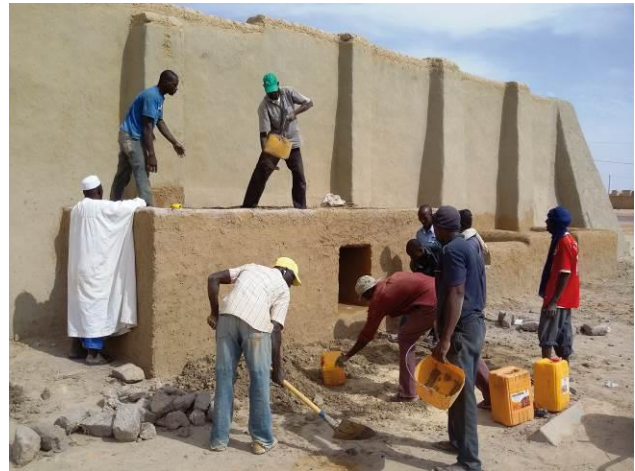
Figure 4. The pilot reconstruction project at the juxtaposed mausoleums of Cheikh Sidi Mahamane al Foulani and Cheikh Sidi Baber Baba Idjé © Koné M., Audex.

The reconstruction was planned as an iterative process. The idea thus was to start with one of the smaller mausoleums and possibly in a place which was both safe and easily accessible. Fitting these criteria, the cautious choice for this first activity was that of the two juxtaposed mausoleums of Cheikh Sidi Mahamane al Foulani and Cheikh Sidi Baber Baba Idjé, located against the west wall of the courtyard of the Djingarey-ber mosque, along one of the main streets of the city. This (re)construction site was a chance to organise discussions between conservation experts and traditional masons, using it as a sort of structural model of the larger mausoleum structures (40-50 % scale) to be reconstructed. This allowed them to check different information on the building materials (stones, two kinds of earth, palm trees and branches, etc.), their origin and selection criteria, building techniques, tools and methods on the (re)construction site.

An evaluation of this first sample work was carried out after the 2014 rainy season. This led to some adjustments, which mostly concerned the size and shape of the waterspouts and the composition of the mortar for the plastering.

The waterspouts needed to be much longer and more sloping to project rain water far enough from the wall to avoid drips on the plaster (due to wind) and also to protect the base of the structure from splashing and pools of water that could lead to wall base degradation.

The plastering was only partially satisfactory and the superficial erosion after just a season (though quite a good one) led to reconsidering its composition. The issue had been discussed earlier, some advocating adding more sand to avoid cracks and get a smooth surface, others preferring a high clay content,

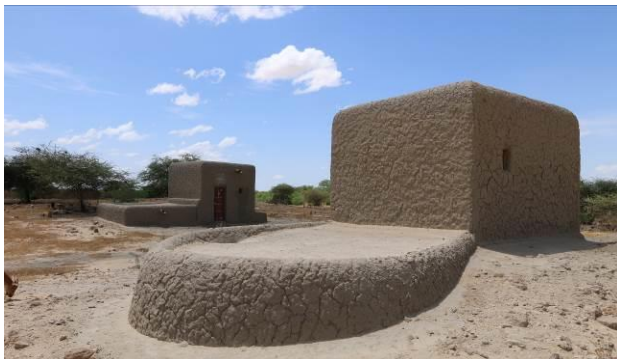
Figure 5. Mausoleums of Cheik al Tawaty (front) and Cheik Sidi Mohammed Mikki (back) after reconstruction, September 2015. © Joffroy T. CRAterre.

The second phase (Figure 5) was planned taking into account the results of the pilot reconstruction project beside Djingarey-ber, both technically and for the estimation of costs needed to ensure the proper involvement of young masons alongside their elders (Figure 6).

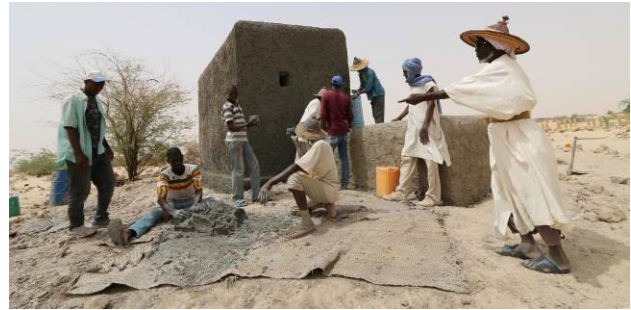
Figure 6. Preparation of mortar for plastering by young masons supervised by the head of the masons' corporation. Mausoleum of Cheik Sidi Ben Amar, April 2015 © Joffroy T. CRAterre.

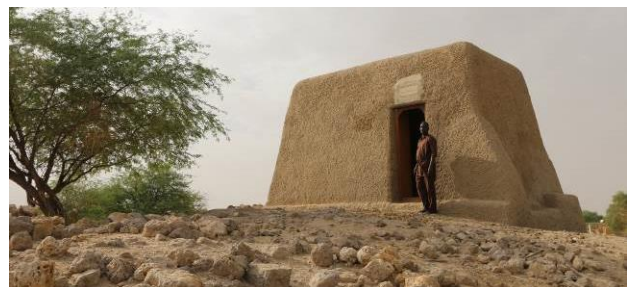
Figure 7. Mausoleum of Cheik Alpha Moya after its reconstruction - September 2015. © Joffroy T. CRAterre.

Both phases 2 and 3 included larger and smaller mausoleums to be reconstructed. An important criterion for being in the third phase was that of complexity. Thus, the Mausoleum of Alpha Moya (Figure 7) with its very distinctive semi-pyramidal shape and some old broken walls was part of this phase. It also included the three mausoleums located in Kabara, the port city 15 km from Timbuktu on the north bank of the Niger River where safety conditions were sufficiently ensured to allow the architects and the head of the masons' corporation to supervise on a regular basis.

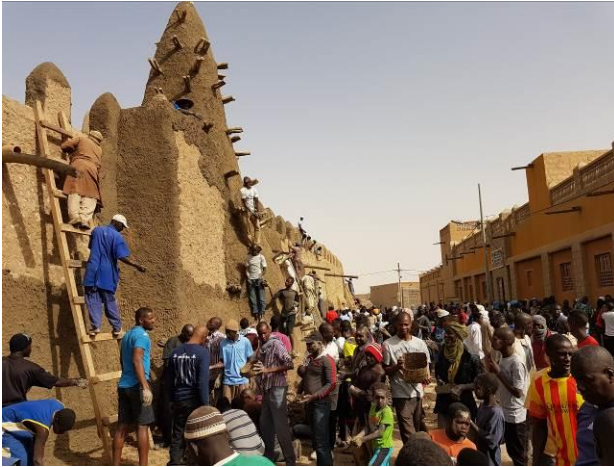
Figure 8. Traditional plastering of Djingarey-ber mosque by the masons and the community of Timbuktu on February 19, 2017.
© UNESCO - Bagayoko M.

For the mosques, funding was allocated mostly to facilitate maintenance (Figure 8) and to implement preventative conservation measures. Some more important conservation works were also implemented.

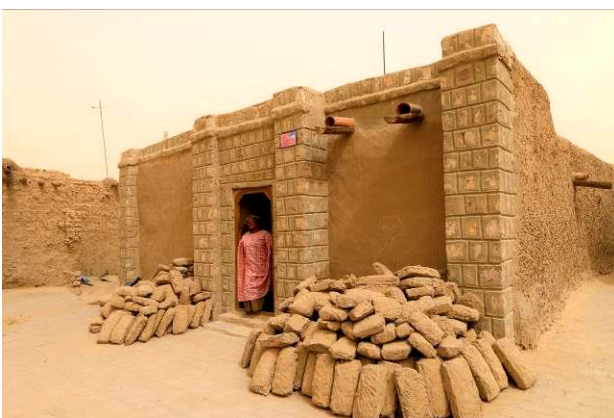
Figure 9. Restored house of widow Nana Ber, ready to carry on with additional repairs © Joffroy T. CRATERre.

Moreover, the project managed to positively combine heritage conservation with the needs of the affected population for recovery. With the help of AIMF²⁶, a series of interventions were planned within the old town to assist a selection of inhabitants whose family structure had been affected by the occupation (directly or indirectly through family members having migrated to the south, mainly to Bamako). Two series of works were implemented, with a strict selection of the beneficiaries by representatives of the municipality and condition surveys carried out by national architects, taking into account guidance provided by the project for the purpose. This project lasted three years and made it possible to undertake preventive measures and urgent repairs at twenty-five private properties in the old city centre, contributing to both the recovery process and safeguarding the main characteristics of its historic fabric (Figure 9).

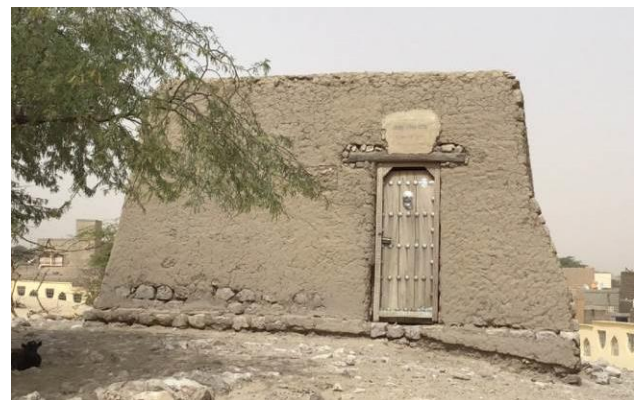
However, when looking at the state of conservation, the situation is less positive. The inside of the mausoleums is kept clean and well maintained, but the external plastering has been washed away in most places, with a serious impact on the eastern elevation, the most exposed to the driving rain during the rainy season in Timbuktu (an average of 5 heavy rains per year). In fact, after 5 years the plastering should have been done at least once at every mausoleum, but only one of them (that of Cheikh Sidi Mahamane al Foulani al Macini, located in Kabara) benefited from this traditional maintenance practice. While the masons everywhere obviously have very good knowledge of what should be done and of the “maintenance guide” drawn up within the project, it appears that nothing has been done while the condition of some of the mausoleums should be cause for their concern (Figure 10).

Figure 10. Mausoleum of Cheik Alpha Moya in January 2020.
© Essayouti B. MCB.

The responses given by the custodians here are vague, often referring to the difficulties to get the right materials for the maintenance, or saying that today maintenance should be decided by professionals and done under their supervision. Though there is probably a financial aspect linked to this “wait and see” behaviour. Even though the custodians probably receive some tips/gifts from visitors/worshippers, they are not convinced that these should fund the works or even justify the purchase of the materials needed. For their part, the masons also probably expect to be paid for the work to be done. The overall cost would not be excessive but they seem to be acting on principle.

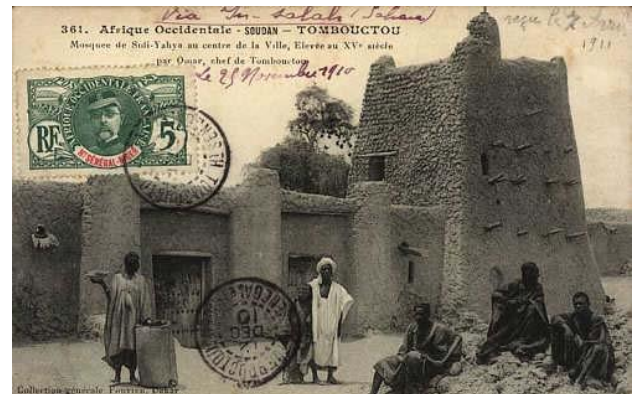
Figure 11. Postcard sent on 25 November 1910 showing Sidi Yahia Mosque with serious erosion of the eastern elevation of its minaret. (Collection Fortier – archives MCT).

At present, the monuments in Timbuktu are living heritage. They have always evolved over time both with annual cycles (that of the rain and the erosion of the plastering it entails); that of regular maintenance (every three to five years); repairs of structural pathologies, often adding buttresses³⁰; and at times more important works, including extensions and raising of the roof structure.
