Hydraulics and bridges: A French case study of monitoring of a bridge affected by scour

Frédérique Larrarte Ph. D. Senior researcher^{a,b,*}, Christophe Chevalier^a, Louis Battist^a, Hugues Chollet^c

This paper reports on the "field approach" task of a project [35]. The presented study thus aimed at providing an insight into the global monitoring of scour affecting an abutment. The first step of our study has been to identify the pilot site, representative of scour vulnerability, to review available data and to define requirement for the monitoring devices and structure adapted to the different situation. In situ implementation will then be presented with a focus on the preliminary measurements including data processing and post-treatments. Results and feedback after some months of instrumentation will finally conclude this paper.

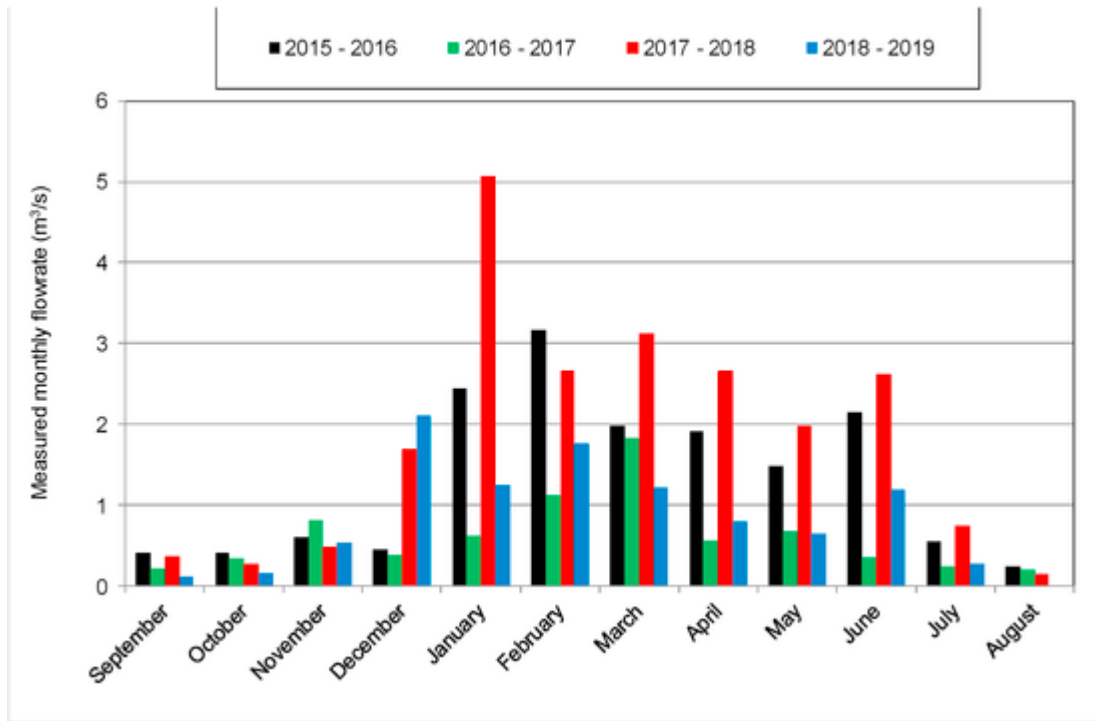
Fig. 1. Aurence river - Monthly flow rate variations.

The French National database "Banque Hydro" (<http://www.hydro.eaufrance.fr/>) has a gauging station located 3 km upstream. This station is located 230 m above the sea level and records Aurence flow rate since 1995. Fig. 1 shows the variations of the monthly flowrate from September 2015 to July 2019. The river is located into the oceanic climate zone with high flow rates in winter and low flows in summer. Strong variations with lower values in summer can be observed as well as inter annual ones. In this small catchment, whose area equals 87 km², the highly rainy month of January 2018 can also be seen. The Aurence catchment it is very reactive with a flood duration of approximately 24 h. The peak discharge of the highest floods that appeared on the river during the last 25 years was about 28 m³/s in February 2003. The return period of this flood is estimated at twenty years.

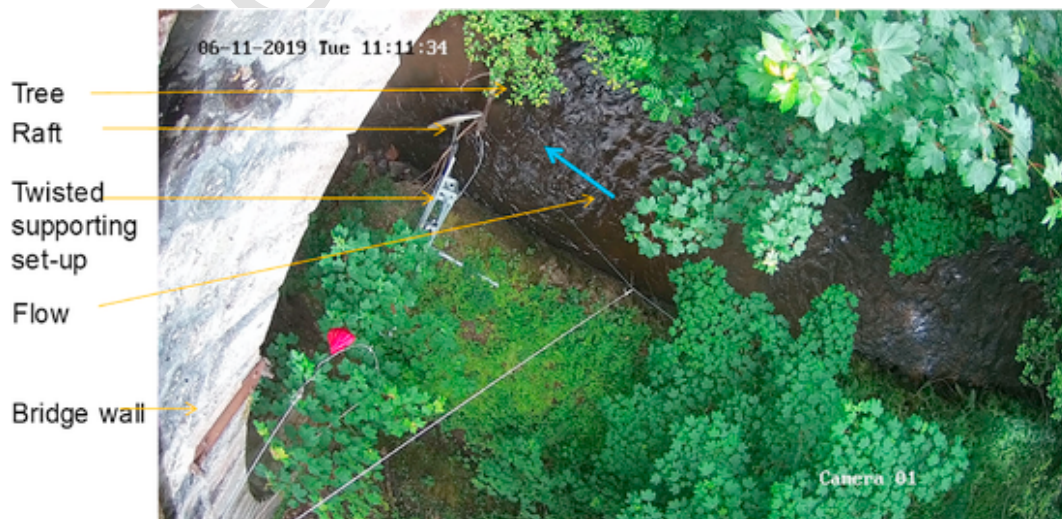
Fig. 11. View from the video camera.

was confirmed thanks to the supervision camera (Fig. 11): a dead tree has twisted the set-up.

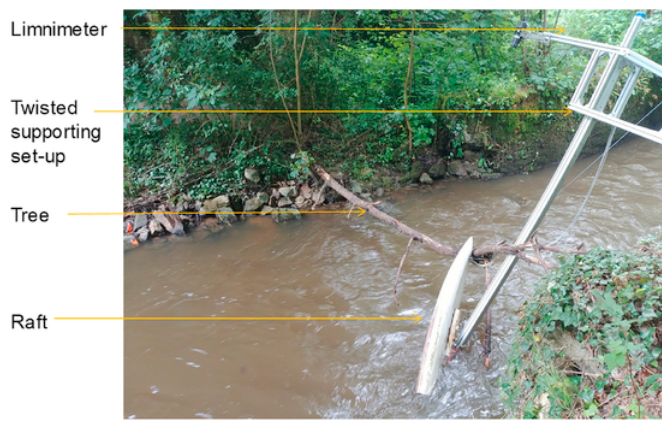
Fig. 12. View from the bank before reparation work.

The Aurence river flows through a quiet and wooded valley mainly used by hikers and cyclists but there is no longer any real activity so the maintenance of the banks remains limited. Finally, the technical team has been able to repair it as soon as the water level has decreased enough to allow safe operation (Fig. 12). Efforts are done to obtain a more regular preventive cleaning in the future.
