Xin Wang, Joyraj Chakraborty, Antoine Bassil, Ernst Niederleithinger

Xin Wang, Joyraj Chakraborty, Antoine Bassil, Ernst Niederleithinger. Detection of Multiple Cracks in Four-Point Bending Tests Using the Coda Wave Interferometry Method. *Sensors*, 2020, 20 (7), 17p. 10.3390/s20071986 . hal-02948040

Detection of Multiple Cracks in Four-Point Bending Tests Using the Coda Wave Interferometry Method

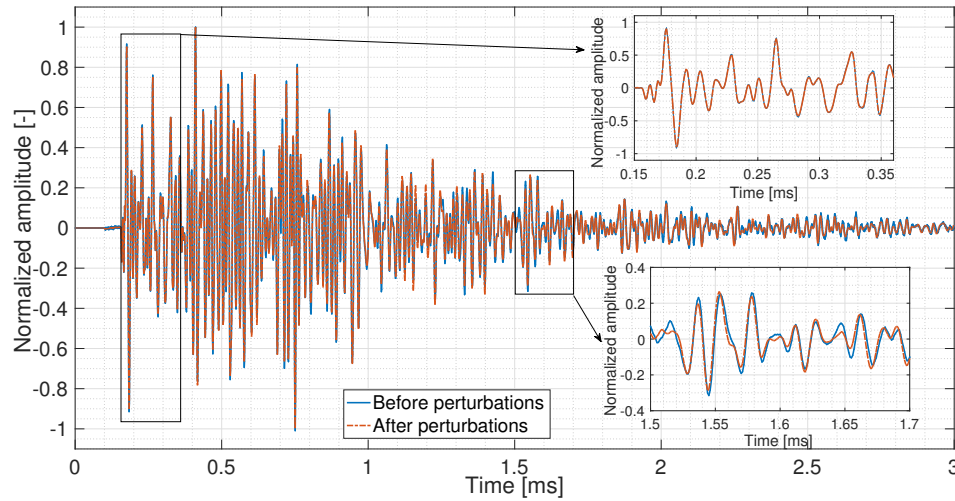
Figure 1. Signals recorded before and after small perturbations in the medium.

Traditionally, sonic methods or vibration measurements for Structural Health Monitoring (SHM) are performed below 20 kHz; the wavelength is larger than or of the order of the macroscopic size of the structure [30]. Thus, it has a limitation in detecting the microscopic features and many typical defects. However, when the working frequency range exceeds 50 kHz, the wavelength is in the order of the size of the aggregates, and waves interact strongly with the heterogeneities and propagate along the multiple scattering trajectories, which are longer and much more complicated than the direct wave or simple reflected ones. Coda wave is an accumulation of all scattered, diffuse waves which are highly repeatable. Subtle changes in the medium are amplified by repeated sampling [17]. Therefore, the coda wave has a higher sensitivity to weak perturbations in the medium. The scientific fundamental of the CWI method is to extract information from two US signals recorded in different states as shown in Figure 1. It is easy to see that the first arrivals of two signals are almost identical; however, a slight waveform variation and time-domain perturbation are observed in the coda wave part (later arrivals).

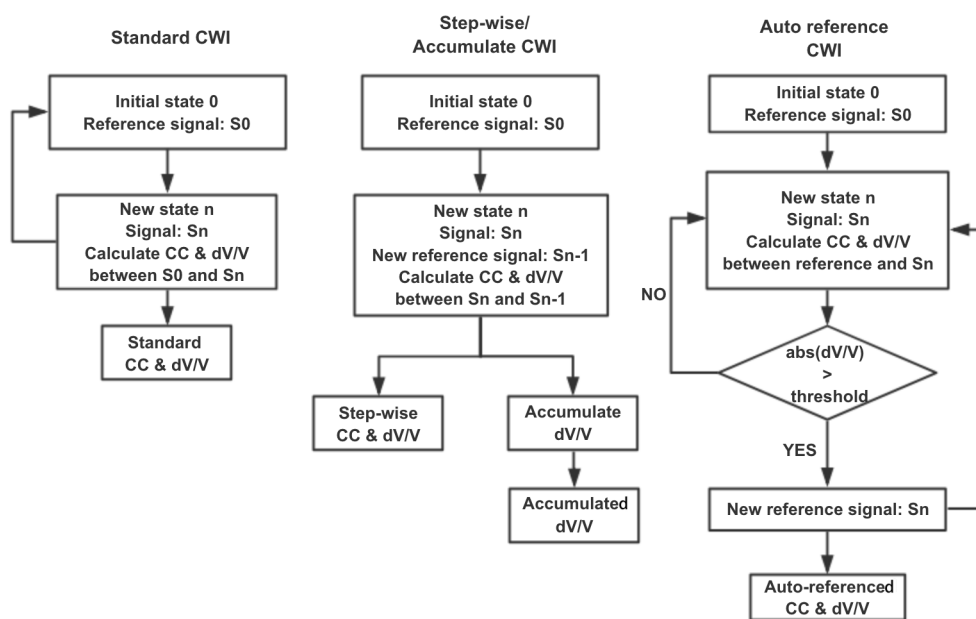
Figure 2. Algorithm of three CWI methods.

Regularly, the standard CWI method chooses a fixed reference to calculate the CWI properties. Nonetheless, when the changes in the medium reach a certain level, the waveform and/or the time-shift of the US signal in the new state could change substantially. Even though CC can still be useful as it presents the similarity of two signals, the dV/V is not meaningful anymore. In this case, step-wise CWI or auto reference CWI procedures, which changes the reference signal according to different situations, are proposed [32]. In the step-wise CWI method, a moving reference is used; CC and dV/V are calculated by the current signal and its previous signal. The step-wise dV/V could be accumulated to provide an overall change compared to the first reference signal. However step-wise CC cannot be multiplied as it is non-unique [32]. Damage such as crack openings might cause a velocity variation of more than 1% [27]. In this paper, when the absolute value of dV/V exceeds the threshold of 1%, the reference signal will be switched to the current US signal automatically; this is the so-called ‘auto reference’ CWI. This method limits the dV/V variation range to $[-1, 1]$ which gives us a clearer view of velocity change when it is relatively small. The algorithms of these methods are shown in Figure 2.

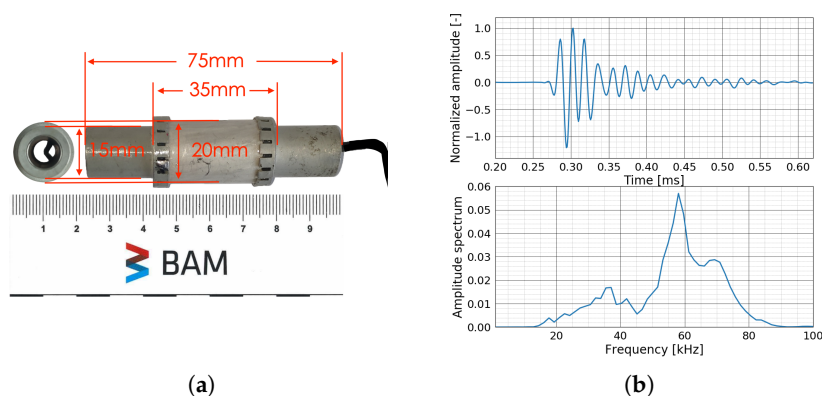
Figure 3. (a) Dimension of transducer SO807. (b) Response of transducer SO807 recorded in water (top) and the corresponding amplitude spectrum (bottom).

The ultrasonic sensor used in these experiments is ‘SO807’ which is a hollow piezoceramic US transducer designed by Acoustic Control Systems, Ltd. exclusively for BAM. It can be easily installed in the structure during the construction before casting [26,29]. Moreover, a special installation method is developed allowing its installation on existing structures [25,28]. As the transducer is installed inside the structure, the interior of the structure is better monitored and the influence of near-surface changes is reduced. SO807 can be used as both transmitter and receiver. Figure 3a shows the dimension of SO807 transducer. Two SO807 transducers were placed 40 cm away from each other in parallel in water. A short pulse of 60 kHz excited one transducer and the first arrival received by the other one is shown in Figure 3b. According to the amplitude spectrum, the central frequency peak is around 58 kHz, which leads to the interaction between waves and heterogeneities.

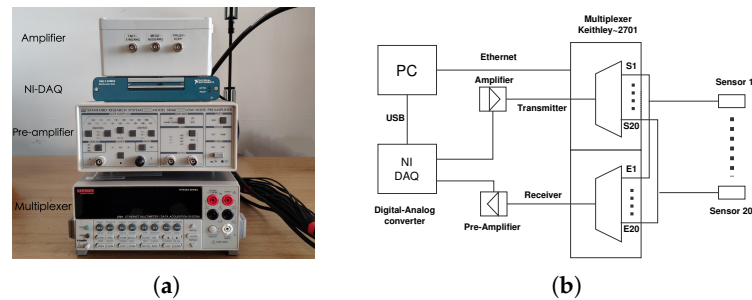
Figure 4. (a) Data acquisition devices (b) Diagram of the data acquisition system.

The data acquisition system (Figure 4) allows continuous monitoring with a maximum of twenty US transducers with a sampling frequency of 1 MHz. If necessary, the temperature can be also recorded for long-term monitoring. As the experiments described in this paper were performed in a laboratory

environment, the influence of temperature was negligible. Transducer transmitter-receiver pairs can be controlled and configured easily in the control program. All the US data could be synchronised to the specified FTP server automatically, which allows remote measurement. The whole system includes:

- Amplifier to amplify the input signal of transmitter
- Pre-amplifier with analog filter to improve the signal recorded by receiver
- Digital-analog data acquisition module to convert signal
- Multiplexer with 20 channels to switch between different combinations of transducers
- PC with control software and data storage

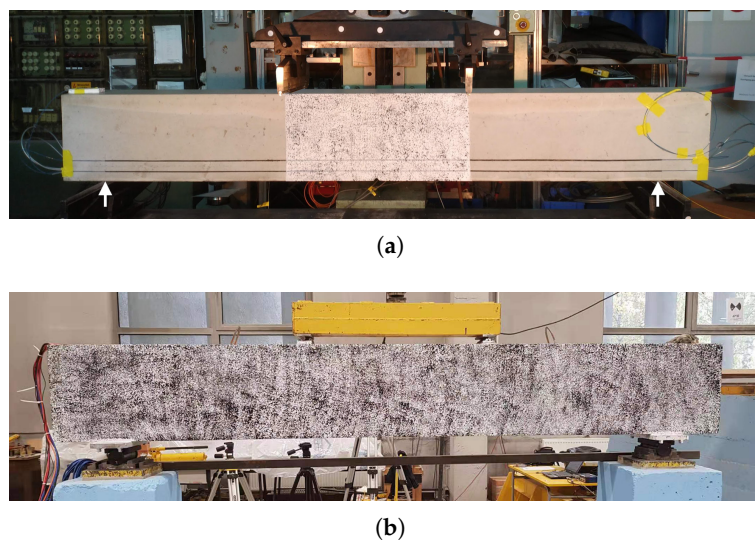
Figure 5. Front view of the beams and contract points position (a) At BAM and (b) at NEOSTRIN.

Two similar RC specimens were designed to perform four-point bending tests at BAM and NEOSTRIN. The dimension of the beams is 290 cm \times 20 cm \times 40 cm (length \times width \times height). The beam at BAM (Figure 5a and 6) was reinforced with two ϕ 6 rebars in the compression zone and two ϕ 14 rebars in the tension zone, attached by six ϕ 6 stirrups with a spacing of 30 cm. The beam at NEOSTRIN (Figure 5b and 7) was reinforced with three ϕ 10 rebars in the tension zone and two ϕ 10 rebars in the compression zone, attached by thirteen ϕ 6 stirrups.

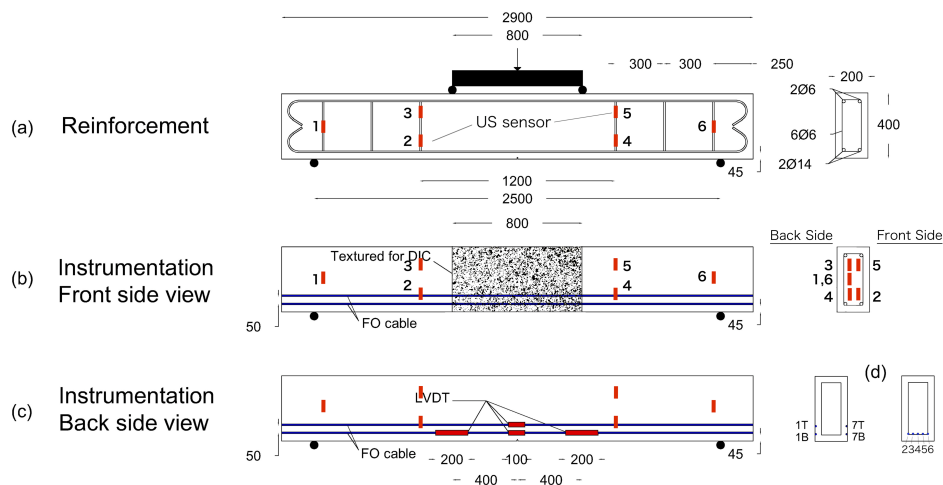
**Figure 6.** Dimensions of the beam, rebars distribution and sensors positions at BAM.

A limited number of US transducers was attached on the stirrups and installed inside both beams before casting. Two vibrating wire strain gauges and two rebar stress meters were installed in the beam at NEOSTRAIN to measure the strain variation in the beam and the rebar. As the quantity and position of all the cracks were not predictable, only four LVDT sensors were glued on the back surface of the beam at BAM to measure the Crack Opening Displacement (COD) for a few cracks on the surface and to double verify the FOS measurement. Strain changes and crack width inside the beam were also measured by FOS. Although FOS technique was not applied at NEOSTRAIN, DIC technique which covered the whole beam still provided a roughly COD and propagation map. Position and spacing between all the transducers are shown in Figures 6 and 7.

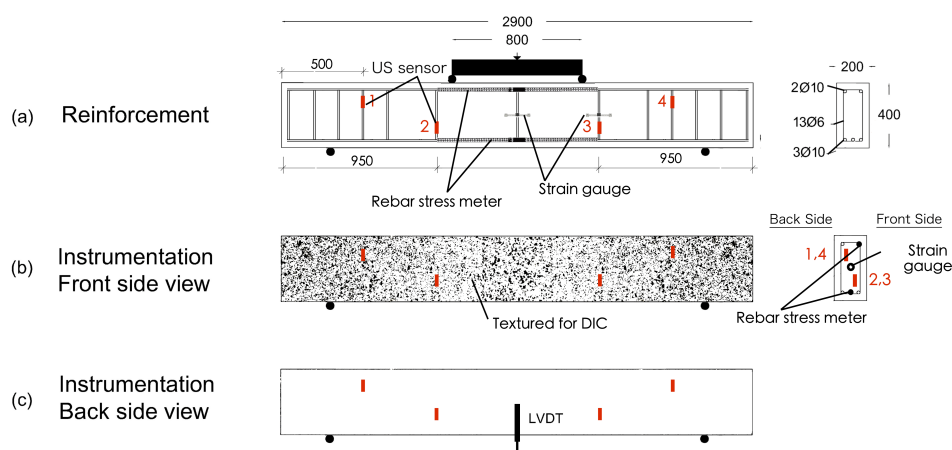
**Figure 7.** Dimensions of the beam, rebars distribution, and sensors positions at NEOSTRAIN.

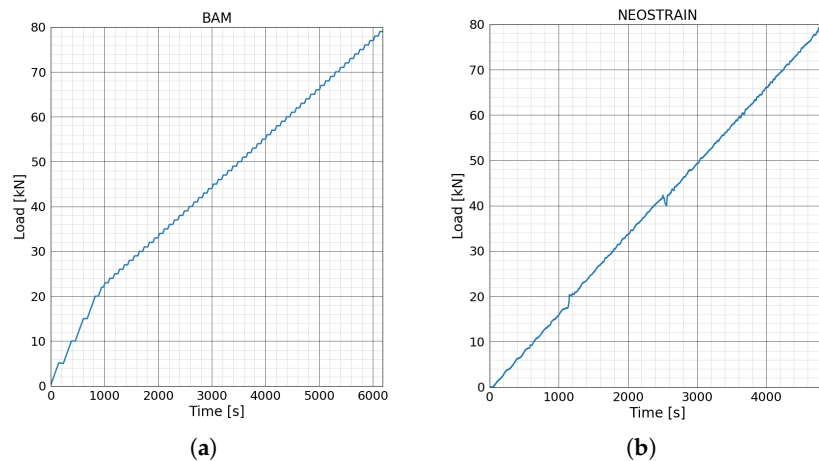
Figure 8. Loading steps of four points bending test at (a) BAM and at (b) NEOSTRIN.

A step-wise loading procedure was performed for the test at BAM due to the low measurement frequency of the interrogator of FOS technique. In total, 64 load steps were performed. The load increased 5 kN/min and remained stable for one minute until 20 kN. For the following steps, the load increases 1 kN/min and remained stable for one more minute until reaching 80 kN as shown in Figure 8a. The loading procedure of the test at NEOSTRIN was performed continuously with an increasing rate of 1 kN/min. Since the loading procedure at NEOSTRIN was controlled manually, the load increased unexpectedly from 18 kN to 19.4 kN due to a mistake of the operator (Figure 8b).

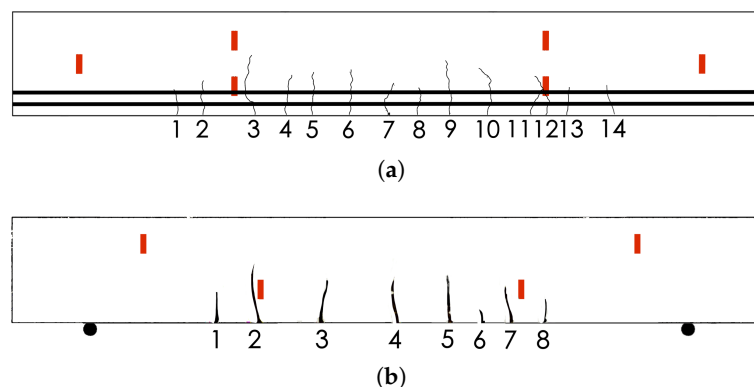
Figure 9. Cracks map of beam at (a) BAM and at (b) NEOSTRIN.

At the end of the test, fourteen cracks appeared at the beam at BAM and eight cracks occurred in the beam at NEOSTRIN. The locations of the cracks are presented in Figure 9. Cracks were mainly distributed between the two bottom US transducers. No crack was located in between the direct path of top level US transducers.

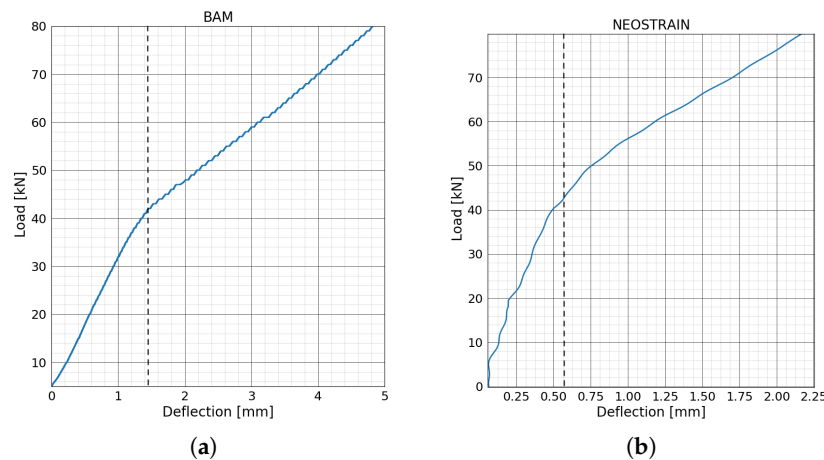
Figure 10. Load-deflection curve for bending test at (a) BAM and at (b) NEOSTRAIN.

The deflections of two beams during the four-point bending test are shown in Figure 10. Load-deflection curves for both beams lost their linearity at around 42 kN; the beams went into the plastic phase from the elastic phase, meaning that single or multiple cracks appeared. As mentioned

in the previous section, the loading procedure at NEOSTRAIN was controlled manually; there was a small load fluctuation during the whole test.

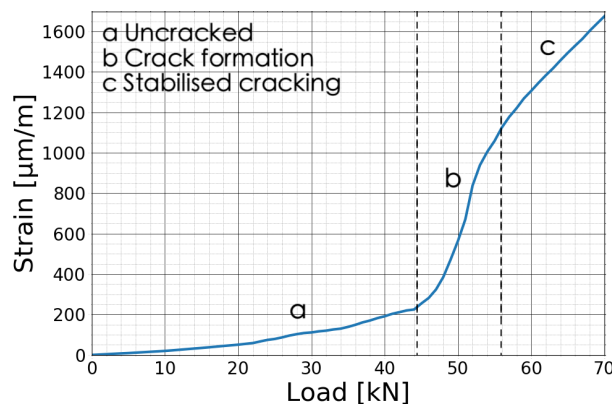
Figure 11. Force-strain curve of crack 5 measured by fiber line 7B.

The stress-strain relationship can distinguish between different stages of the crack opening: the uncracked stage, the crack formation stage and the stabilised cracking phase [33]. Figure 11 shows the three different stages of crack number 5 in the beam at BAM measured by fiber line 7 on the bottom in the front. The measured area remained uncracked until 45 kN, then the crack started to form and went into the stabilised cracking phase at 56 kN.

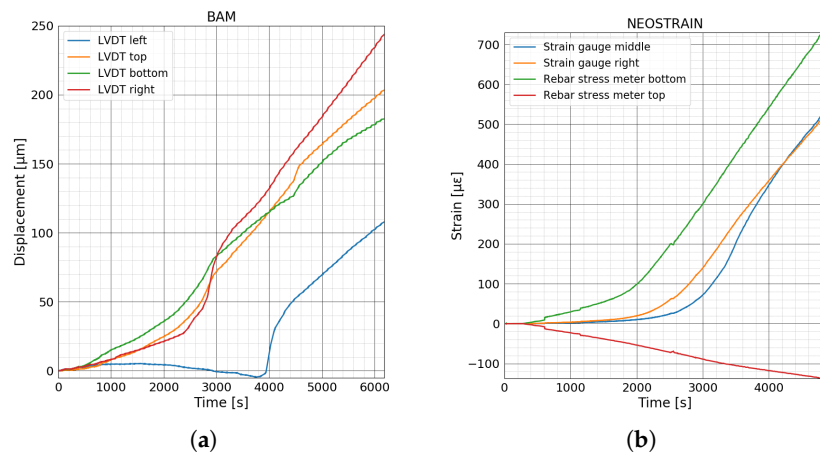
Figure 12. (a) Displacements measured by LVDT sensors at BAM. (b) Strain variation inside concrete and rebars measured by strain gauges and rebar stress meters at NEOSTRIN.

Figure 12a shows the COD of crack number 4, 7 and 10 measured by four LVDT sensors. The results are in accordance with the FOS measurement. A comparison of FOS technique, DIC, and LVDT in this experiment is presented in [34]. As fibers covered the whole beam and successfully detected all of the fourteen cracks in this experiment, the loads corresponding to the different stages of the crack opening are only determined by the force-strain curves measured by FOS (Figure 13a). Strain variations inside the beam and rebar at NEOSTRAIN are shown in Figure 12b. The top rebar was always under compression. The slope of two strain gauges started to change around 40 kN. The stress in the bottom rebar increased slowly until 32 kN and then increased linearly and rapidly after 35 kN.

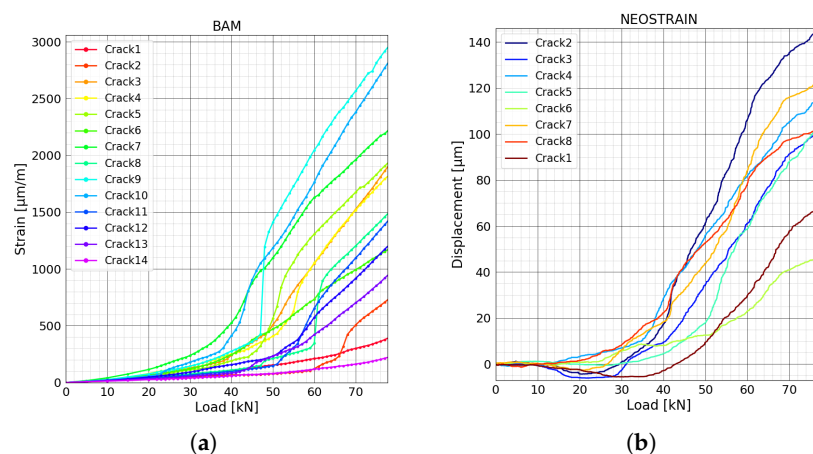
Figure 13. (a) Strain variation at position of all cracks measured by fiber line 7B at BAM. (b) Displacement at position of all cracks measured by DIC technique at NEOSTRIN.

Figure 13a shows the strain variation for all the crack positions measured by FOS during the bending test at BAM. Assuming that the strain variations are caused by the deformation discontinuity, COD could then be estimated [34]. This paper focuses only on the detection of the load level when cracks enter different phases, thus the calculation of COD is not necessary and not presented. The FOS technique was not implemented for the test at NEOSTRIN; nonetheless, the approximate CODs of all the cracks were measured by the DIC technique, which covered the whole front surface. The DIC technique detected the COD by analysing the deformation of the surface of the beam which is caused by strain change [9]. Hence, different crack opening phases can also be determined by the stress-displacement curve Figure 13b. When the deformation is relatively small, the displacement measurement is strongly disturbed by the friction. This is the reason for the unusual negative displacement values at the beginning of the experiment.

suddenly at 18 kN due to a misoperation during the load procedure. This proves again the high sensitivity of CWI method to stress variation. A change was detected by CC and dV/V of transducer combination S02E03 at 32 kN, which is the moment when stress in the bottom rebar lost its linearity. The authors assume it as a sign before the first crack appeared. According to the COD measured by DIC, the first crack (crack 4) appeared at 37 kN and was located in the middle of the beam. All the transducer combinations related to transducer number 2 detected a change in dV/V and CC, which indicates the creation of crack number 2. According to DIC, all the other cracks beside crack number 6 started to form at around 41 kN. CC and dV/V measured by transducer combinations S01E03, S02E03, and S03E04 started to fluctuate at 40.5 kN because of crack number 7 and 8, which surrounded transducer number 3. During the ‘crack formation’ phase, crack number 2, 4, 7, and 8 had bigger COD than the others (Figure 13).

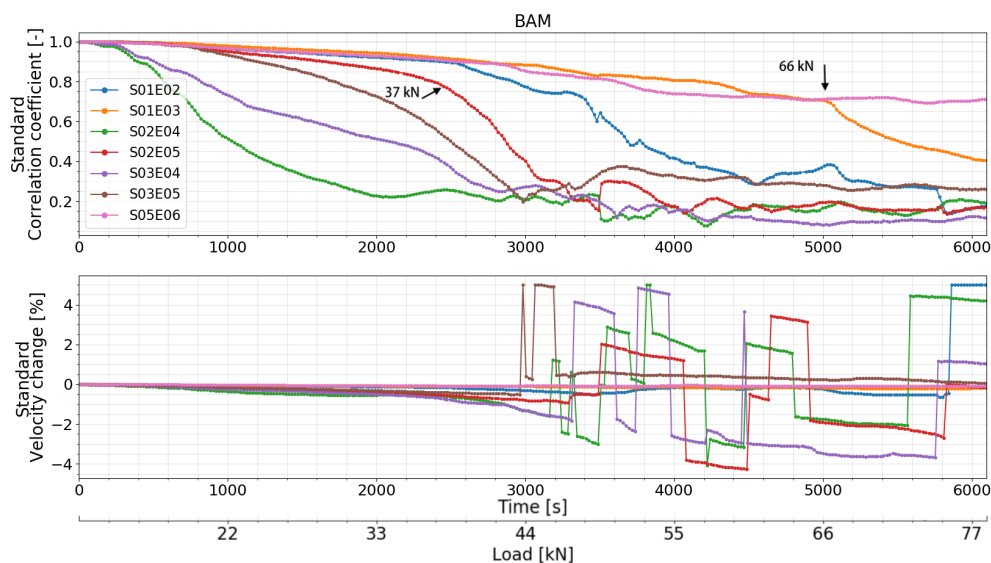
Figure 15. Correlation coefficient and relative velocity change of all the transducers combinations in test at BAM calculated by standard CWI.

CC and dV/V of all the transducer combinations calculated by all the different CWI methods are presented in Figure 15 (standard CWI), Figure 16 (auto reference CWI), and Figure 17 (Step-wise CWI). Reference signals of all transducer combinations were recorded at the initial state of the beam before the start of the loading procedure. CC and dV/V were then calculated by normal CWI procedure. For the auto reference CWI, when the absolute value of dV/V exceed 1%, the damage in the structure

reached a certain level. It is difficult to compare the following signals with the original reference signal. Thus, the current signal was chosen as a new reference signal until dV/V reached 1% again.

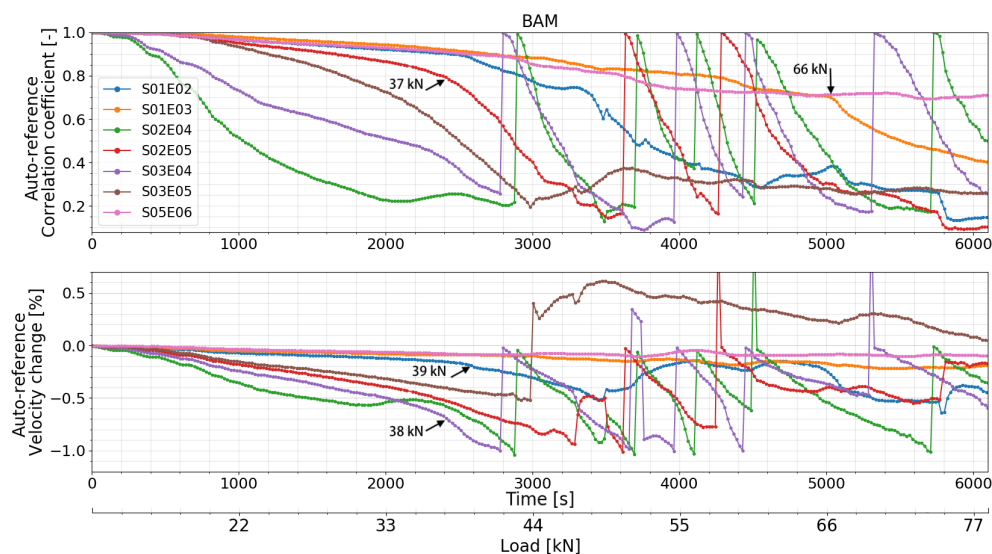
Figure 16. Correlation coefficient and relative velocity change of all the transducers combinations in test at BAM calculated by auto reference CWI.

Unusual behaviors of transducer 04 were detected. The CC and dV/V of all the transducer combinations related to transducer 04 varied too much compared to other combinations which were located in the symmetrical positions of the beam. Signals recorded by S02E04 and S03E04 before the start of load test showed that the performance of transducer 04 was not so stable. However, the CC and dV/V related to transducer number 4 calculated by step-wise CWI are still helpful. Before the first cracks appeared, all the transducer combinations successfully detected the different loading steps, especially by step-wise CWI method. The CC and dV/V of transducer combination S02E05 lost their linearity (Figures 15 and 16) at around 37 kN which indicates one or more very early stage crack(s) opening. This change was also detected by almost all the transducer combinations by step-wise CWI method (Figure 17), while by standard and auto reference methods, transducer

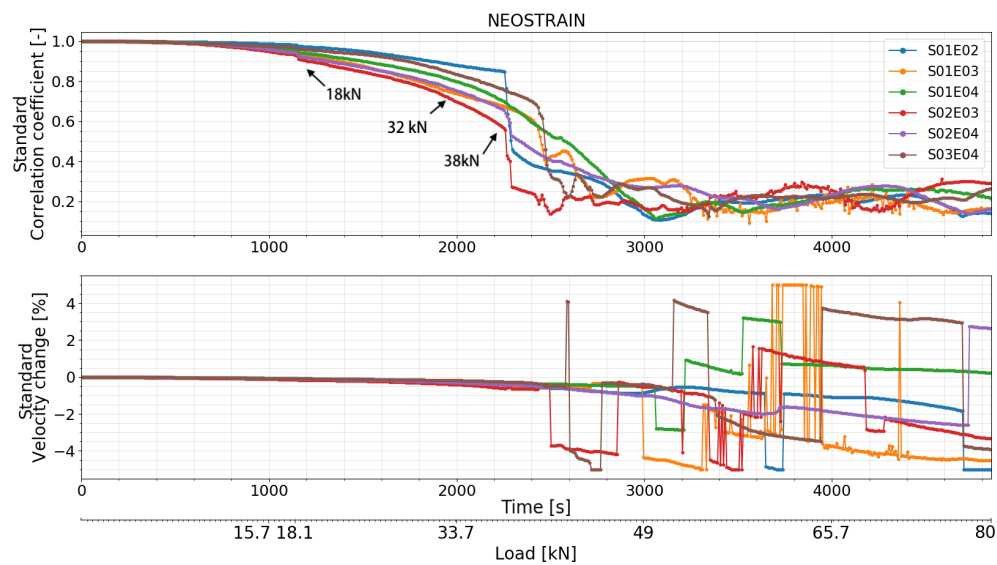
Figure 18. Correlation coefficient and relative velocity change of all the transducers combinations in test at NEOSTRIN calculated by standard CWI.

As shown in Figures 18–20, small variations in CC and dV/V were observed at 18 kN which corresponded to the misoperation mentioned in the ‘loading procedure’ section. Both features of all transducer combinations then decreased smoothly. CC and dV/V of transducer combination S02E03 decreased with a higher rate at 32 kN. A small change was detected by transducer combinations S01E03, S02E03, and S03E04 at 36 kN by step-wise CWI method. A second strong change can be seen in the CC and dV/V of transducer combinations S01E02, S02E04, and S02E03 at 38 kN. CC and dV/V of all transducer combinations related to transducer number 3 (S01E03, S02E03, and S03E04) started to change irregularly from 40.5 kN, meaning that the multiple cracks occurred near transducer number 3. This is close to the moment when the beam entered plastic phase. CC and dV/V measured by the top level transducer combination S01E03 had

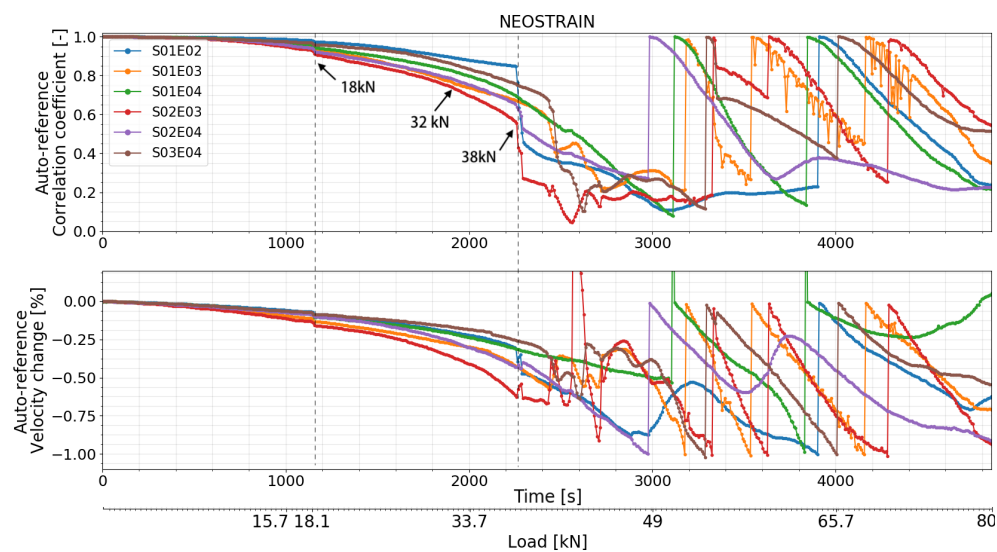
Figure 19. Correlation coefficient and relative velocity change of all the transducers combinations in test at NEOSTRIN calculated by auto reference CWI.
