Detection of Multiple Cracks in Four-Point Bending Tests Using the Coda Wave Interferometry Method

Xin Wang, Joyraj Chakraborty, Antoine Bassil, Ernst Niederleithinger

Article

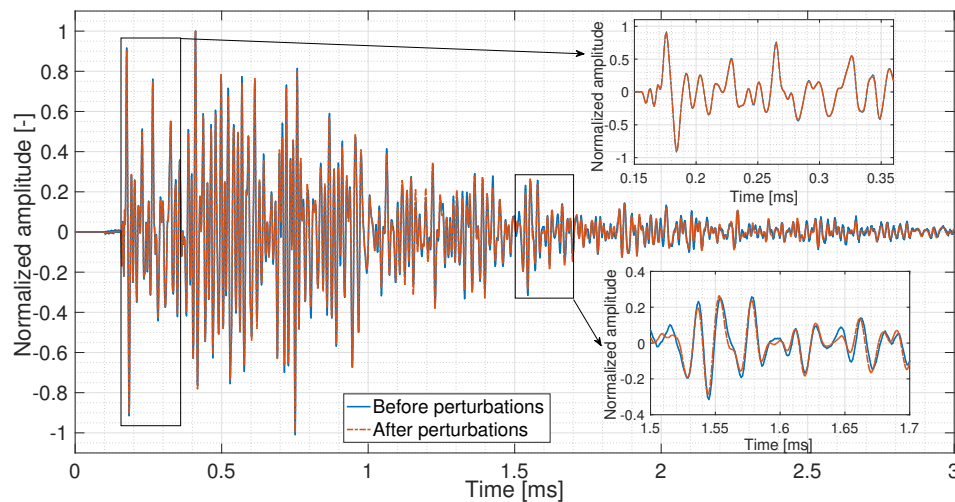
Figure 1. Signals recorded before and after small perturbations in the medium.

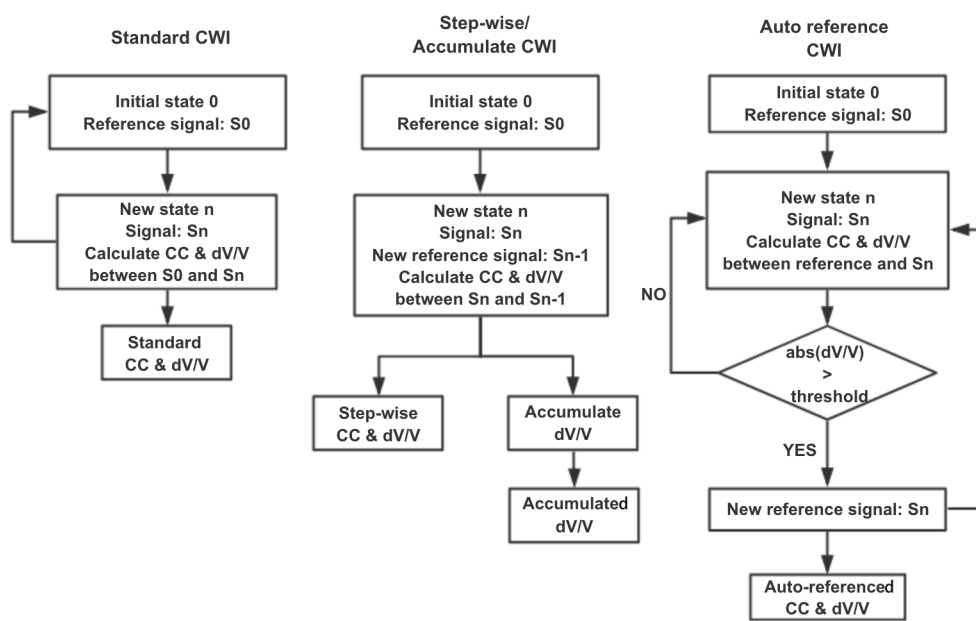
Figure 2. Algorithm of three CWI methods.

Regularly, the standard CWI method chooses a fixed reference to calculate the CWI properties. Nonetheless, when the changes in the medium reach a certain level, the waveform and/or the time-shift of the US signal in the new state could change substantially. Even though CC can still be useful as it presents the similarity of two signals, the dV/V is not meaningful anymore. In this case, step-wise CWI or auto reference CWI procedures, which changes the reference signal according to different situations, are proposed [32]. In the step-wise CWI method, a moving reference is used; CC and dV/V are calculated by the current signal and its previous signal. The step-wise dV/V could be accumulated to provide an overall change compared to the first reference signal. However step-wise CC cannot be multiplied as it is non-unique [32]. Damage such as crack openings might cause a velocity variation of more than 1% [27]. In this paper, when the absolute value of dV/V exceeds the threshold of 1%, the reference signal will be switched to the current US signal automatically; this is the so-called ‘auto reference’ CWI. This method limits the dV/V variation range to $[-1, 1]$ which gives us a clearer view of velocity change when it is relatively small. The algorithms of these methods are shown in Figure 2.

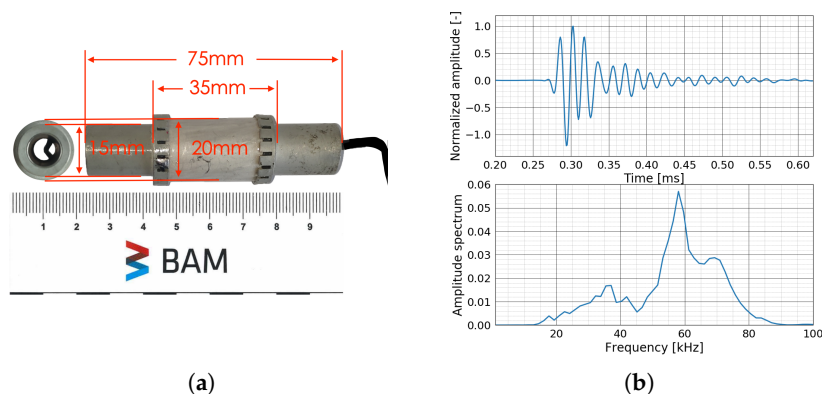
Figure 3. (a) Dimension of transducer SO807. (b) Response of transducer SO807 recorded in water (top) and the corresponding amplitude spectrum (bottom).

The ultrasonic sensor used in these experiments is ‘SO807’ which is a hollow piezoceramic US transducer designed by Acoustic Control Systems, Ltd. exclusively for BAM. It can be easily installed in the structure during the construction before casting [26,29]. Moreover, a special installation method is developed allowing its installation on existing structures [25,28]. As the transducer is installed inside the structure, the interior of the structure is better monitored and the influence of near-surface changes is reduced. SO807 can be used as both transmitter and receiver. Figure 3a shows the dimension of SO807 transducer. Two SO807 transducers were placed 40 cm away from each other in parallel in water. A short pulse of 60 kHz excited one transducer and the first arrival received by the other one is shown in Figure 3b. According to the amplitude spectrum, the central frequency peak is around 58 kHz, which leads to the interaction between waves and heterogeneities.

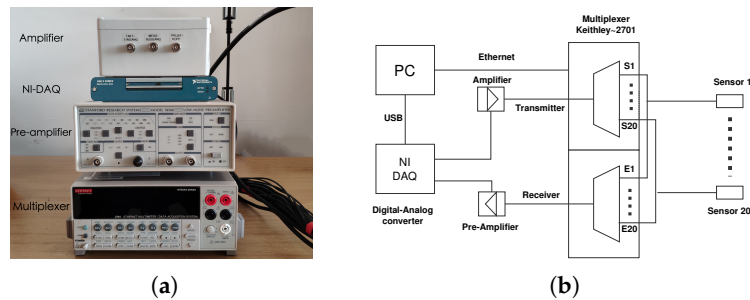
Figure 4. (a) Data acquisition devices (b) Diagram of the data acquisition system.

The data acquisition system (Figure 4) allows continuous monitoring with a maximum of twenty US transducers with a sampling frequency of 1 MHz. If necessary, the temperature can be also recorded for long-term monitoring. As the experiments described in this paper were performed in a laboratory

environment, the influence of temperature was negligible. Transducer transmitter-receiver pairs can be controlled and configured easily in the control program. All the US data could be synchronised to the specified FTP server automatically, which allows remote measurement. The whole system includes:

- Amplifier to amplify the input signal of transmitter
- Pre-amplifier with analog filter to improve the signal recorded by receiver
- Digital-analog data acquisition module to convert signal
- Multiplexer with 20 channels to switch between different combinations of transducers
- PC with control software and data storage

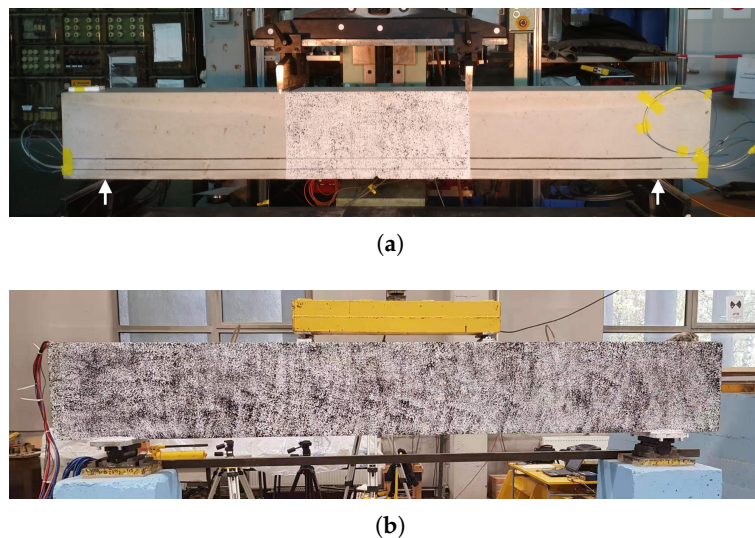
Figure 5. Front view of the beams and contract points position (a) At BAM and (b) at NEOSTRIN.

Two similar RC specimens were designed to perform four-point bending tests at BAM and NEOSTRIN. The dimension of the beams is 290 cm \times 20 cm \times 40 cm (length \times width \times height). The beam at BAM (Figure 5a and 6) was reinforced with two ϕ 6 rebars in the compression zone and two ϕ 14 rebars in the tension zone, attached by six ϕ 6 stirrups with a spacing of 30 cm. The beam at NEOSTRIN (Figure 5b and 7) was reinforced with three ϕ 10 rebars in the tension zone and two ϕ 10 rebars in the compression zone, attached by thirteen ϕ 6 stirrups.

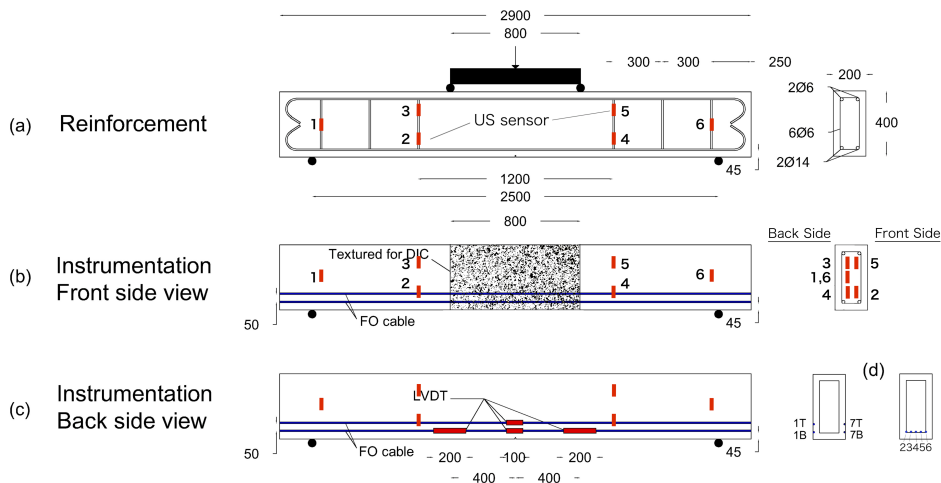
Figure 6. Dimensions of the beam, rebars distribution and sensors positions at BAM.

A limited number of US transducers was attached on the stirrups and installed inside both beams before casting. Two vibrating wire strain gauges and two rebar stress meters were installed in the beam at NEOSTRAIN to measure the strain variation in the beam and the rebar. As the quantity and position of all the cracks were not predictable, only four LVDT sensors were glued on the back surface of the beam at BAM to measure the Crack Opening Displacement (COD) for a few cracks on the surface and to double verify the FOS measurement. Strain changes and crack width inside the beam were also measured by FOS. Although FOS technique was not applied at NEOSTRAIN, DIC technique which covered the whole beam still provided a roughly COD and propagation map. Position and spacing between all the transducers are shown in Figures 6 and 7.

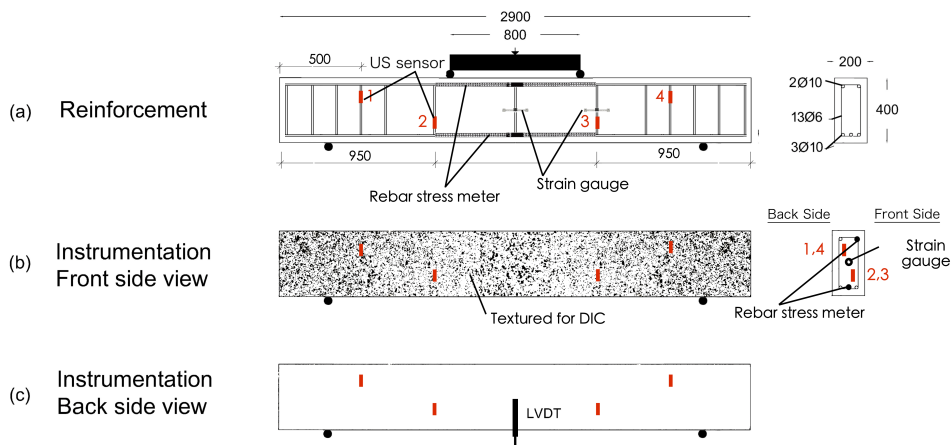
Figure 7. Dimensions of the beam, rebars distribution, and sensors positions at NEOSTRAIN.

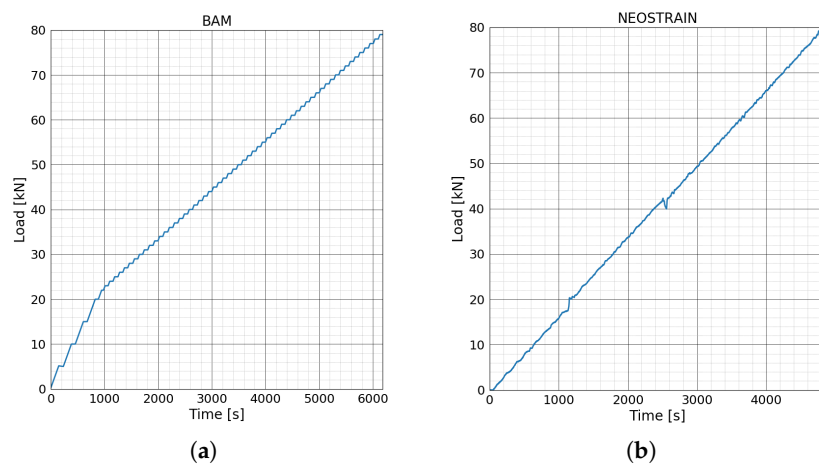
Figure 8. Loading steps of four points bending test at (a) BAM and at (b) NEOSTRAIN.

A step-wise loading procedure was performed for the test at BAM due to the low measurement frequency of the interrogator of FOS technique. In total, 64 load steps were performed. The load increased 5 kN/min and remained stable for one minute until 20 kN. For the following steps, the load increases 1 kN/min and remained stable for one more minute until reaching 80 kN as shown in Figure 8a. The loading procedure of the test at NEOSTRAIN was performed continuously with an increasing rate of 1 kN/min. Since the loading procedure at NEOSTRAIN was controlled manually, the load increased unexpectedly from 18 kN to 19.4 kN due to a mistake of the operator (Figure 8b).

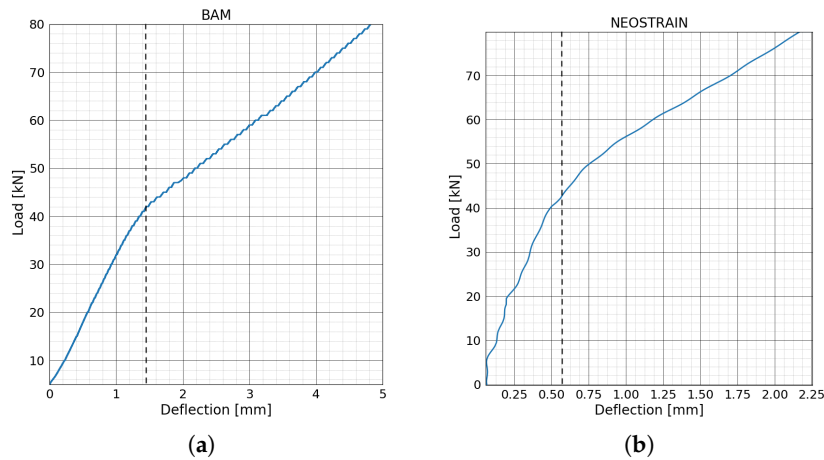
Figure 10. Load-deflection curve for bending test at (a) BAM and at (b) NEOSTRAIN.

The deflections of two beams during the four-point bending test are shown in Figure 10. Load-deflection curves for both beams lost their linearity at around 42 kN; the beams went into the plastic phase from the elastic phase, meaning that single or multiple cracks appeared. As mentioned

in the previous section, the loading procedure at NEOSTRAIN was controlled manually; there was a small load fluctuation during the whole test.

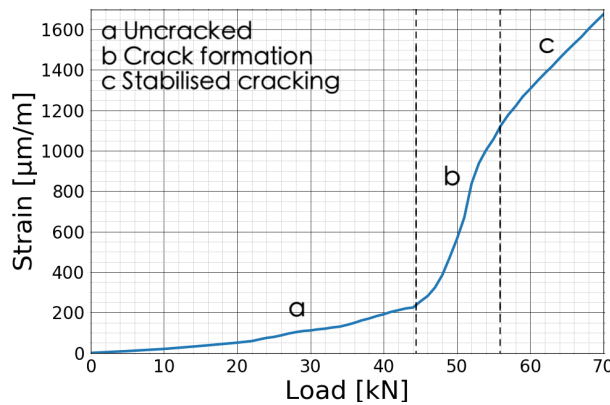
Figure 11. Force-strain curve of crack 5 measured by fiber line 7B.

The stress-strain relationship can distinguish between different stages of the crack opening: the uncracked stage, the crack formation stage and the stabilised cracking phase [33]. Figure 11 shows the three different stages of crack number 5 in the beam at BAM measured by fiber line 7 on the bottom in the front. The measured area remained uncracked until 45 kN, then the crack started to form and went into the stabilised cracking phase at 56 kN.

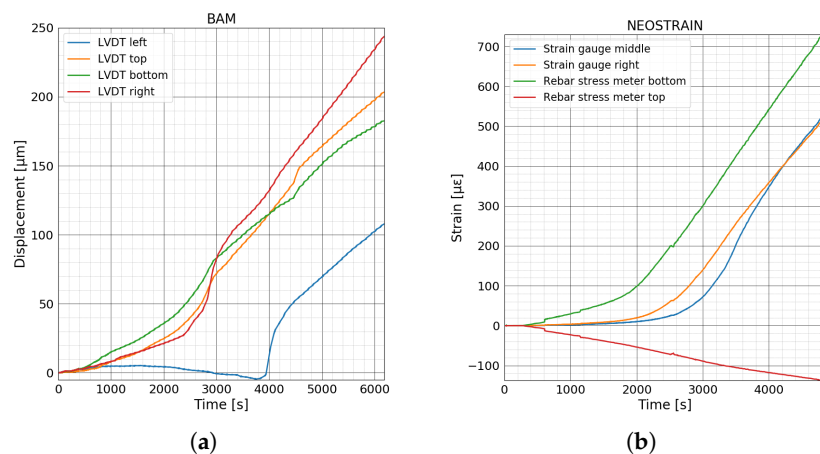
Figure 12. (a) Displacements measured by LVDT sensors at BAM. (b) Strain variation inside concrete and rebars measured by strain gauges and rebar stress meters at NEOSTRAIN.

Figure 12a shows the COD of crack number 4, 7 and 10 measured by four LVDT sensors. The results are in accordance with the FOS measurement. A comparison of FOS technique, DIC, and LVDT in this experiment is presented in [34]. As fibers covered the whole beam and successfully detected all of the fourteen cracks in this experiment, the loads corresponding to the different stages of the crack opening are only determined by the force-strain curves measured by FOS (Figure 13a). Strain variations inside the beam and rebar at NEOSTRAIN are shown in Figure 12b. The top rebar was always under compression. The slope of two strain gauges started to change around 40 kN. The stress in the bottom rebar increased slowly until 32 kN and then increased linearly and rapidly after 35 kN.

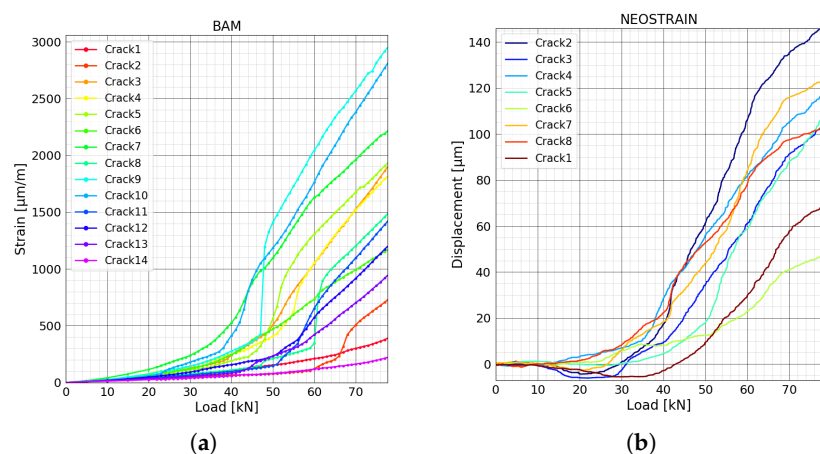
Figure 13. (a) Strain variation at position of all cracks measured by fiber line 7B at BAM. (b) Displacement at position of all cracks measured by DIC technique at NEOSTRAIN.

Figure 13a shows the strain variation for all the crack positions measured by FOS during the bending test at BAM. Assuming that the strain variations are caused by the deformation discontinuity, COD could then be estimated [34]. This paper focuses only on the detection of the load level when cracks enter different phases, thus the calculation of COD is not necessary and not presented. The FOS technique was not implemented for the test at NEOSTRAIN; nonetheless, the approximate CODs of all the cracks were measured by the DIC technique, which covered the whole front surface. The DIC technique detected the COD by analysing the deformation of the surface of the beam which is caused by strain change [9]. Hence, different crack opening phases can also be determined by the stress-displacement curve Figure 13b. When the deformation is relatively small, the displacement measurement is strongly disturbed by the friction. This is the reason for the unusual negative displacement values at the beginning of the experiment.

suddenly at 18 kN due to a misoperation during the load procedure. This proves again the high sensitivity of CWI method to stress variation. A change was detected by CC and dV/V of transducer combination S02E03 at 32 kN, which is the moment when stress in the bottom rebar lost its linearity. The authors assume it as a sign before the first crack appeared. According to the COD measured by DIC, the first crack (crack 4) appeared at 37 kN and was located in the middle of the beam. All the transducer combinations related to transducer number 2 detected a change in dV/V and CC, which indicates the creation of crack number 2. According to DIC, all the other cracks beside crack number 6 started to form at around 41 kN. CC and dV/V measured by transducer combinations S01E03, S02E03, and S03E04 started to fluctuate at 40.5 kN because of crack number 7 and 8, which surrounded transducer number 3. During the 'crack formation' phase, crack number 2, 4, 7, and 8 had bigger COD than the others (Figure 13).

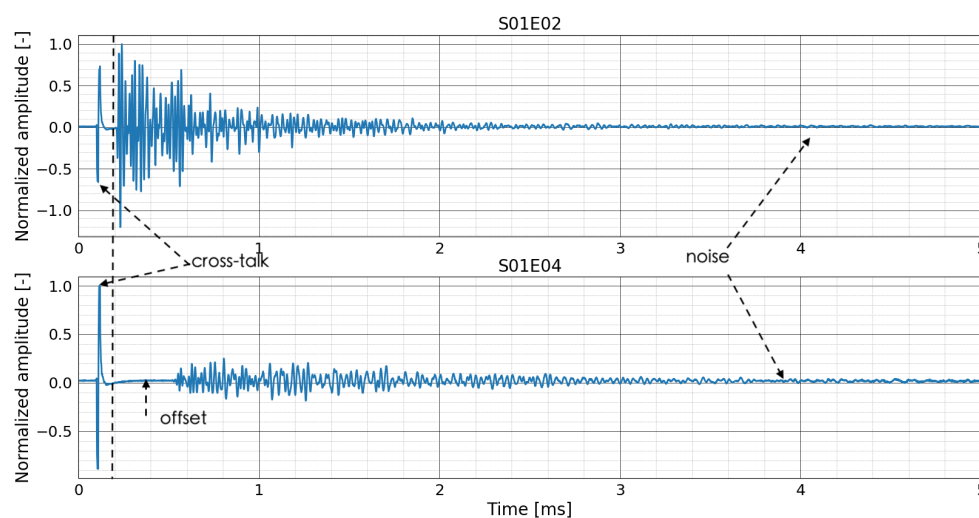
Figure 14. Correlation coefficient and relative velocity change of all the transducers combinations in test at BAM.

As an example, signals measured by transducer combinations S01E02 and S01E04 ($S_{xx}E_{yy}$: transmitter xx and receiver yy) during the initial stage of the beam at NEOSTRAIN are plotted in Figure 14. The signals need to be pre-processed to filter the noise and to remove offset and cross-talk (more details can be found in [32]). As the distance between transducer number 1 and 4 is longer than that of transducer number 1 and 2, the signal received by transducer combination S01E04 has a longer time of flight and lower amplitude due to the attenuation of US wave in concrete.

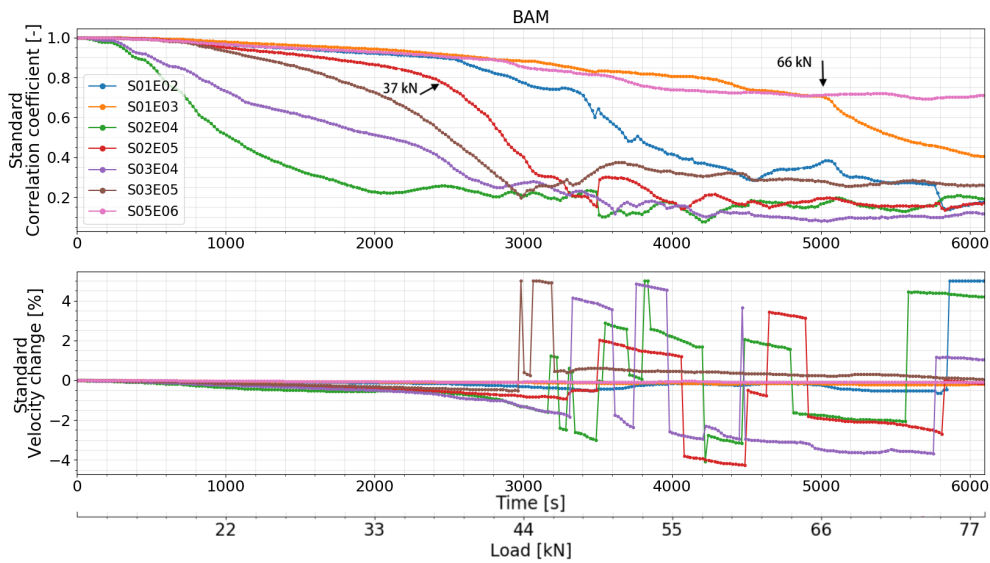
Figure 15. Correlation coefficient and relative velocity change of all the transducers combinations in test at BAM calculated by standard CWI.

CC and dV/V of all the transducer combinations calculated by all the different CWI methods are presented in Figure 15 (standard CWI), Figure 16 (auto reference CWI), and Figure 17 (Step-wise CWI). Reference signals of all transducer combinations were recorded at the initial state of the beam before the start of the loading procedure. CC and dV/V were then calculated by normal CWI procedure. For the auto reference CWI, when the absolute value of dV/V exceeded 1%, the damage in the structure

reached a certain level. It is difficult to compare the following signals with the original reference signal. Thus, the current signal was chosen as a new reference signal until dV/V reached 1% again.

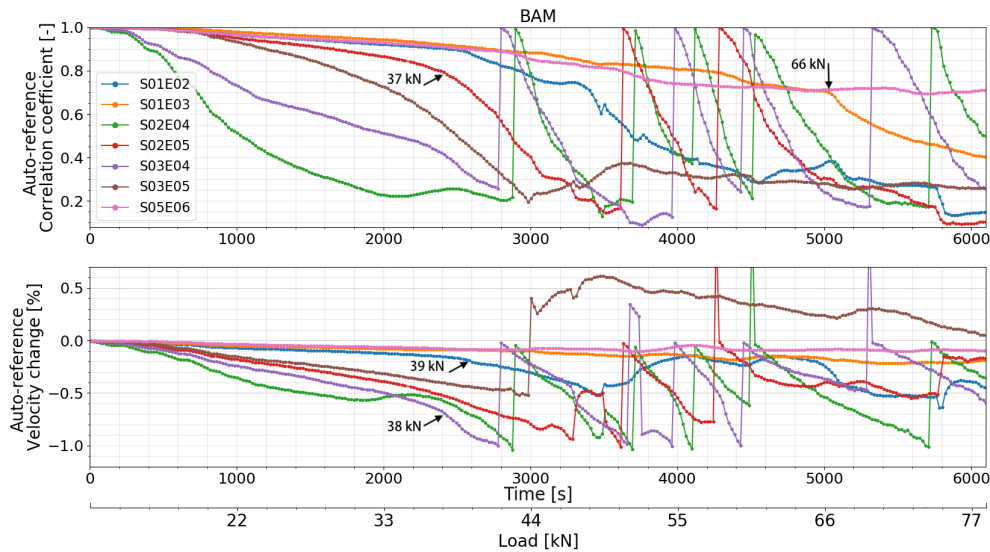
Figure 16. Correlation coefficient and relative velocity change of all the transducers combinations in test at BAM calculated by auto reference CWI.

Unusual behaviors of transducer 04 were detected. The CC and dV/V of all the transducer combinations related to transducer 04 varied too much compared to other combinations which were located in the symmetrical positions of the beam. Signals recorded by *S02E04* and *S03E04* before the start of load test showed that the performance of transducer 04 was not so stable. However, the CC and dV/V related to transducer number 4 calculated by step-wise CWI are still helpful. Before the first cracks appeared, all the transducer combinations successfully detected the different loading steps, especially by step-wise CWI method. The CC and dV/V of transducer combination *S02E05* lost their linearity (Figures 15 and 16) at around 37 kN which indicates one or more very early stage crack(s) opening. This change was also detected by almost all the transducer combinations by step-wise CWI method (Figure 17), while by standard and auto reference methods, transducer

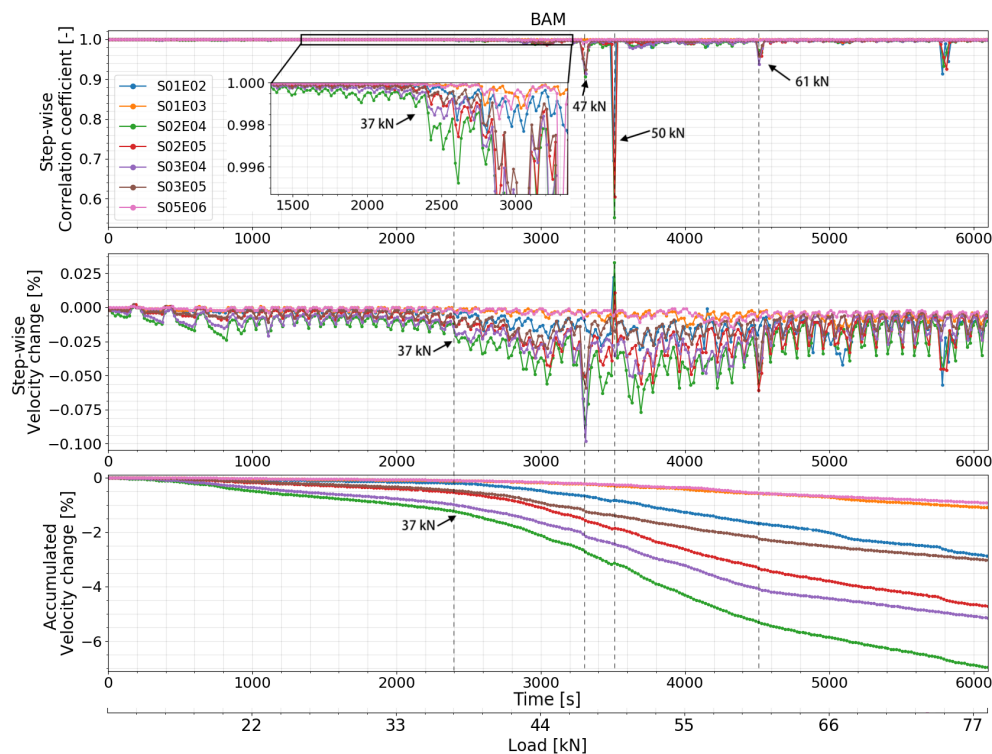
Figure 17. Correlation coefficient and relative velocity change of all the transducers combinations in test at BAM calculated by step-wise and accumulate CWI.

combination *S01E02* detected this change at 39 kN, as the crack is not in between its direct path area. The combinations of transducers *S01E03* and *S05E06* were located in the left and right corner on the top of the beam where there was no crack occurrence during the whole experiment. Nevertheless, they still detected the first crack(s) opening at 39 kN. This is very close to the moment when the first cracks started to form. Transducer combination *S03E04* detected the first cracks at 38 kN. When the dV/V of transducer combination *S03E04* reached -1% at 44 kN, a new reference was chosen automatically; furthermore, the continuous load was detected again. At 66 kN, CC measured by transducer combination *S01E03* decreased rapidly. Using the step-wise CWI method, a significant change was detected at 47 kN (Figure 17) by all the combinations between transducer 02, 03, 04 and 05 which were located in the main stress change part of the beam; this indicated a higher level of damage in the beam. A second significant change was detected at 50 kN by all the transducer combinations related to transducer 02, which means the damage was close to transducer 02. According to the accumulated CWI, CC, and dV/V of transducer combinations *S01E03* and *S02E05* varied the least as they were not located in the damage area.

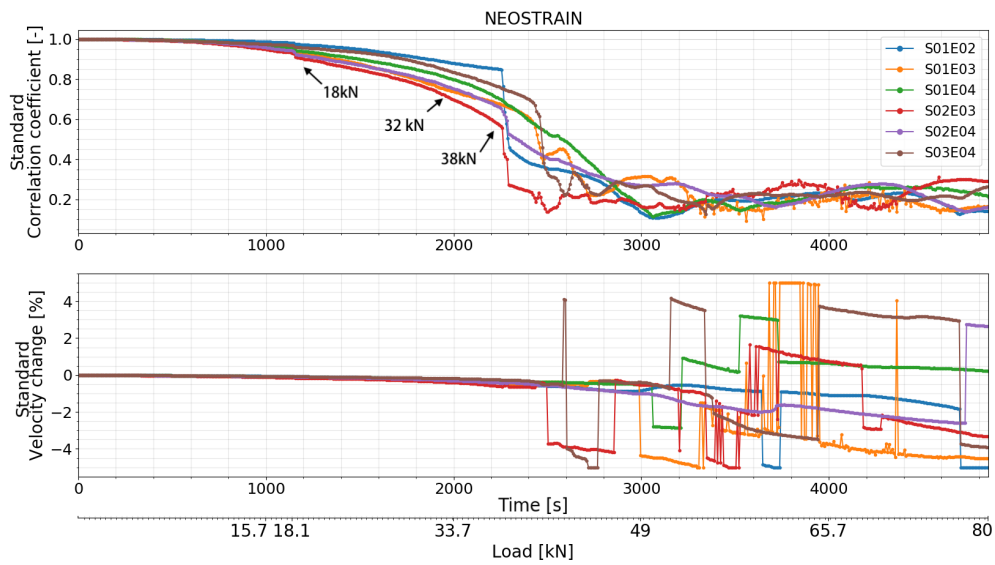
Figure 18. Correlation coefficient and relative velocity change of all the transducers combinations in test at NEOSTRAIN calculated by standard CWI.

As shown in Figures 18–20, small variations in CC and dV/V were observed at 18 kN which corresponded to the misoperation mentioned in the ‘loading procedure’ section. Both features of all transducer combinations then decreased smoothly. CC and dV/V of transducer combination *S02E03* decreased with a higher rate at 32 kN. A small change was detected by transducer combinations *S01E03*, *S02E03*, and *S03E04* at 36 kN by step-wise CWI method. A second strong change can be seen in the CC and dV/V of transducer combinations *S01E02*, *S02E04*, and *S02E03* at 38 kN. CC and dV/V of all transducer combinations related to transducer number 3 (*S01E03*, *S02E03*, and *S03E04*) started to change irregularly from 40.5 kN, meaning that the multiple cracks occurred near transducer number 3. This is close to the moment when the beam entered plastic phase. CC and dV/V measured by the top level transducer combination *S01E03* had

their first sudden change at 54 kN. This means either cracks affected the direct path between them or the global damage in the beam reached a certain level.

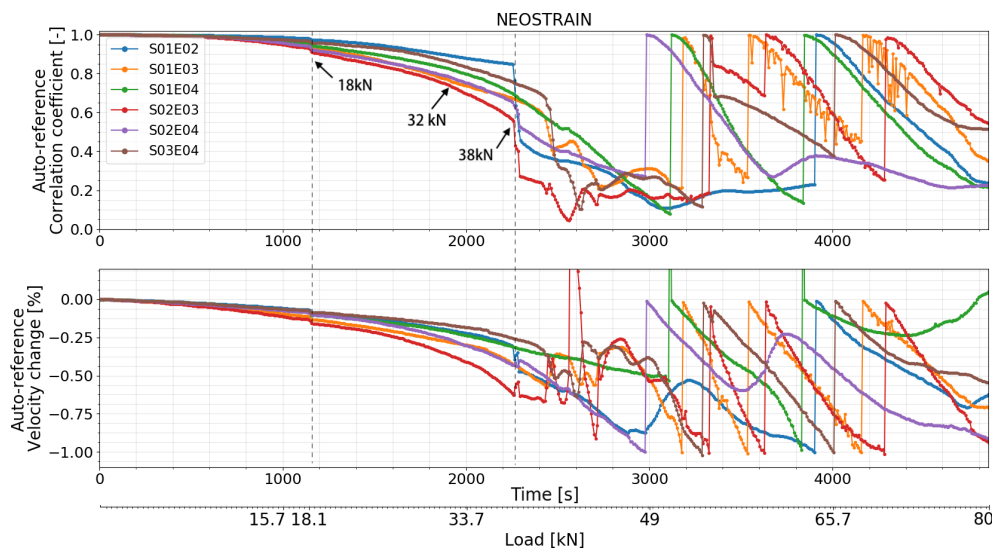
Figure 19. Correlation coefficient and relative velocity change of all the transducers combinations in test at NEOSTRAIN calculated by auto reference CWI.

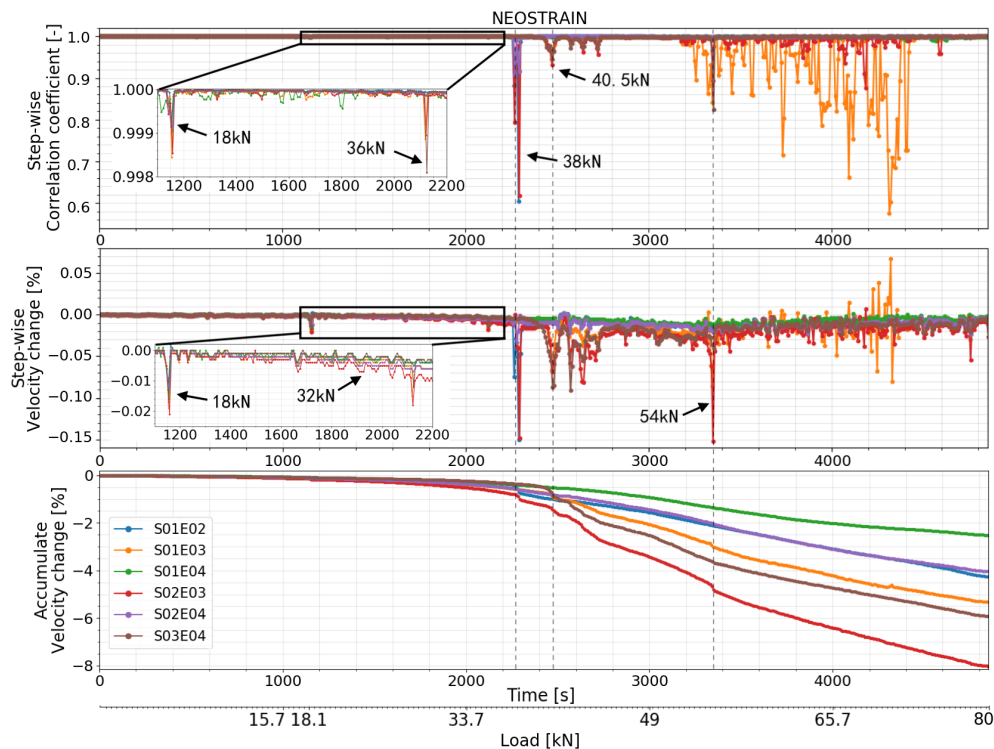
Figure 20. Correlation coefficient and relative velocity change of all the transducers combinations in test at NEOSTRAIN calculated by step-wise and accumulate CWI.
