# **Investigation and identification of damage mechanisms of unidirectional carbon/flax hybrid composites using acoustic emission.**

The objective of the present experimental work is to determine the damage mechanisms appearing in unidirectional carbon/flax hybrid composites during tensile tests. The specimens tested consist of unidirectional carbon and flax fiber plies with different stacking sequences. Laminated composites were manufactured using a manual lay-up process. The specimens were tested under uniaxial tensile loading in static and cyclic fatigue tests. The tests carried out were monitored by the acoustic emission (AE) technique in order to identify the damage mechanisms evolutions. This identification was made with an unsupervised clustering technique. The recorded events were classified with the k-means algorithm based on temporal classification parameters. For each kind of specimen, four classes of AE events were obtained. Then, the contribution of each damage mechanism to overall failure was evaluated by the amplitude range, the cumulative number of hits and the acoustic energy activity. The AE classes obtained were correlated with scanning electron microscopy (SEM)

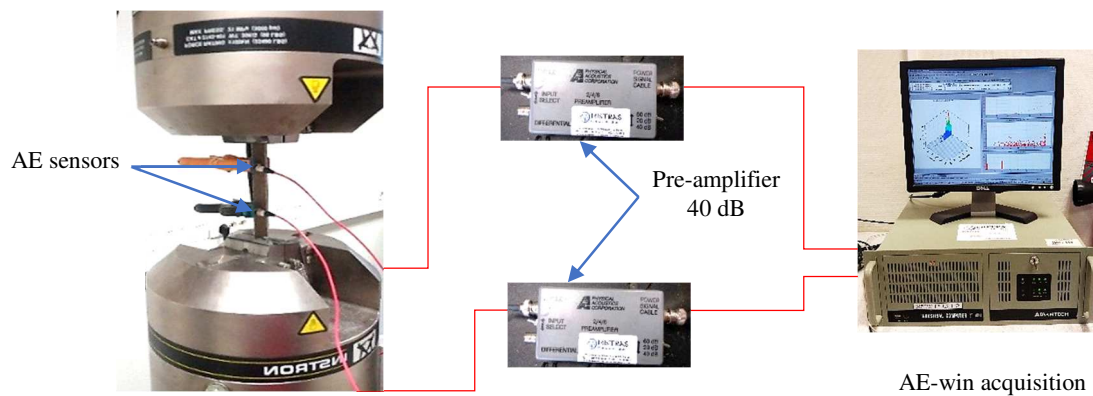
**Fig. 3.** Experimental setup of acoustic emission method.

During the static and fatigue tensile tests, damage and fracture progression in the tested specimens were analyzed by the AE method. Two resonant piezoelectric sensors (PCA MICRO-80) with a frequency bandwidth of 100 kHz-1 MHz and a resonance peak of 300 kHz, provided by Euro Physical Acoustics (EPA) corporation, were used. They were clamped to the specimens on the same side with a plier using a coupling agent (silicon grease) between the specimen and the sensors. For best results, we do not take too much of the coupling agent. Therefore, a thin layer of grease was used on the sensor against the specimen surface. These AE sensors were used to record the transient waves propagated through the material under loading. These acoustic waves were generated as a consequence of elastic deformations and damage mechanisms. In fact, events created in the gauge length and under grips were recorded. The gauge length was 100 mm. In the interest of reducing the attenuation of the waves originating from the source, the distance between the two AE sensors was set to 50 mm. The recorded AE signals were amplified and filtered using two pre-amplifiers with a gain of 40 dB, provided by Mistras Group Company. The acquisition of the acoustic emission signals was processed using the AEwin software, provided by EPA corporation, with a sampling frequency rate of 5 MHz. This system was equipped with a PCI acquisition card connected to the micro-computer (Fig. 3). The AE data were dependent on temporal acquisition parameters, namely: PDT (Peak Definition Time), HDT (Hit Definition Time) and HLT (Hit Lockout Time) [30]. The values of these temporal parameters were set to: PDT = 50  $\mu$ s, HDT = 100  $\mu$ s and HLT = 200  $\mu$ s. The amplitude of the acquisition threshold was determined using the Pencil Lead Breaking (PLB) procedure [49, 50] and was equal to 40 dB in order to filter the AE signals coming from external sources (noise). For each
