Airbag Jacket for Motorcyclists: Evaluation of Real Effectiveness

Thierry Serre, Catherine Masson, Maxime Llari, Bastien Canu, Max Py,
Christophe Perrin

Thierry Serre, Catherine Masson, Maxime Llari, Bastien Canu, Max Py, et al.. Airbag Jacket for Motorcyclists: Evaluation of Real Effectiveness. IRCOBI 2019, International Conference on the Biomechanics of Injury, Sep 2019, Florence, Italy. pp533-547. hal-02958978

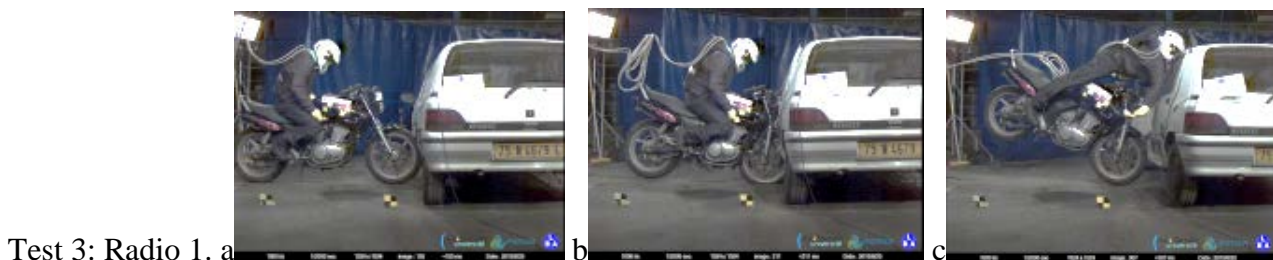
Figure 5 shows the chronology of the four crash-tests in three images:

- a) The first image corresponds to the first contact between the front wheel and the obstacle. This contact has been considered as $t=0$ ms.
- b) The second image corresponds to the triggering of the airbag jacket.
- c) The third image corresponds to the contact between the motorcyclist and the obstacle.

Fig. 5. Chronology of the four crash tests. Test 1 & 2 with mechanical triggering (cable), Test 3 & 4 with electronic triggering (radio).

From a general point of view, it can be observed that the airbag jackets with cable are triggered later than electronic ones. All the airbag jackets except during test n°2 were triggered before the impact of the motorcyclist against the obstacle.
