## **Airbag Jacket for Motorcyclists: Evaluation of Real Effectiveness**

Thierry Serre, Catherine Masson, Maxime Llari, Bastien Canu, Max Py,  
Christophe Perrin

Thierry Serre, Catherine Masson, Maxime Llari, Bastien Canu, Max Py, et al.. Airbag Jacket for Motorcyclists: Evaluation of Real Effectiveness. IRCOBI 2019, International Conference on the Biomechanics of Injury, Sep 2019, Florence, Italy. pp533-547. hal-02958978

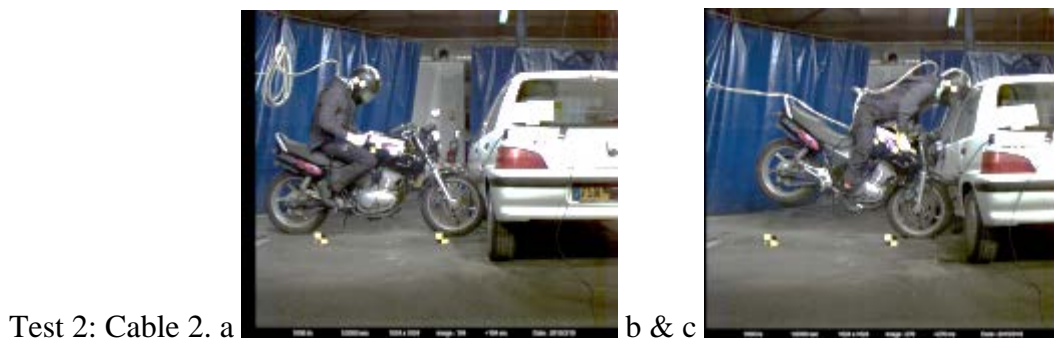
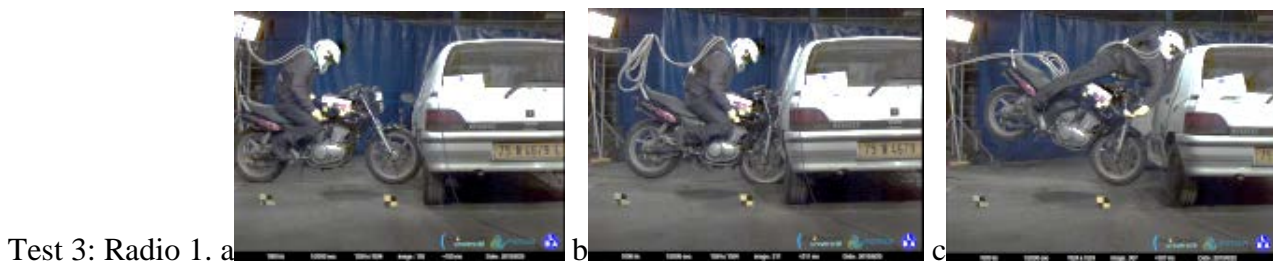
Figure 5 shows the chronology of the four crash-tests in three images:

- a) The first image corresponds to the first contact between the front wheel and the obstacle. This contact has been considered as  $t=0$ ms.
- b) The second image corresponds to the triggering of the airbag jacket.
- c) The third image corresponds to the contact between the motorcyclist and the obstacle.

Fig. 5. Chronology of the four crash tests. Test 1 & 2 with mechanical triggering (cable), Test 3 & 4 with electronic triggering (radio).

From a general point of view, it can be observed that the airbag jackets with cable are triggered later than electronic ones. All the airbag jackets except during test n°2 were triggered before the impact of the motorcyclist against the obstacle.
