Airbag Jacket for Motorcyclists: Evaluation of Real Effectiveness

Thierry Serre, Catherine Masson, Maxime Llari, Bastien Canu, Max Py,
Christophe Perrin

Thierry Serre, Catherine Masson, Maxime Llari, Bastien Canu, Max Py, et al.. Airbag Jacket for Motorcyclists: Evaluation of Real Effectiveness. IRCOBI 2019, International Conference on the Biomechanics of Injury, Sep 2019, Florence, Italy. pp533-547. hal-02958978

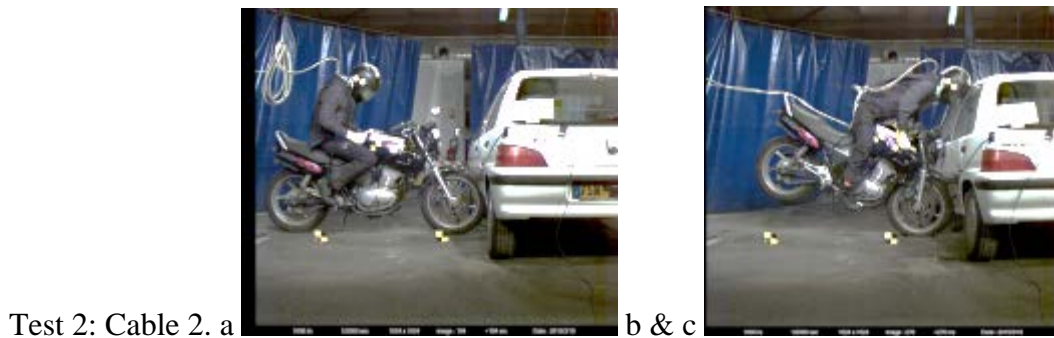
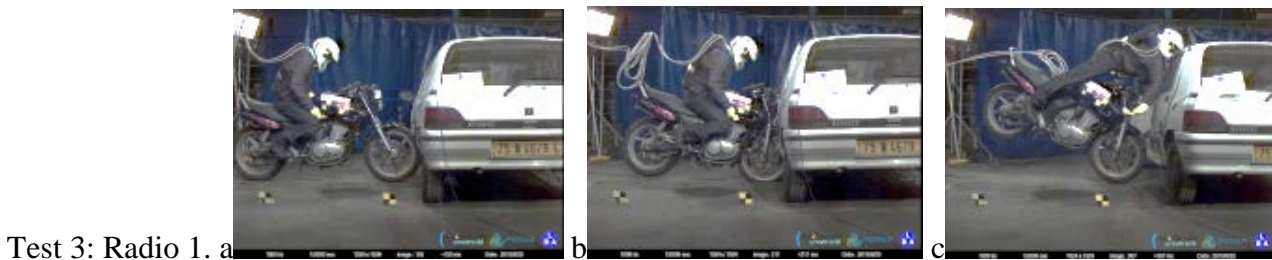
Figure 5 shows the chronology of the four crash-tests in three images:

- a) The first image corresponds to the first contact between the front wheel and the obstacle. This contact has been considered as $t=0$ ms.
- b) The second image corresponds to the triggering of the airbag jacket.
- c) The third image corresponds to the contact between the motorcyclist and the obstacle.

Fig. 5. Chronology of the four crash tests. Test 1 & 2 with mechanical triggering (cable), Test 3 & 4 with electronic triggering (radio).

From a general point of view, it can be observed that the airbag jackets with cable are triggered later than electronic ones. All the airbag jackets except during test n°2 were triggered before the impact of the motorcyclist against the obstacle.
