## **Comparison between cryogenic coolants effect on tool wear and surface integrity in finishing turning of Inconel 718**

# Comparison between cryogenic coolants effect on tool wear and surface integrity in finishing turning of Inconel 718

S. Chaabani<sup>a,b,\*</sup>, P.J. Arrazola<sup>a</sup>, Y. Ayed<sup>b</sup>, A. Madariaga<sup>a</sup>, A. Tidu<sup>c</sup>, G. Germain<sup>b</sup>

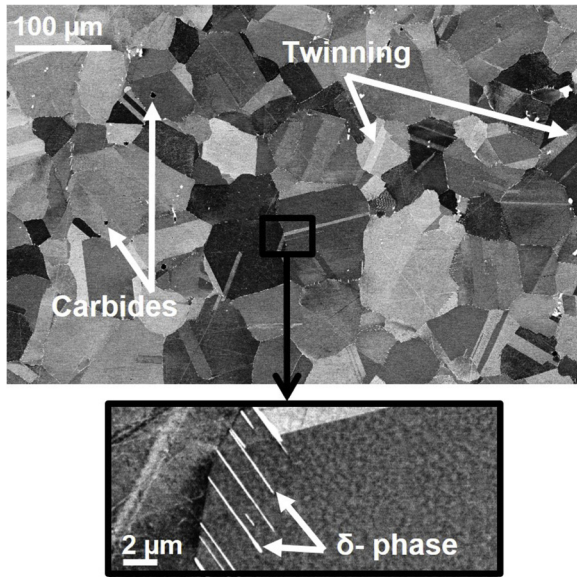
Fig. 1. Illustration of Inconel 718 microstructure in the as-received state observed by SEM technique.

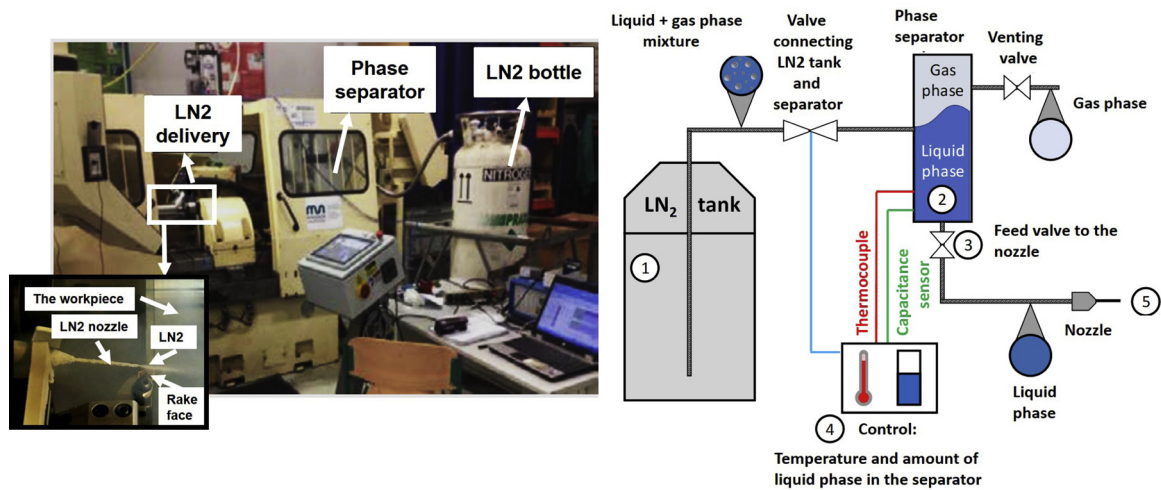
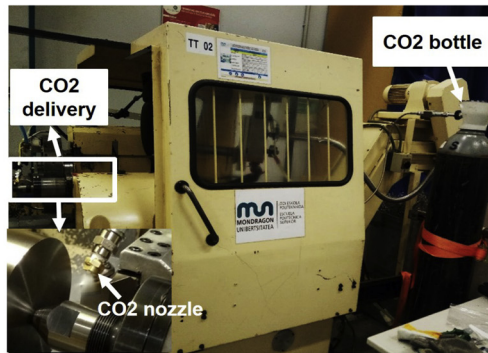
Fig. 2. Experimental set-up for the cryogenic tests: (a) LN<sub>2</sub> set-up; (b) LCO<sub>2</sub> set-up.

nitrogen bottle mounted on the CNC lathe (Fig. 2).

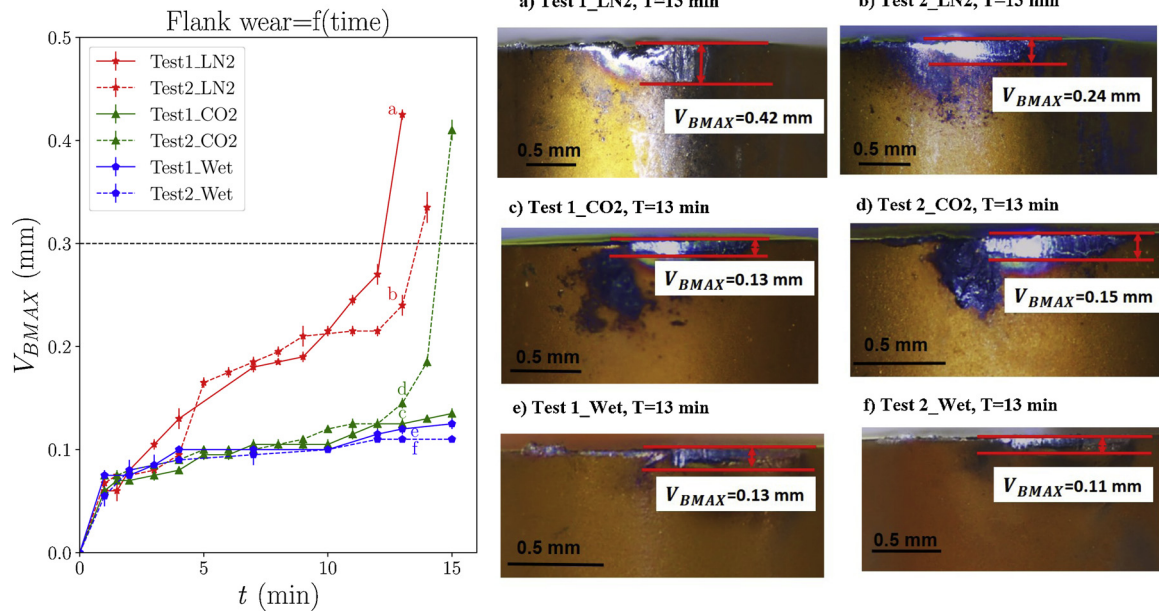
Fig. 3. Tool flank wear evolution under wet, LN<sub>2</sub> and LCO<sub>2</sub> cooling conditions during the tests.

Tool flank wear evolution was measured throughout the turning operations for all cooling methods (conventional and cryogenic conditions). The trials were stopped when reaching 15 min of cutting in conventional lubrication even if the criterion of maximum flank wear namely  $V_{BMAX} = 0.3$  mm was not achieved. Regard the LCO<sub>2</sub> condition, both tests were stopped at 15 min while the tool flank wear levels were notably different. However, under LN<sub>2</sub> cryogenic condition, the trials were stopped when the criterion of  $V_{BMAX}$  was reached. Focusing on Fig. 3, results indicated that the conventional condition revealed the longest tool life. In fact, the tool flank wear did not surpass 0.12 mm over 15 min of cutting in conventional lubrication. Both repetitions induced the same trend during the cutting process showing a good repeatability.

As for the LCO<sub>2</sub> cooling strategy, a similar evolution has been perceived up to 13 min of cutting. Nevertheless, beyond this duration, the tool flank wear progressed drastically to surpass the criterion at 15 min during the second repetition of LCO<sub>2</sub> experiment. With respect to LN<sub>2</sub> cryogenic condition, tool flank wear increased rapidly from the first 2 and 6 min of cutting during test 1 and test 2 respectively causing reduced tool life. In addition, tool flank wear progress in both cryogenic conditions is quite repeatable at the beginning of the machining process. Nevertheless, a significant variability was observed at 11 min and 13 min respectively in LN<sub>2</sub> and LCO<sub>2</sub> cooling strategies when the tool flank wear increased notably. In conventional cooling approach, a homogeneous tool flank wear evolution was observed even after longer machining times. In contrast, during LN<sub>2</sub> cryogenic machining, wear peaks occurred from the beginning of the turning process, indicating that the cutting process is not performed homogeneously while this parameter showed a steady and slow evolution in LCO<sub>2</sub> cryogenic condition except the last minutes of machining.

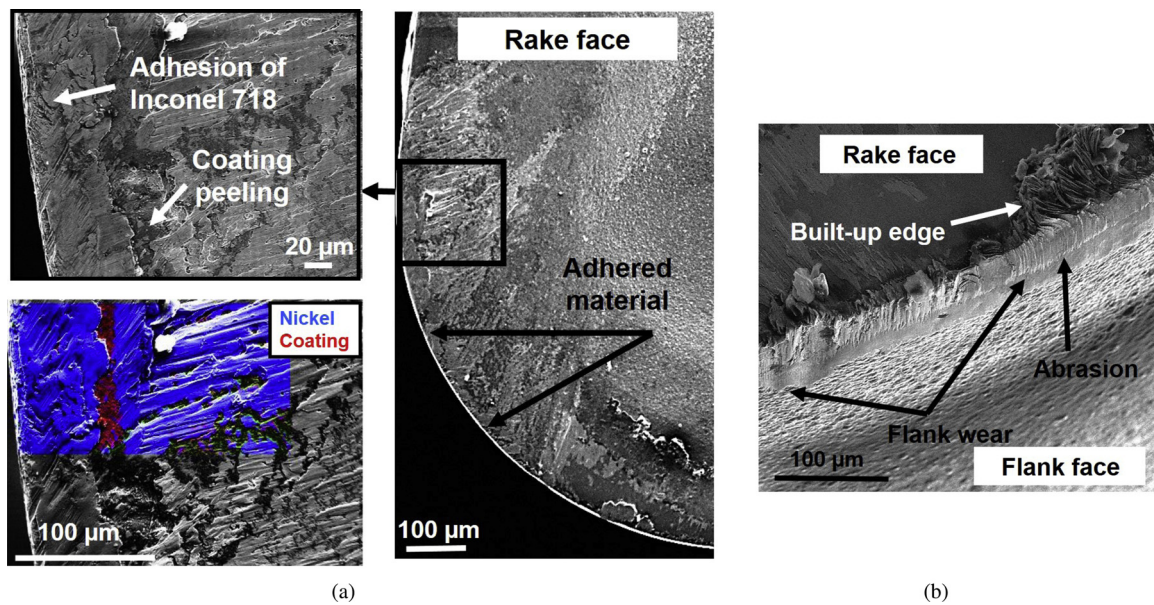
Fig. 4. SEM observations of the tool wear after 15 min of machining in wet condition: (a) rake face/EDS analysis; (b) flank face.

properties are significantly different compared to the one used in the current study. In addition, other factors could be identified consisting in the cutting conditions (cutting parameters as well as the cutting tool geometry). For these reasons, a scientifically rigorous comparison between previous studies and the current job seems to be difficult. Additional analysis have been carried out in order to study the tool wear mechanisms when machining Inconel 718 under conventional lubrication and cryogenic conditions using SEM. Fig. 4 shows the SEM observations of the tool wear state on the rake face as well as the flank face obtained in wet condition after 15 min of cutting.

The main mechanism observed consists in adhesion wear. Effectively, deposits of workpiece material were stuck on the rake face near the cutting edge revealing the chip rubbing. This observation is proved by EDS analysis showing the adhered material consisted in nickel. In fact, as long as machining time increased, adhered layers were formed progressively to establish built-up edges that protect the rake face (Xue and Chen, 2011). However, when achieving stagnation state, the built-up edges are not stable inducing the peeling of tool coating material.

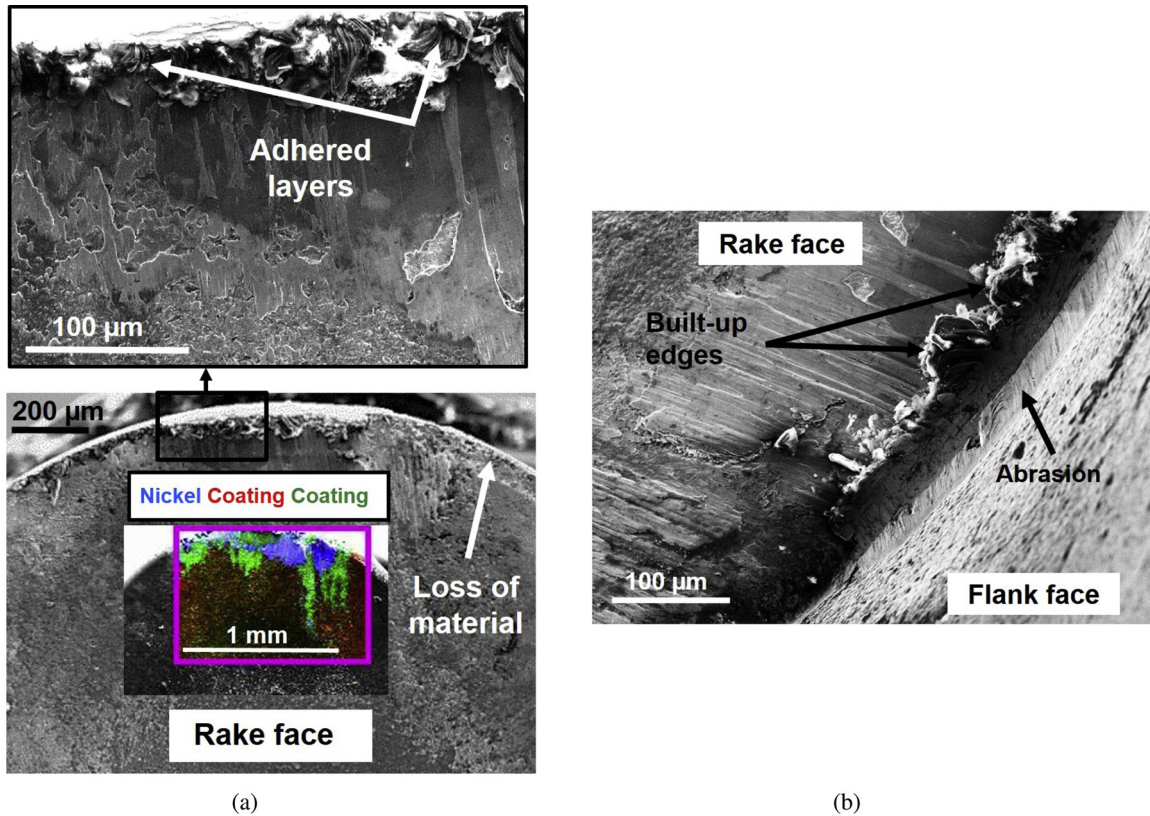
Fig. 5. SEM observations of the tool wear after 15 min of machining in LCO<sub>2</sub> condition during Test 1: (a) rake face/EDS analysis; (b) flank face.

With respect to tool wear mechanisms under LCO<sub>2</sub> condition, the two tests revealed different mechanisms. The first test exhibits the same trend as the conventional lubrication. Indeed, adhered layers are formed during machining as well as abrasion wear that is mainly caused by the hard carbide particles present in the workpiece material. It is worth mentioning that these two wear mechanisms are closely related (Cantero et al., 2013). Effectively, the adherence of the workpiece material inducing the formation of the built-up edge (BUE) leads to tool chipping, because of the instability of BUE that breaks off alternatively tearing out a small lump of the cutting edge (Fig. 5).

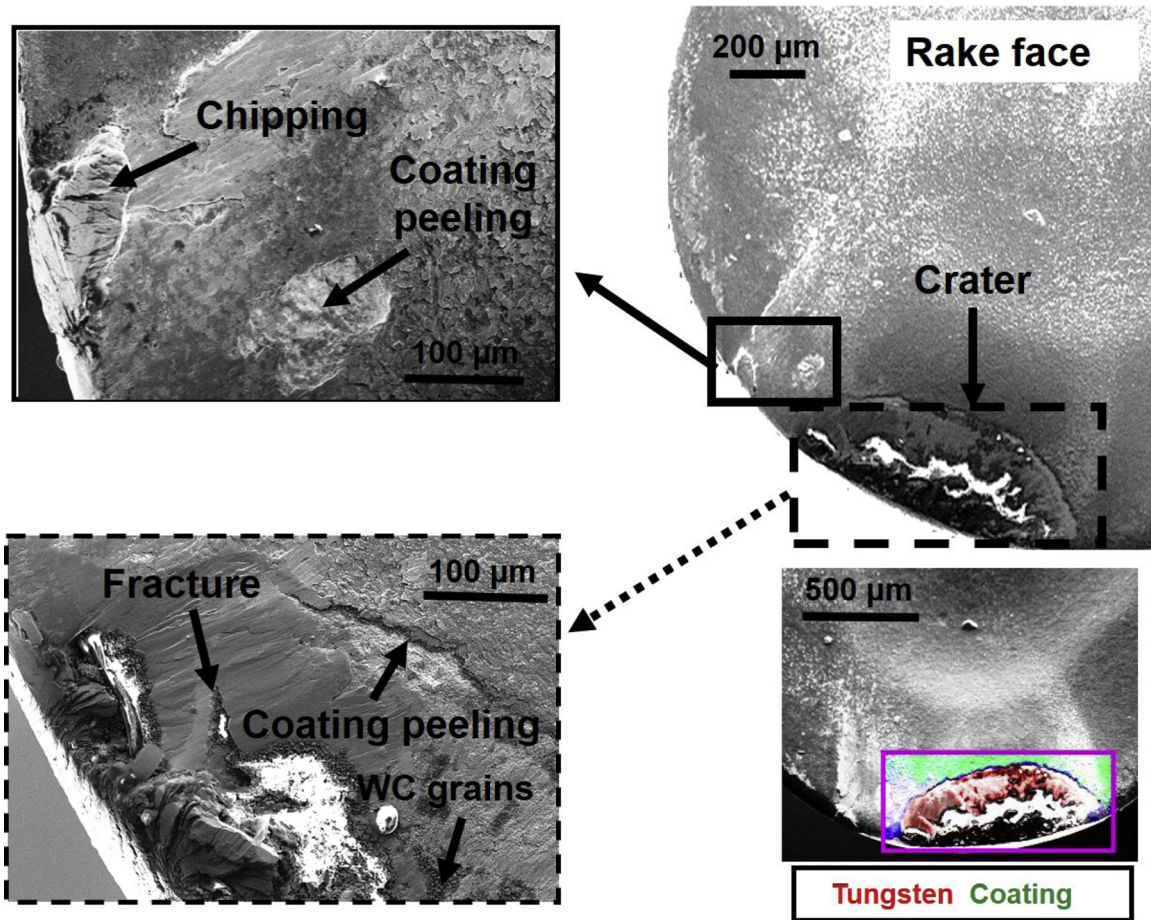
Fig. 6. SEM observations of the tool wear after 15 min of machining in LCO<sub>2</sub> condition during Test 2.

Nevertheless, the tool wear modes and mechanisms occurred during the second test when using LCO<sub>2</sub> are rather different. Besides the flank wear, drastic crater wear took place caused by the plucking out of the tool coating particles as illustrated in Fig. 6.

Micro-cracks and chipping of the cutting edge have also been observed. Overall, these mechanisms are induced by mechanical loads which developed chipping, fracture and coating peeling as well as the chemical interactions at the tool-workpiece and tool-chip interfaces that caused adhesion (Halim et al., 2019).

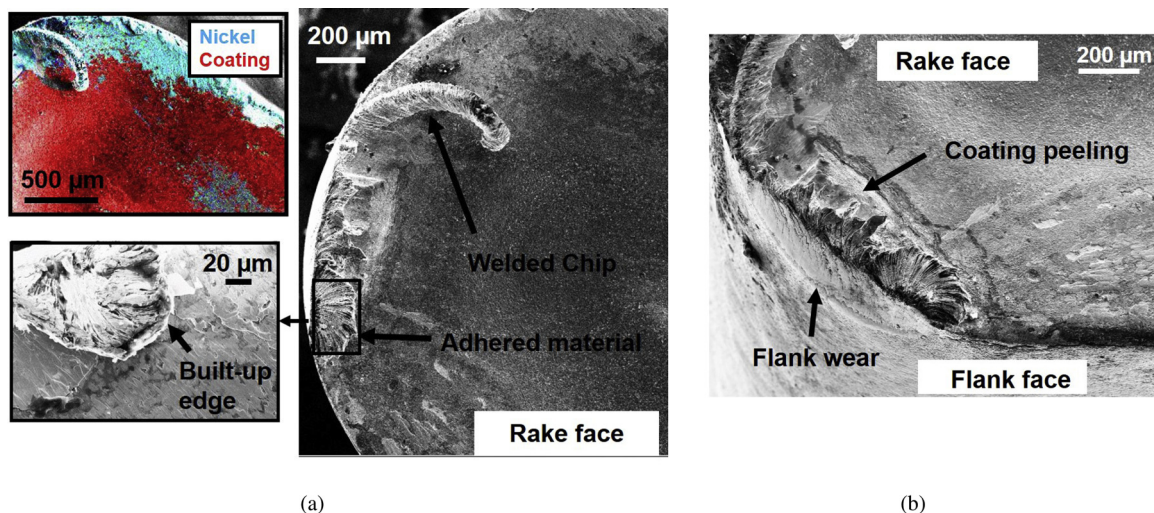
Fig. 7. SEM observations of the tool wear after 13 min of machining in LN<sub>2</sub> condition during Test 1: (a) rake face/EDS analysis; (b) flank face.

Concerning the LN<sub>2</sub> cooling conditions, tool wear mechanisms that have been detected through the SEM observations and the EDS analysis are not far from those obtained during the second test of LCO<sub>2</sub> lubrication. Indeed, during both LN<sub>2</sub> tests, the degradation of cutting tool is primarily caused by adhesion and micro-chipping as depicted in Figs. 7 and 8.

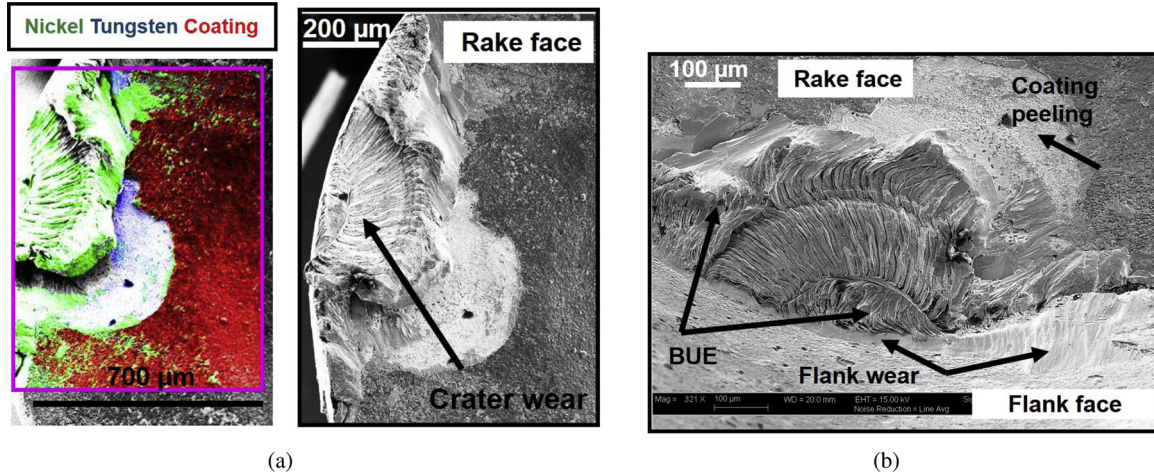
Fig. 8. SEM observations of the tool wear after 14 min of machining in LN<sub>2</sub> condition during Test 2: (a) rake face/EDS analysis; (b) flank face.

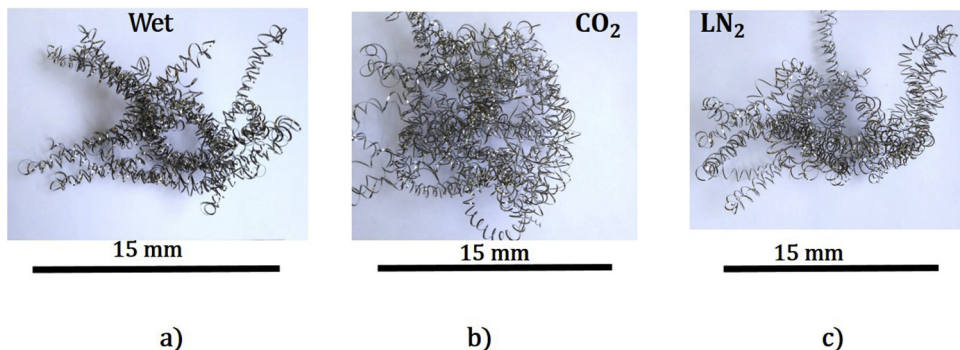
Fig. 9. Chip morphology obtained in the three cooling strategies: (a) wet, (b) CO<sub>2</sub> and (c) LN<sub>2</sub>.

Another aspect should be stated consisting in that when delivering LN<sub>2</sub> cutting fluid on the tool rake face, it seems complicated to avoid cooling the unmachined workpiece. Consequently, the work material deformation behavior as well as the thermal properties could change by the cryogenic temperature (−196 °C). Thereby, the cutting process in this case turns out to be nonhomogeneous affecting the tool wear resistance. Moreover, when examining the chip morphology obtained under all cooling conditions, there is no significant difference; the chips exhibit almost the same morphology as depicted in Fig. 9.

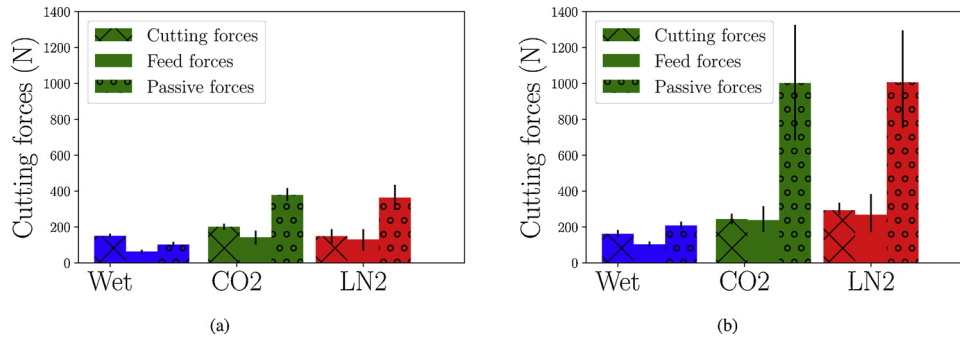
Fig. 10. Comparison between cutting forces components: at the beginning (a); at the end (b) of test.

Results showed that all cutting forces components exhibit lower values in conventional cooling condition than in the case of cryogenic conditions (Fig. 10). Indeed, the cryogenic cutting fluids (LN<sub>2</sub> and LCO<sub>2</sub>) display very low temperature throughout machining time leading to increase the flow stress of the workpiece material. As a result, the machining forces components heighten significantly. For instance, when examining the values of the cutting forces components found in conventional and cryogenic conditions, a strong difference is obtained where the maximum value of cutting forces that has been measured in conventional condition is 180 N. In contrast, in LN<sub>2</sub> and LCO<sub>2</sub> cooling approaches, this variable has exceeded 300 N and 250 N respectively at the end of cutting. Furthermore, the feed forces show the same tendency where the highest values are achieved in LN<sub>2</sub> cryogenic conditions. However, the passive forces revealed the highest values recorded in all cooling environment compared to the cutting and feed forces reaching over 1200 N after 14 min of machining in LN<sub>2</sub> condition.

Cutting forces values are key factors to indicate the tool wear state. Fig. 10 illustrates the cutting forces measurements at the beginning and the end of the cutting process revealing the effect of tool wear evolution. Obviously, over machining time, the tool wear increases relatively to the cooling environment and therefore cutting forces rise as well. In

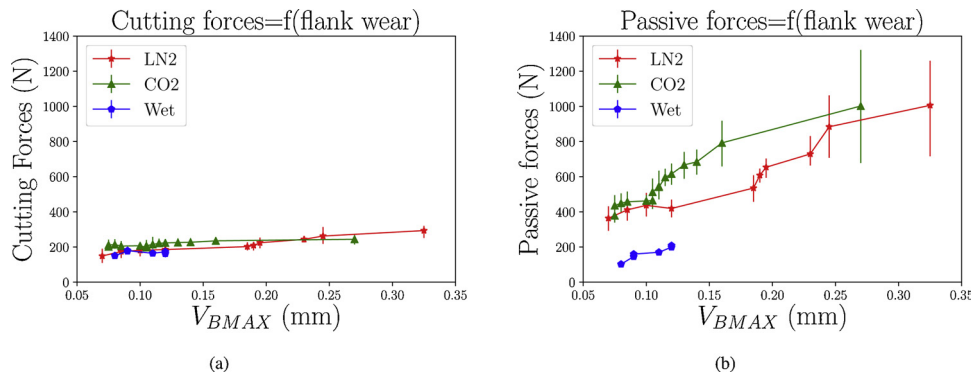
Fig. 11. Correlation between cutting forces components evolution and tool flank wear under Wet, LN<sub>2</sub> and LCO<sub>2</sub> conditions: (a) cutting forces, (b) passive forces.

addition, when comparing between the three components of the cutting forces regardless the lubrication strategy, one could recognize that the passive force measurements showed the highest values, mostly by the end of the machining process where the tool flank wear increased notably (Grzesik et al., 2018). In addition, when comparing between the different cooling methods, one could notice that passive force progress is slow and steady in conventional condition. Nevertheless, under cryogenic conditions, this parameter evolves drastically at the end of machining. This tendency is more pronounced under LN<sub>2</sub> cryogenic condition than under LCO<sub>2</sub> condition. This result may be attributed to the rapid tool flank wear progress in LN<sub>2</sub> cryogenic strategy mentioning that the passive forces are the most sensitive to tool flank wear as depicted in Fig. 11.

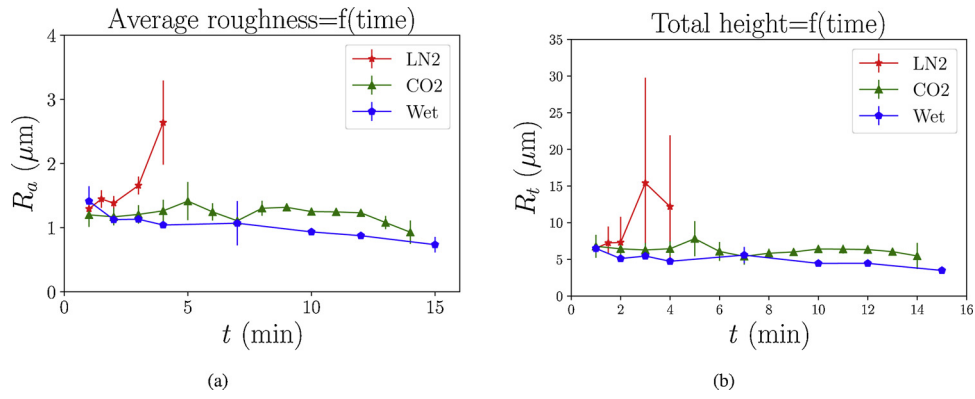
Fig. 12. Surface roughness evolution under wet, LN<sub>2</sub> and LCO<sub>2</sub> cooling conditions: (a) average roughness, (b) total height of the profile.

Surface finish is a crucial parameter that provides good machining performance of machined parts. Fig. 12 illustrates the evolution of surface roughness obtained in conventional and cryogenic conditions. Results showed that conventional coolant tended to enhance significantly the surface finish as it provides the lowest values in terms of the average roughness  $R_a$  as well as the total height of the profile  $R_t$ . Concerning the LCO<sub>2</sub> condition, it induced approximately the same tendency as the conventional strategy. Nevertheless, in LN<sub>2</sub> cryogenic condition, the surface quality exhibited a mediocre state in comparison with wet and LCO<sub>2</sub> conditions. Actually, under LN<sub>2</sub> cryogenic condition, surface roughness has achieved very high values reaching more than 3 μm of  $R_a$  and 20 μm of  $R_t$ . In comparison with LN<sub>2</sub> cryogenic

condition, conventional lubrication produces an improvement of more than 30%.

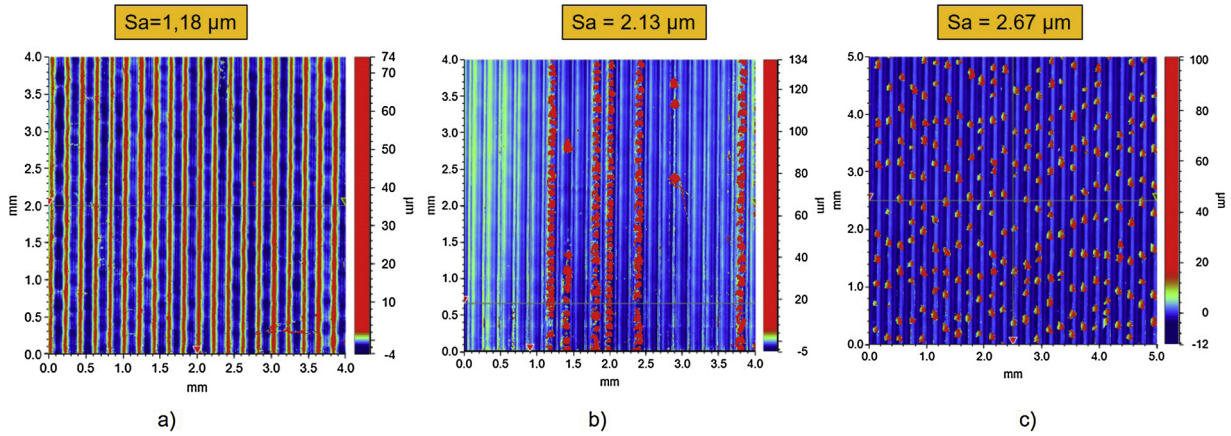
Fig. 13. Surface topography scanned using the Bruker profilometer after machining under LN<sub>2</sub> condition: (a)  $t = 0.5$  min, (b)  $t = 5.5$  min, (c)  $t = 11$  min.

the profilometer in order to characterize the LN<sub>2</sub> surface finish measuring the average areal roughness  $S_a$ . Fig. 13 highlights the increase of  $S_a$  measured at different machining times. Indeed, the scanned surfaces reveal the presence of adhered particles on the machined workpiece surfaces that become more important as the machining time increases. This could be the main reason of the worst surface quality obtained in LN<sub>2</sub> cryogenic condition.

Results showed that the average areal roughness  $S_a$  values are in the range of 1.18 μm when the microchips are not present. In contrast, the

machined surfaces exhibiting the adhered microchips revealed higher values holding 2.13 and 2.67 μm. Overall, whatever the rate of the adhered microchips, the surface finish revealed in this case is poor. To better understand the poor surface quality when machining Inconel 718 under LN<sub>2</sub> cryogenic condition, SEM metallographic observations of the machined surface have been carried out. Fig. 14 describes the machined surface obtained after 11 min of cutting under LN<sub>2</sub> cryogenic cooling condition. The major defects observed consist essentially in the adhered material as well as the smearing.

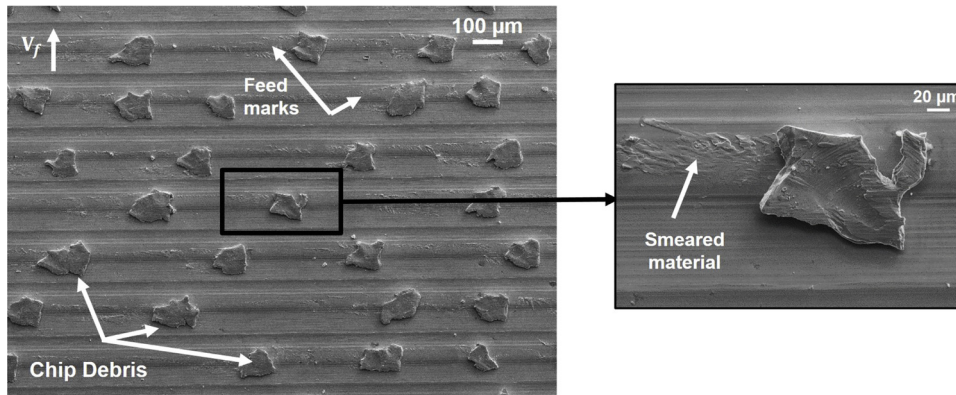
Fig. 14. SEM observations of the surface topography after 11 min of machining under LN<sub>2</sub> condition.

These observations of the machined surface could be explained by the fact that during the chip formation process, the LN<sub>2</sub> cutting fluid did not efficiently evacuate the chip from the cutting zone. Consequently, the chips were stuffed between the cutting edge and the freshly machined surface. Furthermore, the degree of tool wear affects strongly the machined surface quality knowing that thereby the cutting forces and the cutting temperature increase as well when the tool wear evolves. Indeed, these features have been observed in previous work (Zhou et al., 2012). The study pointed out that the chip debris (the adhered chip) is attributed to the increase of the plastic deformation localized at the cutting tool-work material interface. It is worth mentioning that the carbides particles could deteriorate the machined surface quality by generating the smearing of the fresh machined surface as displayed in Fig. 14.

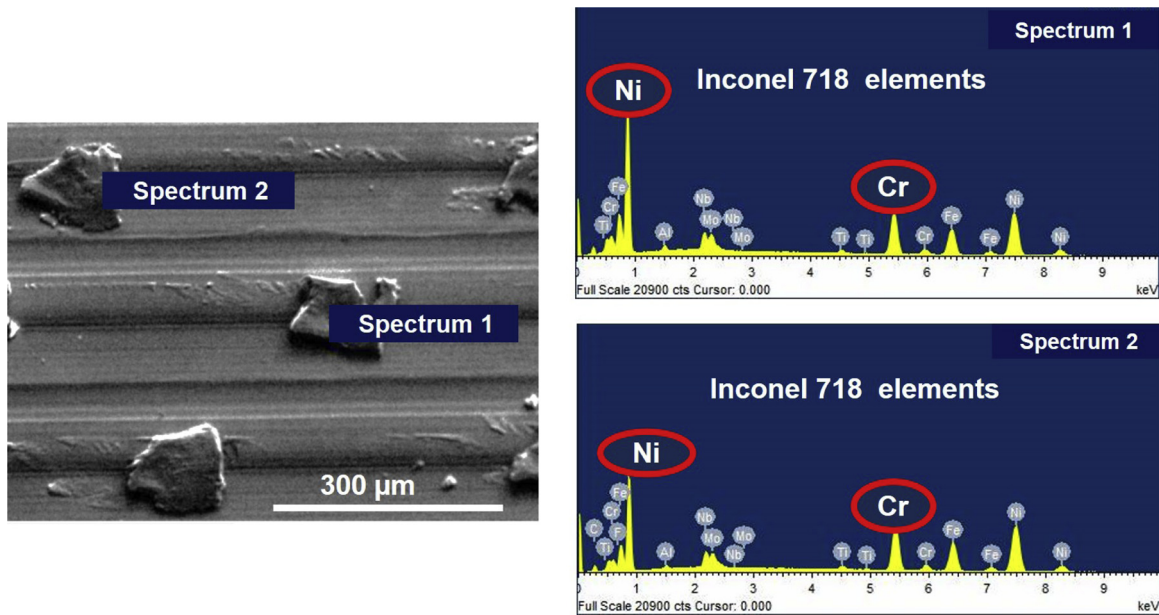
Fig. 15. EDS analysis carried out on the machined surface after 11 min of machining under LN<sub>2</sub> condition.

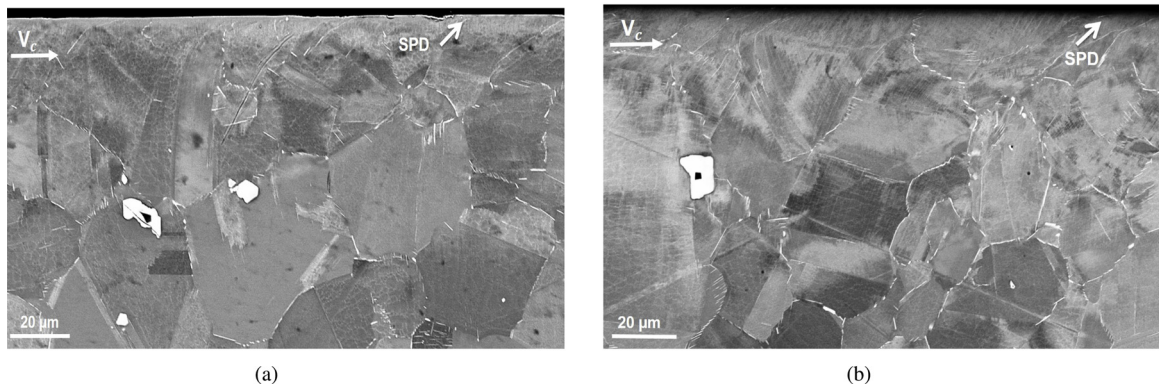
Fig. 16. SEM observations of the machined surfaces in wet condition using new and semi-worn tools: (a) new tool, (b) semi-worn tool ( $V_{BMAX} = 0.12$  mm,  $t = 15$  min).

Figs. 16–18 disclose the machined surfaces and subsurfaces alterations induced by machining under the conventional and cryogenic conditions when using new and worn tools along the cutting direction.

First of all, when focusing on the SEM metallographic observations of the machined surfaces obtained when cutting with new tools, all the cooling strategies have exhibited similar effect generating very thin affected zone. Indeed, very close to the free machined surface, a severe plastic deformation (SPD) could be observed in all cooling conditions. M'Saoubi et al. (2014) pointed out that very close to the free machined surface severe plastic deformation occurs when machining Inconel 718.

SEM observations obtained when machining employing semi-worn and worn tools highlight remarkable difference between surface damage induced when using new and several state of tool wear. As displayed in the previous figures, an appearance of deeper affected layer is clearly observed compared to the case of fresh tool. For instance, very close to the machined surfaces, more deformed grains are observed indicating a particular orientation along the cutting direction as reported in Sharman et al. (2015). Chen et al. (2016) extensively focused

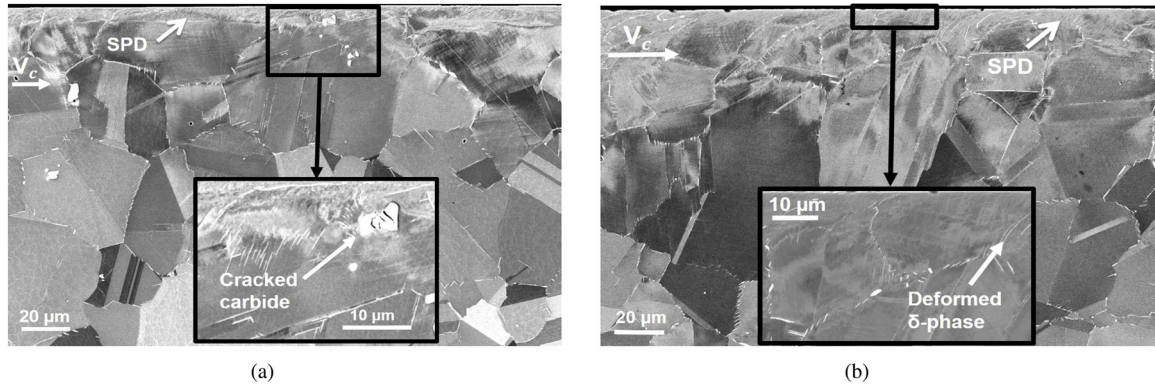
Fig. 17. SEM observations of the machined surfaces in LCO<sub>2</sub> condition using new and semi-worn tools: (a) new tool, (b) semi-worn tool ( $V_{BMAX} = 0.14$  mm,  $t = 15$  min).

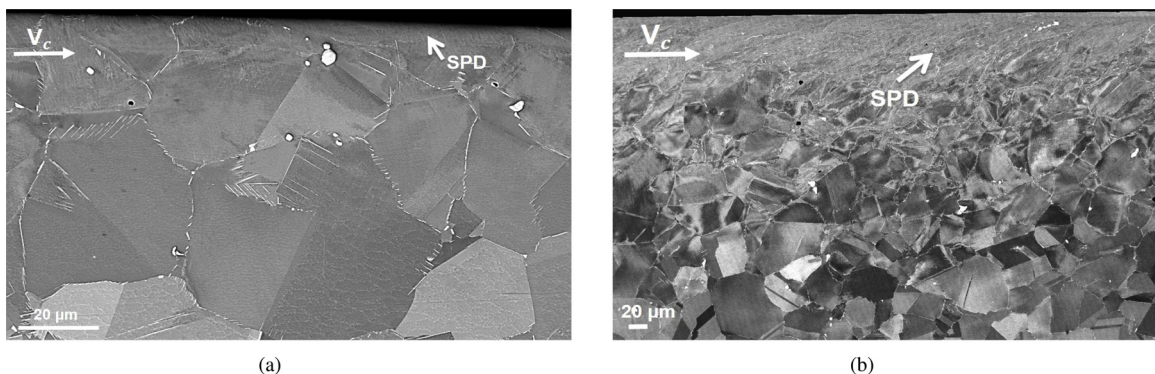
Fig. 18. SEM observations of the machined surfaces in LN<sub>2</sub> condition using new and worn tools: (a) new tool, (b) worn tool ( $V_{BMAX} = 0.35$  mm,  $t = 14$  min).

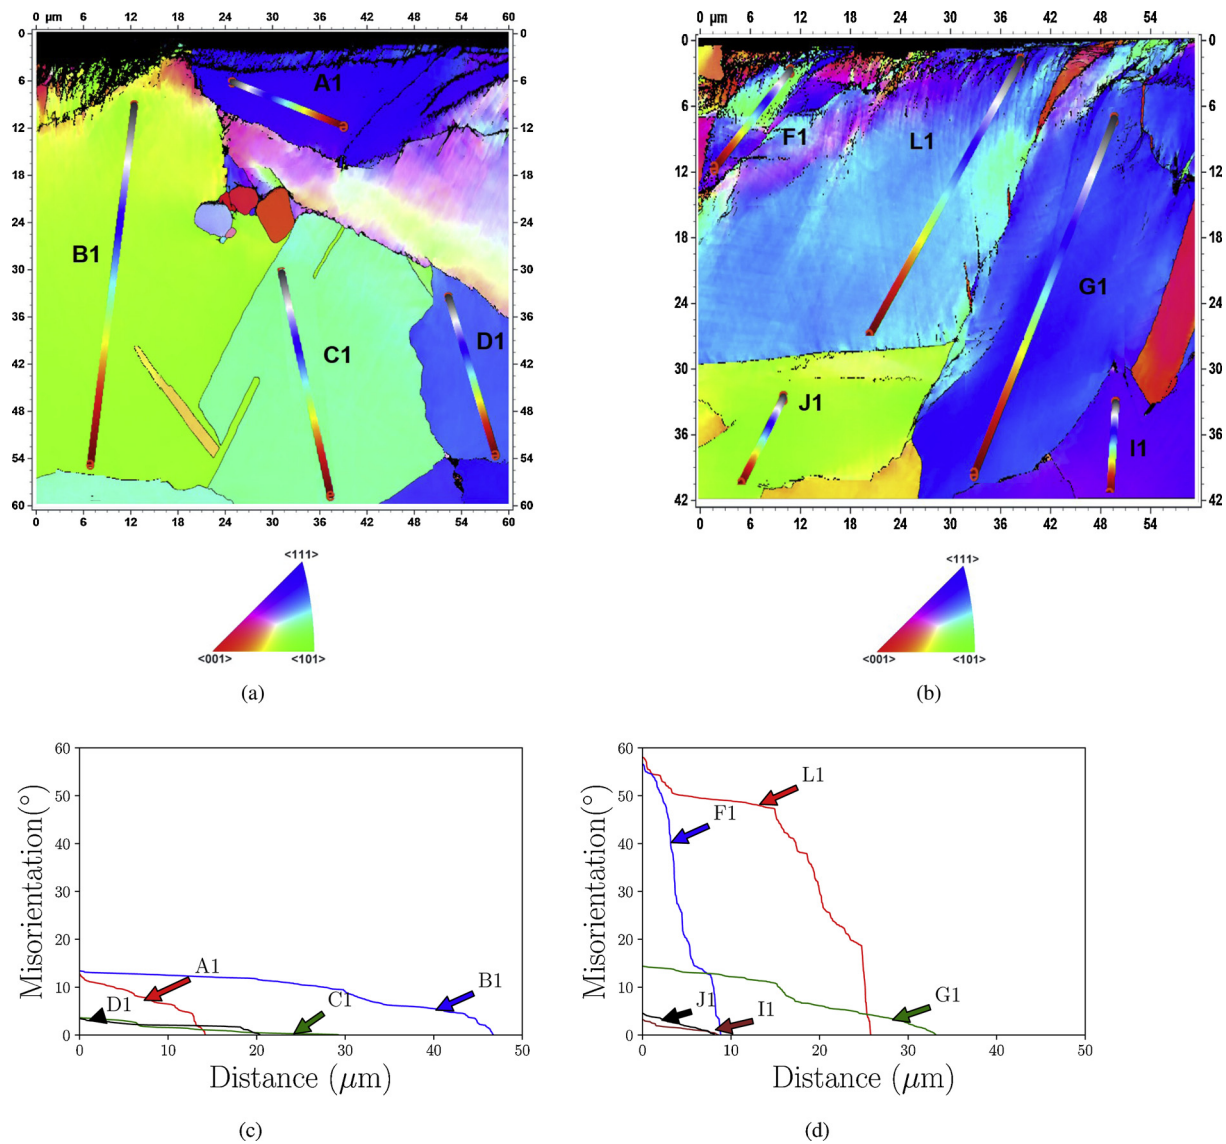
Fig. 19. EBSD maps of the machined surfaces (projection axis [001]) obtained in LCO<sub>2</sub> condition using new tool (a) and semi-worn tool (b); misorientation gradients measured inside deformed grains (in the direction as indicated by lines) in the case of: (c) new tool, (d) semi-worn tool.

In contrast, as for the grains located far away from the machined surface, the misorientation gradient inside the grains reduces significantly because of the decrease of the plastic deformation for instance along the lines I1 and J1. However, when focusing on these two lines, slight difference could be noticed concerning the misorientation gradients values. Although these two lines are located almost at the same depth from the machined surface, each grain was initially oriented differently and thereby the rate of plastic deformation may not be the same. In addition, an important aspect should be identified concerning the non-indexed zone that proves the severe plastic deformation occurring very close to the free machined surface.

Moreover, when focusing on the tool wear effect and thereby comparing between the profiles obtained using new and semi-worn tools, one could notice that the highest misorientation gradients inside the deformed grains is attributed to the case that reveals higher tool wear. As the tool wear increases, the cutting forces tend to increase notably and therefore plastic deformation increases as well (Pradhan

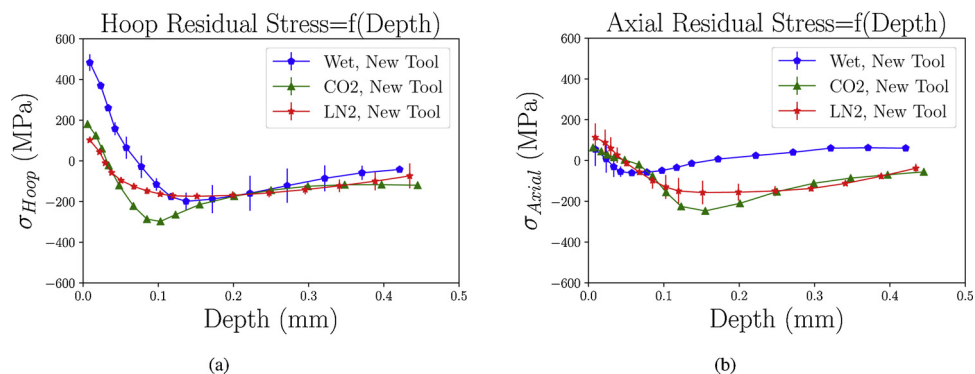
Fig. 21. Residual stress profiles near and beneath the machined surface using a new tool wet, LCO<sub>2</sub> and LN<sub>2</sub> cooling conditions measured along: (a) hoop direction (cutting direction); (b) axial direction (feed direction).

Additionally, conventional condition generated the largest tensile hoop stress layer reaching 100 μm below the machined surface and induced a compressive peak holding around -200 MPa. In contrast, LCO<sub>2</sub> cooling condition revealed the largest compressive depth initiating from 35 μm to more than 400 μm and provided the highest compressive peak reaching almost -300 MPa. Concerning the LN<sub>2</sub> condition, beneath the machined surface within 30 μm, hoop stress shifted to compressive values showing larger compressive depth compared to conventional condition. Overall, under cryogenic conditions, as the depth beneath the workpiece surface rose, the tensile hoop stresses rapidly dropped and quickly reached compressive levels before slowly returning to bulk values in the case of machining using new tools.

As for the axial stress profiles, results indicated very low tensile values near the surface that shifted gradually to compressive trend under wet and LN<sub>2</sub> cryogenic conditions. However, under LCO<sub>2</sub> cryogenic condition, residual stress in the feed direction induced more

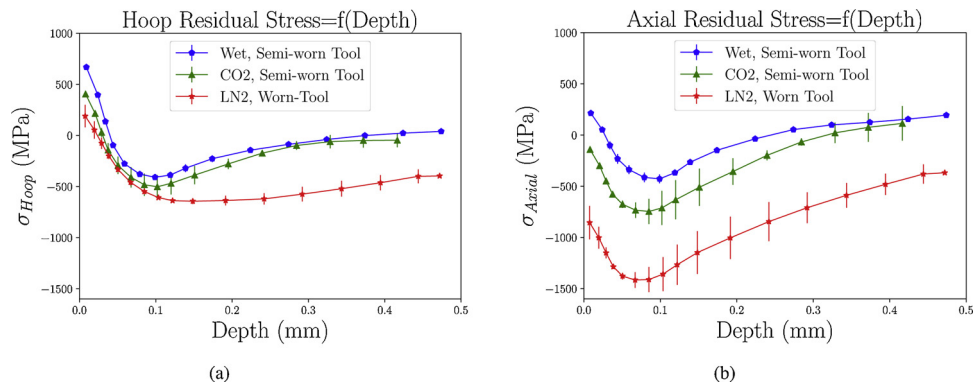
Fig. 22. Residual stresses profiles near and beneath the surface machined using semi-worn tools under conventional and LCO<sub>2</sub> cooling conditions and worn tool under LN<sub>2</sub> condition measured along: (a) hoop direction; (b) axial direction.

With regard to the LCO<sub>2</sub> cooling condition, as expected, near the surface, hoop residual stresses rose significantly reaching 405 MPa and then decreased gradually to compressive values at the depth of 50  $\mu\text{m}$  showing higher compressive peak around  $-468$  MPa in comparison with the values obtained in the case of using new tool. Alternatively, along the axial direction, residual stresses tended to be much more compressive from the first increment (10  $\mu\text{m}$ ) and penetrated to a deeper depth inducing greater compressive peak holding  $-746$  MPa compared to the result obtained when cutting with a new tool. Another aspect that should be noticed is that when comparing conventional and LCO<sub>2</sub> cooling conditions that exhibited the same tool wear state, results showed better residual stress distribution revealed in the case of LCO<sub>2</sub> strategy indicating the advantage of cryogenic approaches with respect to fatigue resistance.

Concerning the LN<sub>2</sub> cooling method, when examining the residual stress distribution near the surface, in the cutting direction, it is obvious that residual stresses were tensile. Nevertheless, they are surprisingly maintained almost at the same range when using a new tool holding 189 MPa versus 102 MPa respectively. Consequently, one is interested to mention that when machining with severe tool wear, it is well known that temperatures rise drastically near the surface due to the increase of friction contact area between tool flank face and the workpiece. However, LN<sub>2</sub> cryogenic condition that reveals the highest tool wear level induces lower tensile residual stresses along the cutting direction compared to conventional and LCO<sub>2</sub> cooling conditions. In the other hand, along the feed direction, very close to the surface, stresses are much more compressive shifting from 113 MPa to  $-855$  MPa when the

tool wear has evolved dramatically. In addition, the maximum compressive value indicates much higher value than the yield stress about  $-1415$  MPa due to severe hardening. In this context, Peng-Lin et al. (2013) reported that the maximum compressive residual stress and its depth penetration rise drastically when worn tools are used due to essentially the significant growth of cutting forces. Indeed, as it was mentioned in Section 3.2, machining forces evolved dramatically when tool wear has increased, especially the passive forces. Thereby, the residual stresses developed in the workpiece after machining are strongly affected by the increase in cutting forces.
