Comparison between cryogenic coolants effect on tool wear and surface integrity in finishing turning of Inconel 718

Sana Chaabani, Pedro José Arrazola, Yessine Ayed, Aitor Madariaga, Albert Tidu, Guénaël Germain

Sana Chaabani, Pedro José Arrazola, Yessine Ayed, Aitor Madariaga, Albert Tidu, et al.. Comparison between cryogenic coolants effect on tool wear and surface integrity in finishing turning of Inconel 718. *Journal of Materials Processing Technology*, 2020, 285, pp.116780. 10.1016/j.jmatprotec.2020.116780 . hal-02972763

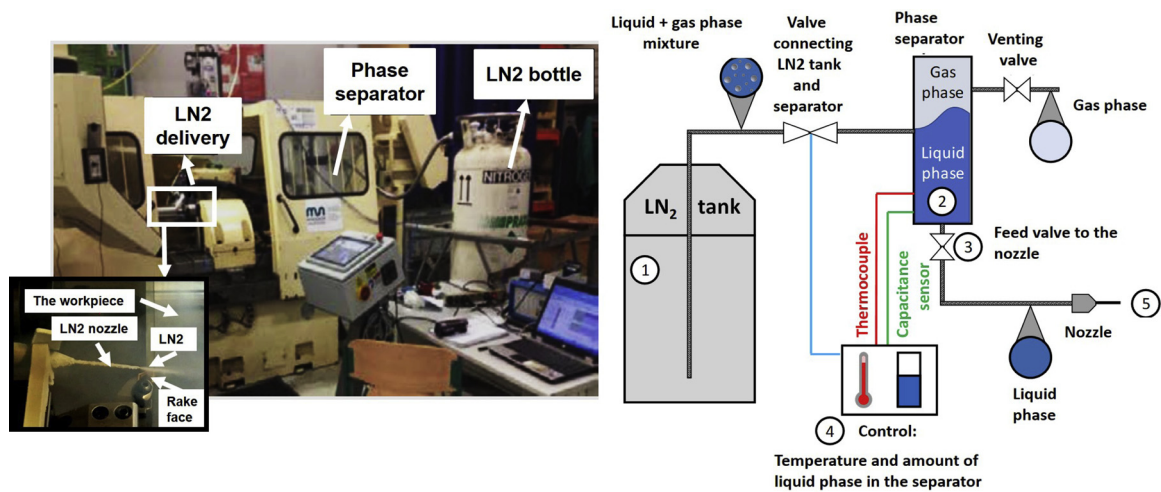
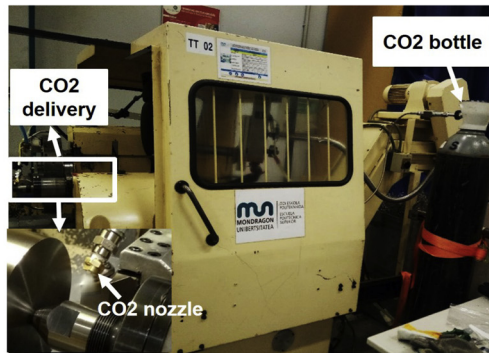
Fig. 2. Experimental set-up for the cryogenic tests: (a) LN₂ set-up; (b) LCO₂ set-up.

nitrogen bottle mounted on the CNC lathe (Fig. 2).

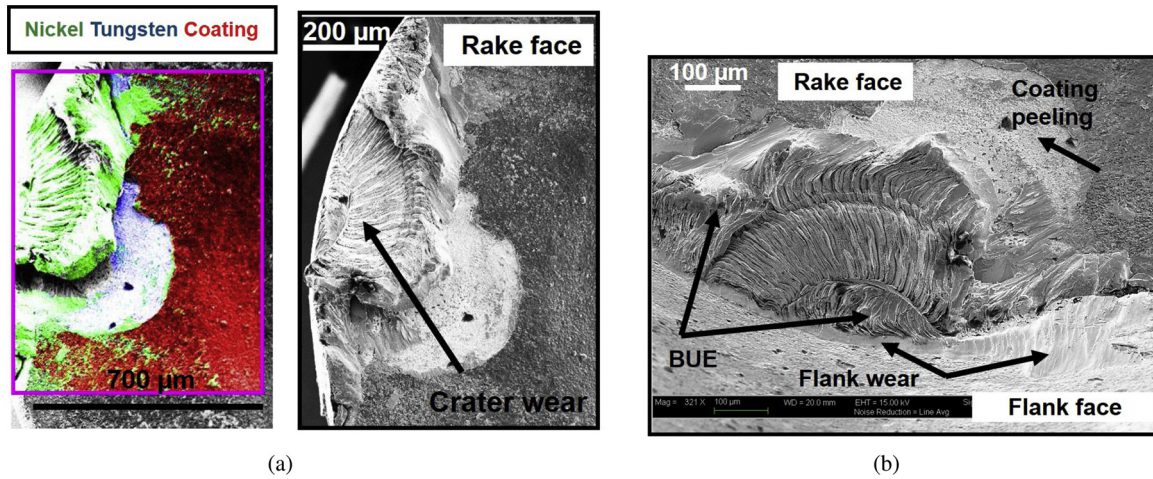
Fig. 8. SEM observations of the tool wear after 14 min of machining in LN₂ condition during Test 2: (a) rake face/EDS analysis; (b) flank face.

Concerning the LN₂ cooling conditions, tool wear mechanisms that have been detected through the SEM observations and the EDS analysis are not far from those obtained during the second test of LCO₂ lubrication. Indeed, during both LN₂ tests, the degradation of cutting tool is primarily caused by adhesion and micro-chipping as depicted in Figs. 7 and 8.

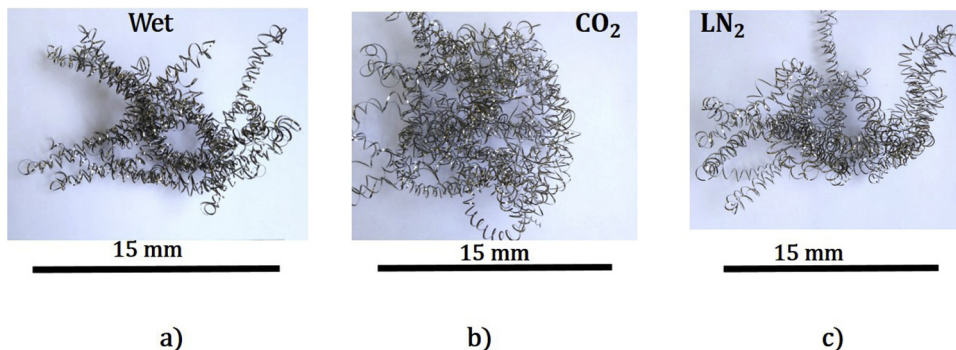
Fig. 9. Chip morphology obtained in the three cooling strategies: (a) wet, (b) CO₂ and (c) LN₂.

Another aspect should be stated consisting in that when delivering LN₂ cutting fluid on the tool rake face, it seems complicated to avoid cooling the unmachined workpiece. Consequently, the work material deformation behavior as well as the thermal properties could change by the cryogenic temperature (−196 °C). Thereby, the cutting process in this case turns out to be nonhomogeneous affecting the tool wear resistance. Moreover, when examining the chip morphology obtained under all cooling conditions, there is no significant difference; the chips exhibit almost the same morphology as depicted in Fig. 9.

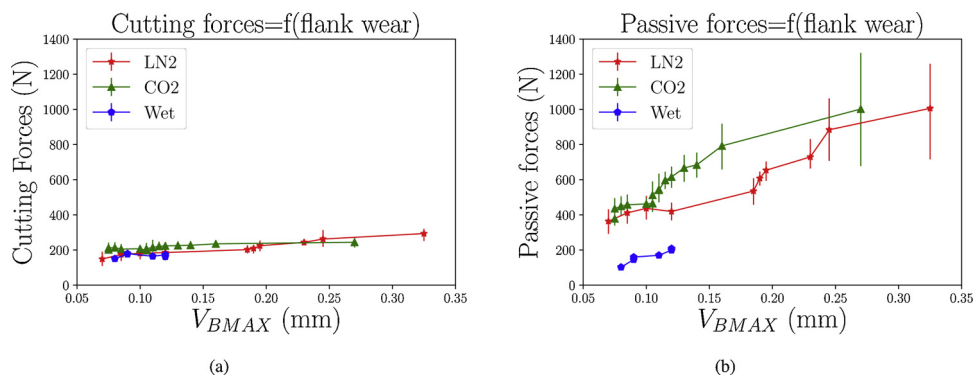
Fig. 11. Correlation between cutting forces components evolution and tool flank wear under Wet, LN₂ and LCO₂ conditions: (a) cutting forces, (b) passive forces.

addition, when comparing between the three components of the cutting forces regardless the lubrication strategy, one could recognize that the passive force measurements showed the highest values, mostly by the end of the machining process where the tool flank wear increased notably (Grzesik et al., 2018). In addition, when comparing between the different cooling methods, one could notice that passive force progress is slow and steady in conventional condition. Nevertheless, under cryogenic conditions, this parameter evolves drastically at the end of machining. This tendency is more pronounced under LN₂ cryogenic condition than under LCO₂ condition. This result may be attributed to the rapid tool flank wear progress in LN₂ cryogenic strategy mentioning that the passive forces are the most sensitive to tool flank wear as depicted in Fig. 11.

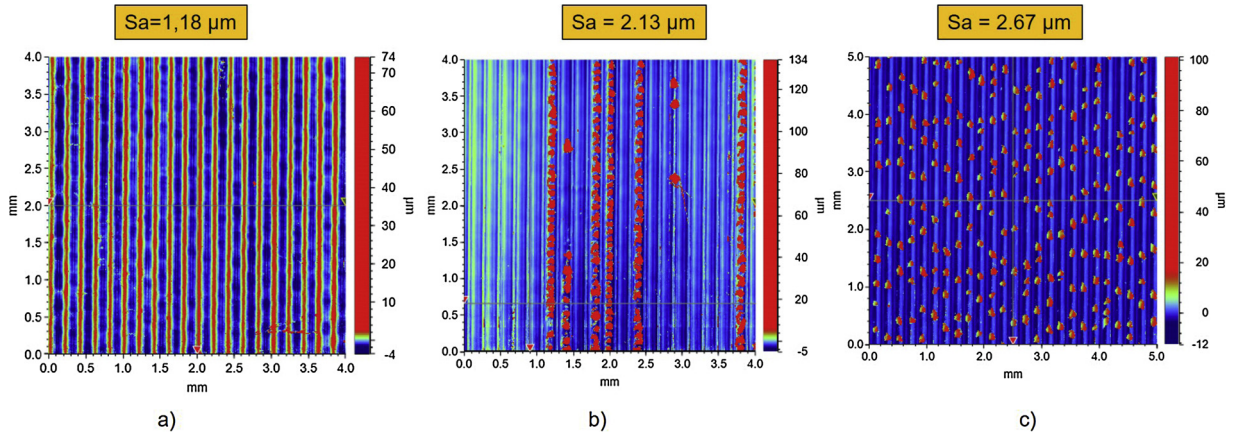
Fig. 13. Surface topography scanned using the Bruker profilometer after machining under LN₂ condition: (a) $t = 0.5$ min, (b) $t = 5.5$ min, (c) $t = 11$ min.

the profilometer in order to characterize the LN₂ surface finish measuring the average areal roughness S_a . Fig. 13 highlights the increase of S_a measured at different machining times. Indeed, the scanned surfaces reveal the presence of adhered particles on the machined workpiece surfaces that become more important as the machining time increases. This could be the main reason of the worst surface quality obtained in LN₂ cryogenic condition.

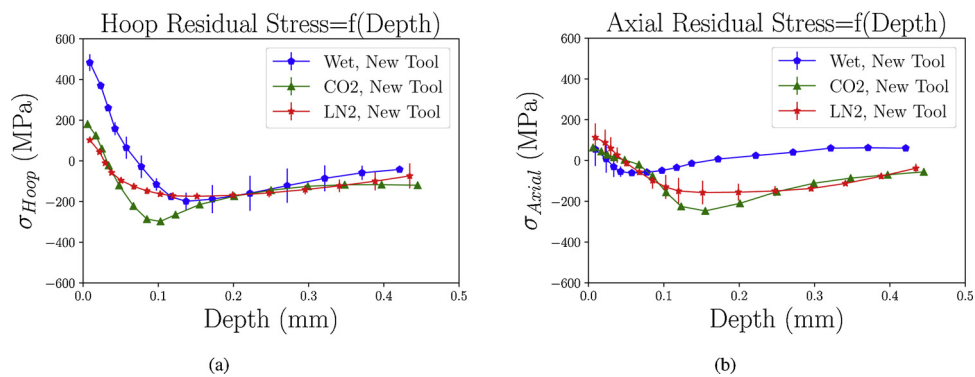
Fig. 21. Residual stress profiles near and beneath the machined surface using a new tool wet, LCO₂ and LN₂ cooling conditions measured along: (a) hoop direction (cutting direction); (b) axial direction (feed direction).

Additionally, conventional condition generated the largest tensile hoop stress layer reaching 100 μm below the machined surface and induced a compressive peak holding around -200 MPa. In contrast, LCO₂ cooling condition revealed the largest compressive depth initiating from 35 μm to more than 400 μm and provided the highest compressive peak reaching almost -300 MPa. Concerning the LN₂ condition, beneath the machined surface within 30 μm, hoop stress shifted to compressive values showing larger compressive depth compared to conventional condition. Overall, under cryogenic conditions, as the depth beneath the workpiece surface rose, the tensile hoop stresses rapidly dropped and quickly reached compressive levels before slowly returning to bulk values in the case of machining using new tools.

As for the axial stress profiles, results indicated very low tensile values near the surface that shifted gradually to compressive trend under wet and LN₂ cryogenic conditions. However, under LCO₂ cryogenic condition, residual stress in the feed direction induced more
