Comparison between cryogenic coolants effect on tool wear and surface integrity in finishing turning of Inconel 718

S. Chaabani^{a,b,*}, P.J. Arrazola^a, Y. Ayed^b, A. Madariaga^a, A. Tidu^c, G. Germain^b

A B S T R A C T

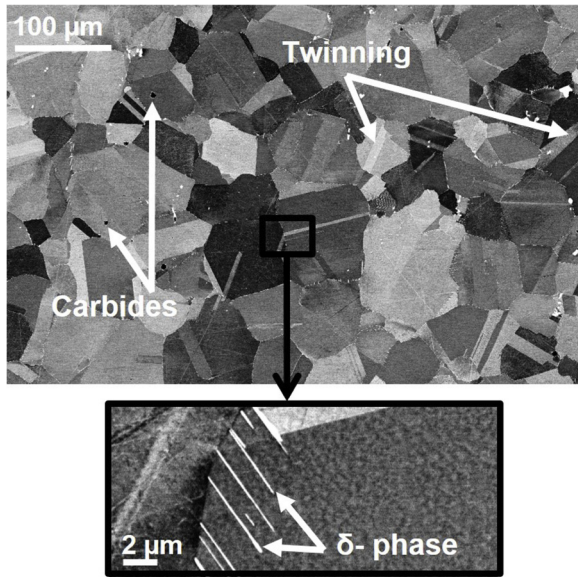
Fig. 1. Illustration of Inconel 718 microstructure in the as-received state observed by SEM technique.
