Surface performances of PVD ZrN coatings in biological environments

Chams Eddine Ramoul, Nasser Eddine Beliardouh, R. Bahi, Corinne Nouveau, Abdelghani Djahoudi, Michael J. Walock

Chams Eddine Ramoul, Nasser Eddine Beliardouh, R. Bahi, Corinne Nouveau, Abdelghani Djahoudi, et al.. Surface performances of PVD ZrN coatings in biological environments. Tribology - Materials, Surfaces & Interfaces, 2018, 13 (1), pp.12-19. 10.1080/17515831.2018.1553820 . hal-03066513

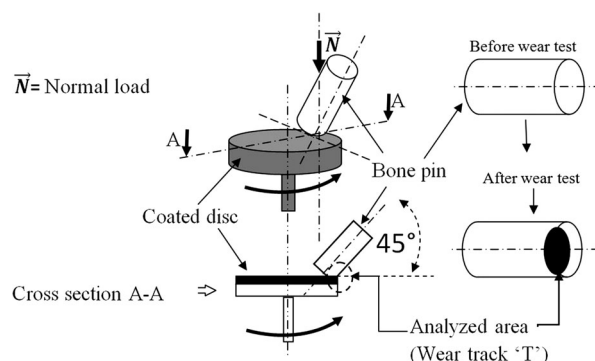
Figure 1. Schematic of the pin-on-disc tests.

When it is impossible to make a ball geometry, e.g. from organic matter of animal origin (bone, cartilage, etc.), the pin-on-disk configuration provided by [®]CSM Instrument tribometer is perfectly adapted for this case (Figure 1). The pin holder is positioned at 45°; this allows to make several tests with one pin. The tribological test parameters are listed in Table 2.

Figure 6 (a–d) shows micrographs of the bone pin wear scars. It appears that the edges of the bone pin (see Figure 1; *analyzed area (Wear track 'T')*) become larger after acting as counterparts against ZrN-coated discs. Wear scars also reveal deformation of the Haversian system, lacunae (crevasses indicated by white narrows), isolated wear particles (black narrows) and entrapped particles (ellipse). EDS analyses, carried out at different locations (isolated as well as entrapped

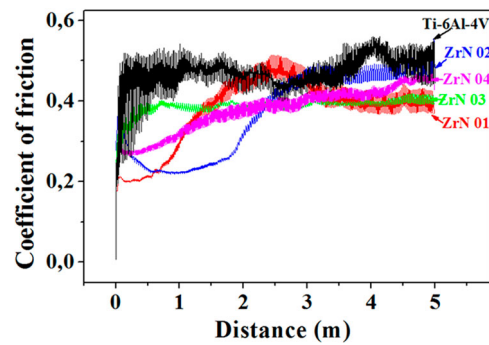
Figure 3. COF of the ZrN coatings sliding against bone counterparts.

Figure 3 shows the friction coefficient curves of the ZrN films sliding against bovine bone in dry conditions. It shows that the friction coefficients of the four coatings possess similar features, i.e. the friction curves of ZrN films are characterized by two different stages. The first stage represents run-in and ends with a rapid increase of the COF; the second stage was the steady state wear regime.

During dry sliding tests, the following scenario most probably occurs; at the beginning of the wear test, there is a severe material transfer between the coating and the pins, which leads to an increase of the COF. When the steady state is reached, the material transfer is slowly reduced and stabilized after a large percentage of the wear track area is covered with the transferred material. At the steady state, the highest COF value (~ 0.58) was observed for the ZrN-02 coating surface, whereas lower COF values (~ 0.38) were obtained for the other three ZrN coatings (Figure 3). Thus, the COF is fairly high. That is the disadvantage of hard ceramic coatings (ZrN), e.g. their brittleness and relatively high COF. The COF of the uncoated substrate at the

steady state was ~ 0.58 . From Figure 3, there is clear evidence that, after 3 m of sliding distance the coatings are destroyed.

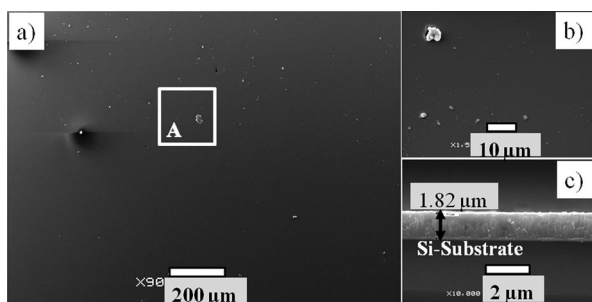
Figure 2. SEM images of the as-deposited ZrN-01 coating on Si substrate: (a) global view of the surface, (b) magnified image of the region enclosed by the white square (area A) and (c) cross-section image of the same sample.

Figure 2 shows SEM images of an as-deposited ZrN coating on a Si substrate. There are some sputtering defects, e.g. pits and droplets, as shown in Figure 2

(a–b). All films have an overall thickness of ~ 1.6 to $1.9 \mu\text{m}$ and exhibit a columnar structure, as shown in Figure 2(c). The surface roughness of the samples is shown in Table 2. No remarkable differences in roughness parameters (R_a , R_q) are observed. The ZrN-01 and ZrN-02 samples have a relatively low oxygen content in comparison to ZrN-03 and ZrN-04.

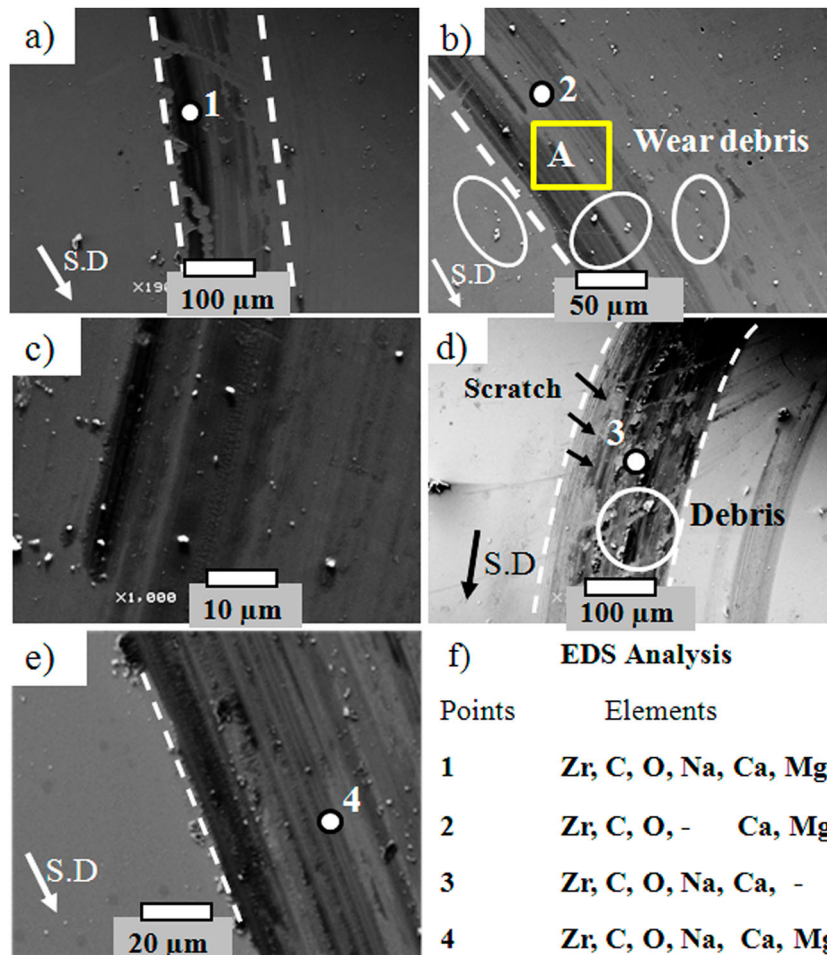
Figure 4. Wear mechanism of ZrN coatings: abrasion (scratches-grooves) and bone adhesion wear; (a) wear track of ZrN-01, (b) wear track of ZrN-02, (c) zoom of the square A, (d) wear track of ZrN-03, (e) wear track of ZrN-04 and (f) EDS analysis results at points 1, 2, 3, 4; (S.D – sliding direction).

Figure 4 shows the wear tracks of ZrN coatings on Ti-6Al-4V substrates tested against bone pins as counterparts in dry conditions. The primary wear mechanism appears to be abrasion, as shown in Figure 4(a–d). In addition to grooves and scratches parallel to sliding direction, wear debris accumulated in the wear tracks are also observed as deep furrows from trapped particles (Figure 4(c)). The elemental composition of some isolated particles, analysed by EDS, indicates the presence of both bone elements (Na, Mg, Ca, K, etc.) and coating elements (Zr and oxygen) in the adhered film (points 1, 2, 3, 4 in Figure 4(a–e)). So, the wear debris is a mixture of the antagonist pair components. From this, one can conclude that bone adhesion to the disc is the second wear mechanism observed in the ZrN/bone contact pair. SEM analysis also revealed some areas within the wear track where the coating did not appear to be damaged after the wear tests. No plastic deformation was detected in the wear tracks on any of the coatings.

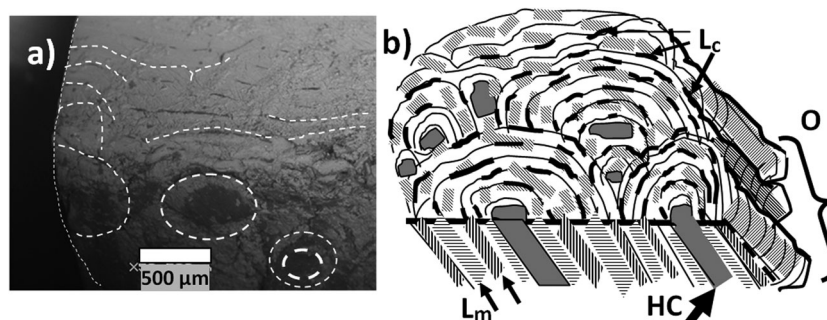
Figure 5. (a) SEM micrograph of a bone pin specimen. (b) A schematic diagram illustrating the macrostructure of cortical bone; O – Osteons (Haversian systems), L_m – concentric lamellae, HC – Haversian canal and L_c – lacunae.

systems or osteons. [6]. The macrostructure of the bone pin specimen (cortical bone) is shown in Figure 5.

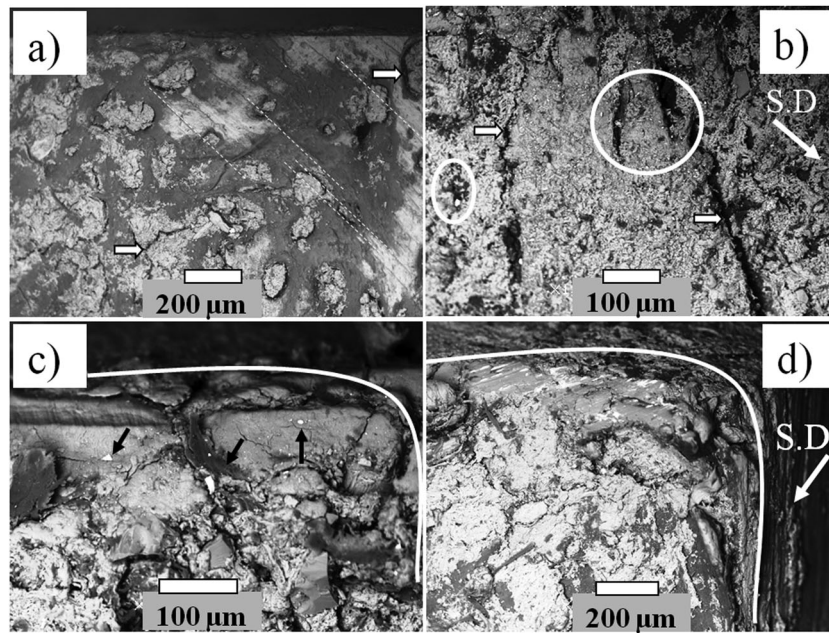
Figure 6. SEM images of wear scars of bone pins after pin-on-disc tests for: (a) ZrN-01, (b) ZrN-02, (c) ZrN-03 and (d) ZrN-04 (dash lines indicate scratch marks, SD – sliding direction).

particles) within the wear scars, indicate that a mixture of both the antagonist elements in contact was found. Abrasive wear is the only wear mechanism observed on the bone pins.

When sliding against ZrN-coated discs, segments of the bone pins were initially scraped off by surface asperities along the wear track. This is due to the large difference in mechanical properties between the antagonists in contact. A literature study reveals the average hardness (H) and elastic modulus (E) of cortical bovine bone obtained from nanoindentation in

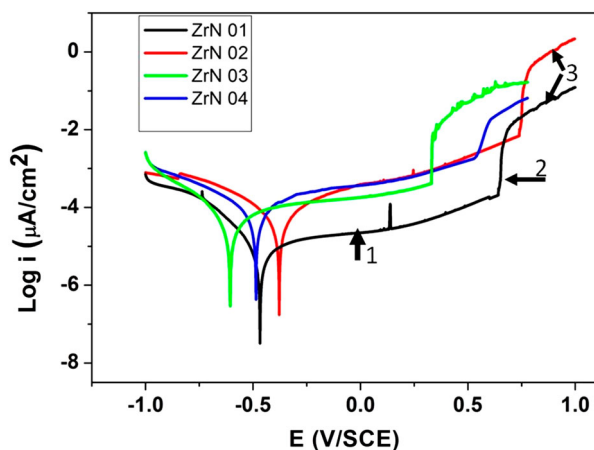
Figure 7. Potentiodynamic polarization curves of ZrN coatings in physiological liquid solution.

Figure 7(a) shows the potentiodynamic polarization curves (plots of potential vs. log current density) of the ZrN coatings exposed to the PS for 2 h. All specimens form an anodic domain (labelled '1'), which corresponds to the formation of a self-passivating (Zr, N,

O) film after being soaked for a period of time. The size of this domain is indicative of the durability of the self-passivating film and the corrosion resistance of each coating. For example, the anodic plateau remained flat from -0.4 up to $+0.65$ V in the case of ZrN-01. The rupture of the passive film occurs in the trans-passivation domain (labelled '2'). In this domain, the current density abruptly increases as the materials start to corrode (labelled '3'). The polarization resistance (R_p) of Tafel curves, which takes into consideration both the corrosion current density and the slopes of polarization curves, can provide a quantitative ranking of coatings resistance to corrosion and can be estimated using the well-known Stern–Geary equation.

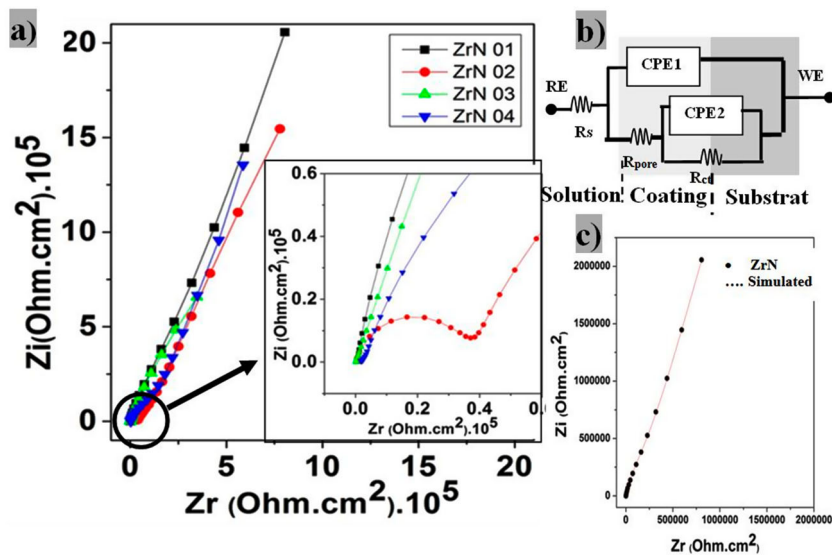
Figure 8. Electrochemical test results (EIS): (a) Nyquist plots of tested specimen in physiological liquid solution, (b) equivalent circuit model and (c) example of fitting curve (WE = working electrode and RE = reference electrode).

Each sample's impedance was measured after 1 h of immersion in the PS. Nyquist plots of the real and imaginary parts of the impedance are shown in Figure 8(a). The plots show that all tested samples are characterized by two capacitive loops in the high and medium

frequency range. By comparing the diameters of the loops in the Nyquist plot, the sample's corrosion properties can be easily evaluated. Larger diameter loops equate to higher corrosion resistance. This analysis supports the previous conclusion: ZrN-01 has the best corrosion resistance of the four tested samples. An equivalent circuit (EC) model, which is shown in Figure 8(b), was selected for quantitative studies. This EC is extensively used in similar situations [9]. Figure 8(c) shows good agreement between the experimental and modelled values. The fitted line was plotted as a dashed line. The fitting errors for each configuration in this study were less than 9%.

In the selected equivalent circuit, R_s represents the electrolyte resistance. The Constant Phase Elements, CPE1 and CPE2, are the double layer capacitance and the coating capacitance respectively. R_{ct} is the charge transfer resistance and R_{pore} represents the pore resistance (and other fails of coating).

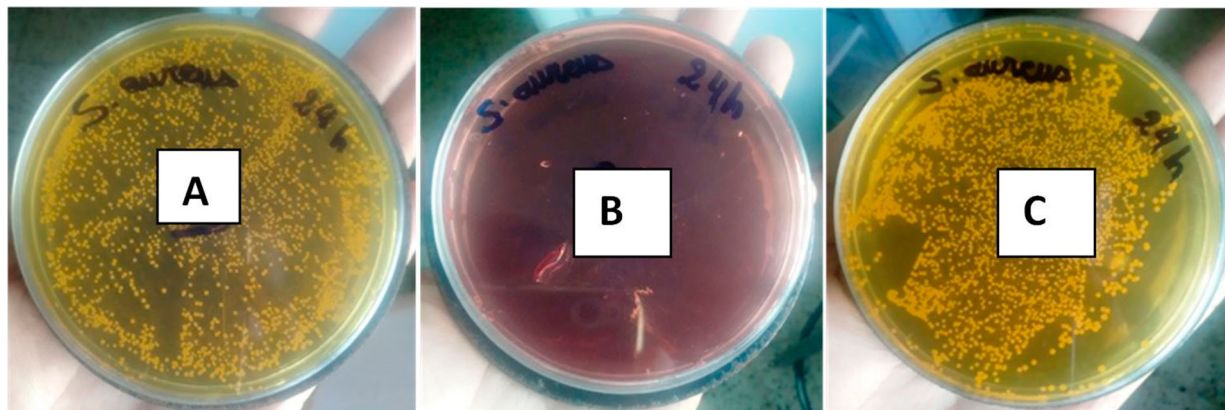
**Figure 9.** *Staphylococcus aureus* colonies grown in sterilized Petri dishes of: (a) specimen A, (b) specimen B and (c) specimen C.

After incubation, the *S. aureus* colonies are clearly visible (Figure 9) and were easily counted. The results indicate that *S. aureus* bacteria were completely killed in specimen B, while the surviving bacterial colonies are 3.2×10^5 (CFU/ml) for specimen A and 5.2×10^5 (CFU/ml) for specimen C. Specimen B and Specimen C have approximately similar surface parameters (i.e. roughness, morphology, etc.) but there is a noticeable difference in the oxygen content of the samples. So, surface morphology effects cannot explain the difference in the biocidal effect of these two specimens (B and C). In addition, it has been reported that a surface roughness $<0.2 \mu\text{m}$ may not affect bacterial adhesion because most bacteria are $>0.2 \mu\text{m}$ [12].
