Jean Geringer, Vincent Fridrici, Haohao Ding, Kyungmok Kim, T. Taylor, Lerato Semetse, Sara Ehsani-Majd, Peter Olubambi, Julien Fontaine, Philippe Kapsa

Article

Some Hard or Soft Coatings to Protect the Pristine Biometallic Substrates under Fretting-Corrosion Solicitations: What Should Be the Best Solution?

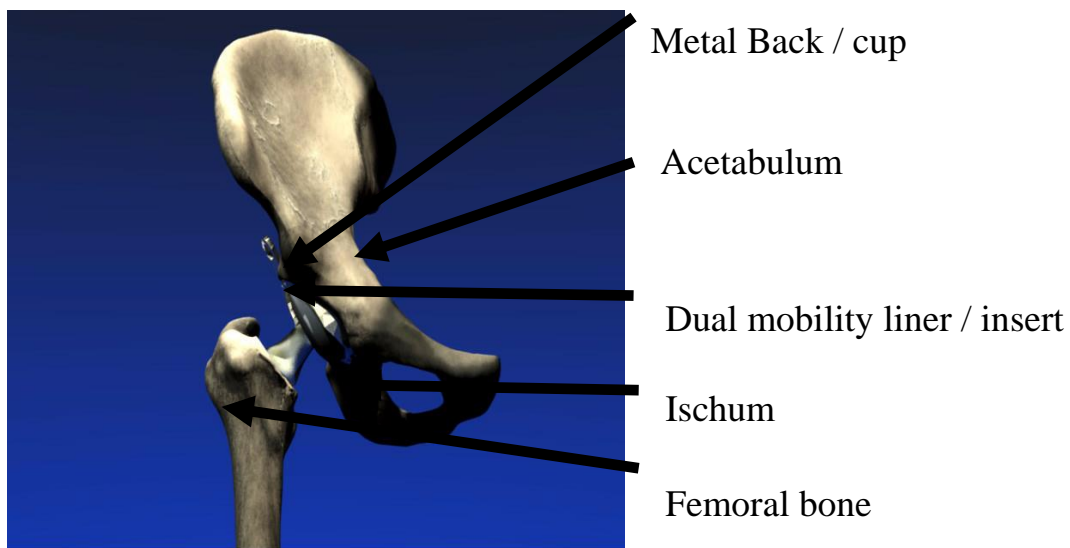
Figure 1. Total hip joint, schematic view, dual mobility.

Hip joint, Figure 1, is one of the most practiced surgical operations, i.e., 160,000 total hip arthroplasty (THA) operations in France (order of magnitude coming from [1]). All over the world, there are more like than 1.5 million every year.

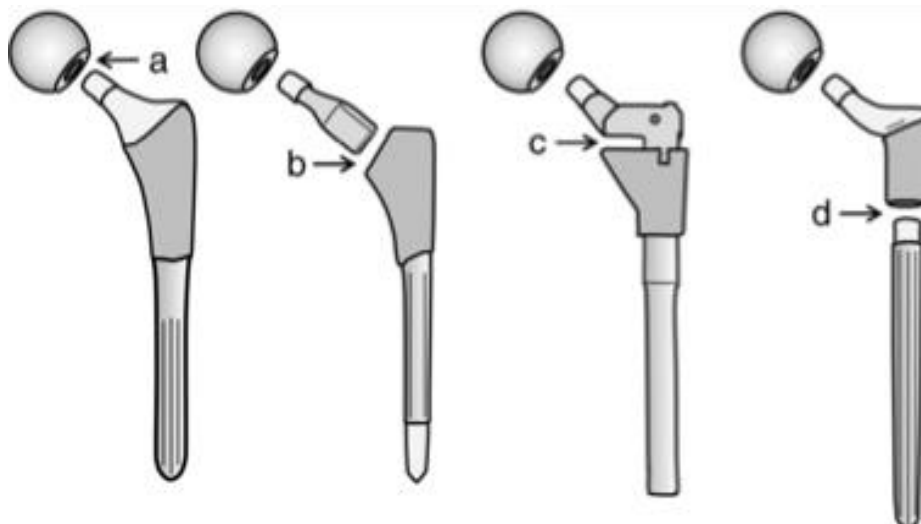
Figure 2. (a) Usual femoral component as hip joint; (b) modular hip joint as adapting the size; (c) modular hip joint as adapting the angle of the femoral neck; (d) modular hip joint as adapting the stem length [2].

As shown in Figure 2, one may notice the metallic junction that is occurring on every implant. During the human gait, some alternative loadings will be imposed on every metallic junction. By having a look at the ISO 14242 standard and the ASTM F1714 [3,4], the load amplitude should reach from 300N to 5000N. Every metallic junction does not match disassembling, except the positioning issue; however, some small relative displacements will occur on every metallic junction, i.e., few dozens of microns. Moreover, total hip joints are immersed among physiological liquid protein solutions. First, one may imagine some metals involved in a metallic junction. The mechanical properties are quite different, 115 GPa concerning the Ti-6Al-4V and 200 GPa concerning the 316L stainless steel or the Co-Cr-Mo, between materials in contact. Under applied stress, the deformation should be different and the friction/fretting (friction under small displacements) should take place. Second, even if the material is quite the same, Ti-6Al-4V concerning femoral stem, the junction roughness, S_a value, will vary from 1650 nm to 2250 nm \pm 30 nm [5]. On some surface peaks (small contact area), the contact stress may also reach some GPa. Due to metal plasticity the mechanical properties on the top surface should be different from the ones related to the bulk material. Under applied stresses some micro relative displacements may also occur. This last phenomenon is not predominant through

With the modular junctions related to Ti-6Al-4V/Ti-6Al-4V, shown in Figure 2d, the expected coatings should be a benefit according to avoiding some fretting corrosion degradations. The fretting corrosion experiments were investigated for 16 h in bovine serum solution in order to mimic the physiological liquid. The protein concentrations respected the ISO 14242 [4], i.e., $30 \text{ g}\cdot\text{L}^{-1}$. First of all, some interesting behavior about Ti-6Al-4V/Ti-6Al-4V contact will be presented (sometimes stick sometimes slip). Second some DLC coating effects will be described and commented according to Ti-6Al-4V/Ti-6Al-4V behavior. Third some comparisons with PEEK coatings will be investigated.

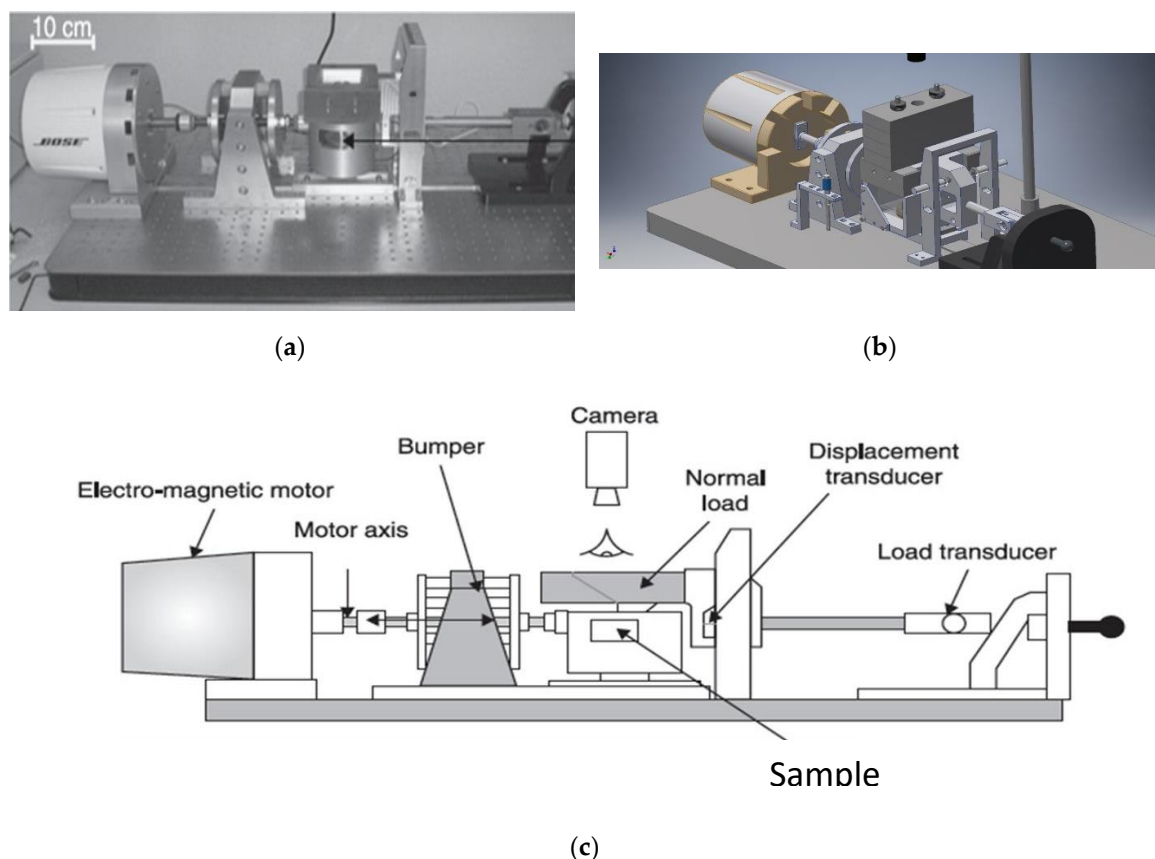
Figure 3. (a) The fretting corrosion machine; (b) schematic view, right side; (c) fretting corrosion machine with legends.

The Figure 3 is showing the fretting corrosion machine (TA instruments Inc, New Castle, De, USA) and some elements around. The motor is electromagnetic, ex. Bose™ TAinstruments™. The displacement transducer capacity is maximum $\pm 400 \mu\text{m}$.

The Figure 3a,b are representing the global overview of the device. The Figure 3c is showing a scheme with legends. The bumper is a key element in order to accommodate the relative displacement during the friction process, i.e., few microns. The fixed sinusoidal displacement amplitude is $\pm 40 \mu\text{m}$ during the whole campaign dedicated to this survey. The normal load is driven through the contact

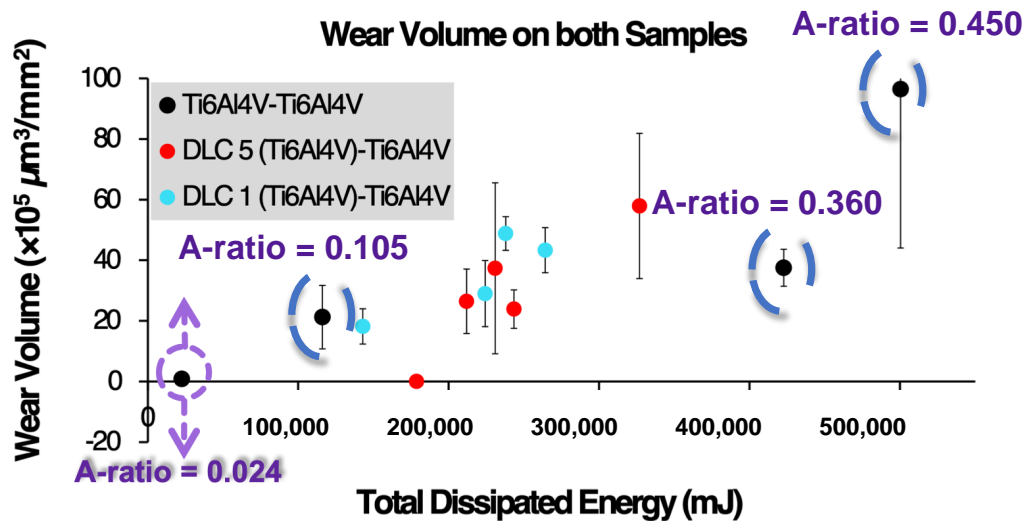
Figure 4. Evolution of the total wear volume ($10^5 \mu\text{m}^3/\text{mm}^2$), both samples in contact, according to the total dissipated energy (mJ).

Before studying the coating impact on Ti-6Al-4V, one paid attention on the pristine contact Ti-6Al-4V/Ti-6Al-4V. Under fretting corrosion in bovine serum solution during 16 h, the curve wear volume vs. dissipated energy provided both behavior tendencies. The Figure 4 is highlighting the total wear volume, i.e., the cylindrical sample wear volume (Ti-6Al-4V) and the flat sample wear volume (Ti-6Al-4V and Ti-6Al-4V + diamond-like carbon coating), according to the total dissipated energy. The area of the cycle tangential load vs. displacement means the dissipated energy. Every second, 1Hz of frequency, is corresponding to an amount of dissipated energy. By adding every energy through 57,600s, i.e., 16 h, the total dissipated energy was obtained. The black dots correspond to Ti-6Al-4V/Ti-6Al-4V contact. It is worth noting that the mechanical contact conditions are exactly the same between the four highlighted dots on the graph. The electrochemical conditions are quite similar, open circuit potential (OCP) conditions and solution composition. We are going first to focus on Ti-6Al-4V/Ti-6Al-4V contact. First of all, the physical fact that the wear volume increase is linear, according to the total dissipated energy, is highlighted in Figure 4. The tremendous evolution is related

to a drastically different trend. First, it is worth noting that A ratio is defined as dissipated energy (area of the tangential load vs. displacement / parralelogram) over the total energy (area of the rectangle max-min tangential load multiplied by min-max displacement). Both behaviors, corresponding to the lowest and the highest dissipated energies, show that behind the pseudo linear evolution, i.e., wear volume vs. total dissipated energy, a material issue is occurring.

Figure 7 is representing the A ratio evolution vs. duration of the experiment. Higher than 0.2, it is corresponding to 0.36 and 0.45 experiments on the Figure 4, gross slip regime.

Based on Figure 4, two DLC coatings were tested. The red and blue dots corresponded to the ongoing contact study. The first point is related to the dot with a dissipated energy lower than 20,000 mJ which has a wear volume of 0. It was not related to a measurement; it was due to the discrepancy. From the experimental protocol the wear volume measurements were not achieved by giving actual data. This matter of fact is due to adhesion. It was happening one time over five with DLC 5 coating. The wear volume vs. dissipated energy cloud is located in the same area. The results make sense and the relative straight-line growth is in accordance with other DLC coatings on Ti-6Al-4V vs. Ti-6Al-4V in dry conditions with multiple normal stresses [35–38].

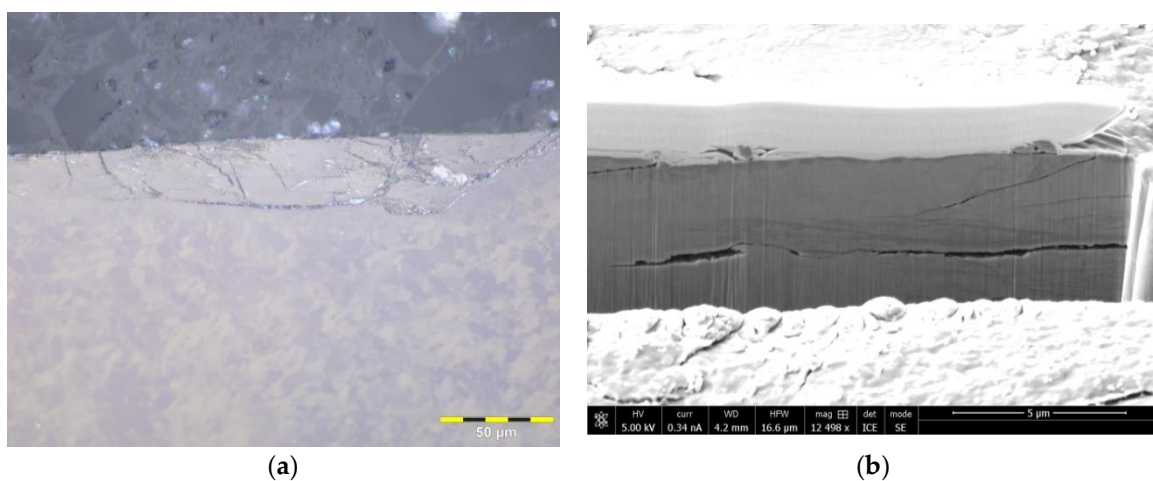
Figure 5. Ti-6Al-4V: (a) cross section image of the wear track area of the $A = 0.024$ sample, smooth polishing technique; (b) focused ion beam (FIB) cross section of the same wear track area.

The Figure 5 is showing the cross section, partially, of the flat sample corresponding to the $A = 0.024$ case. The Figure 5a is corresponding to a cross section corresponding to the wear track area. It is worth noting that the sub surface cracks are particularly prominent. The stick behavior enhanced some crack formations from the top surface until the maximum of the contact stresses was reached. From contact mechanics [34], the maximum contact pressure is located under the contact surface. Figure 5b highlights a crack, $2 \mu\text{m}$ under the surface level, that dissipated the energy through a parallel orientation compared to the surface. It is more difficult to go from the top of the bulk material than to propagate in parallel with the material surface when considering a crack. About the case of $A = 0.105$, the stick behavior was promoted. It is worth noting that all mechanical data are consistent with the metallographical observations, Figure 5.

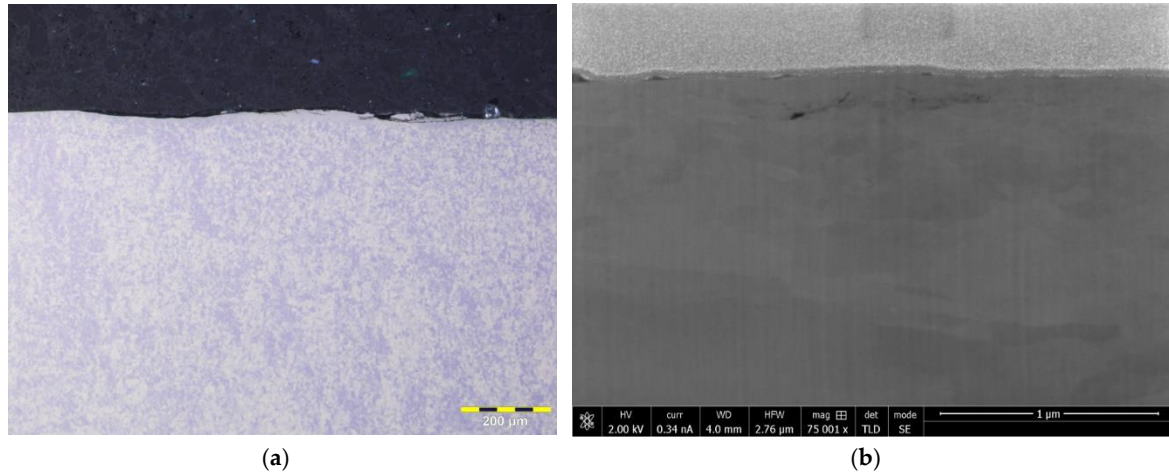
Figure 6. Ti-6Al-4V; (a) cross section image of the wear track area of the $A = 0.36$ sample, smooth polishing technique; (b) FIB cross section of the same wear track area.

Concerning other experimental data, high wear volume-high total dissipated energy, the metallographical data are consistent with gross slip regime. A ratio is higher than 0.2. Moreover, Figure 6 is highlighting no crack on the subsurface of the material. Some wear debris are visible on the top surface without generating any crack.

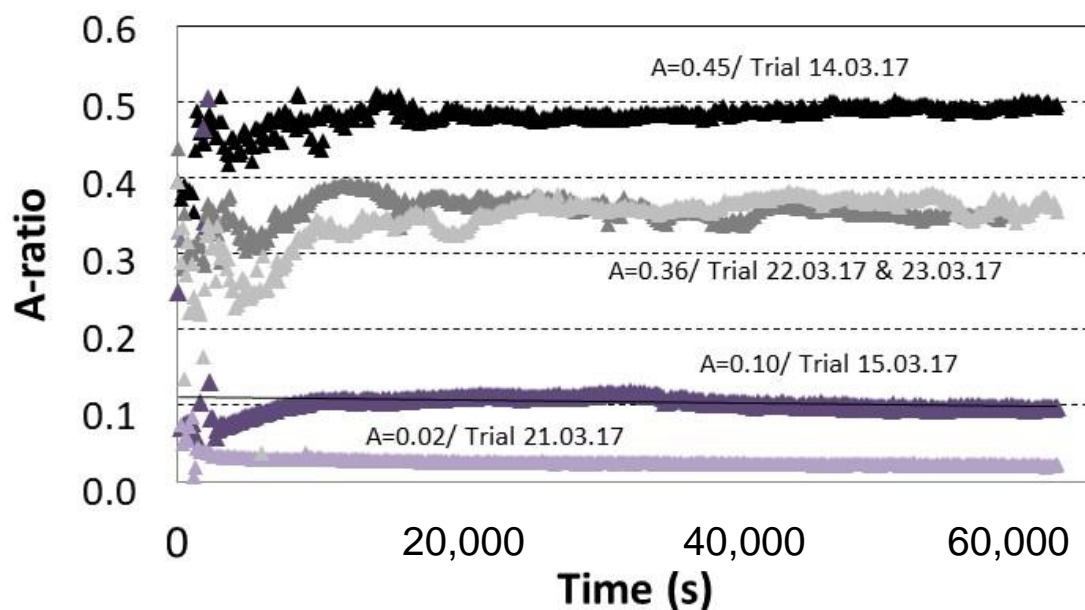
Figure 7. A ratio vs. time concerning Ti-6Al-4V/Ti-6Al-4V contact. A: E_d/E_{tot} ; E_d : dissipated energy, E_{tot} : total energy, reciprocal displacement between materials in contact.

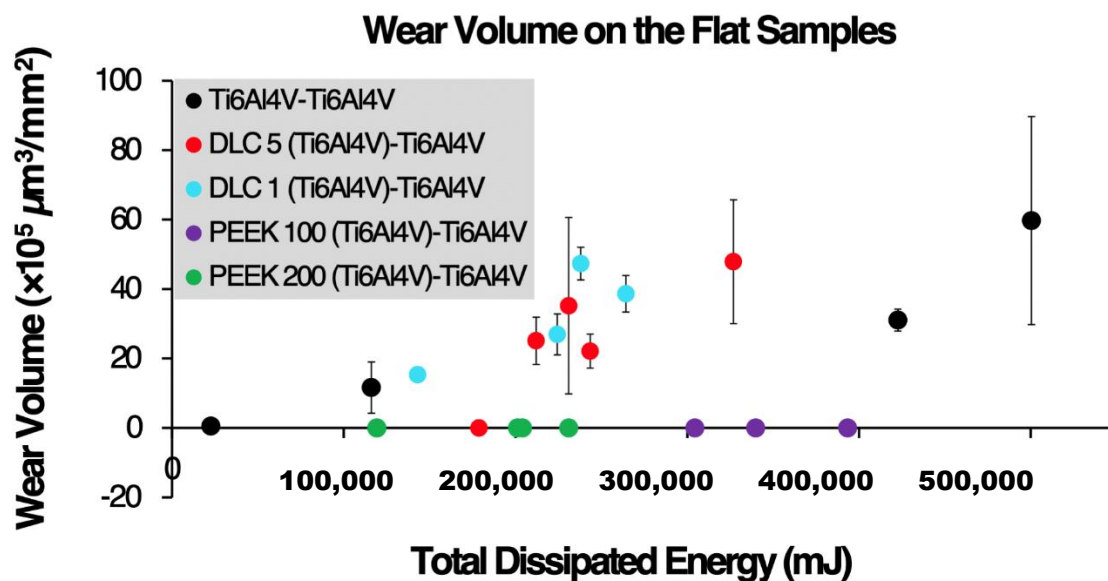
Figure 8. Evolution of the total wear volume ($10^5 \mu\text{m}^3/\text{mm}^2$), Ti-6Al-4V + coatings, according to the total dissipated energy (mJ). Polyetheretherketone (PEEK) xxx coating is representing roughly the thickness of the PEEK coating.

The Figure 8 is highlighting the wear volume vs. the total dissipated energy concerning the flat sample, i.e., Ti-6Al-4V + coating. The coating should be DLC, i.e., diamond-like carbon, and PEEK, polyetheretherketone.

It is worth noting that wear volume measurement was not possible on the coating of PEEK. The wear phenomenon is not the physical phenomenon that is relevant concerning the key point of friction. Through the experimental conditions the competition between adhesion and relaxation processes is occurring, i.e., Ti-6Al-4V/PEEK contact. No experimental wear volume is measurable on PEEK coating. Inside part 3 the Schallamach waves were evoked. The difference of elastic moduli between materials in contact was between 100 and 1000 ($E_{\text{Rubber}} = 1\text{--}0.01 \text{ GPa}$ and $E_{\text{Glass}} = 70 \text{ GPa}$ [39]); some Schallamach waves are generated and this physical phenomenon is well described [26,40]. In our case $E_{\text{PEEK}} = 4 \text{ GPa}$ and $E_{\text{Ti-6Al-4V}} = 115 \text{ GPa}$, roughly a ratio of 30 is exhibited. The ratio value between

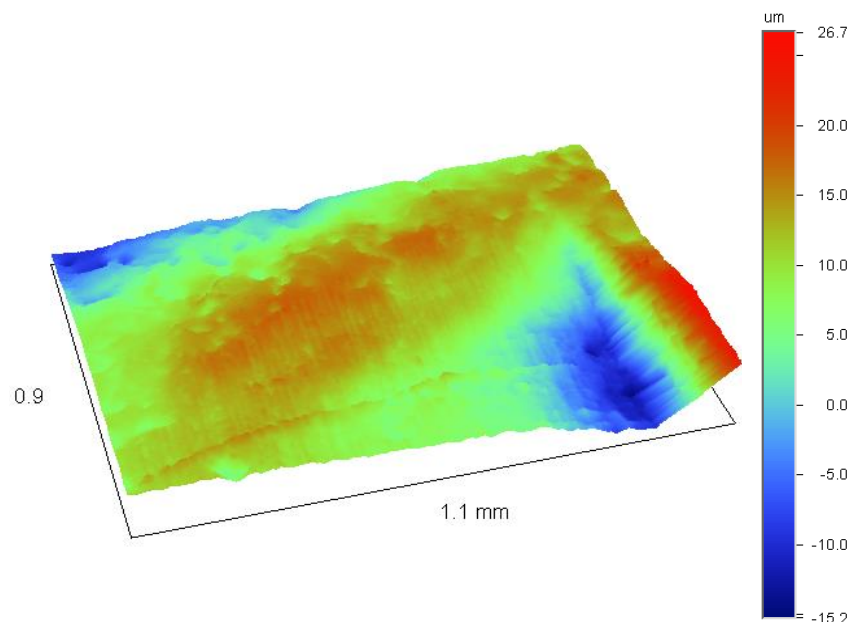
Figure 9. PEEK 200 on Ti-6Al-4V after 16 h of fretting corrosion in bovine serum, inside the wear track area.

The Figure 9 shows the surface of PEEK 200 on Ti-6Al-4V after 16 h of fretting corrosion against Ti-6Al-4V in bovine serum. Some waviness appears on huge valleys ($-15 \mu\text{m}$) and huge mountains ($+26 \mu\text{m}$). The initial roughness was about $0.5 \mu\text{m}$. That is the reason the authors suggest that measuring wear, i.e., issued from debris, is not feasible. No debris were highlighted after the experiment on the top surface of every material in contact.

The PEEK material is deformed but no wear is visible and measurable on this face and on the Ti-6Al-4V. In order to assess this experimental fact, one might have a look at the evolution of Open

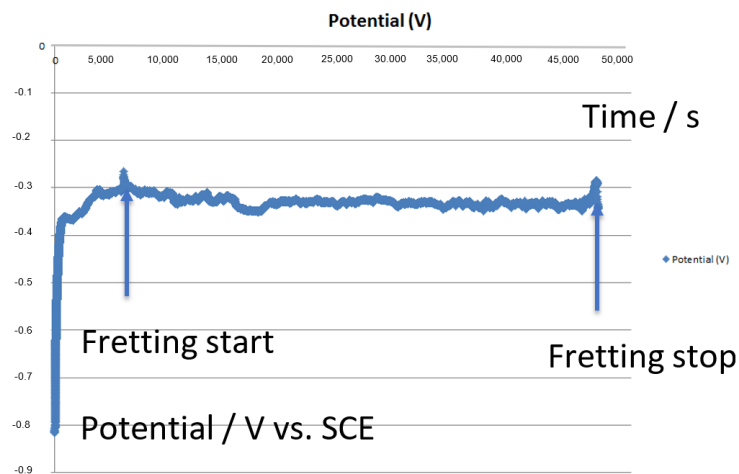
Figure 10. Open Circuit Potential vs. Standard Calomel Electrode (SCE) of the PEEK 200 on Ti-6Al-4V and Ti-6Al-4V assembly. A wire connection is fixed between both materials involved in the contact.

Circuit Potential vs. the Standard Calomel Electrode as a reference electrode. Figure 10 is showing the OCP evolution concerning one test PEEK 200 μm on Ti-6Al-4V against Ti-6Al-4V.

At the fretting start, it is worth noting that no OCP decrease is occurring, arrow fretting starts on the graph of Figure 10. Usually, as reported in [43,44], the OCP decreases according to the time when some friction occurs between materials solicited under friction conditions (Figure 11). Destroying the oxides layer involves 'naked' metal in contact with solution. Thus, the corrosion and dissolution of metal, was ongoing. However, from Figure 10, because the OCP is not decreasing according to the time, it means that the oxide layer is not destroyed during the fretting phase.

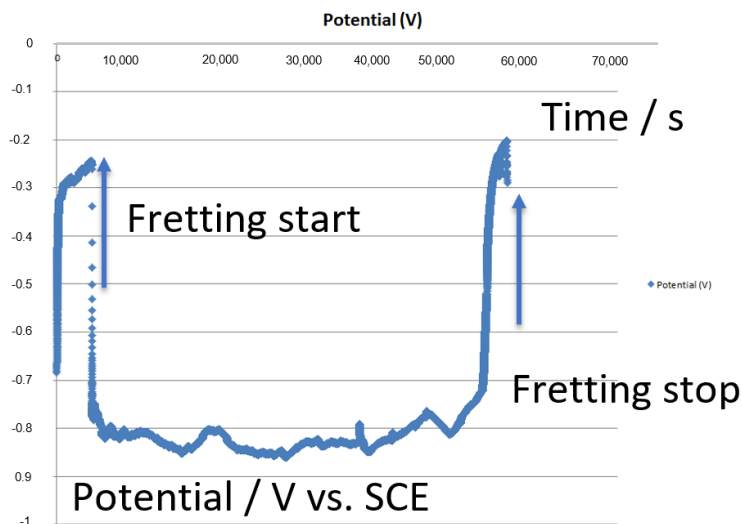
Figure 11. Open Circuit Potential vs. SCE of the Ti-6Al-4V and Ti-6Al-4V assembly. A wire connection is fixed between both materials involved in the contact.

The Figure 11 is highlighting the usual OCP evolution when some friction and/or fretting is occurring between metallic materials. The OCP drop is characterized as 600 mV. The major benefits of the PEEK coatings are the lack of mechanical and corrosive wear.
