## Integrated methods for reconstructing the decoration and production process of the frigidarium wall-paintings, at the Sarno Baths, Pompeii

Integrated methods for reconstructing the decoration and production process of the *frigidarium* wall-paintings, at the Sarno Baths, Pompeii

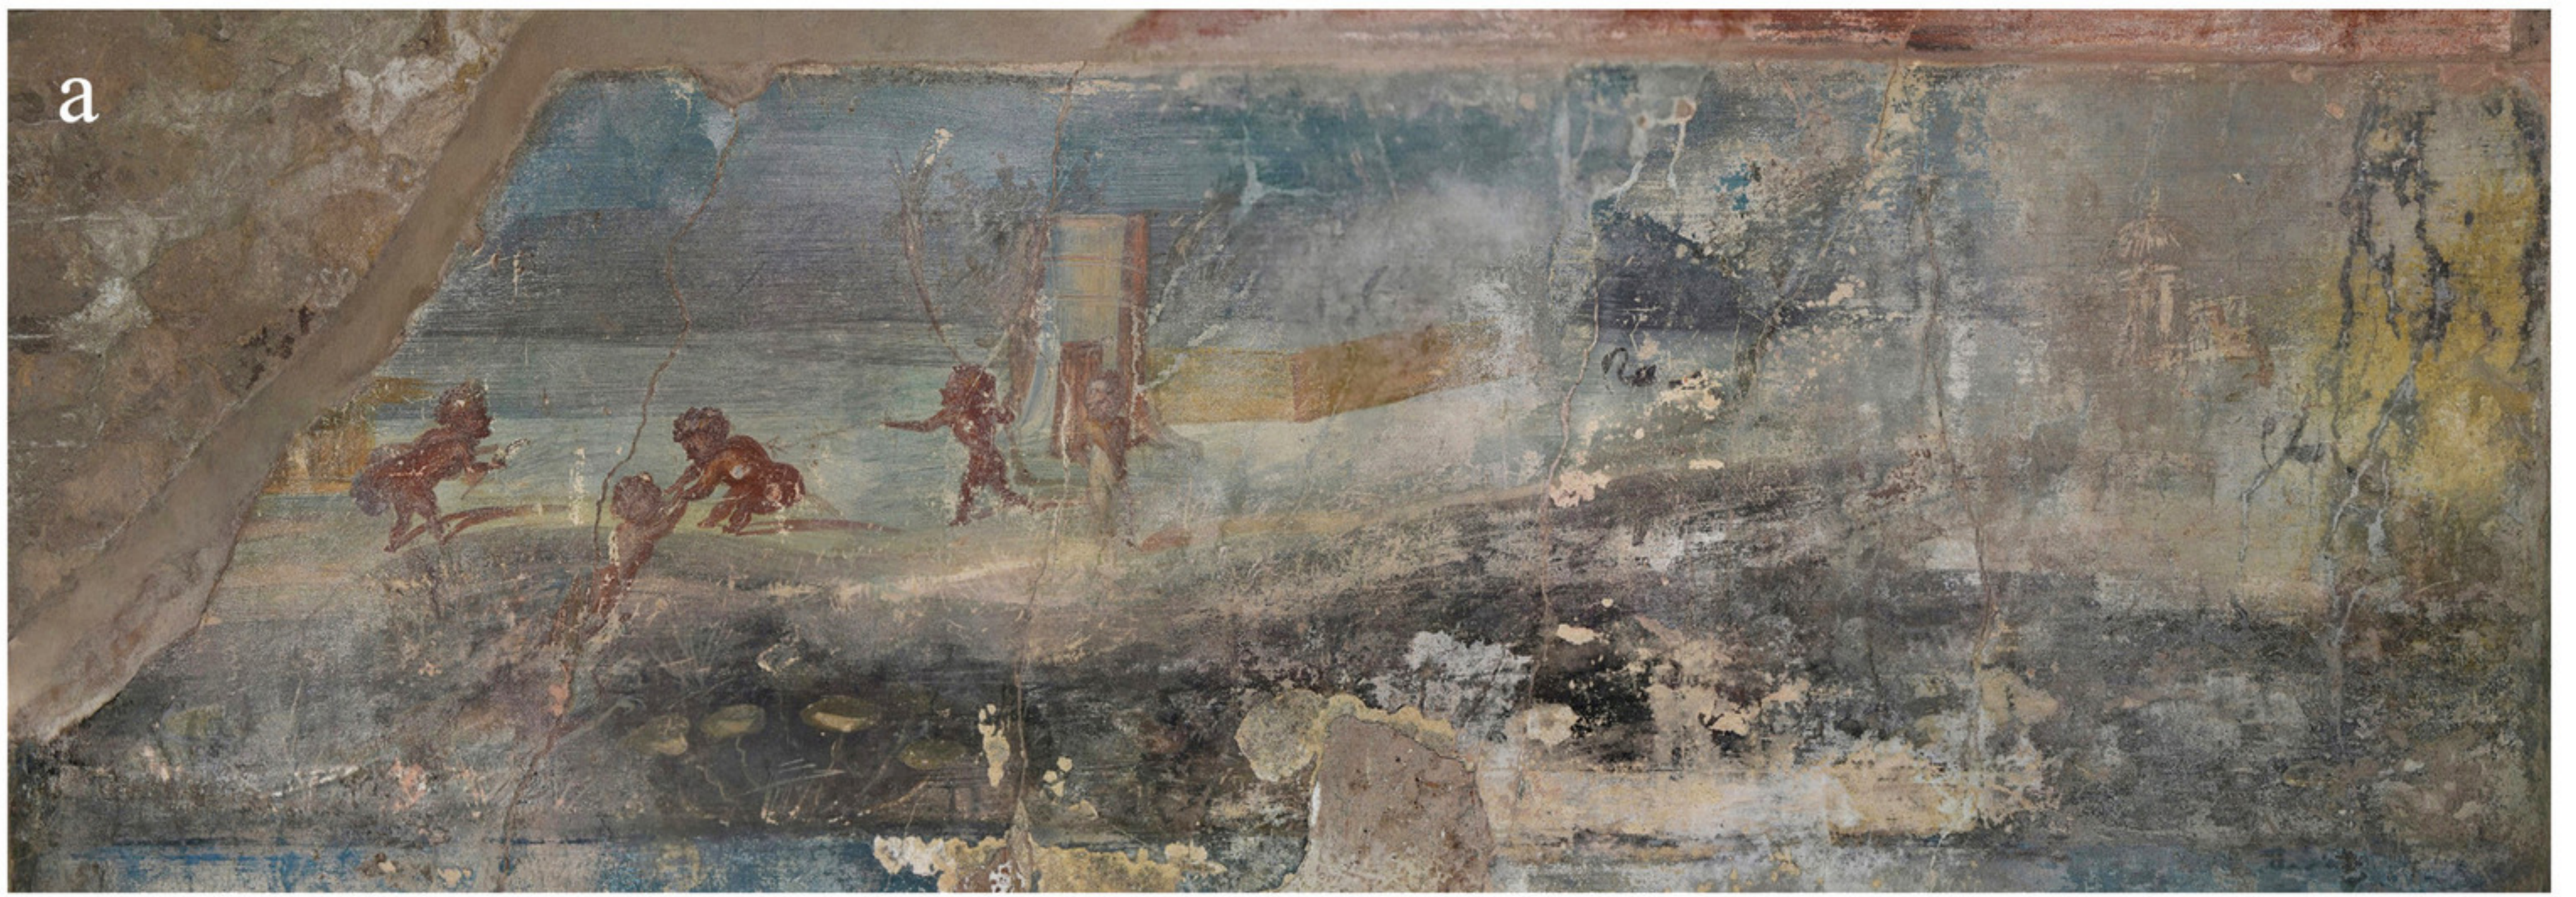
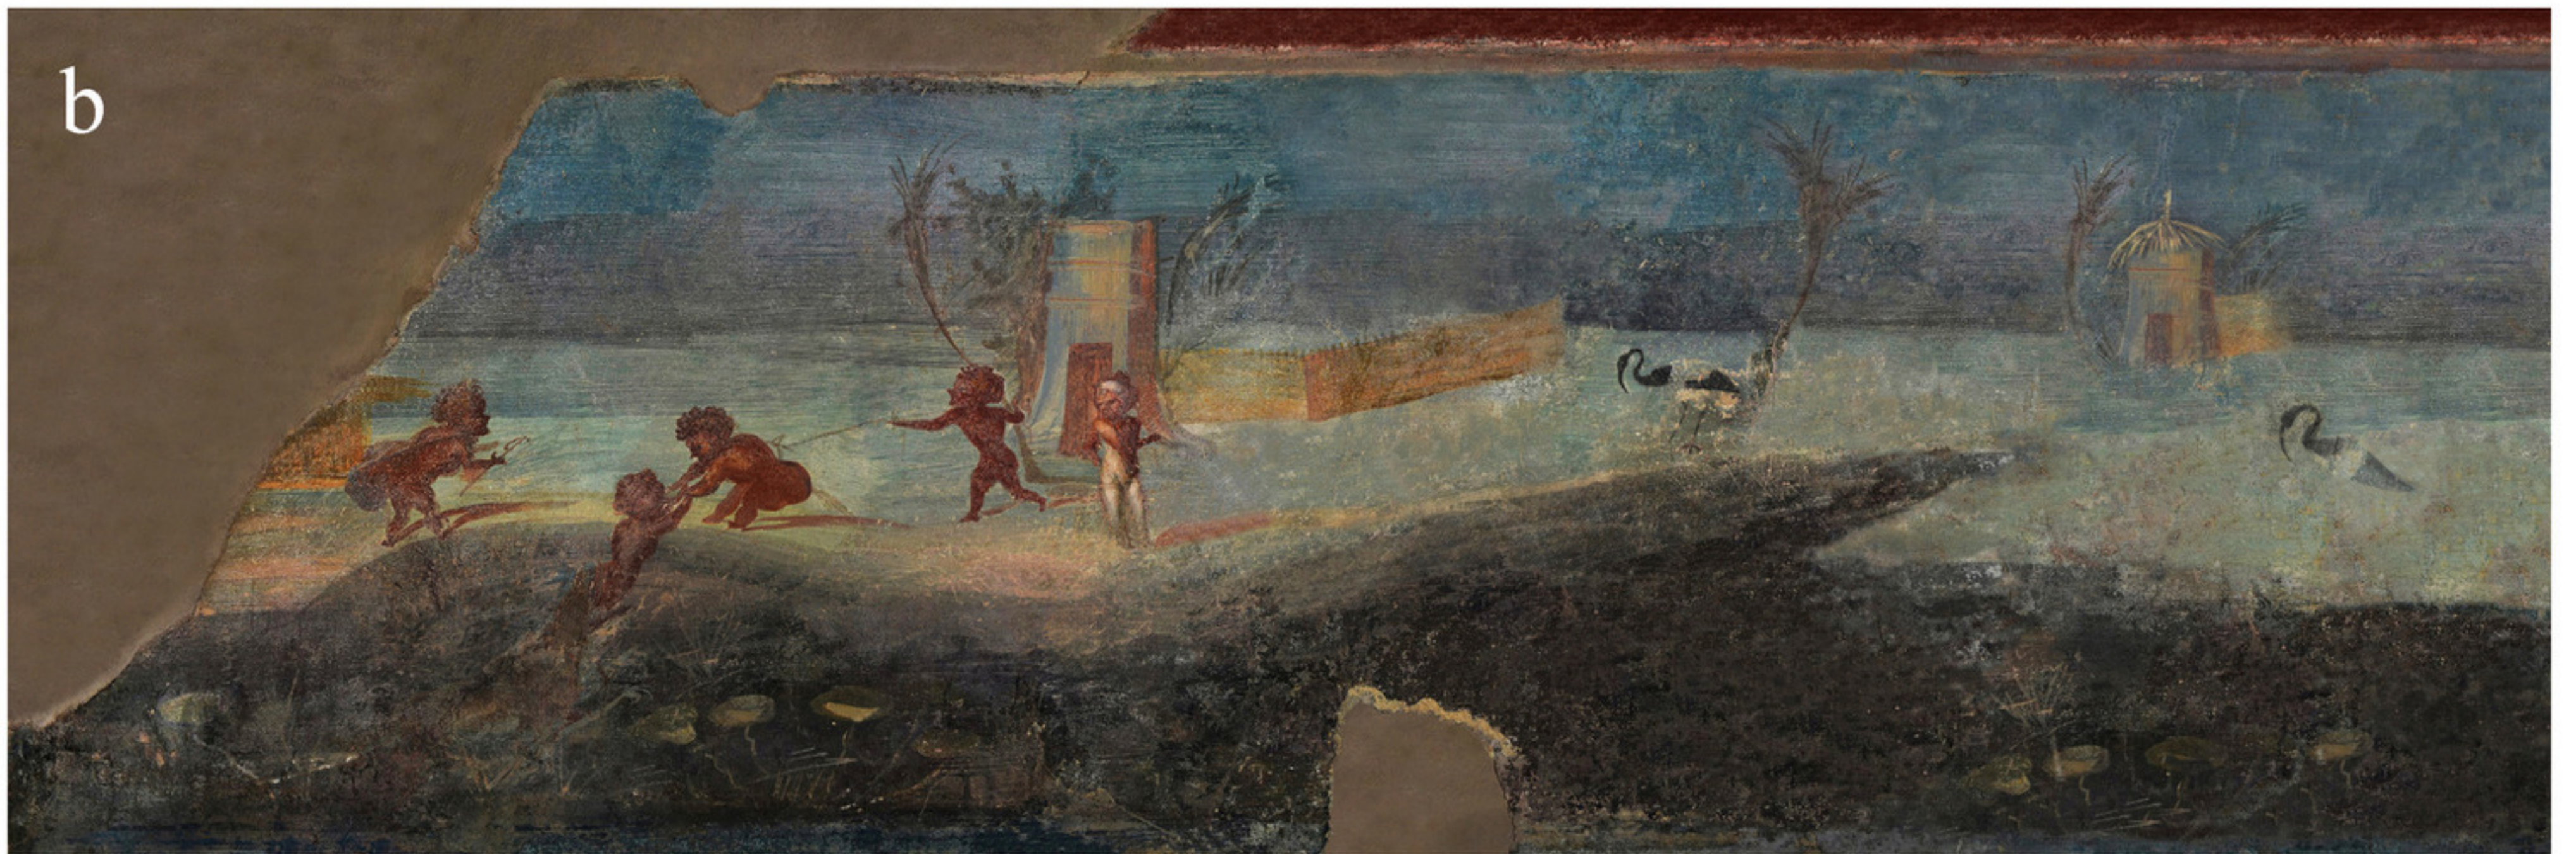
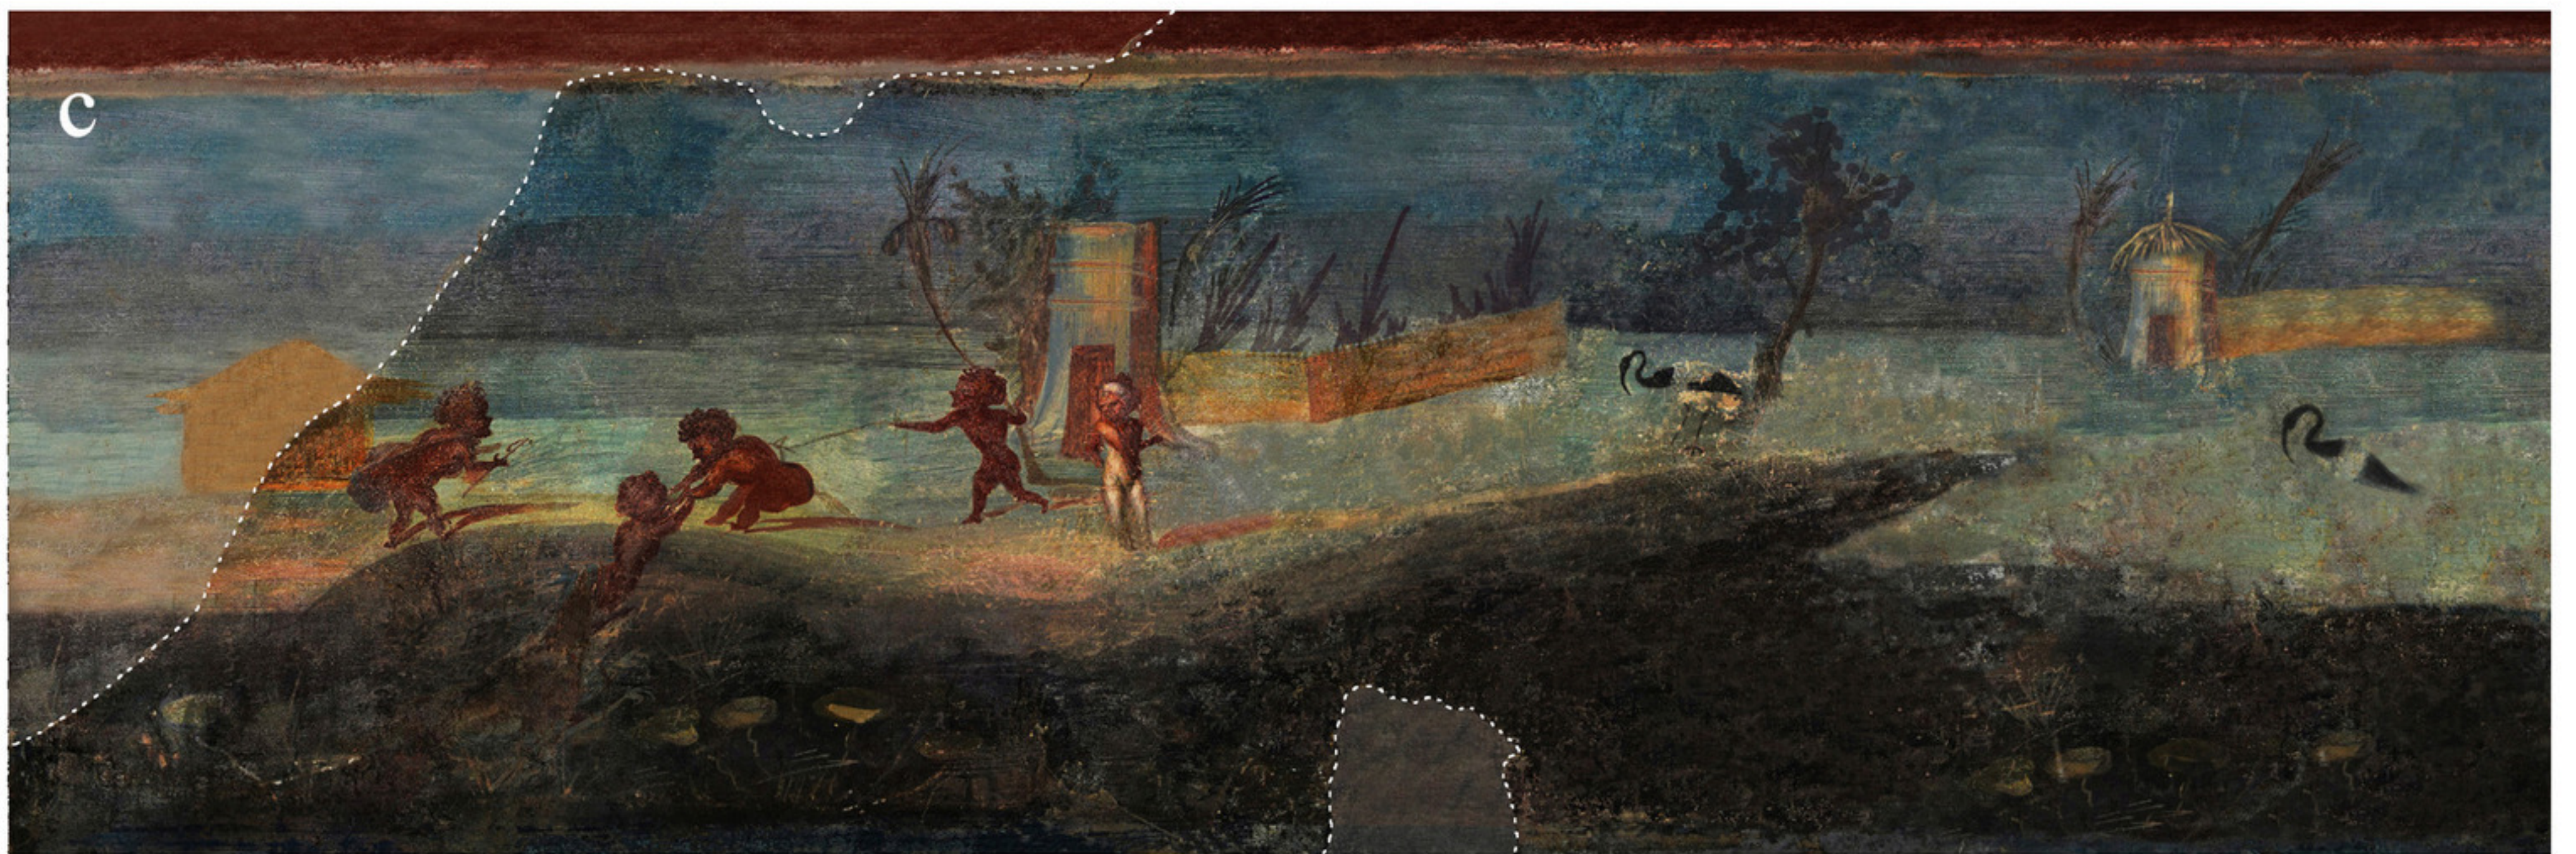
Fig. 1. Digital conservation of the Nilotic frieze, on the western wall of the pool: a) current situation; b) digital conservation, based on naked eye observations; c) digital conservation, with *sottotono* integrations and the addition of elements visible thanks to the multi-spectra analysis and the Egyptian blue maps.

For a better accuracy, naked-eye observation was also used for the digital survey, to verify in situ the small details, under different lighting conditions. Moreover, a virtual cleaning of the portion of the decoration depicting a Nilotic landscape, on the western side of the bath, was made experimentally (Fig. 1a), to offer a realistic representation of what the paintings should look like after a conservation intervention [6-8]. The choice to work on this part of the decoration was due to the preservation state of the depicted scenes, still clearly visible, especially in lower portion, despite the presence of a thick and diffuse salt deposit.

A clearer painting was obtained after ideally removing the salt deposits, filling fractures and applying mimetic integrations on the missing parts (Fig. 1b). Moreover, this image was further enriched with some elements, invisible to the naked eye, but identified thanks to multi-spectral analyses and the measurement of cuprorivaite (Egyptian blue) concentrations [9]. Finally, the missing parts were filled with the *sottotono* technique (i.e. using a lower tone of colour) (Fig. 1c).

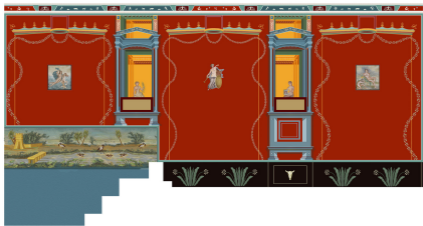
Fig. 6. Digital reconstruction of the process of making the decorations, northern wall, room 7.

Thanks to the detailed technical observations, a more in-depth reconstruction, aiming at representing the process of making the decoration, was possible for the northern wall. The digital reconstruction represents the sequence of operations, summarized in eight reconstructive drawings, starting from laying the mortar and ending with the finishing of the painted surfaces (Fig. 6). The digital reconstruction re-creates objectively the appearance of the moulds used for decorating the stucco borders. The choice of wood was convenient, as wet wood does not stick to wet mortar (Fig. 3).
