Assessment of the effectiveness of wood pole repair using FRP considering the impact of climate change on decay and hurricane risk

Eric MERSCHMAN^a, Abdullahi M. SALMAN^{a,*}, Emilio BASTIDAS-ARTEAGA^b, Yue LI^c

Keywords: Wood poles; FRP repair; Hurricane; Wood decay; Climate change adaptation

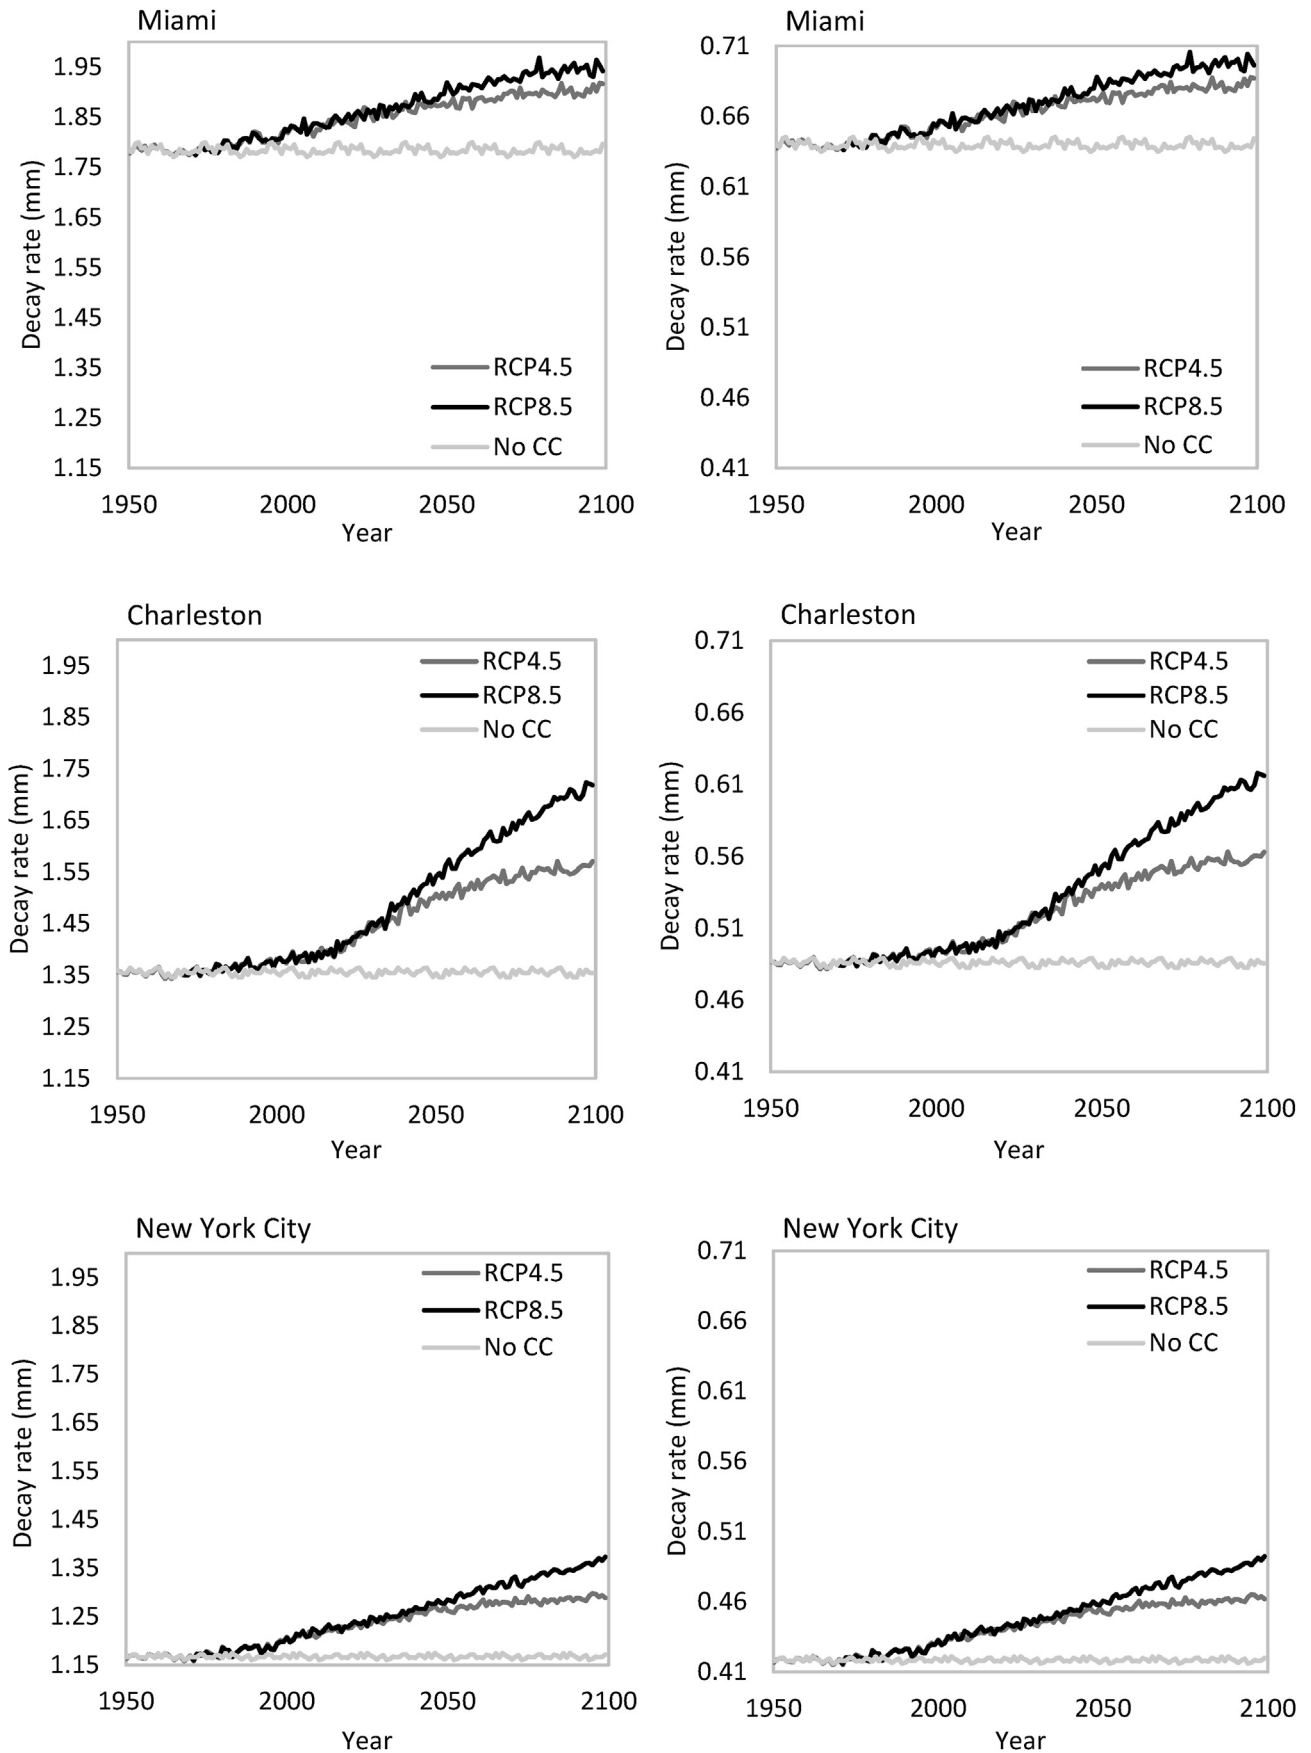
Fig. 1. Mean decay rate, left: sapwood, right: heartwood in 1950–2099 (No CC is no climate change scenario).

decay will attack the heartwood, which has a much lower decay rate, as seen in Fig. 1. This transition will significantly decrease the decay rate despite climate change resulting in little impact of climate change on the failure probability by the end of the 21st century.

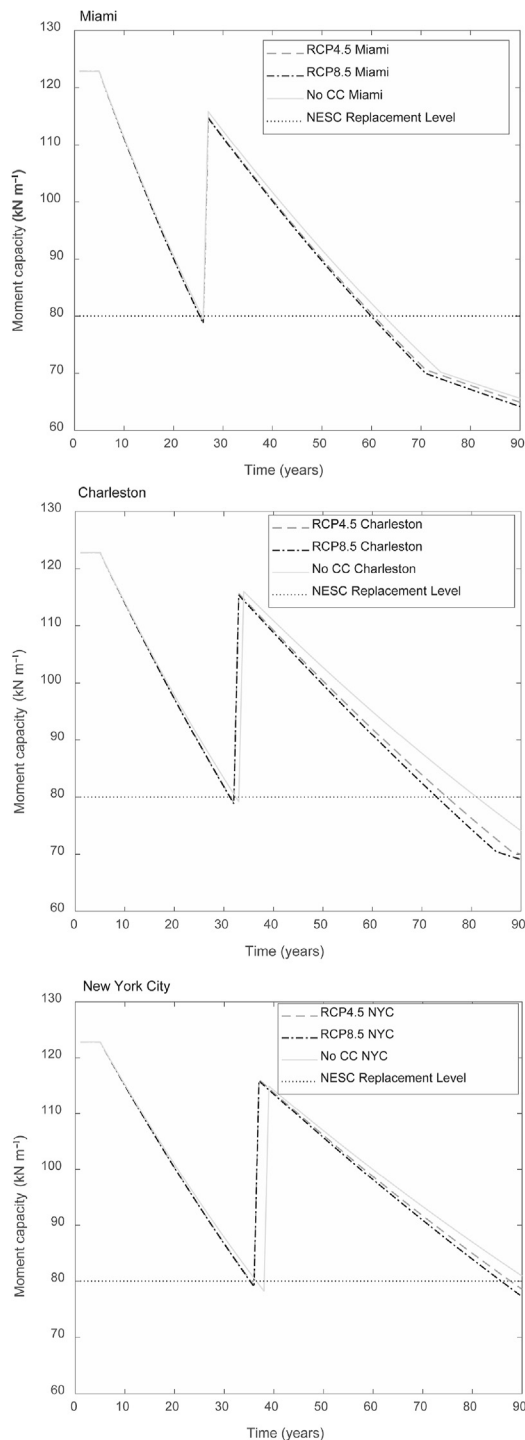
Fig. 2. Average strength plot with FRP repair at NESCR strength threshold (No CC is no climate change scenario).

The period of interest is 2010–2099. FRP repair can be carried out at any time while the pole is in service. One repair scenario will be applying the FRP wrap when the pole's strength reaches two-third of its initial value, which is the NESC threshold for repair or replacement. Fig. 2 shows a plot of the variation of pole strength with time. The time it takes for the strength to reach the NESC threshold is defined as the service life of the pole. For illustration purposes, the added strength due to FRP repair is assumed to be 30% of the initial pole strength. From the analysis, the average service life of the pole in Miami is around 27 years with no climate change effect. The average service life in Miami for both RCP4.5 and RCP8.5 is the same as the no climate change scenario. This is because the difference between the two in terms of changes in decay rate only becomes apparent later in the 21st century, as seen in Fig. 1. Even towards the end of the 21st century, the increase in decay rate due to climate change does not have a significant impact on the change in diameter of the poles and the strength, as seen in Fig. 2. For example, the service life of the pole in Miami only decreased from 62 years for the no climate change scenario to 59 years for the RCP8.5 scenario.

The application of the FRP adds about 35 years to the service life of the pole in Miami with no climate change and 33 and 32 years for RCP4.5 and RCP8.5, respectively. The FRP adds about 49, 44, and 42 years to the service life in Charleston with no climate change, RCP4.5, and RCP8.5, respectively. The corresponding additions are greater than 52, 51, and 49 years in New York City. The variation in the service life in the three locations is due to the varying climates in the regions with poles in Miami having the highest decay rate due to its tropical monsoon climate.

Note that the sudden change in the slope of the lines after about 70 years is due to the transition from the decay of the

sapwood to the heartwood. Because the k_{wood} factor in Eq. (1) is lower for the heartwood, the transition leads to a decrease in decay rate, which resulted in a decrease in strength loss seen in Fig. 2.

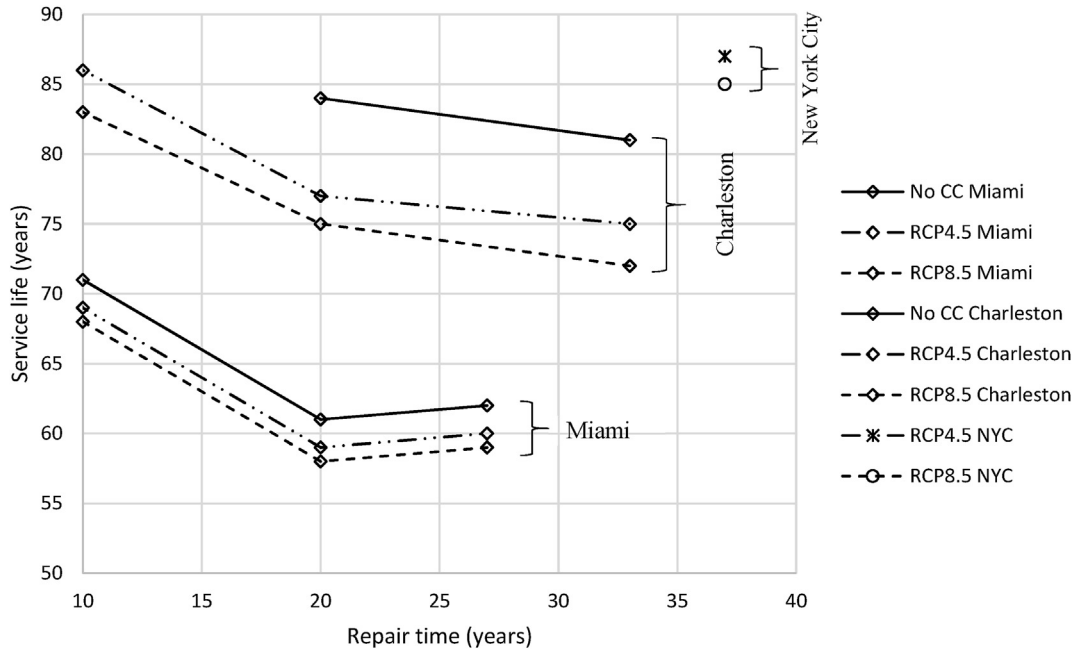
Fig. 4. Estimated average service life for different repair times (No CC is no climate change scenario).

The FRP can also be installed at any time before the strength of the pole reaches the NESC threshold. In Fig. 4, the time of repair is varied along the pole's service life to determine if there is an optimal time of repair. The figure shows the relation between the service life of the pole and FRP repair age. For Fig. 4, the added strength by the FRP is assumed to be 30% of the initial strength of the pole for illustration purposes. From the results, it is apparent that there is a positive correlation between earlier repair time and extended pole life. This is most likely due to the assumption that the presence of the FRP reduces the amount of moisture and fungal contact with the underlying pole, which produces a slower decay rate than merely treating the poles. The only exception to this trend is for Miami, in which there is an uptick of service life for FRP installation at the NESC threshold (27 years) compared to installation at 20 years. This is most likely due to the projections that precipitation is not expected to drastically increase in the RCP4.5 and RCP8.5 conditions in Miami with the RCP8.5 scenario actually projecting that precipitation will decrease (Fig. A1). In all cases, the service life could not be accurately estimated past the 90-year mark as the CMIP5 data only extends through the end of the 21st century. Hence, in cases where the service life extends beyond the end of the 21st century after FRP repair, the service life is not estimated. Consequently, only two points of the New York City results are plotted. The service life of the poles for repair at 10 and 20 years extends beyond the 90-year mark.

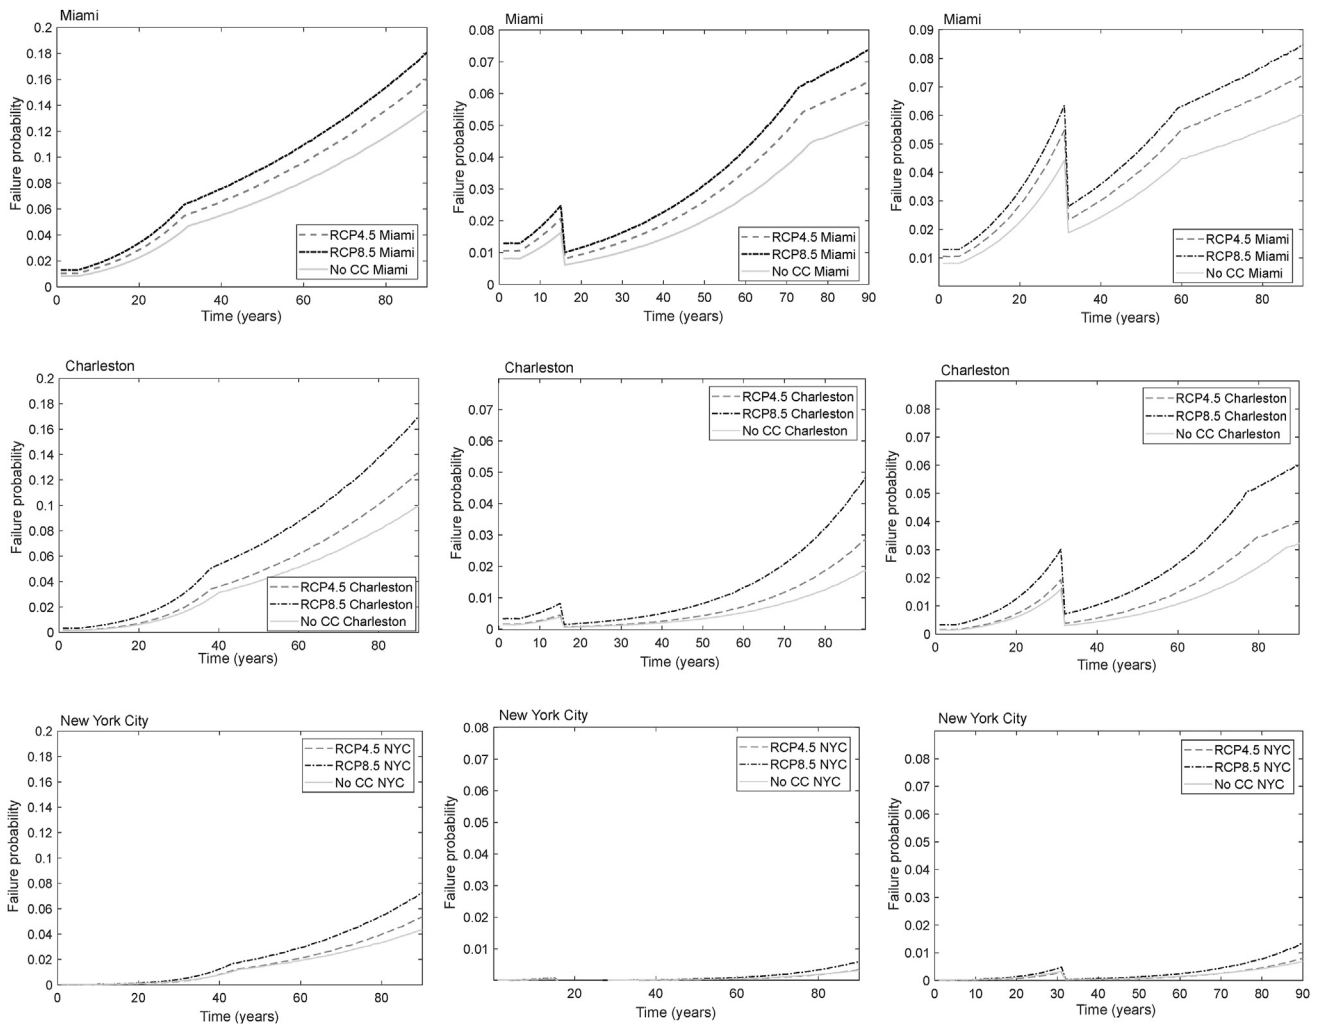
Fig. 5. Type 1 failure probabilities with no FRP (left), FRP installation at 16 years (middle), and installation at 32 years (right) (No CC is no climate change scenario).

Figure 5 illustrates the change in the probability of Type 1 failure (due to hurricane winds) for each of the three zones studied for three repair scenarios: no FRP, FRP installation at 16 years, and FRP installation at 32 years. To determine the failure probabilities here and in subsequent sections, the gain

in strength due to FRP repair is assumed as random as described in Section 2.4. The figure illustrates that the effectiveness of FRP repair is not only time-dependent but location or climate-dependent as well. This is most readily apparent in the New York City cases in which the difference between applying the FRP coat at 16 or 32 years do not differ greatly. However, the decision to apply the FRP sleeve reduces the probability of failure in New York City from about 4% in 2099

The results in Fig. 5 demonstrate that climate change dramatically increases the probability of failure, subsequently lowering the lifespan of wooden poles. RCP4.5 and RCP8.5 scenarios increased the failure probabilities in Miami at the end of the 21st century by about 15% and 30%, respectively, compared to the no climate change scenario. The corresponding increases are 23% and 70% in Charleston, and 25% and 73% in New York City. The comparatively lower increase in Miami is due to a decrease in precipitation towards the end of the 21st century for the RCP8.5 scenario and little increase in precipitation for the RCP4.5 scenario, as seen in Fig. A1.

While the decision to implement the FRP repair always improves the lifespan of wooden utility poles, as seen in Fig. 5, the optimal time of repair is dependent on the location. In most cases, there was a positive relationship between early repair and extension of effective service life. The exception to this being applying FRP at the time of replacement for Miami. This again is most likely due to the predicted decrease in precipitation in Miami. It is seen that the application of the FRP sleeve is effective in mitigating the probability of failure of the poles due to the RCP4.5 and RCP8.5 scenarios.

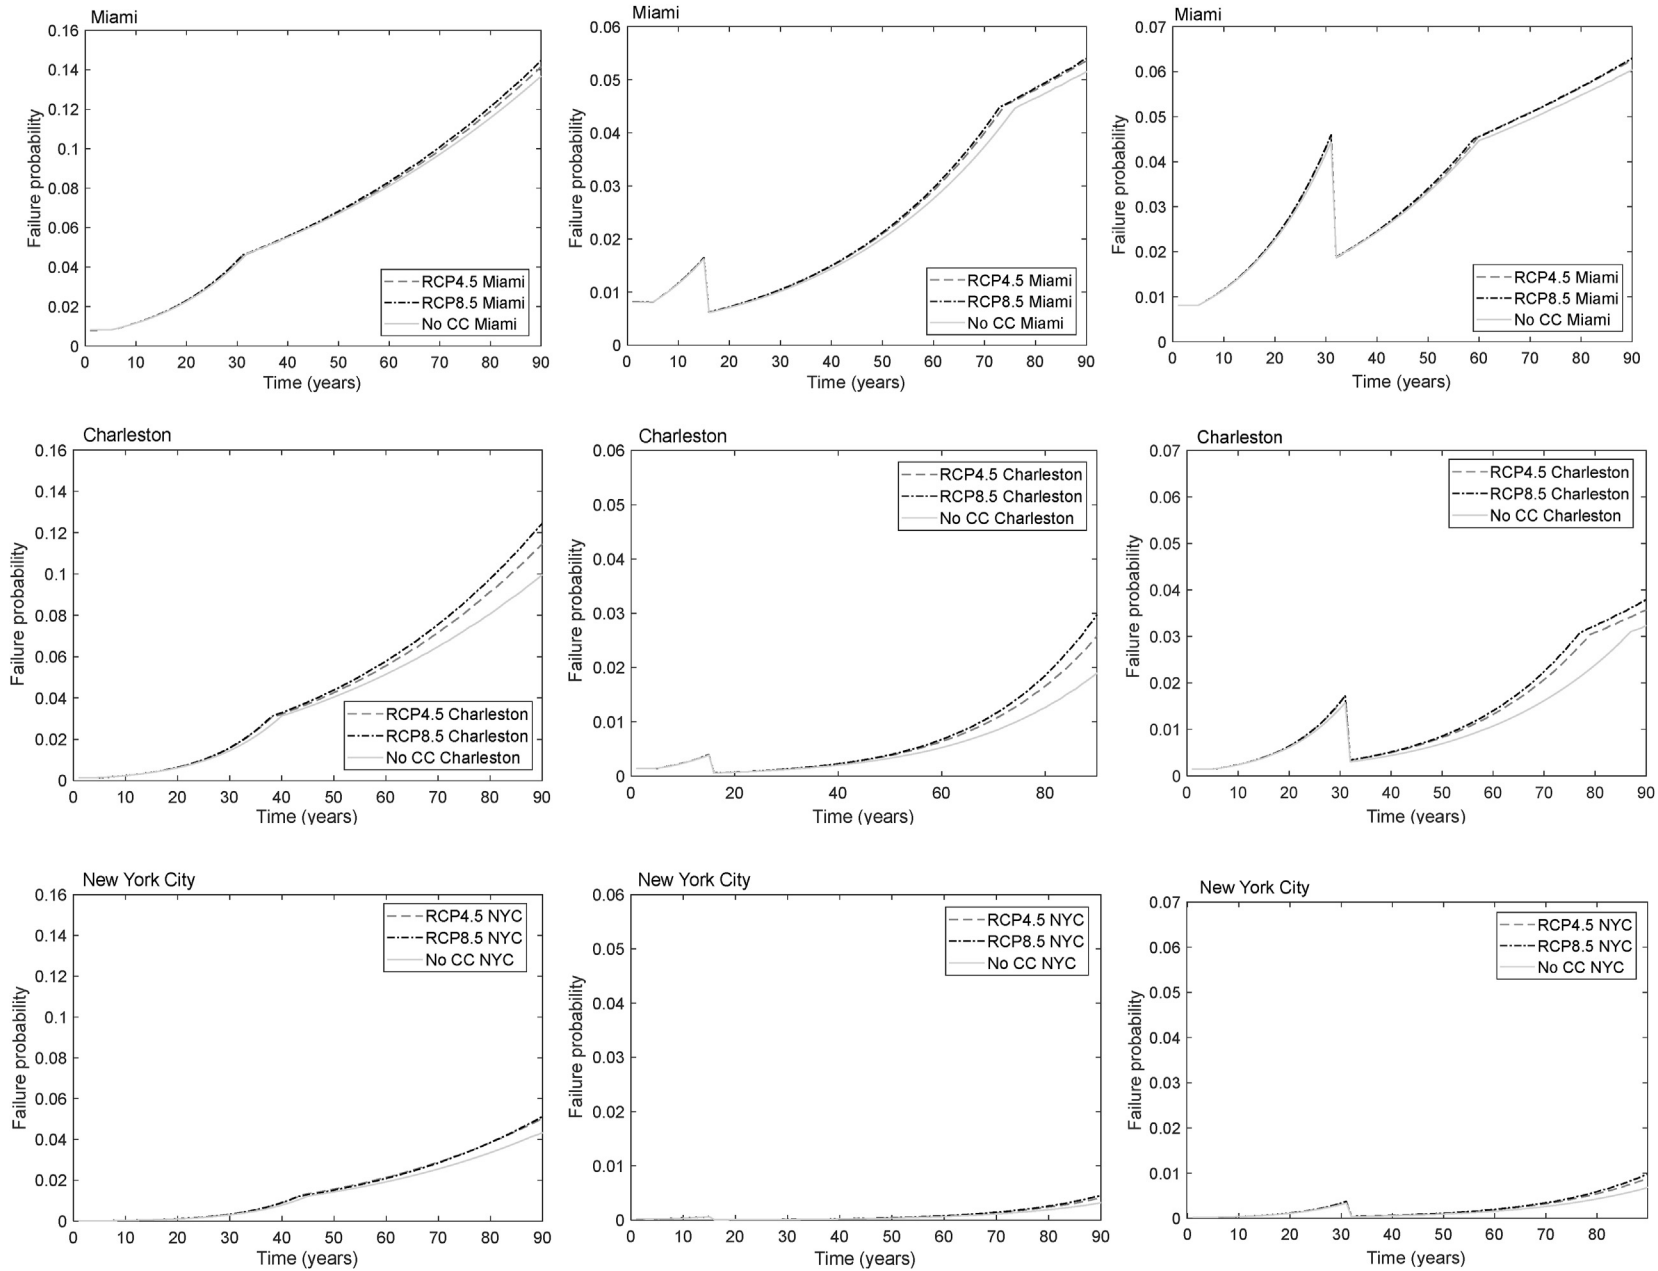
Fig. 7. Type 1 failure probabilities with no FRP (left), FRP installation at 16 years (middle), and installation at 32 years (right) without hurricane intensity increase (No CC is no climate change scenario).

As mentioned previously, studies have been done to predict the magnitude of changes to tropical cyclone intensity and frequency through the end of the 21st century (Emanuel, 2005; Knutson et al., 2008; Mudd et al., 2014b; Oouchi et al., 2006; Webster et al., 2005). Based on these results, a linear increase in intensity of 10% by the year 2099 for the RCP4.5 scenario and 20% for the RCP8.5 scenario with no change in frequency was assumed. To investigate the sensitivity of Type 1 failure (due to hurricane wind) to only changes in decay rate due to climate change, the failure probabilities are evaluated assuming that there is no increase in the intensity of hurricanes. Only the impact of climate change on decay rate is considered. The results are shown in Fig. 7. Comparing Fig. 7 to Fig. 5 exemplifies the impact that an increase in storm intensity has on the failure probabilities. When only taking into account the impact of climate change on decay for the two RCP scenarios (Fig. 7), the increase in the probability of failure without FRP by the end of 2099 under RCP8.5 scenario range from about 5% in Miami to about 22% and 20% in Charleston and New York City compared to a no climate change scenario. Adding increases in the probability of more intense wind events (Fig. 5), however, yields an increase in failure probabilities of the baseline no-FRP case of about 30%, 70%, and 73% in Miami, Charleston, and New York City, respectively.

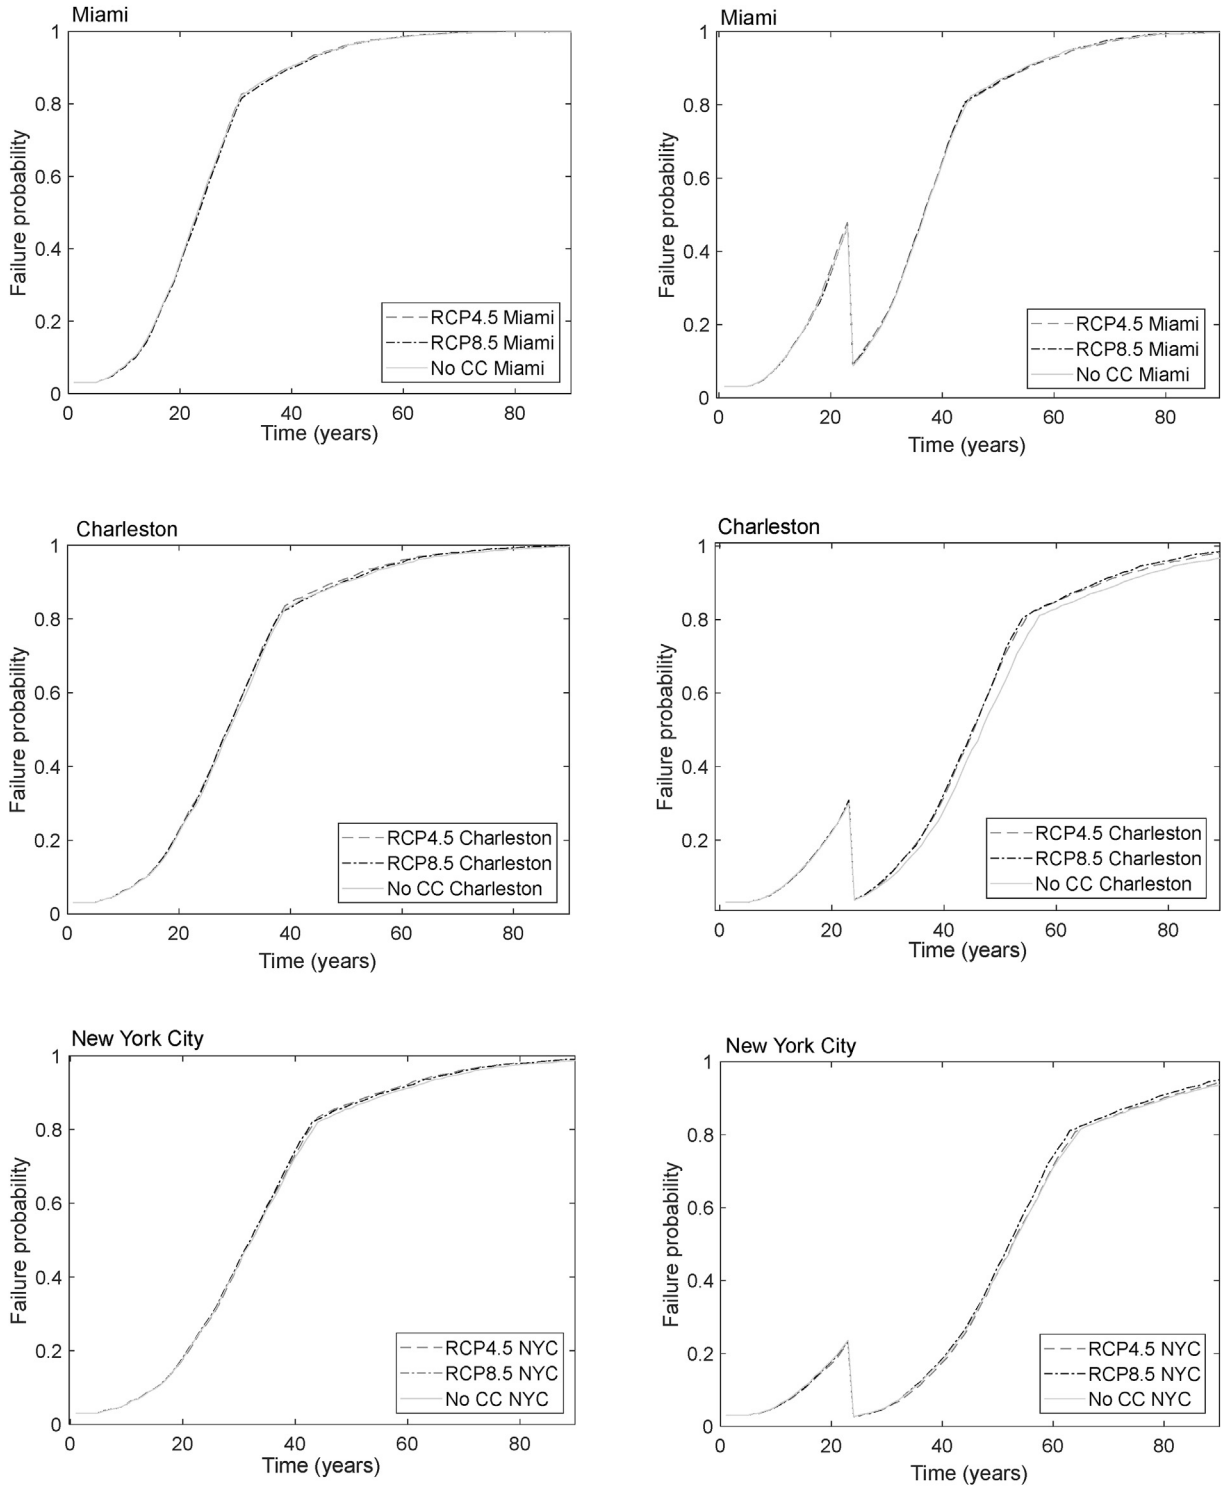
Fig. 8. Type 2 failure probabilities with FRP installed at 24 years, assuming a decrease in wood decay rate after FRP repair (left), assuming no change in wood decay rate after FRP repair (right) (No CC is no climate change scenario).

assumption on the results, a sensitivity analysis is carried out assuming the FRP has no effect on the decay rate of the poles. The results are shown in Fig. 8 for Type 2 failure. The assumption has a significant impact on the results. In New York City for example, the probabilities increased from around 0.55 to more than 0.9. The results illustrate an additional advantage of the FRP repair. Not only does it restore the strength of the poles, but it can slow down the decay rate and, consequently, extend the service life of the poles. Note that while the extent to which the FRP slows down the decay is unknown in this case, there is significant evidence that the repair of structural components using FRP can significantly decrease the strength deterioration of the component as mentioned previously (Debaiky et al., 2002; Masoud and Soudki, 2006; Pantazopoulou et al., 2001).

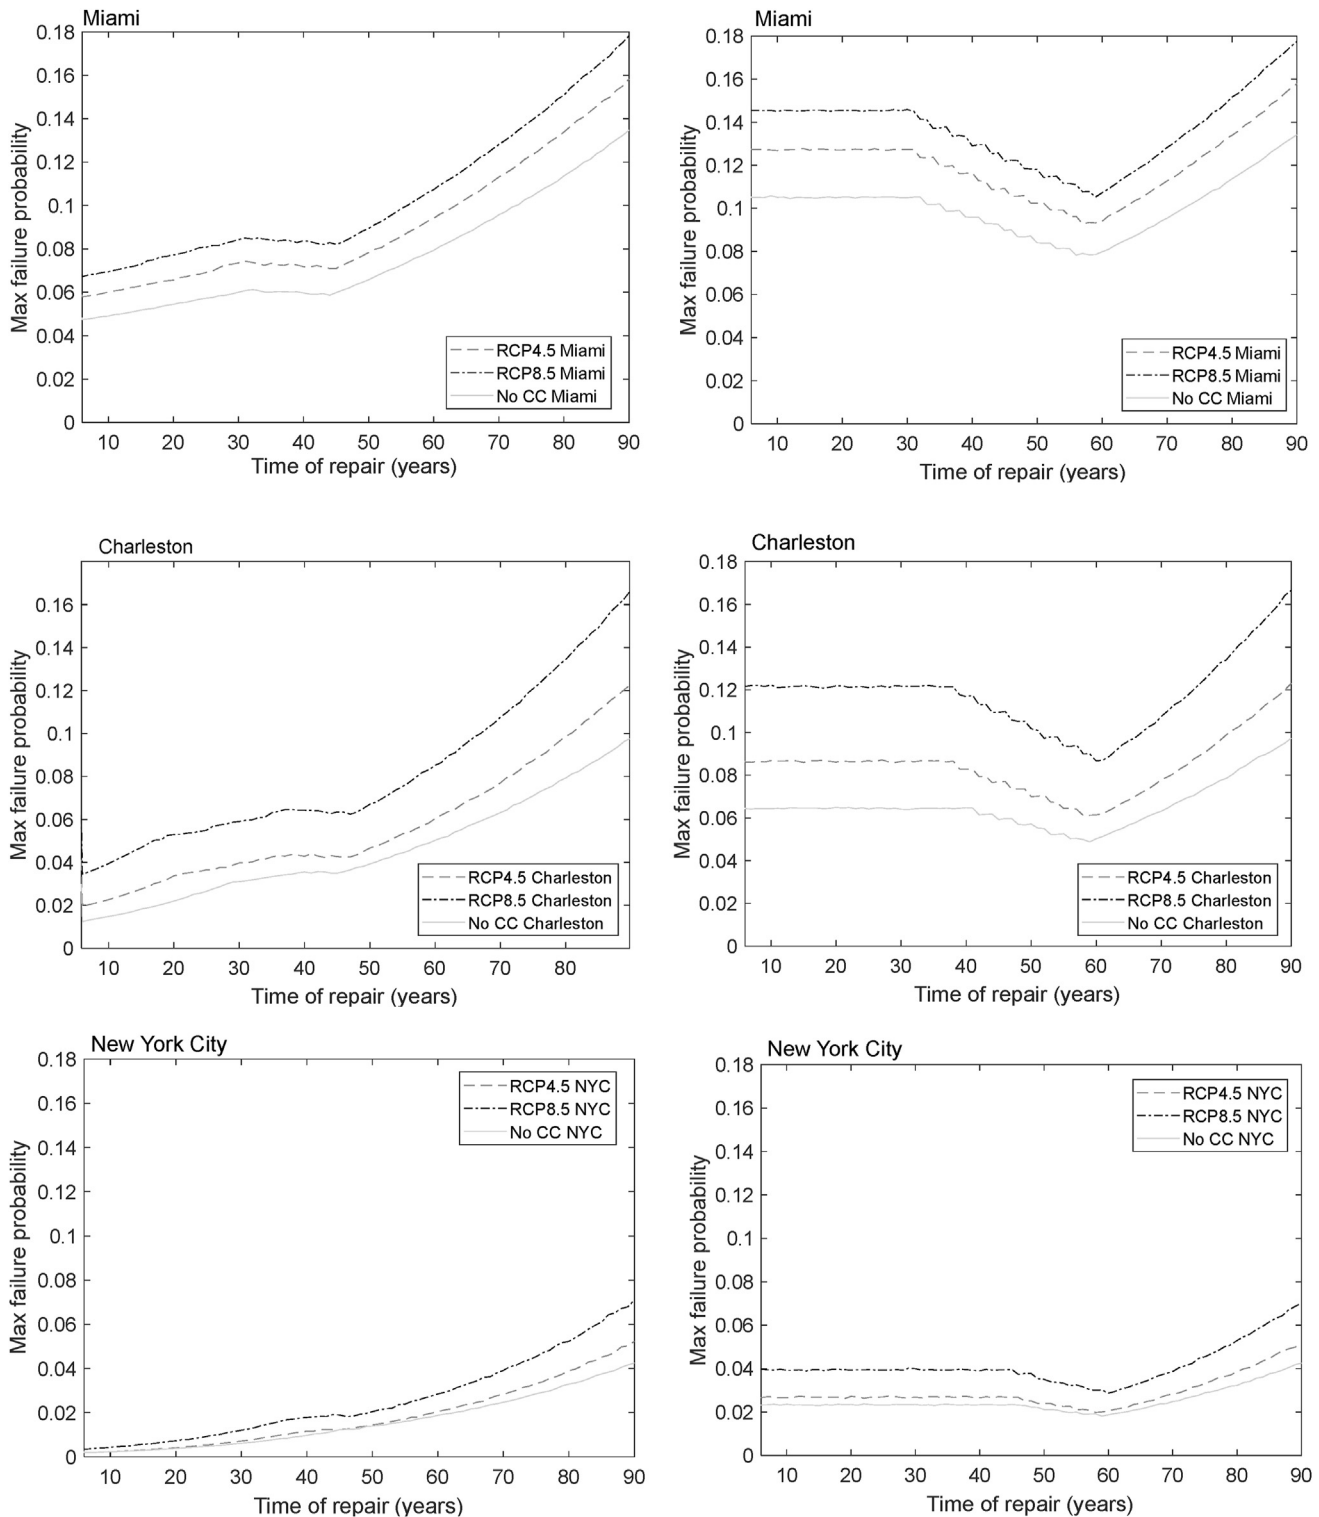
Fig. 9. FRP repair optimization results for type 1 failure probabilities, assuming a decrease in wood decay rate after FRP repair (left), and assuming no change in wood decay rate after FRP repair (right) (No CC is no climate change scenario).

The objective of the optimization is to find the FRP repair time that will minimize the failure probability over the considered period (2010–2099). Fig. 9 shows the FRP repair optimization results, where the maximum failure probability variation over the considered period for different repair times is plotted. Note that only Type 1 failure probability is considered because the case study locations have hurricane risk. Recall that Type 1 failure includes the effects of both wood decay and hurricane hazard. For locations without hurricane hazard, the optimization can be carried out in a similar manner using Type 2 failure probability. The plots on the left side of Fig. 9 show the results based on the previously stated assumption that the application of the FRP will slow down the wood's decay rate by half. The results show that the optimal FRP installation time is at the beginning of the pole's life cycle, i.e., at the end of the decay lag period. This is because of the assumption of the significant decrease in the decay rate of the wood after FRP installation. Early FRP installation leads to slow decay throughout the considered period, which significantly decreases the failure probability. The plots in Fig. 5 confirm this trend.

The results on the right side of Fig. 9 show the optimal repair time if the FRP installation has no effect on the decay rate of the wood. In this case, the optimal repair time is not at the beginning of the pole's life cycle. Rather, it is more than halfway through the life cycle in all cases. The results show that it is better to allow the pole to decay significantly before the repair is carried out. The optimal repair times in Miami, Charleston, and New York City with no climate change are 58, 59, and 59 years, respectively. While climate change has an impact on the failure probabilities, as seen earlier, it does not affect the optimal FRP repair time. In Miami, the optimal repair times are 58, 57, and 59 years, for no climate change, RCP4.5, and RCP8.5, respectively. The corresponding repair times are 59, 58, and 60 years in Charleston; and 59, 59, and 60 years in New York City.

Even though the decay rates in the three considered locations vary, the results on the right of Fig. 9 show that the optimal repair time is independent of location. This is because the optimization is based on the maximum failure probability over the considered period. Hence, the optimal repair year depends on the point at which the failure

probability at the end of the 21st century and the year of the repair will be minimized. In other words, the optimization is about finding a balance point to keep the failure probability from becoming too large over the 90-year period. Hence, the magnitude of the failure probability does not influence the optimal repair time.
