Assessment of the effectiveness of wood pole repair using FRP considering the impact of climate change on decay and hurricane risk

Eric MERSCHMAN^a, Abdullahi M. SALMAN^{a,*}, Emilio BASTIDAS-ARTEAGA^b, Yue LI^c

Abstract

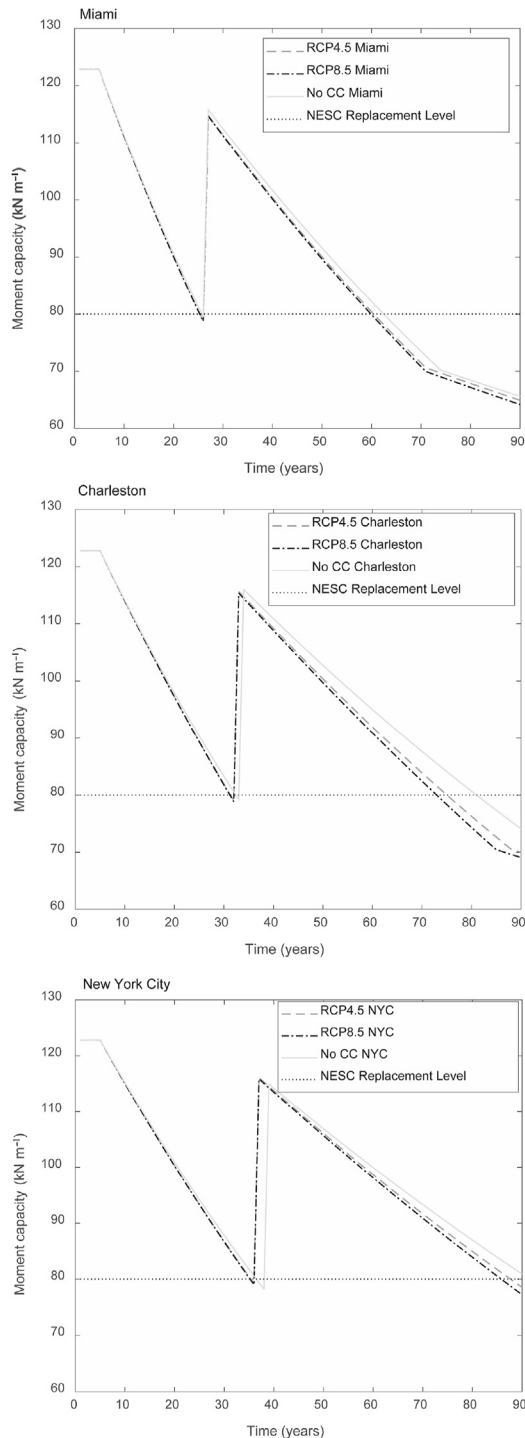
Fig. 2. Average strength plot with FRP repair at NESC strength threshold (No CC is no climate change scenario).

The period of interest is 2010–2099. FRP repair can be carried out at any time while the pole is in service. One repair scenario will be applying the FRP wrap when the pole's strength reaches two-third of its initial value, which is the NESC threshold for repair or replacement. Fig. 2 shows a plot of the variation of pole strength with time. The time it takes for the strength to reach the NESC threshold is defined as the service life of the pole. For illustration purposes, the added strength due to FRP repair is assumed to be 30% of the initial pole strength. From the analysis, the average service life of the pole in Miami is around 27 years with no climate change effect. The average service life in Miami for both RCP4.5 and RCP8.5 is the same as the no climate change scenario. This is because the difference between the two in terms of changes in decay rate only becomes apparent later in the 21st century, as seen in Fig. 1. Even towards the end of the 21st century, the increase in decay rate due to climate change does not have a significant impact on the change in diameter of the poles and the strength, as seen in Fig. 2. For example, the service life of the pole in Miami only decreased from 62 years for the no climate change scenario to 59 years for the RCP8.5 scenario.

The application of the FRP adds about 35 years to the service life of the pole in Miami with no climate change and 33 and 32 years for RCP4.5 and RCP8.5, respectively. The FRP adds about 49, 44, and 42 years to the service life in Charleston with no climate change, RCP4.5, and RCP8.5, respectively. The corresponding additions are greater than 52, 51, and 49 years in New York City. The variation in the service life in the three locations is due to the varying climates in the regions with poles in Miami having the highest decay rate due to its tropical monsoon climate.

Note that the sudden change in the slope of the lines after about 70 years is due to the transition from the decay of the

sapwood to the heartwood. Because the k_{wood} factor in Eq. (1) is lower for the heartwood, the transition leads to a decrease in decay rate, which resulted in a decrease in strength loss seen in Fig. 2.

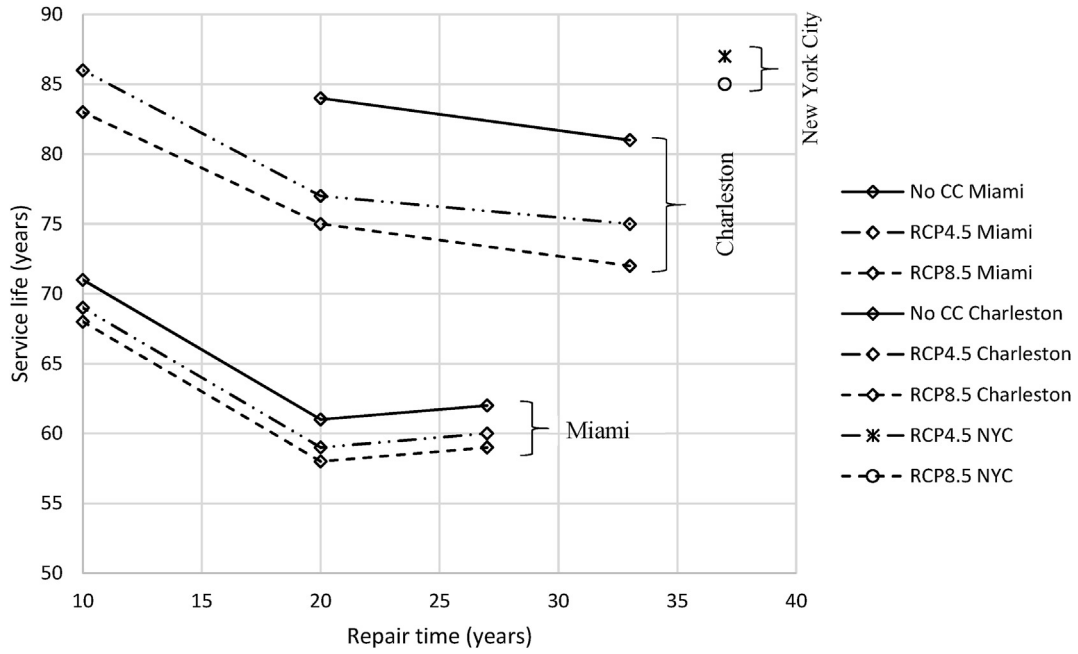
Fig. 4. Estimated average service life for different repair times (No CC is no climate change scenario).

The FRP can also be installed at any time before the strength of the pole reaches the NESC threshold. In Fig. 4, the time of repair is varied along the pole's service life to determine if there is an optimal time of repair. The figure shows the relation between the service life of the pole and FRP repair age. For Fig. 4, the added strength by the FRP is assumed to be 30% of the initial strength of the pole for illustration purposes. From the results, it is apparent that there is a positive correlation between earlier repair time and extended pole life. This is most likely due to the assumption that the presence of the FRP reduces the amount of moisture and fungal contact with the underlying pole, which produces a slower decay rate than merely treating the poles. The only exception to this trend is for Miami, in which there is an uptick of service life for FRP installation at the NESC threshold (27 years) compared to installation at 20 years. This is most likely due to the projections that precipitation is not expected to drastically increase in the RCP4.5 and RCP8.5 conditions in Miami with the RCP8.5 scenario actually projecting that precipitation will decrease (Fig. A1). In all cases, the service life could not be accurately estimated past the 90-year mark as the CMIP5 data only extends through the end of the 21st century. Hence, in cases where the service life extends beyond the end of the 21st century after FRP repair, the service life is not estimated. Consequently, only two points of the New York City results are plotted. The service life of the poles for repair at 10 and 20 years extends beyond the 90-year mark.

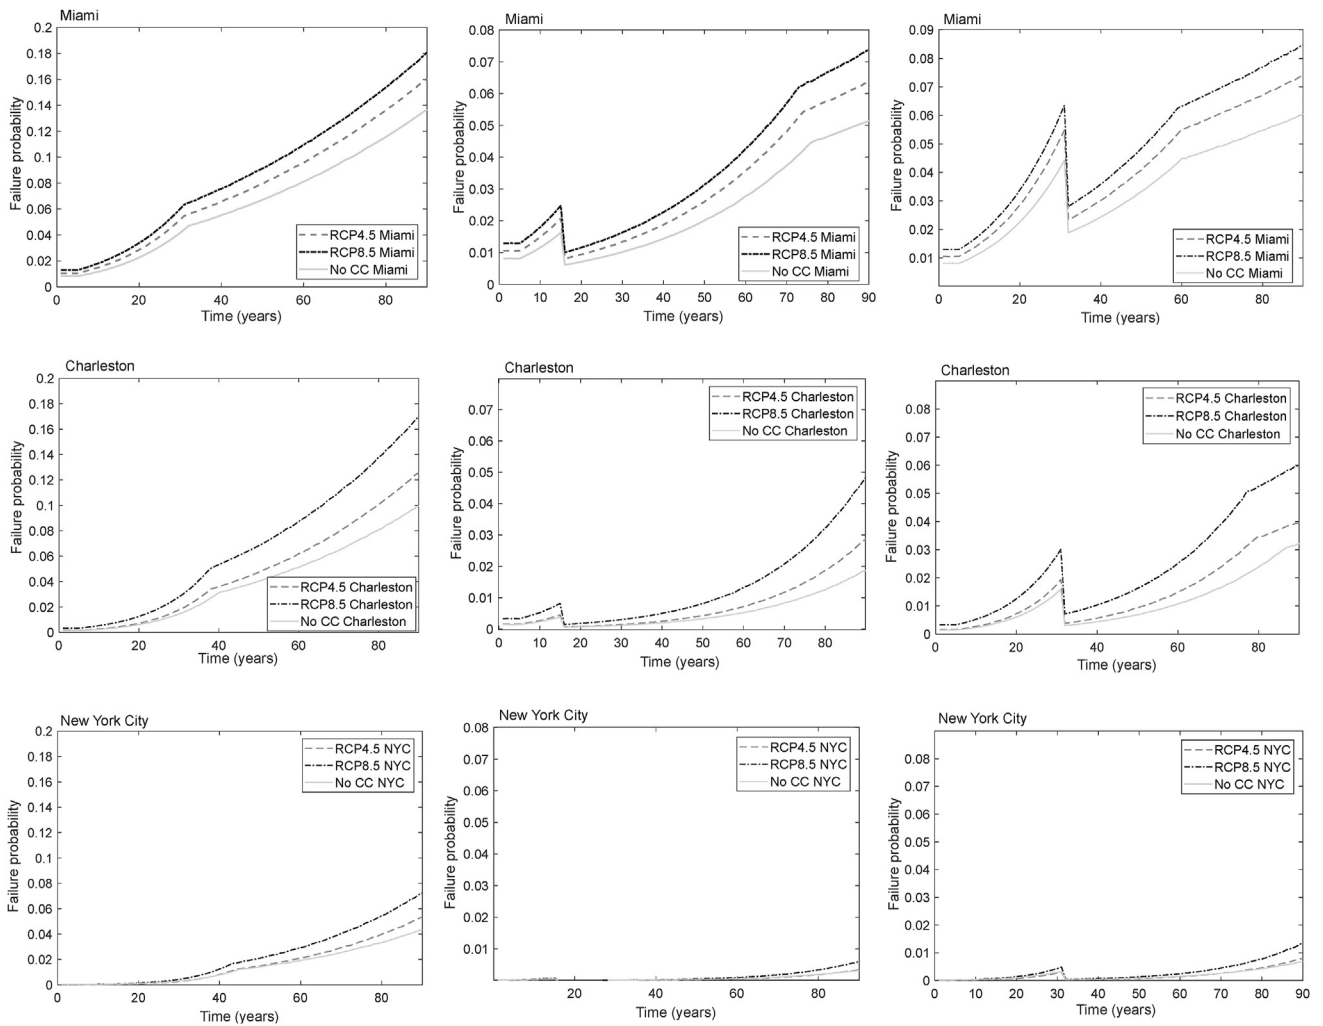
Fig. 5. Type 1 failure probabilities with no FRP (left), FRP installation at 16 years (middle), and installation at 32 years (right) (No CC is no climate change scenario).

Figure 5 illustrates the change in the probability of Type 1 failure (due to hurricane winds) for each of the three zones studied for three repair scenarios: no FRP, FRP installation at 16 years, and FRP installation at 32 years. To determine the failure probabilities here and in subsequent sections, the gain

The results in Fig. 5 demonstrate that climate change dramatically increases the probability of failure, subsequently lowering the lifespan of wooden poles. RCP4.5 and RCP8.5 scenarios increased the failure probabilities in Miami at the end of the 21st century by about 15% and 30%, respectively, compared to the no climate change scenario. The corresponding increases are 23% and 70% in Charleston, and 25% and 73% in New York City. The comparatively lower increase in Miami is due to a decrease in precipitation towards the end of the 21st century for the RCP8.5 scenario and little increase in precipitation for the RCP4.5 scenario, as seen in Fig. A1.

While the decision to implement the FRP repair always improves the lifespan of wooden utility poles, as seen in Fig. 5, the optimal time of repair is dependent on the location. In most cases, there was a positive relationship between early repair and extension of effective service life. The exception to this being applying FRP at the time of replacement for Miami. This again is most likely due to the predicted decrease in precipitation in Miami. It is seen that the application of the FRP sleeve is effective in mitigating the probability of failure of the poles due to the RCP4.5 and RCP8.5 scenarios.

When comparing the results from Fig. 6 to that of Fig. 5, the largest discrepancy is that the spread of the results in Fig. 6 is significantly lower. The reason is that for the Type 1 failure probability, the limit state function is a convolution of the failure probability given a wind speed with the probability of the wind speed occurring. The combined impact of climate change on both decay and hurricane hazard in Fig. 5 resulted in a much higher impact on Type 1 failure probabilities. This is further discussed in the subsequent sensitivity analysis section.

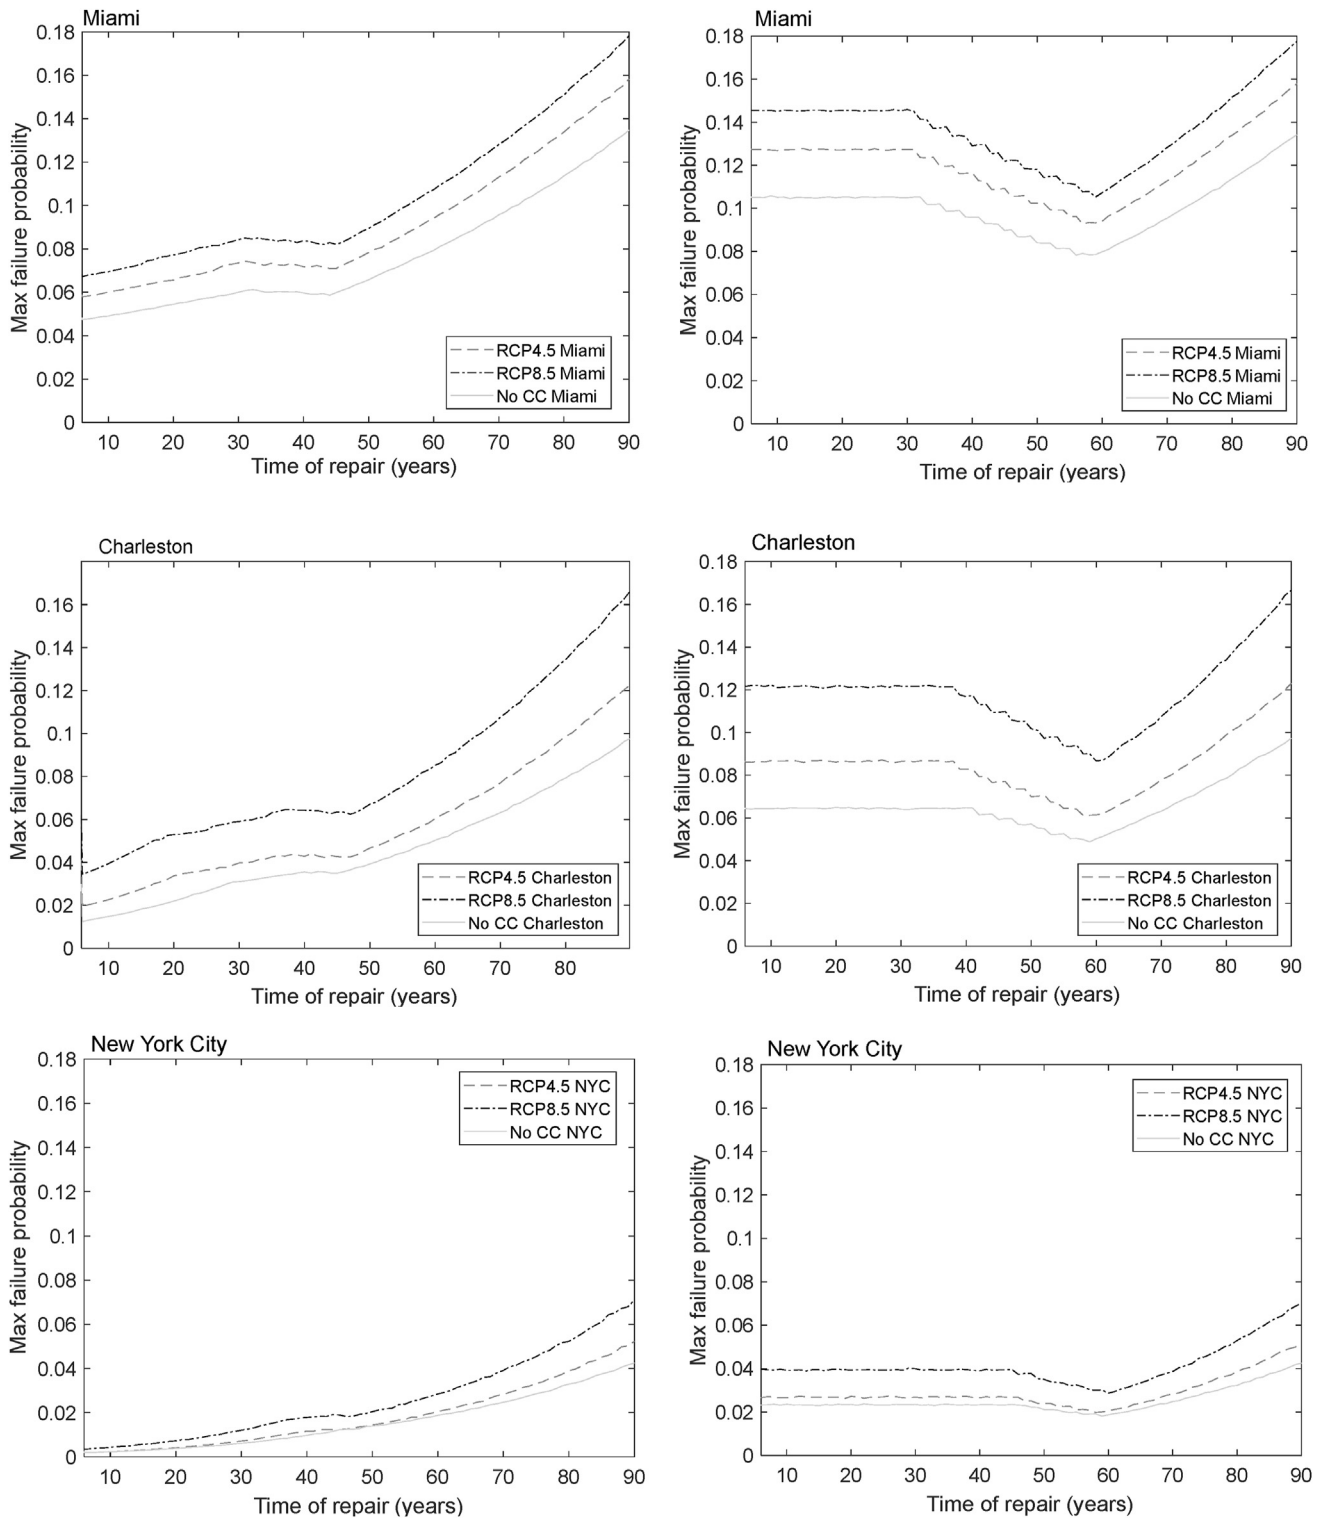
Fig. 9. FRP repair optimization results for type 1 failure probabilities, assuming a decrease in wood decay rate after FRP repair (left), and assuming no change in wood decay rate after FRP repair (right) (No CC is no climate change scenario).

The objective of the optimization is to find the FRP repair time that will minimize the failure probability over the considered period (2010–2099). Fig. 9 shows the FRP repair optimization results, where the maximum failure probability variation over the considered period for different repair times is plotted. Note that only Type 1 failure probability is considered because the case study locations have hurricane risk. Recall that Type 1 failure includes the effects of both wood decay and hurricane hazard. For locations without hurricane hazard, the optimization can be carried out in a similar manner using Type 2 failure probability. The plots on the left side of Fig. 9 show the results based on the previously stated assumption that the application of the FRP will slow down the wood's decay rate by half. The results show that the optimal FRP installation time is at the beginning of the pole's life cycle, i.e., at the end of the decay lag period. This is because of the assumption of the significant decrease in the decay rate of the wood after FRP installation. Early FRP installation leads to slow decay throughout the considered period, which significantly decreases the failure probability. The plots in Fig. 5 confirm this trend.

The results on the right side of Fig. 9 show the optimal repair time if the FRP installation has no effect on the decay rate of the wood. In this case, the optimal repair time is not at the beginning of the pole's life cycle. Rather, it is more than halfway through the life cycle in all cases. The results show that it is better to allow the pole to decay significantly before the repair is carried out. The optimal repair times in Miami, Charleston, and New York City with no climate change are 58, 59, and 59 years, respectively. While climate change has an impact on the failure probabilities, as seen earlier, it does not affect the optimal FRP repair time. In Miami, the optimal repair times are 58, 57, and 59 years, for no climate change, RCP4.5, and RCP8.5, respectively. The corresponding repair times are 59, 58, and 60 years in Charleston; and 59, 59, and 60 years in New York City.

Even though the decay rates in the three considered locations vary, the results on the right of Fig. 9 show that the optimal repair time is independent of location. This is because the optimization is based on the maximum failure probability over the considered period. Hence, the optimal repair year depends on the point at which the failure

probability at the end of the 21st century and the year of the repair will be minimized. In other words, the optimization is about finding a balance point to keep the failure probability from becoming too large over the 90-year period. Hence, the magnitude of the failure probability does not influence the optimal repair time.
