# Hi-tech restoration by two steps biocleaning process of *Triumph of Death* fresco at the Camposanto Monumental Cemetery (Pisa, Italy)

**Aims:** In this work, the “hi-tech” complex biocleaning and restoration of the 14th-century fresco *Triumph of Death* (5.6x15.0 m) at the Camposanto Monumental Cemetery (Pisa, Italy) is reported.

In this work, we report the *ex situ* large-scale biotreatment of *Triumph of Death* fresco (5.6 x 15.0 m) painted by Buonamico Buffalmacco in the period 1336-41. The conservation state of this fresco showed evident problems due to the color loss caused by pulverization processes, but also due to recent restoration practices that in the course of time resulted inappropriate. The study aimed to the setting up of a “hi-tech restoration process” based on a two-steps biocleaning of the proteinaceous residues (mainly animal glue and casein) present both on the front and back of the fresco paintwork, including the removal of the old asbestos cement support. In addition, the adoption of a new support with specific properties in terms of resistance, insulation and mechanical characteristics for the relocation on the original walls and lastly, the design of a c

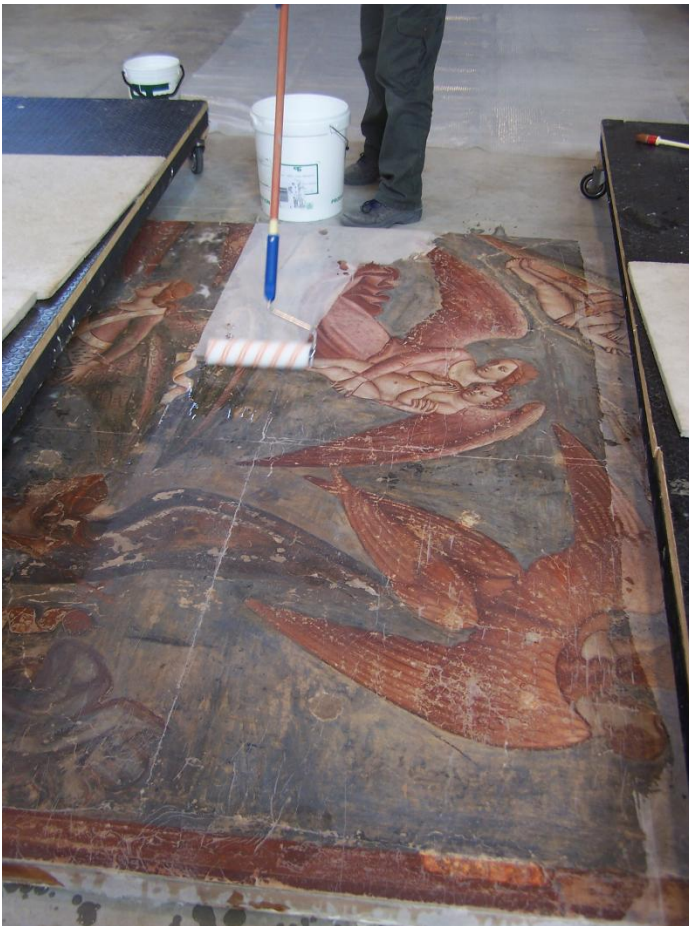
Figure 1 - Biocleaning 1-step on the front surface of “Triumph of Death” fresco altered by animal glue residues.

The *ex situ* biorestitution treatments were performed by a two steps application (front and back) of the *P. stutzeri* strain A29 bacterial suspension on the altered fresco as indicated in Materials and Methods section (**Figure 1**).

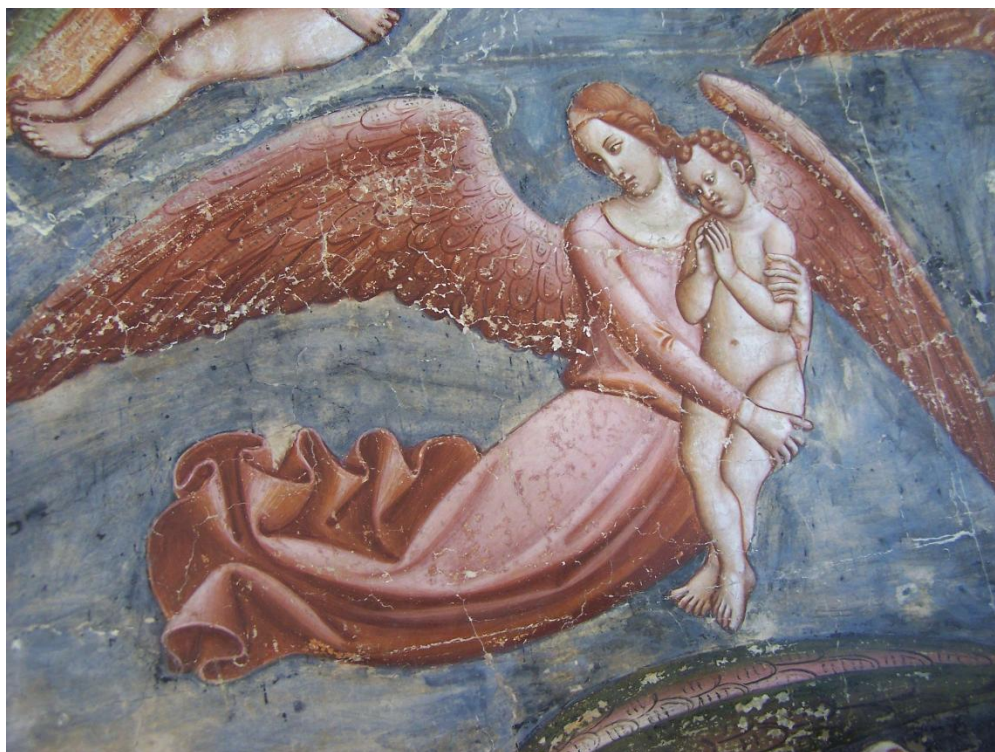
Figure 2 - Particular of “Triumph of Death” fresco surface after the 1-step biocleaning.

After 3 hours of biotreatment using bacterial suspension F (at the front of the fresco) and B (at the back of the fresco), the bacterial activity was so intense that the treated areas were largely biocleaned and no residues of proteinaceous materials were present. The treatment was soft and delicate and did not show any structural damage (**Figure 2**).

Residues of glue from the front and casein from the back of the fresco, present as thin layer at the beginning of the treatments, were completely cleaned. At the back only where small spots of calcium caseinate were thicker (as 1-2 mm), some residues were still noticed, but no greater than around 0.4 mm. Anyway for the Restorers the residual traces of glue and casein were at very low level not visible to the naked eye and by use of a magnifying glass.

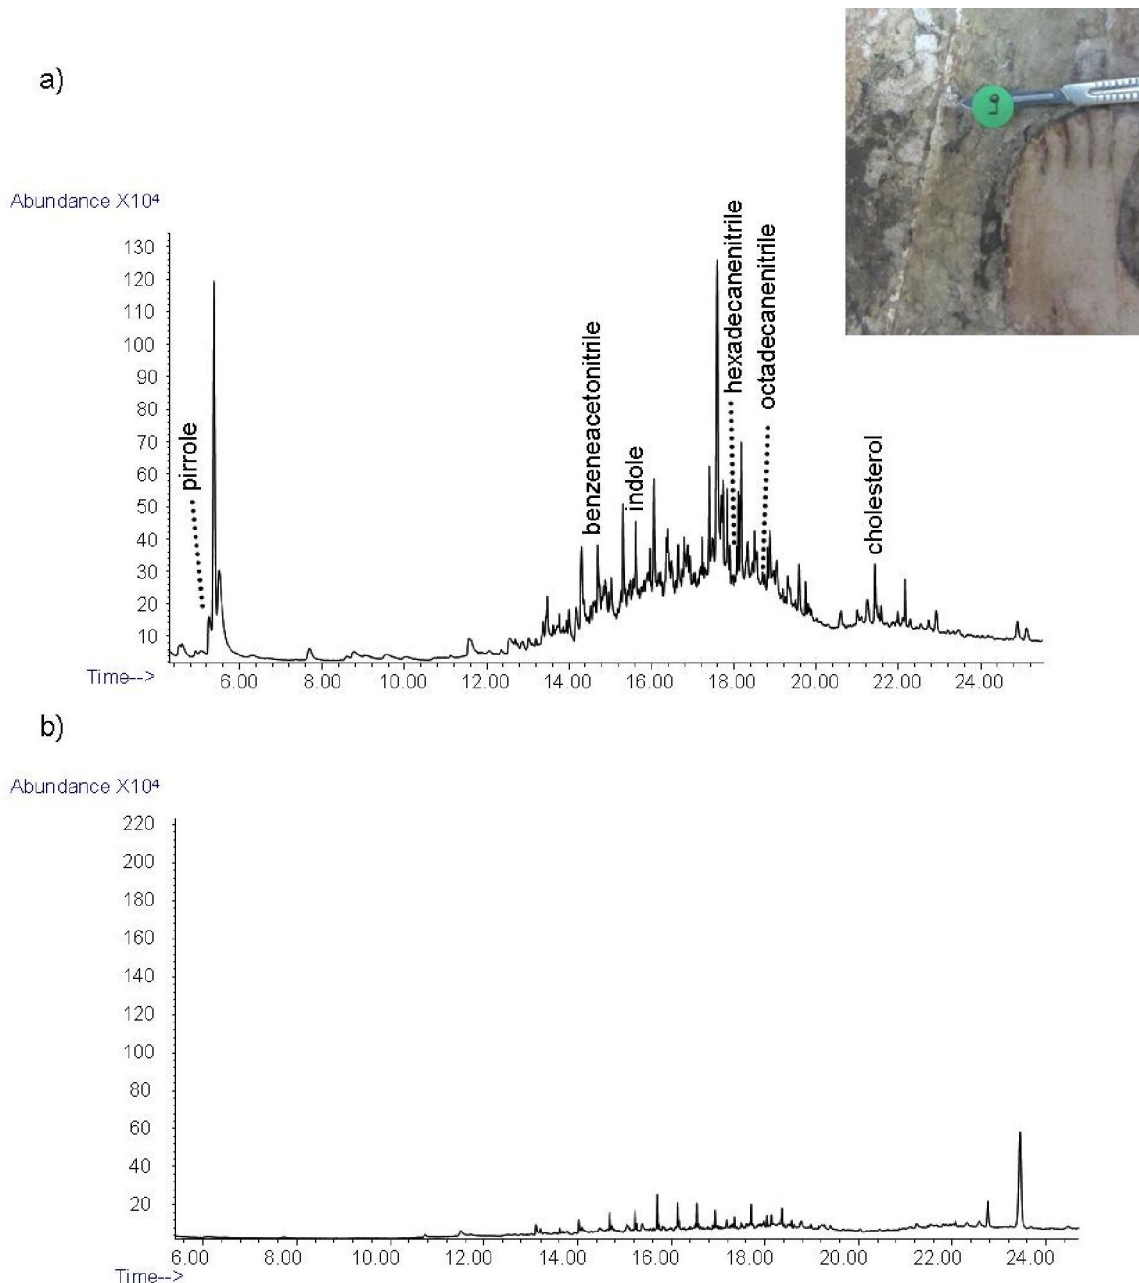
Figure 3 - Pyrogram of a sample from *Triumph of Death* front fresco surface with the specific markers identified for each protein (benzeneacetonitrile and indole for casein, pyrrole for animal glue, and hexadecanenitrile, octadecanenitrile and cholesterol for egg).

The analyses by GC-MS and PY/GC-MS techniques evidenced the presence of proteinaceous material, mainly animal glue, used in the past to glue the gauze onto the front of the fresco (“*strappo*” technique) and casein from the calcium caseinate used on the back of the painting. In a few samples in which the paint layer was most abundant respect to the overlying patina, egg was also present, suggesting his use as organic binder of a few details of the fresco or in the retouching. **Figure 3a** shows the pyrogram of one of the samples, with the specific markers identified for each protein. Benzeneacetonitrile and indole for casein, pyrrole for animal glue, and hexadecanenitrile, octadecanenitrile and cholesterol for egg (other peaks in the pyrogram are not labeled for simplicity, but they are typical rearrangement

products of the pyrolysis of these proteinaceous materials). Finally, the GC-MS amino acidic profiles confirmed that all the proteins had undergone degradation. After 3 hours of biotreatment with bacterial cells suspension F and three gently manual washing steps, the proteinaceous materials were bio-dissolved and not more detectable since below the instrumental limit and sensitivity of the method adopted (see the absence of the main markers of proteinaceous material **(Figure 3b)**).

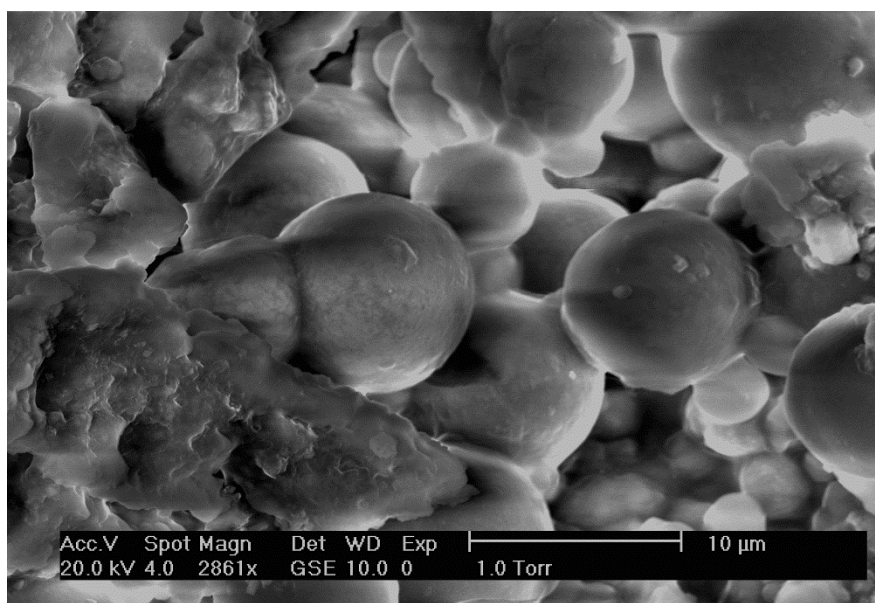
Figure 4 - SEM image of a representative sample from the front fresco after the biocleaning and the anionic resin treatment (bar = 10 µm).

As already indicated in Materials and Methods section, at the end of the restoration, the front fresco surface was treated with anionic resin to remove traces of organic residues. Some representative micro-samples from the fresco were observed by SEM, at higher magnifications, and confirmed the absence of microorganisms after the treatment with the anionic resin and the large presence of spherical particles. In fact, as we observed from the low-magnification picture (**Figure 4**), spherical particles were detected with the diameter-around 10 µm; the same morphology has been previously reported in literature in SEM analyses of anionic resins similar to those used at the end of the restoration work (Gupta *et al.* 2006; Albuszis *et al.* 2016).

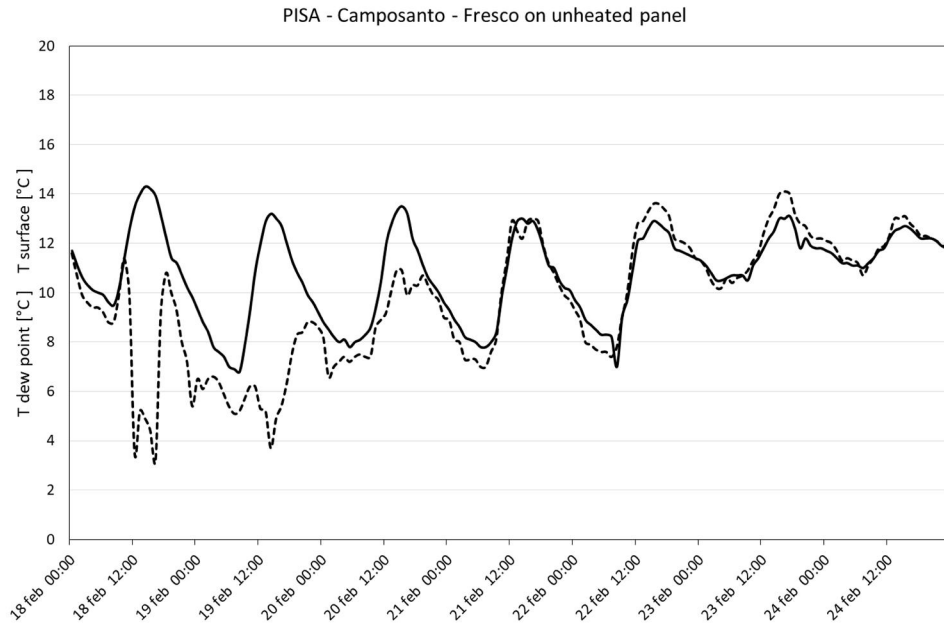
Figure 6 - Fresco on unheated panel. The vapor condensation conditions occur when the dew point temperature (dots) exceeds the fresco surface temperature (solid). Condensation events on 22 to 24 February 2017.

The charts (**Figure 6** and **Figure 7**) show the frescoes surface temperature  $T_s$  and the dew point temperature  $T_d$ . The vapor condensation conditions occur when the dots/yellow curve ( $T_d$ ) exceeds the solid/green curve ( $T_s$ ). The unheated panel shows the condensation conditions during the same period. The variation in surface temperature between heating power-on and off is about  $2.5^{\circ}\text{C}$ .

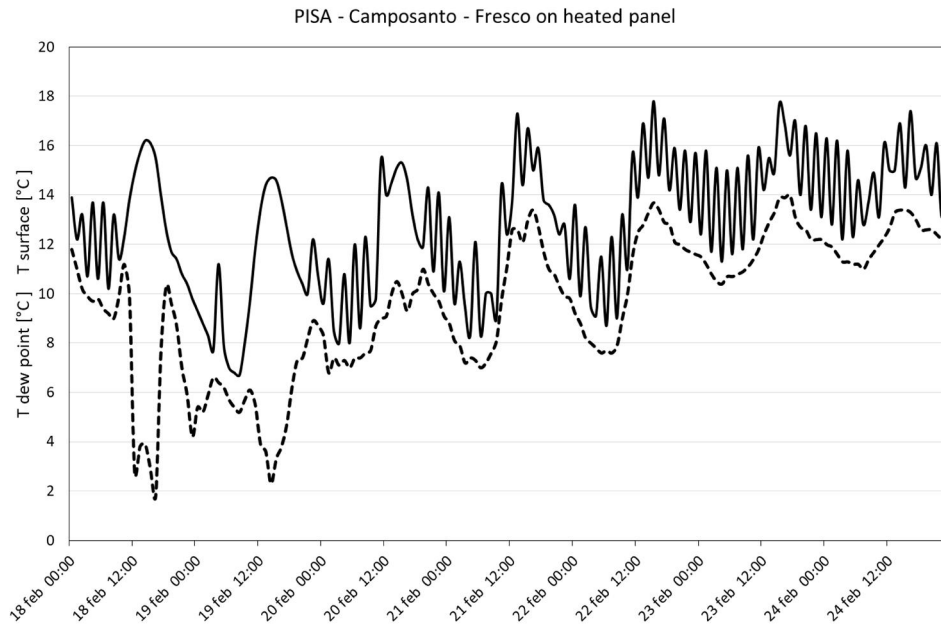
Figure 7 - Fresco protected with heated panel. The vapor condensation conditions occur when the dew point temperature (dots) exceeds the fresco surface temperature (solid).

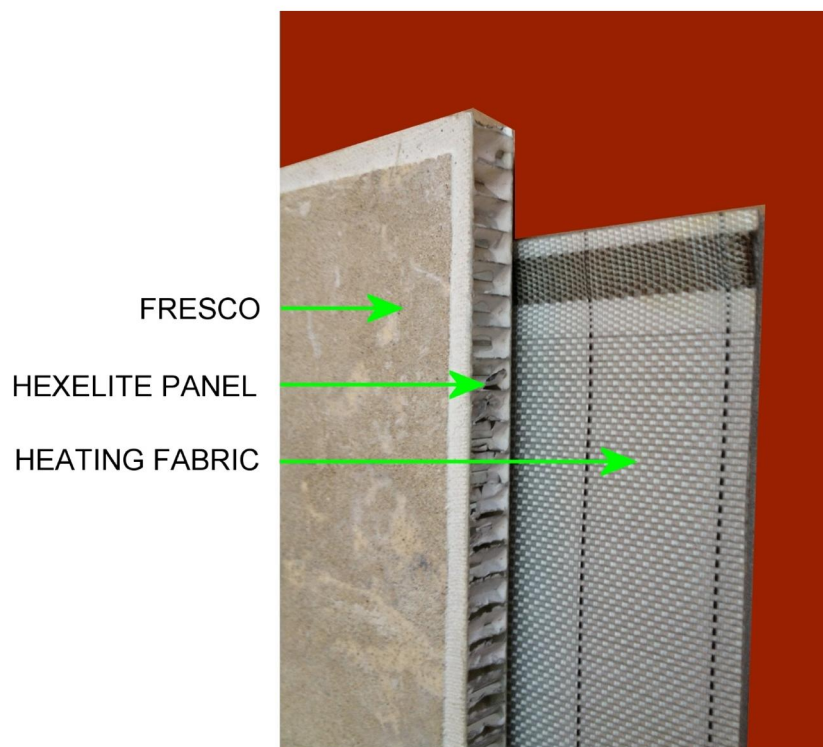
Figure S1 - The new fresco's support composed by restored fresco mounted on canvas, aluminum-centered honeycomb, heating fabric of polyester and carbon fibers.

The new support, known as Compolam or Hexelite, is a panel of aluminum-centered honeycomb used extensively in aircraft industry because of their extreme rigidity, strength and lightweight. The sandwich panel has outer surfaces in fiberglass reinforced epoxy resin (Figure S1). Compolam is a complex material, which requires particular processes and therefore its production is limited in quantities and customized for unique use. The cost indicatively ranges between 80 and 120 €/m<sup>2</sup>. In addition, to complete the final relocation on the original wall, all parts of the fresco were fixed on a special aluminum structure with an additional cost ranging between 100-150 €/m<sup>2</sup> (De Simone, Firenze, IT). The protection of the frescoes occurs through heating of the painted surfaces that is achieved using heating fabric of polyester and carbon fibers adopted for military and civilian heated clothing. The low power supply voltage, the absence of metallic conductors and the reduced energy consumption, guarantee the long time reliability of this application. The heating sheets are based on a traditional manufacturing way, that is a longitudinal warp and a transversal weft, mainly in polyester yarns. At the ends of the fabric, or in the warp (lengthwise), tinned copper filaments are inserted to form two bands, about one cm wide each, which serve to feed the fabric. Transversely, or in the weave (in the sense of width), carbon filaments are inserted into continuous fibers that intersect the two copper bands at the ends of the warp. There are therefore many parallel strands, spaced apart by a few centimeters. The carbon fiber

behaves like a current conductor characterized by a specific resistance such as to generate heat (due to Joule effect) when it is crossed by an electric current. Therefore, the carbon fibers inserted into the fabric behave as parallel resistors that take power from the two copper bands. The result was a fabric that, once powered by an appropriate electrical source, generated homogeneous heat over the entire surface, according to the desired temperature, the size of the fabric and the supply voltage. The fabric thus produced was then coupled on both sides with a thin polyurethane film which guaranteed an electrical insulation, an adequate protection of the fabric and a good mechanical stability. One of the two sides was then coupled with an expanded material and finally with a reflecting film to ensure good thermal insulation on the back side (passive) thus maximizing the heat transfer on the active face of the sheet which is placed in contact with the back fresco surface. In addition, to the conductive component, a high radiating component is obtained which also heats by infrared irradiation. So, the final support produced looks like a sandwich of several layers, of a uniform overall thickness of about 5 mm, robust but light, cut to size with a common scissor, able to develop specific powers up to a few hundred Watts / m<sup>2</sup> and temperatures up to one hundred Celsius degrees. In our specific case at Pisa, after relocation of the frescoes mounted on the new heated panels (**Figure 5**), the protocol adopted guaranteed to obtain a surface temperature of the frescoes at least 2°C higher than the air temperature, so as not to give the water vapor of the air a cold surface on which to condense. Through a constantly microclimatic monitoring, a new-casting model automatically provides the signals required to activate the heating of the frescoes and prevents the beginning of vapor condensation and the dust deposition on the painted surfaces.
