Introduction guide to the preservation of traditional thatching of the Buganda community in Uganda

Traditional thatching

of the
Buganda community in Uganda

December 2019

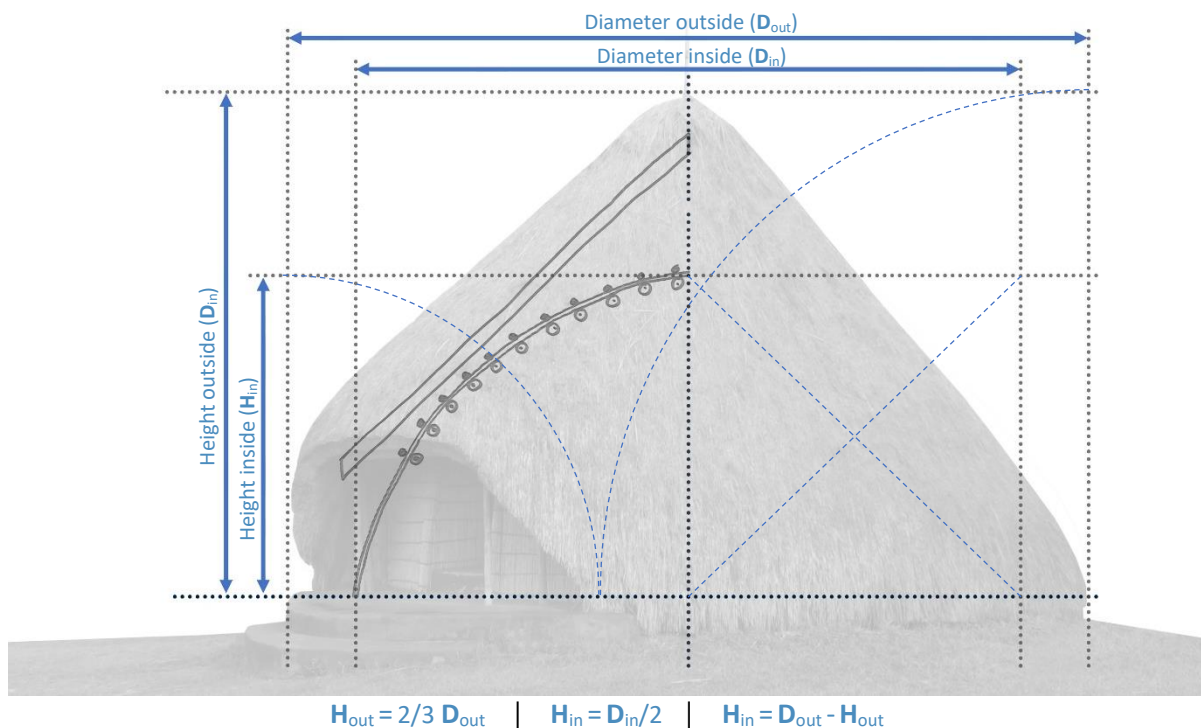
The sketch below shows the common proportions observed on existing roofs.

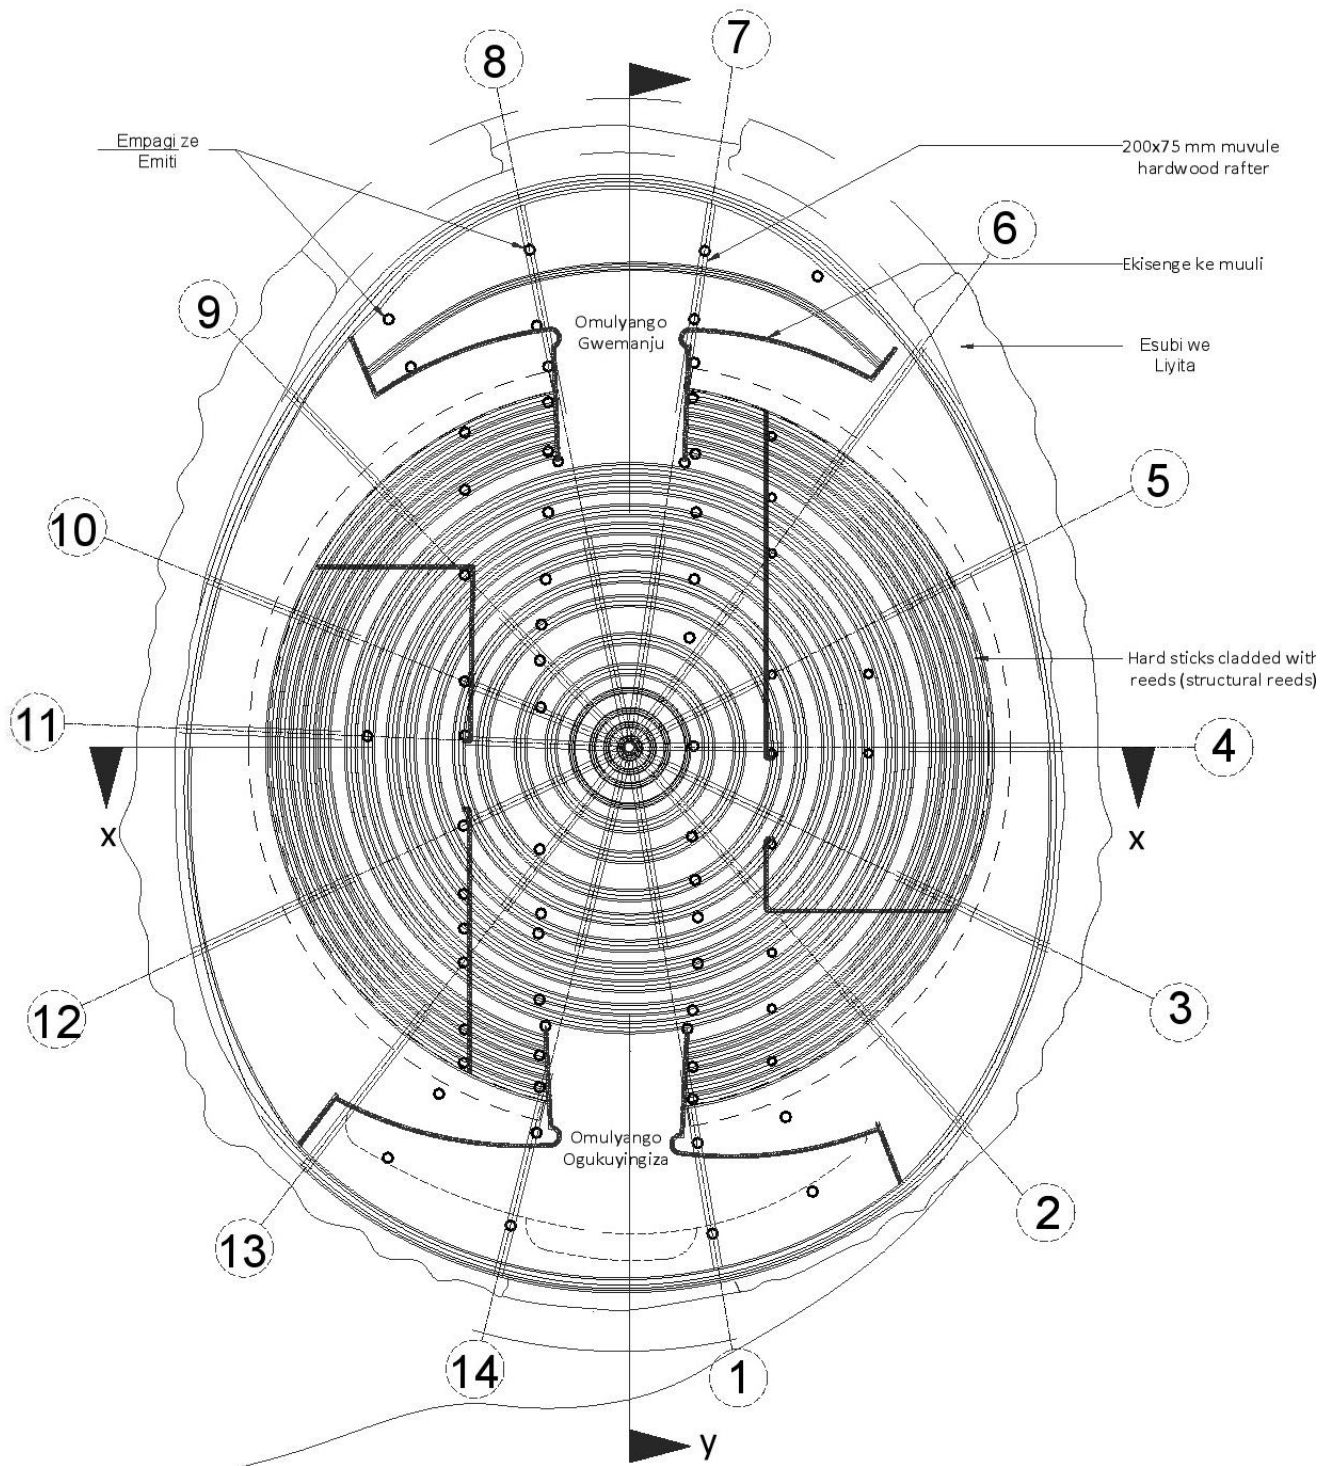
Plan

The numbers (1 to 14) refer to the rafters.

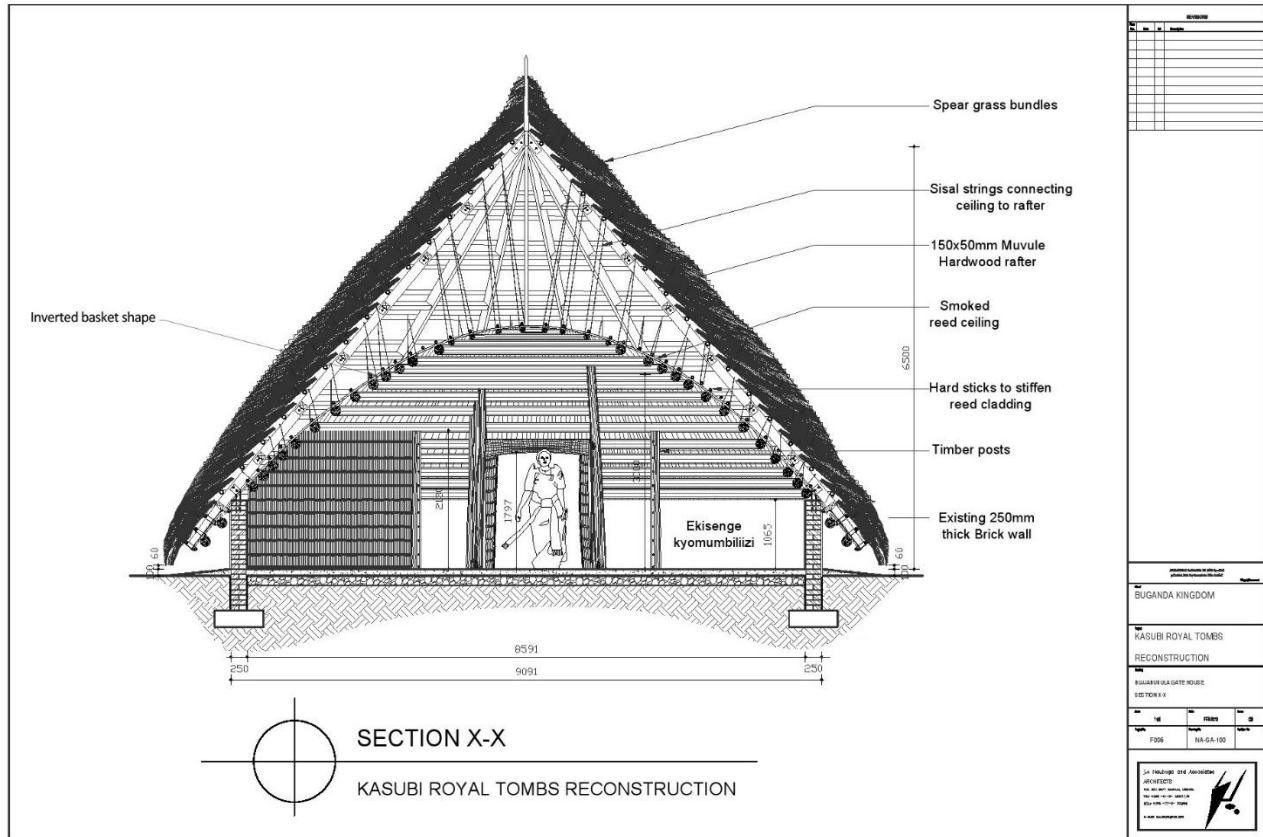
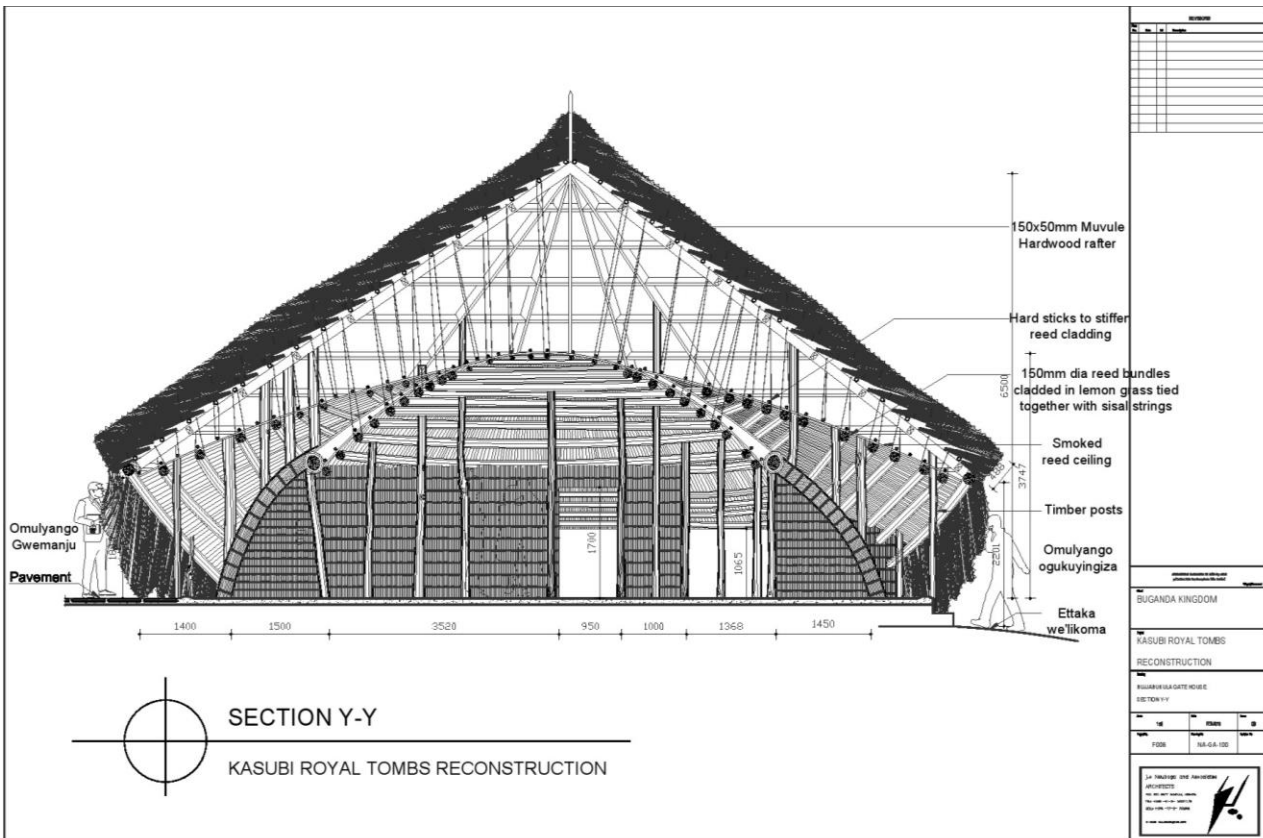
Sections

Bujjabukula restoration drawings by Jonathan Nsubuga & Associates

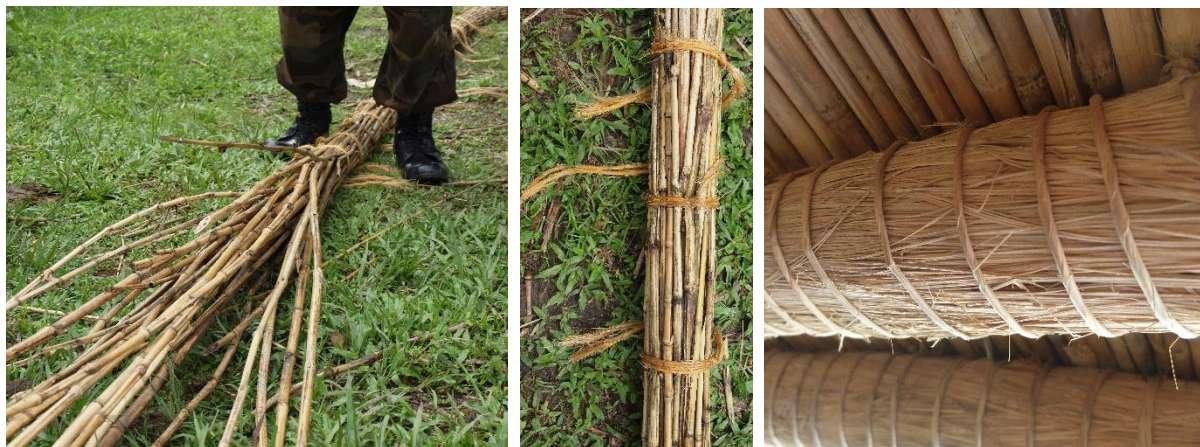
To make the rings, the reeds are tied together with sisal rope. For the visible inner rings, they are covered, once the ceiling is finished, with palm frond sticks (*Amavuvuume*), themselves tied against the rings with water grass rope (*Enjulu*).

Tying the reeds with sisal rope to prefabricate rings

Inner rings covered with palm frond sticks (*Amavuvuume*) tied with water grass rope (*Enjulu*)

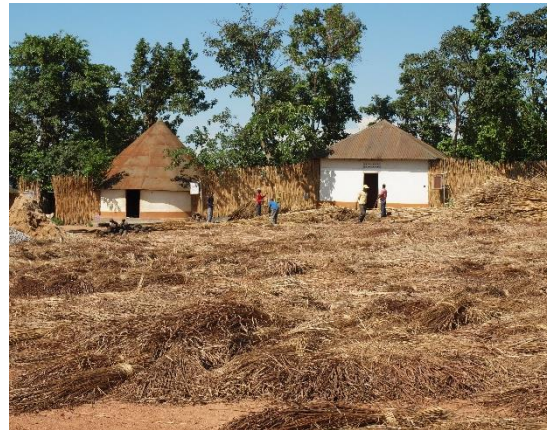
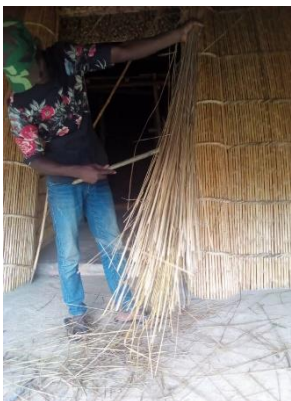
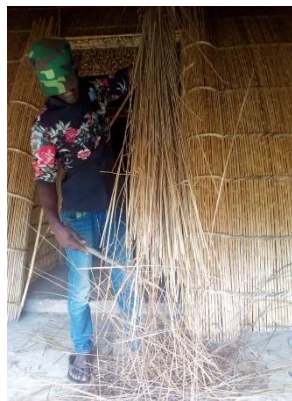
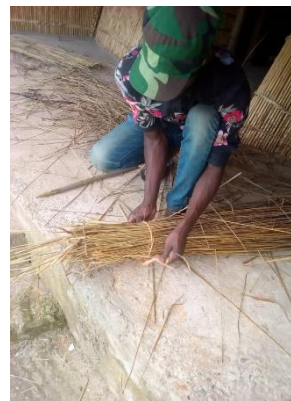
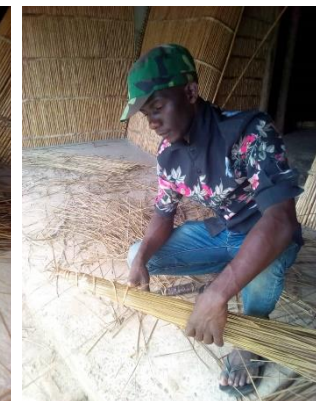
Combing a bundle with a stick to remove unwanted elements and tying the bundle in a conical shape with a sisal rope
4 photos by Brian Kalema

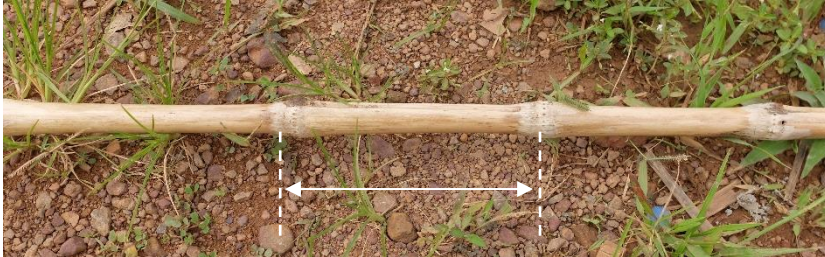
The craftsmen do not use measuring tapes, although they constantly measure elements during the construction process, such as the spacing between the rings to ensure that the circles are perfectly round. According to the thatchers, the eyes play an essential role. The senior thatcher spends most of his time observing the roof from a distance, to ensure that the curves, the spacing between the rings and other details are perfect. Reeds also serve as measuring tools, using the gap between 2 knots as a unit. In that case, all measurements are made with the same reed.

Reeds are used as measuring tools, using the knots as a unit

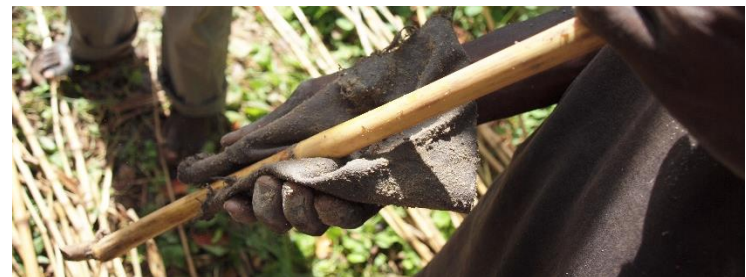
Rags filled with sand are used to smoothen the reeds.

Smoothering reeds with a rag filled with sand

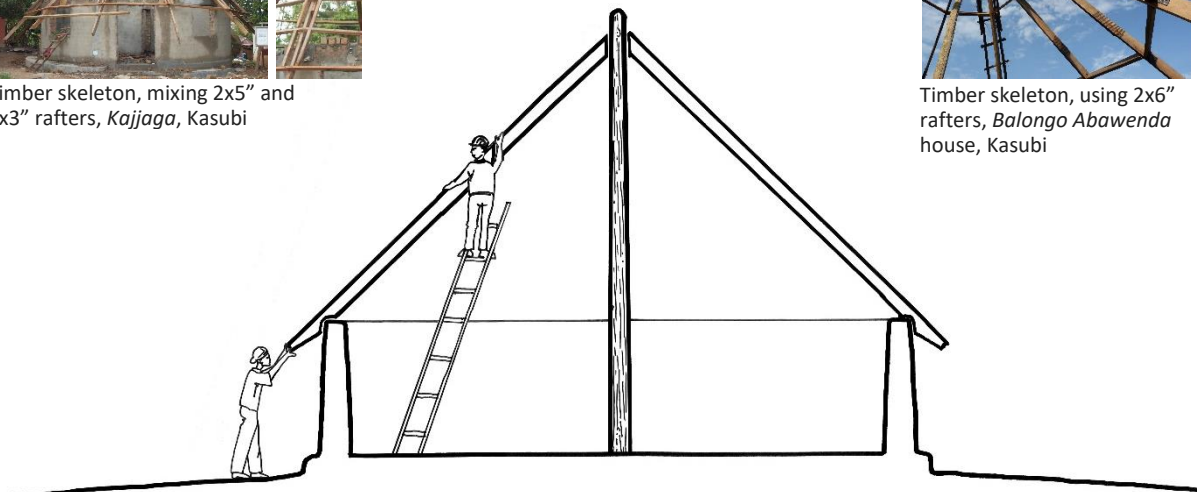
The number and size of the rafters depends on the roof span. The rafters should be resistant enough to carry both the weight of the thatch and the weight of the ceiling. Small structures (6-10 meters diameter) can use ordinary *Muvule* rafters. All wooden rafters are pre-treated against humidity and insects before being assembled.

Timber skeleton, using 2x6" rafters, *Balongo Abawenda* house, Kasubi

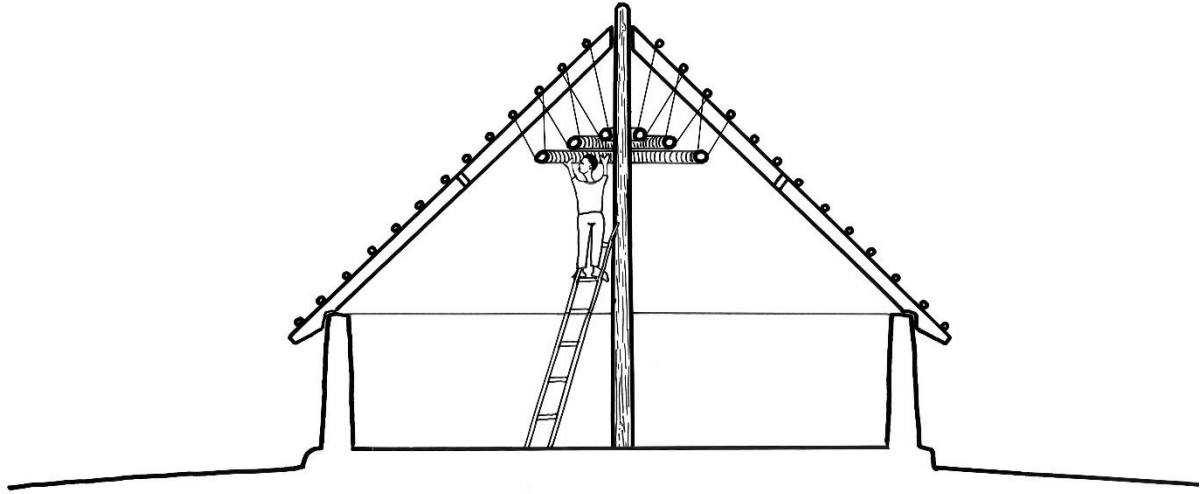
Manufacturing the top rings around the central pole

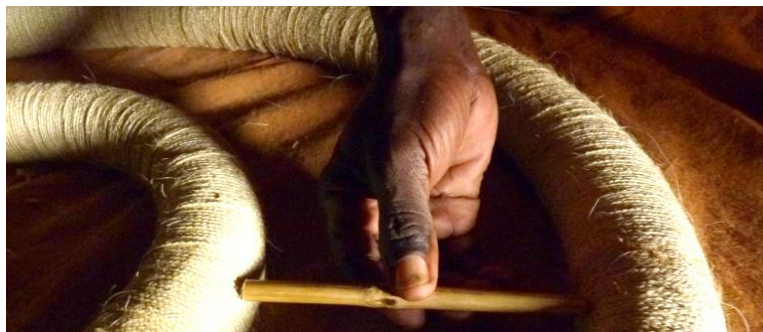
The spacing between subsequent rings is always the same

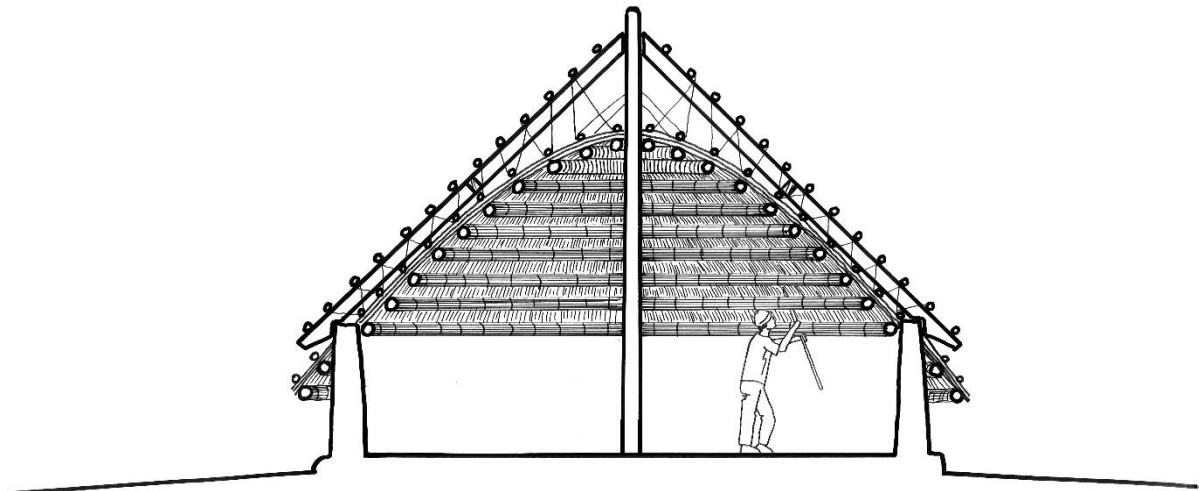
2 mm steel wires connecting the ceiling to the battens

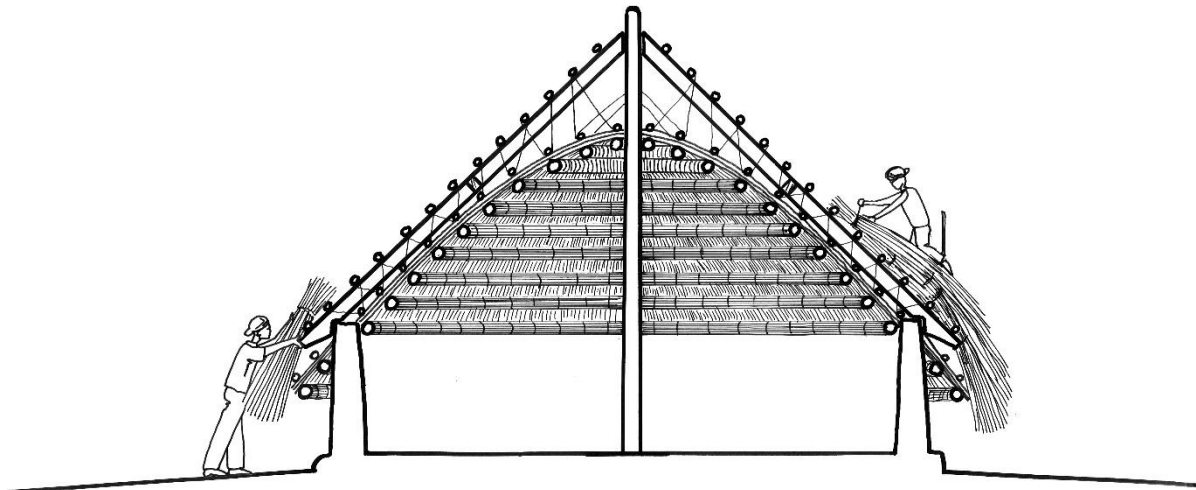
Thatch bundles are attached starting from bottom moving upwards. They are linked to the battens using tree bark fibre (Ebinsambwe) or sisal rope. An additional battens structure is sometimes added to the roof, as shown in the pictures below. The lower eaves are neatly trimmed with a knife at the end.

Tying thatch bundles to the battens
3 photos by Remigious Kigongo

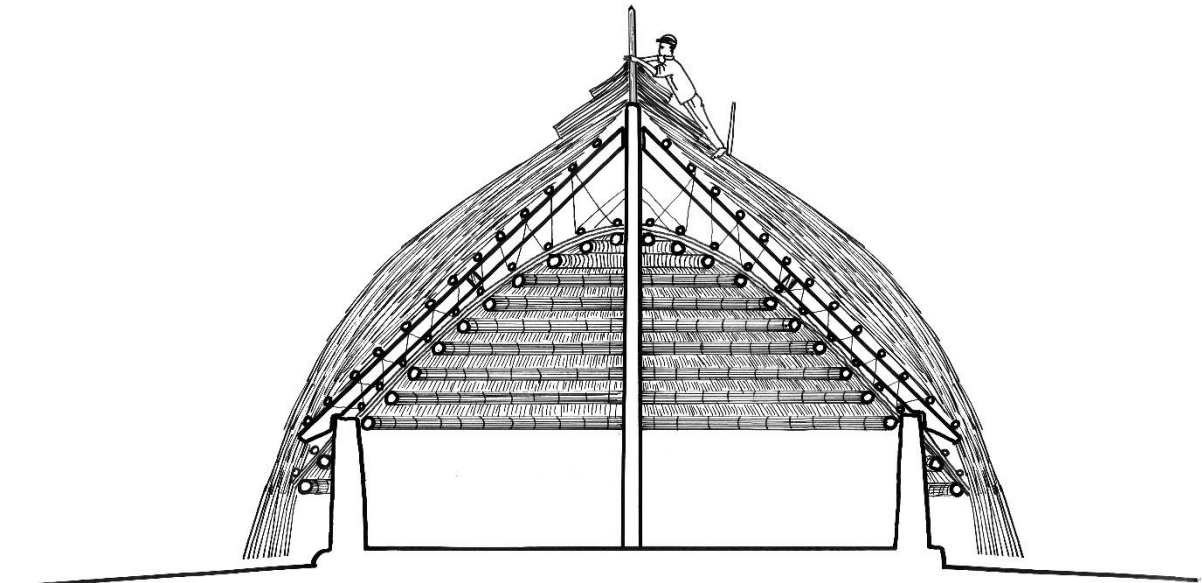
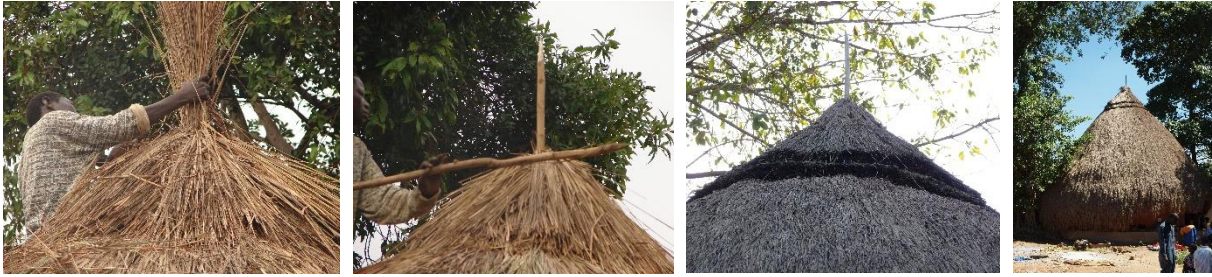
Particular care is taken with the hat that covers the top of the roof. This straw hat is attached to a Musambya stick planted in the straw.

Examples of top finishes
2 photos on the left by Remigious Kigongo

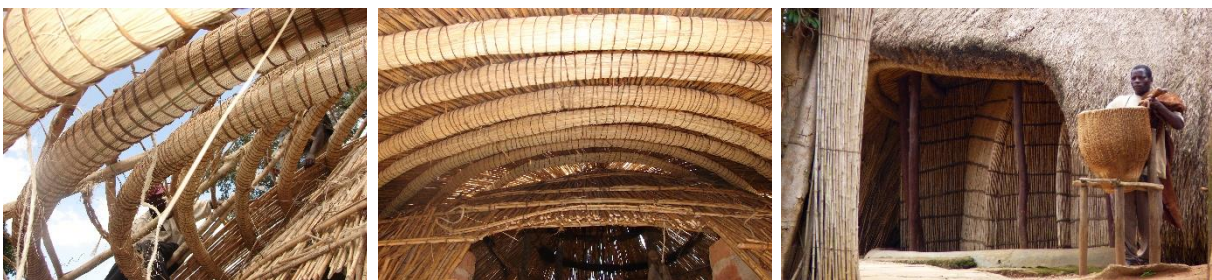
Details on the extra ceiling covering the entrance
2 photos by Remigious Kigongo

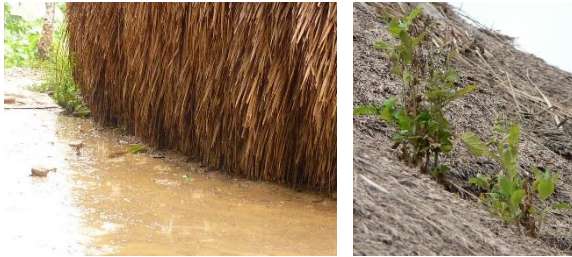
Strong windstorms move the straw and create gullies in which dead leaves and seeds penetrate.

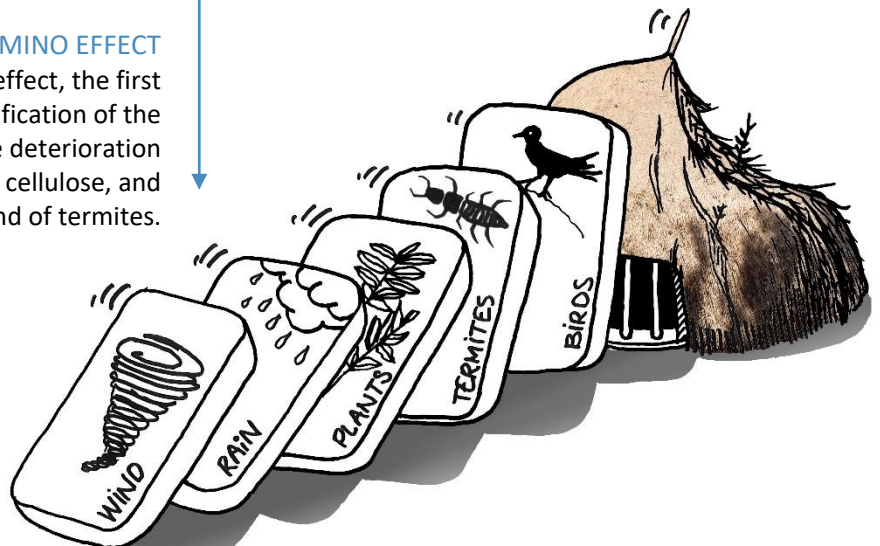
We therefore observe a domino effect, the first infiltrations leading to the humidification of the straw and therefore its progressive deterioration which attracts termites, fond of cellulose, and birds, fond of termites.

If infiltration problems are not addressed by regular replacement of damaged straw, the process can go as far as partial or collapse of the roof.

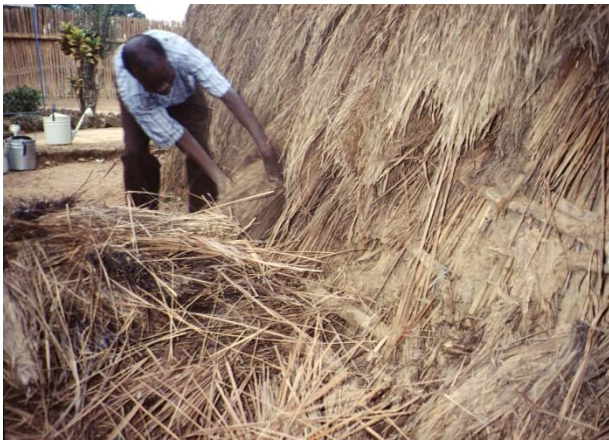
Removal of decayed thatch at Kasubi

This need for permanent maintenance is part of the technology itself, as explained in the introduction and in the previous chapter on construction. If the thatch bundles are not all tied to the roof, it is precisely to enable an easy replacement in case of damage. It is also interesting to note that the replacement of a few decayed thatch bundles can be done by a junior craftsman.

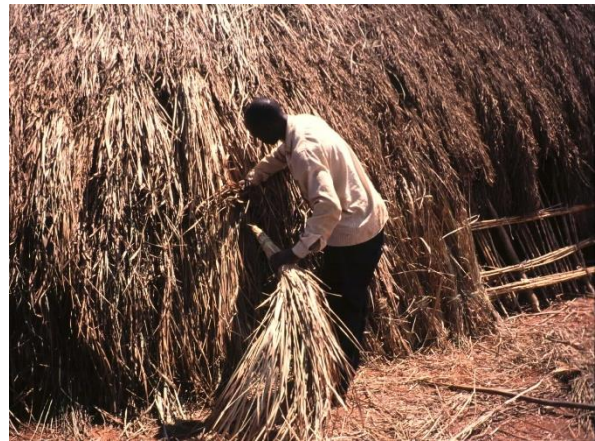
Insertion of new bundles at the base of BujjaBukula, Kasubi

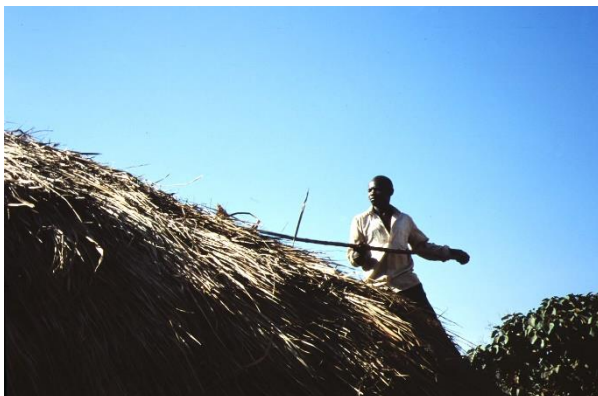
Cleaning and readjusting the thatch with a stick

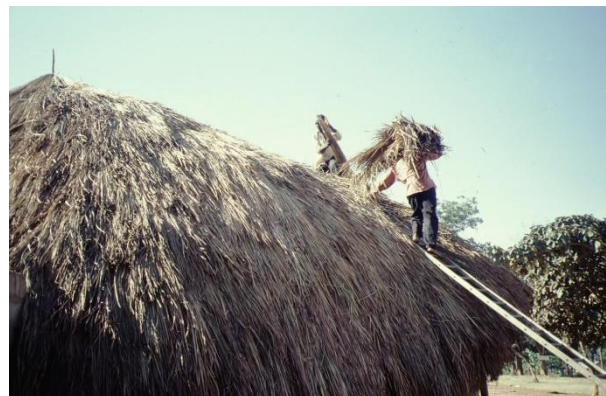
Bringing new spear grass bundles on the roof to fill gullies

The deterioration speed of a roof is directly linked to its moisture content. The drier a straw roof is, the more resistant it is over time. To achieve durability, roofs must be regularly inspected to fill up gullies through which water infiltrates. The inspection should be done at regular intervals and after severe storms.

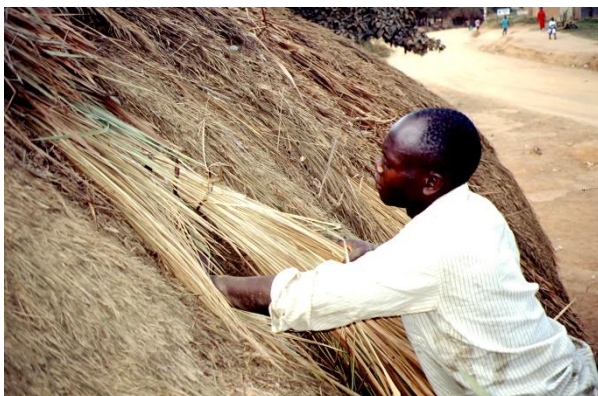
Inserting new bundles in a gully after removing decayed grass

Once the dead leaves and plants have been eliminated, the decomposing straw can be removed and replaced with dry bundles. It is advisable to check the weather forecasts so that this replacement can be done in sunny weather, to allow the roof to dry. The new straw must be perfectly dry when it is laid. The straw removed should not be thrown away. It should be given to farmers for mulching vegetable crops.

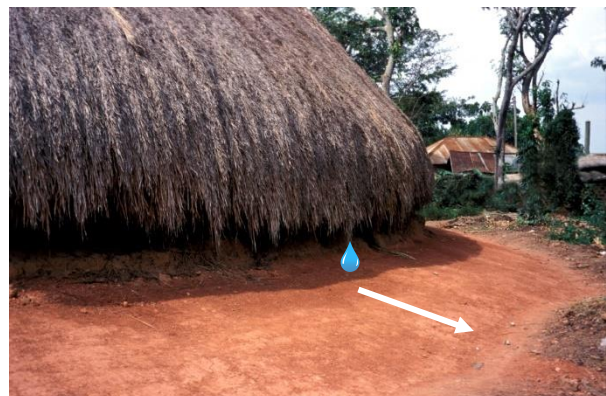
Drainage slopes made of compacted laterite

The drainage of the site also limits the presence of humidity and termites, by diminishing the amount of water absorbed by the ground. Slopes should be provided to drain runoff rainwaters from the buildings towards farmland areas.

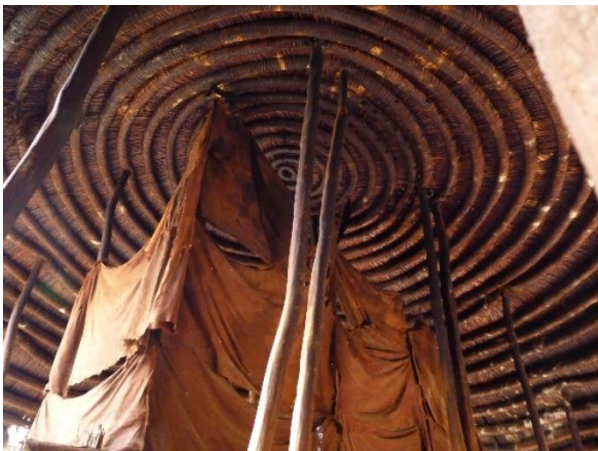
Rings protected by a layer of suit at Wamala tombs.

Thatched roofs are traditionally treated by smoking. Straw coated with soot is more resistant to moisture on the one hand, and discourages termites on the other. Ideally, smoking should be done several times a week, using dry wood that does not spark while burning. Wood species used include *Kasaana* (clears evil), *Musizi*, *Endagi*, *Muzanganda* (to connect with the spirits), *Mwule* and *Muwafa*. In any case, *eucalyptus* and *Twalabafo* are totally prohibited.

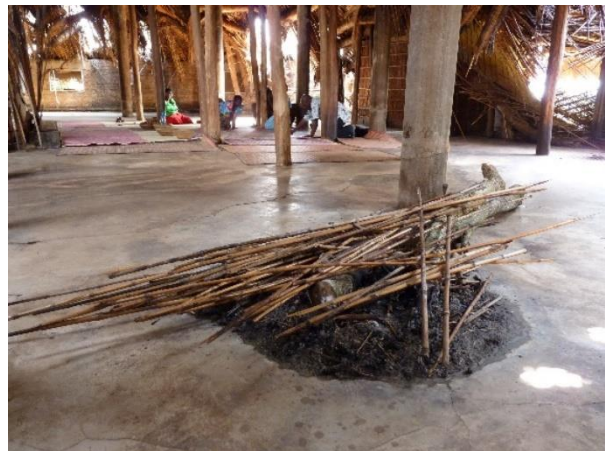
Fire place within Wamala tombs.

Regular indoor fires also help to dry the straw from the inside by sending hot air through the thick thatch layer. To avoid fire hazards. To avoid the risk of fire, it is obvious that the layer of lemon grass on the ground and the mats covering it must be moved when the fire is lit. On the other hand, no fire should be lit during a storm or on a windy day.
