The Qalhât Project. Preliminary Report on the fifth season (30/10-06/12/2012)

The Qalhât Project

Preliminary report on the fifth season

I. Excavations at the funerary terrace B67

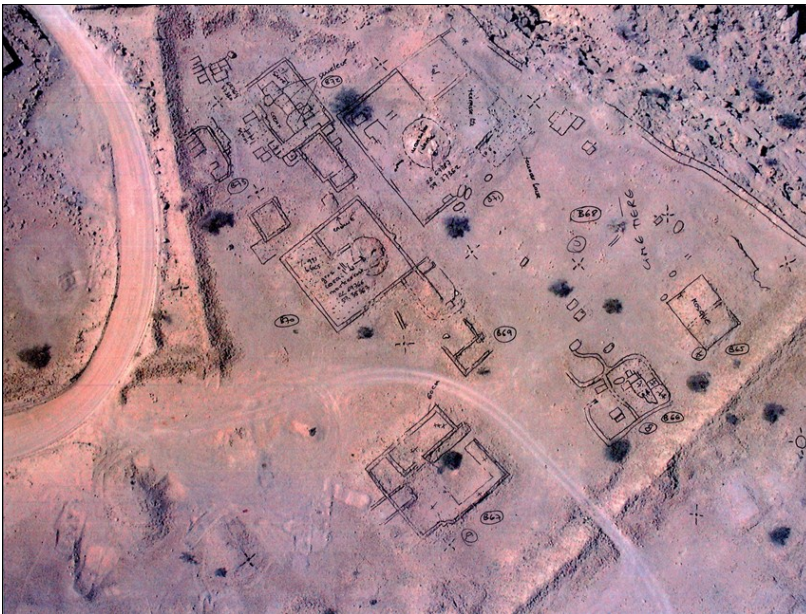
Figure 1: aerial view showing the location of the structures B67, B66, B69 and B70.

The 2012 campaign of excavation in Qalhât was held between October the 30th and December the 5th. We focused on the understanding of the Northern funerary complex located close to Bibi Maryam mausoleum, between the Eastern and Northern walls (Figure 1).

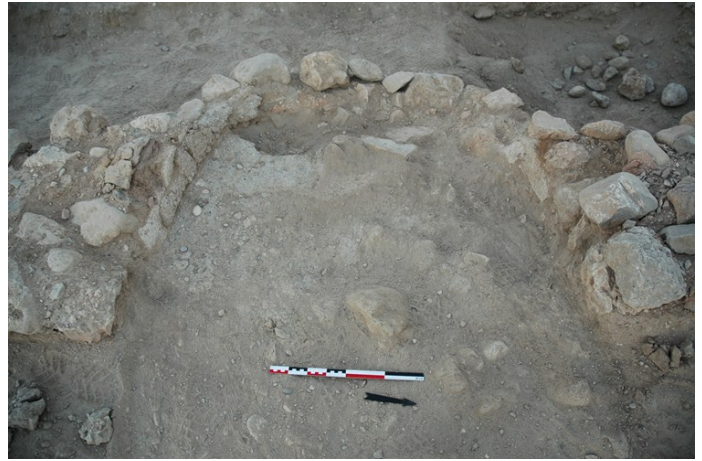
Figure 5: the mihrab (021).

In its original shape, the *musalla* measured 6.5 x 18.5 m. The entrance is located in the east, cutting the original wall 012 in its half, opening directly in front of the *mihrab*. The threshold (020) is well built with flat stones and mortar and associated with three steps of stones down from the courtyard to the *musalla* (Figure 4). Wall 010 is the *qibla* wall cut by the *mihrab* (021) in its half (Figure 5). This *mihrab* was covered inside with two layers of plasters. The first one is white, compact and of good quality while the second one is a raw earth plaster. In a later phase, the

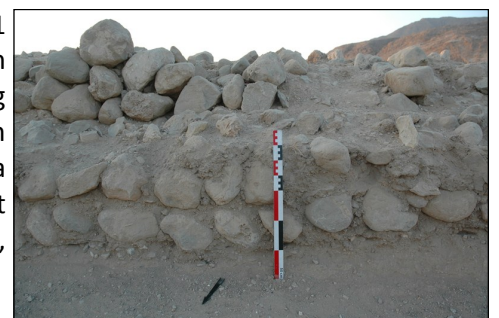
Figure 6: wall 001.

The collapse level against the northern wall 001 was recorded as UF1551 and removed from the entrance (ST 028) to the eastern corner 0.50 m high from the top of the remaining wall down to the base of the slope finishing 1.50 m to the north of the wall. This layer was made of a loosy light brown earth with stones and corals and mixed with mortar pockets. It revealed a regular face of the wall and the basement lies on a mortar layer and not directly on the bedrock. At the eastern corner there is a nice corner stone, indicating the good quality of the walls construction.

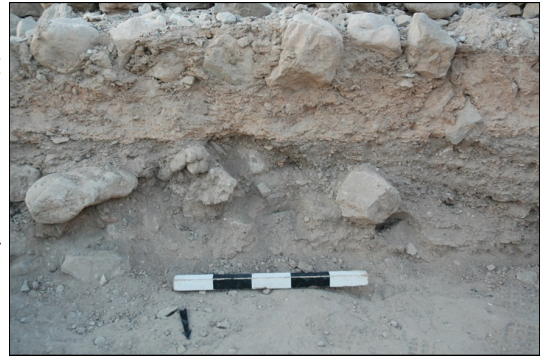
From the other side of entrance 028, the wall 011 was cleared, and the collapse layer removed (UF1553) was made of a light brown earth with stones and corals mixed with an orange mortar. We dig 0.70 m high from the top of the wall in a 2.30 m slope down to the north. We stopped on a basement made of very big stones (031). Actually, this level (UF1553) was mixed with wall 033 built on the top of these big stones and a loose greyish earth level mixed with stones that appears to be an earlier collapse layer. Wall 033 is lying against the external side of wall 011. These two structures (031 and 033) are a later addition to wall 011 (Figure 7) in order to enlarge the wall, and/or to consolidate its basement after a first collapse.

Figure 7: cut showing wall 033 covering the big stones basement (032) and lying on a loose grey layer.

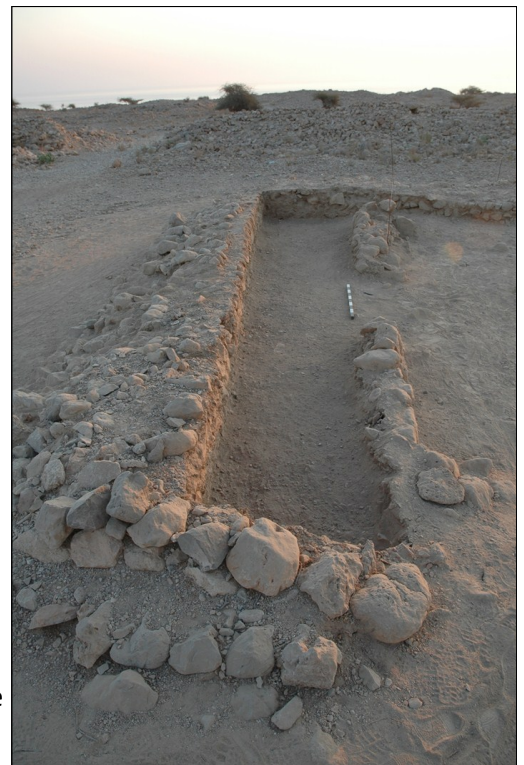
Figure 11: the room F.

Then the terrace has not been completely unearthed but only on its western half, between walls 022 and 038. The first layer removed (UF1560) corresponds to UF1558, that is to say a layer made of loosy brown earth with gravels, small stones and pebbles. This layer is 10 to 15 cm high and corresponds to the last level of backfill in the terrace F. Beneath was the main backfill of the terrace removed on 40 to 50 cm, made of loosy brown earth and pottery sherds lying on a mortar layer (UF1568). The bedrock is located just under this layer of mortar, at Δ 32.54 m. The basement of wall 038 lies directly on the bedrock. However, the mortar layer is cut along the wall and a trench is obvious on approximately 3 m length. The filling inside (UF1565) was a loosy brown earth with a few pottery sherds and rootlets. First interpreted as a foundation trench, it has no connexion with the wall (that lies directly on the bedrock), and is not visible on the bedrock as well. Only traces of ashes were found underneath this trench, on the bedrock. This could be the remains of an earlier occupation, but no structure was associated with it,

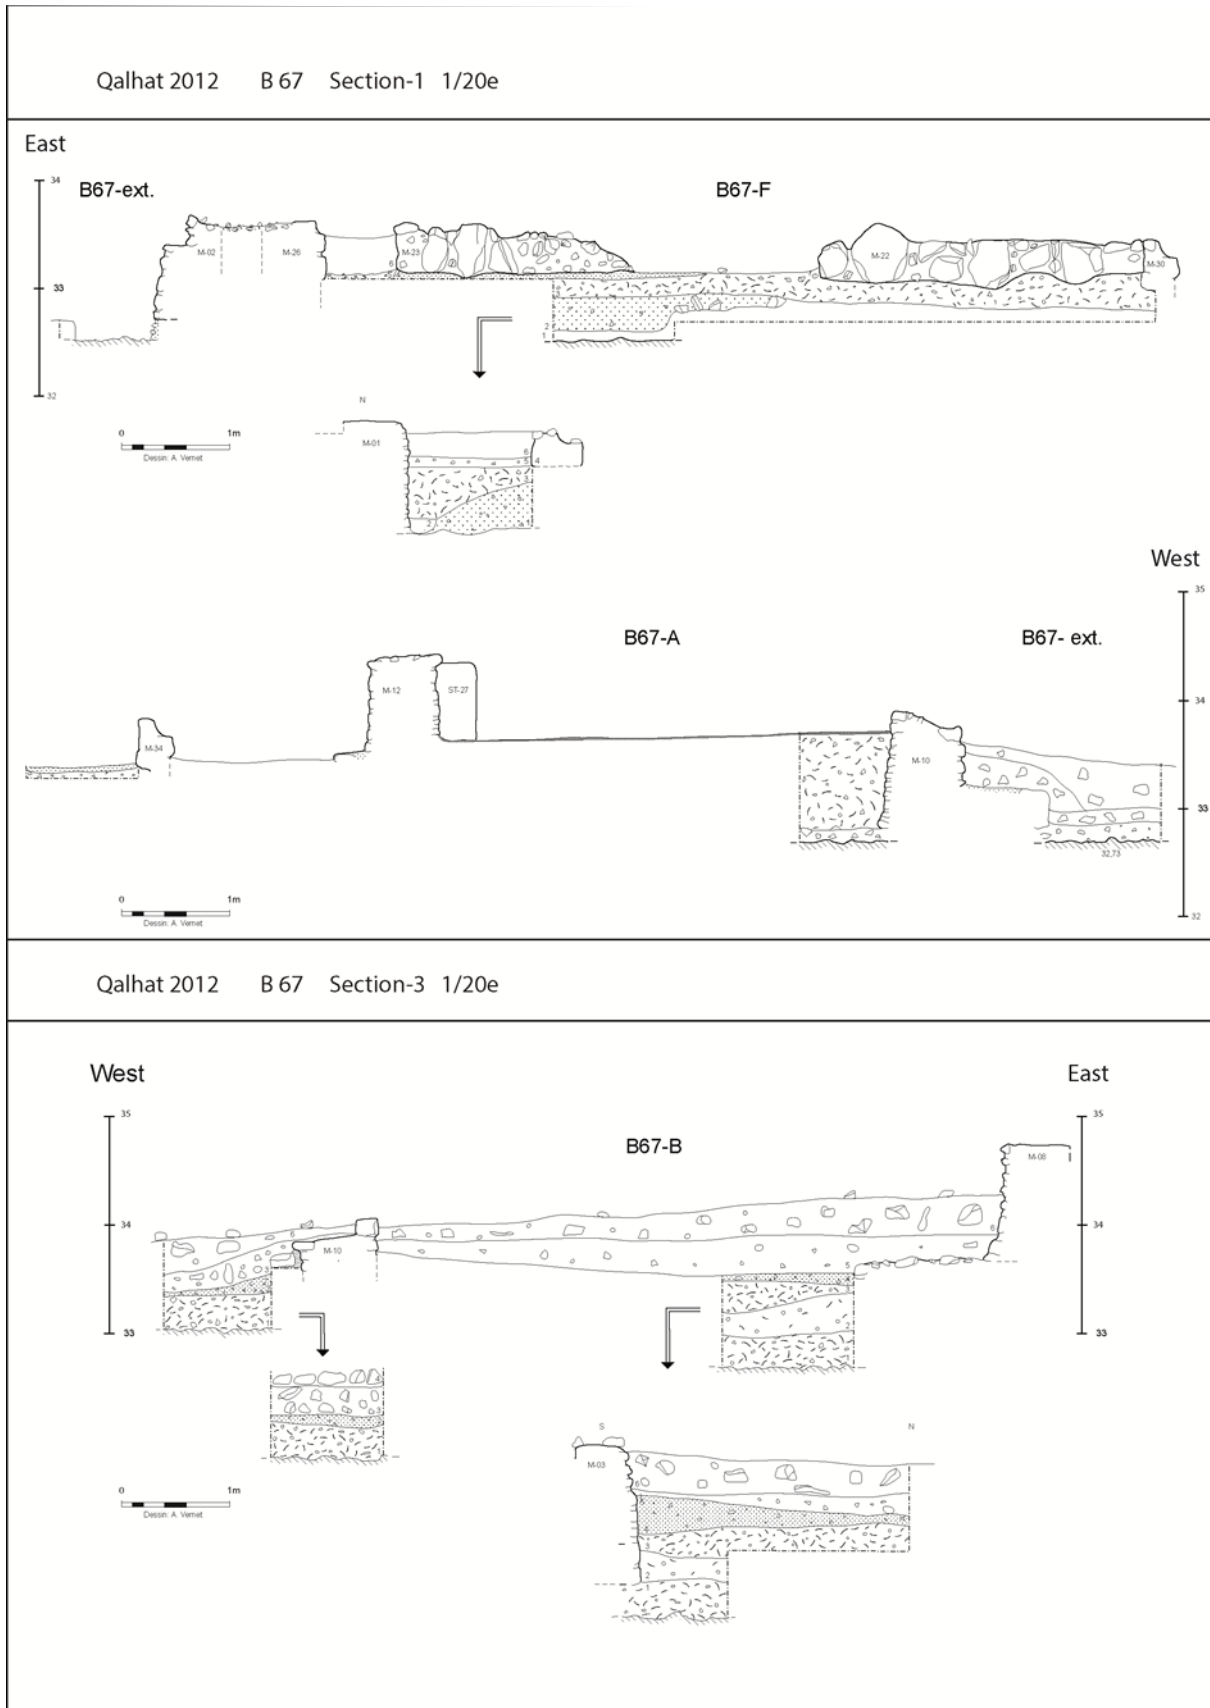
Figure 12: sections 1 and 3.

as it is a different level of mortar that the one located just beneath wall 023 (Figure 12, section 1)

Under the floor appeared a backfill of pottery sherds (UF1585) as we already observed in room F and B, respectively UF1563 and 1581. Finally, the bedrock appeared at Δ 32.63 m after removing the apron (UF1588) that outcrops on the bedrock and on which were based the walls 010 and 011 (Figure 12, section 3).

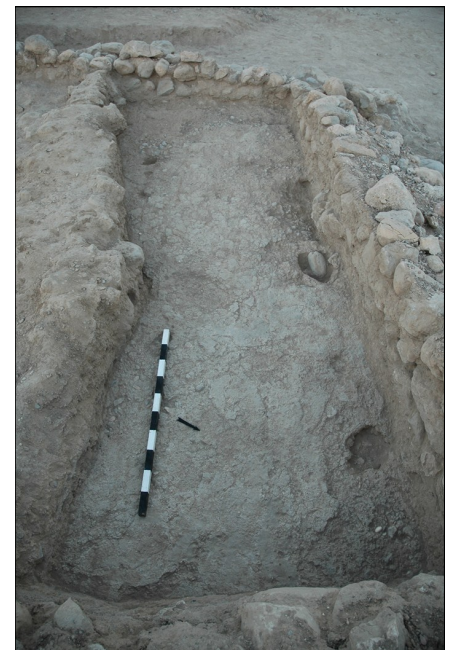
The excavation began with the cleaning of the whole surface of the room except the berm. The collapse layer (UF1569) was made of pulverulent light brown earth with stones and corals on 15-20 cm high from the walls to clear them and to level it. A sounding was excavated in the northern part of the room, between the *qibla* wall and 012, and along 011 up to the berm. The collapse layer UF1573 was removed on 10-20 cm high. It is made of vegetal plaster and a kind of felt (or another fibrous material). A few rolled pottery sherds were mixed in what is interpreted as the cover of this part of the *musalla*. Just beneath was the layer of the collapsed cover itself (UF1576). It was made of compact earth with different exposed elements with vegetal traces and remains mixed with the fibrous material. A piece of wood was also found, indicating there could be palm branches. This covering was presumably made of fibrous material and wood mixed with plaster and a backfill take off in the surroundings.

Figure 14: floor 018 in the musalla with postholes.

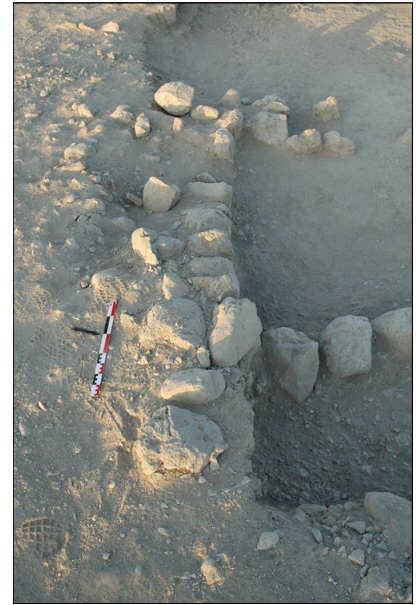
Figure 16: wall 035.

The excavation in the courtyard unearthed a few structures of interest. Firstly, the basement of a wall (035, Figure 16) perpendicular to wall 026 where many tripods and firing waists were found in layer 1567, indicating that the backfill was at least partly made from the pottery kilns waists in Qalhât. This wall is badly preserved and it is impossible to say how long it was and with which structure it was connected apart wall 026. Perpendicularly to it is the wall 025, which is 0.35 m thick and preserved on 3.35 m between the berm and the south excavation limit. It seems that this wall is the continuity of the corner of wall 023. It could have been the same structure, maybe a circulation space.

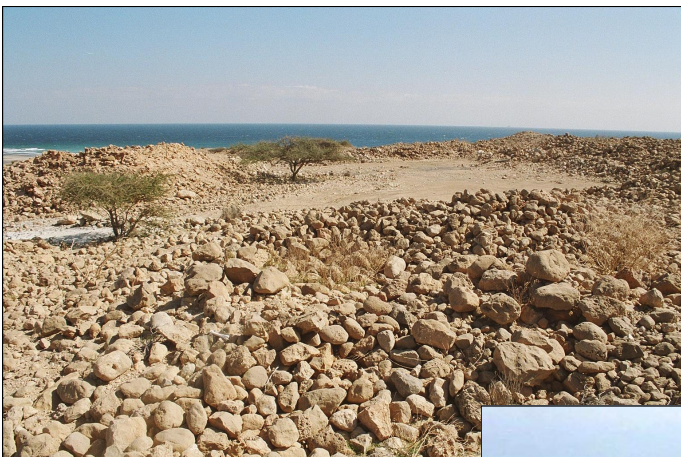
B19 is situated in the north-west quarter QNW1, at the southern edge of the north funerary area. It stands to the north of a rectangular square which is lined on the three other sides by seemingly houses, B21 to the south (see infra), B20 and B22 to the east and west (fig. down).

The building is erected on a platform, 16.4m e-w, 8.2m n-s and about 1.5m high, with retaining walls built in stone blocks of various dimensions (10-40cm) embedded in a pinkish and rather smooth mortar with many inclusions of gravels and small pebbles; the filling is unknown (7-4c). As a matter of fact, the platform is made of two contiguous terraces, one under the courtyard, and the other under the musalla (fig. down).

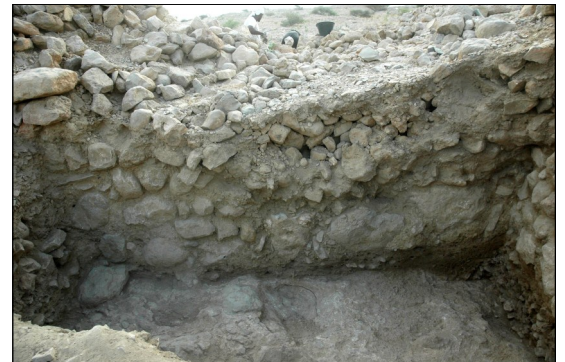
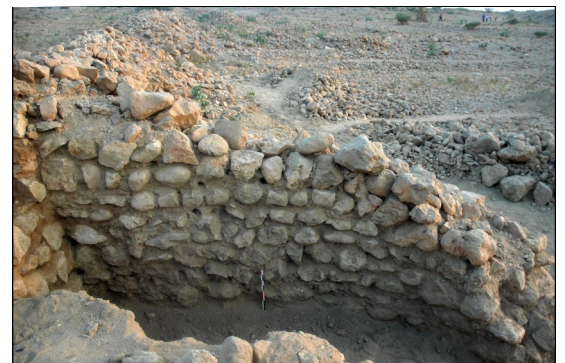
This sounding delivered similar information as the sounding on the outer face of B7, with 4 phases (fig. section preceding page, and right). The bedrock is covered with a very hard layer made of grey earth and few stones, with slight traces of occupation prior to the construction of B7 (Uf 908). This wall is based on the same foundation of gravels (Uf 906) surmounted by a homogeneous thin layer of grey earth (Uf 905); an occupation layer of rather soft grey earth and few stones is leaning against its base (UF 907/910). Wall B6 was built on this level, with a construction layer of a yellowish and very hard clay very similar to the mortar of the wall leaning against the base of the wall in the eastern part of the sounding (Uf 909). B6 is badly preserved here but clearly abuts against the face of B7, with some big stones in its lower course and few small ones added to fill the gap with the facing of B7 (fig.24). It is made of big blocks bounded with a yellowish clay, approximately 2m50 wide and preserved ca. 1m20 high. In the eastern corner of the walls a section of a curving wall was discovered under the collapse layer (B6-001), abutting against B6 (fig. right). Its eastern extremity was not cleared and its general layout is unknown, maybe a quarter-tower about 1.20m in radius. It is entirely built in medium blocks, facings and filling, with some big ones in the curving part. No occupation layer was found associated with B6, the area being later buried under a mass of collapse stones, mostly pebbles and very few corals, mixed with a light brown earth, soft in the surface, harder and darker in the bottom, 1.50m thick in some parts (Uf 901). On top, the north part of the sounding is mostly made of gravels, ca. 10 x 10 cm maximum, with some pottery (Uf 904).
