Driftwood and Hybrid Debris Barrier Interactions: Process of Trapping and Prevention of Releases during Overtopping

Keywords: debris flood, hybrid barrier, open Sabo dam, trapping effect, Discrete Element Method

This study presents a new concept of debris barrier based on an experimental application to the Combe de Lancey stream (Villard-Bonnot, France). In 2005, 20,000 m³ of gravels and large wood (LW) were transported and deposited. A debris basin was designed to trap sediment and LW supplied by extreme events while letting routine bedload transport to pass through. Here, hybrid barrier was successfully tested to achieve this dual objective. A short description of the catchment and proposed barrier is presented. Its trapping efficacy was also examined with a small-scale model. These laboratory observations were used to calibrate a numerical Discrete Element Model that to study processes driving LW entrapment and release. It highlights that a high accumulation of LW may occur on barriers. When water overflowed the barrier above a critical depth, the overtopping of massive LW was observed. To prevent it, a rack was tested and proved sufficient.

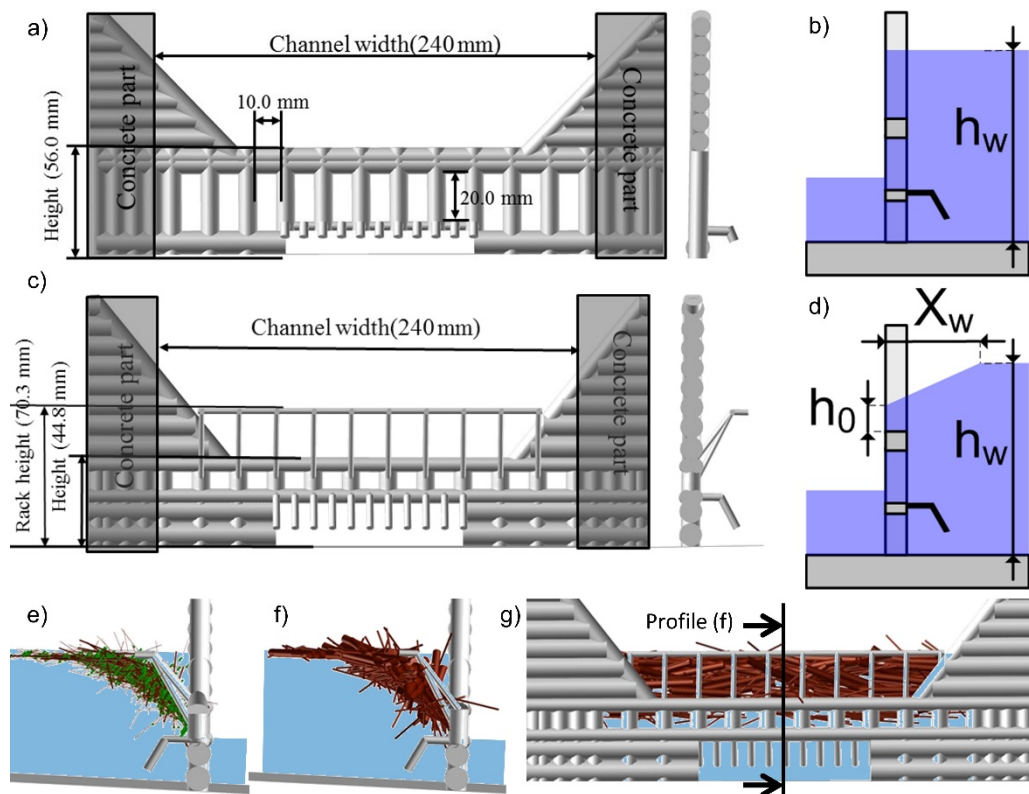
Figure 3 a) upstream and side view of the initial barrier, b) concept of simplified hydraulic free surface longitudinal profile with horizontal hypothesis, c) upstream and side view of the improved barrier, d) concept of longitudinal profile of hydraulic free surface with linear hypothesis, e) side view of contact points within the accumulation for run Q100s, f) side view of accumulation, trapped by improved design for same instant and, g) downstream view for same instant.

A numerical analysis was performed to understand the process of LW over topping at the barriers. It was calibrated on the small-scale model and then a parametric study was performed. The coupled DEM-fluid model developed by Horiguchi et al. (2015) was used to reproduce the initial and improved barriers (Fig. 3a & c). Logs were computed as cylindrical elements with same size as LW used in the flume experiment. The model solves

For the sake of simplicity, the free surface model was initially set horizontal until passing the barrier (Fig. 3b). This hypothesis could be responsible of our overestimation of LW overtopping by overestimating buoyancy force at the crest. Additional flume runs were performed to measure more precisely the free surface profile. It was later simplified in a linear model (Fig. 3d) with parameter X_w set at 0.033 m and h_0 at 0.010 m. Once implemented in the DEM, it computed the overtopping of LW for $h_w = 81$ mm consistent with the flume (Table 1 runs V_Q100L.linear). LW were also correctly released for run Q100s. DEM approach was then considered reasonably calibrated.

Finally, when the crest rack of the improved barrier (Fig. 1d) was numerically tested (Fig. 3e-g), it achieved similar results as the small-scale model, i.e., a few logs passed through the rack but the LW mostly remained trapped by the barrier.
