Impact of temperature on the corrosion of lead-free solder alloy during salt spray test

K.E. Akoda, A. Guédon-Gracia, J.-Y. Delétage, B. Plano, H. Frémont

Abstract

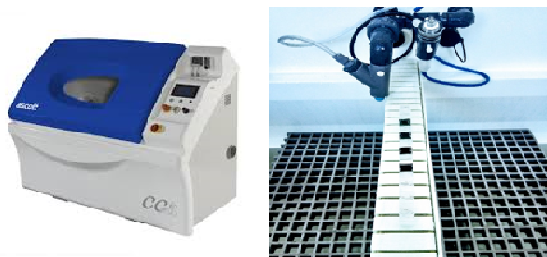
Fig. 1. Salt spray chamber

To investigate the influence of temperature on corrosion, ARSs were aged during 24, 48, 72, and 96 hours in a salt spray chamber (Fig.1) according to ASTM B117 standard (5% NaCl at T=35°C), and at 25°C and 45°C with the standard salinity.

The advantages of the salt spray chamber are its temperature homogeneity ($T \pm 2^\circ\text{C}$) and the possibility to study the corrosion of various metals and surfaces without interference in chemical reactions. So, the test conditions are reproducible. Moreover, this equipment is the most used for industrial tests. The chosen temperature range may seem very narrow.

However, this kind of equipment is designed to perform a standard robustness test at 35°C and does not permit tests at higher temperatures.

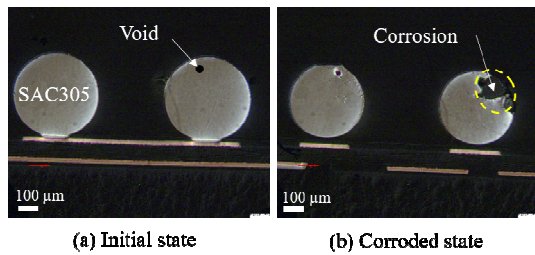
Fig. 2. Cross-section of (a) initial state and (b) corroded state of the BGA as-received samples

Fig. 2 shows the cross-section of solder balls before and after the test. Compared to the solder ball at the initial state, the corrosion is measured by evaluating the eroded area. Image J analysis software is used to evaluate the percentage of the eroded area. For instance, in the picture (Fig.2b), the corroded area is about 22.5% of the total solder surface. A ball is considered as corroded if at least 2.5 % of the material has disappeared.

Corrosion is also detectable by a change in color. The color changing (silver gray) of a part of the ball from its initial state (Fig.2a) to dark gray allows us to highlight the corroded state of that ball (Fig. 2b). Song and Lee observed similar corrosion behaviour [16].

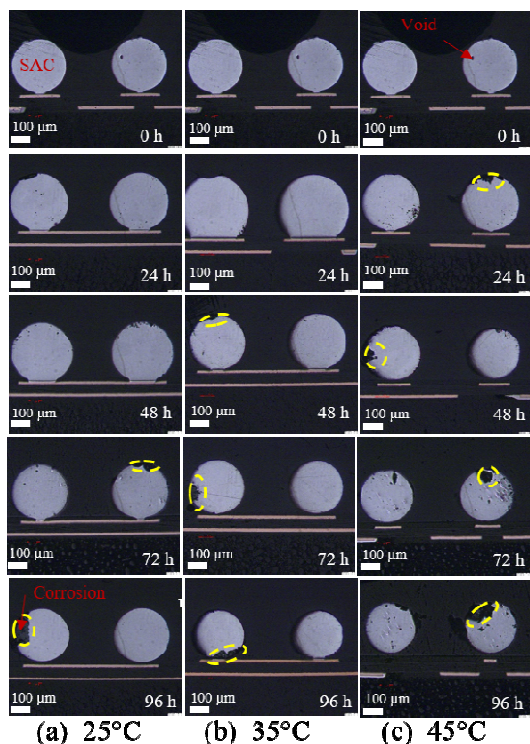
Fig. 3. Corrosion morphology observation change of the as-received SAC305 solder balls

Fig.3 shows the corrosion morphology observation and the corroded area behaviour for OM analyses of the ARS solder balls exposed to a 5% NaCl salt spray at 25°C (Fig. 3a), 35°C (Fig. 3b), and 45°C (Fig. 3c) as a function of exposure time (0, 24, 48, 72 and 96 hours). Corroded areas are visible on the lead-free solder balls after 72h at 25°C, 48h at 35°C, and only 24 h, at 45°C.

At 25°C, after 72 h of ageing, samples have some corroded areas. These areas become larger

after 96 h.

At 35°C, after 48 h, samples have some corroded areas. These areas become larger after 72 h. After 96 h, 67% of the observed surface is corroded. Song and Lee [16] have observed a similar evolution of the corrosion on Sn-Ag-Cu solder balls in the same condition (5% NaCl at 35°C).

At 45°C, after 24 h, samples have some corroded areas. These areas become larger after 48 h and 72 h. After 96 h, 78 % of the observed surface is corroded.

An increase in temperature leads to an earlier onset of corrosion. So, these experiments clearly demonstrate that temperature has a significant effect on the corrosion behaviour of lead-free solder balls.

Another observed phenomenon concerns the corrosion location. The ball surface is not uniformly attacked. There is only one corrosion product site per ball. The corrosion site is different from one ball to another.

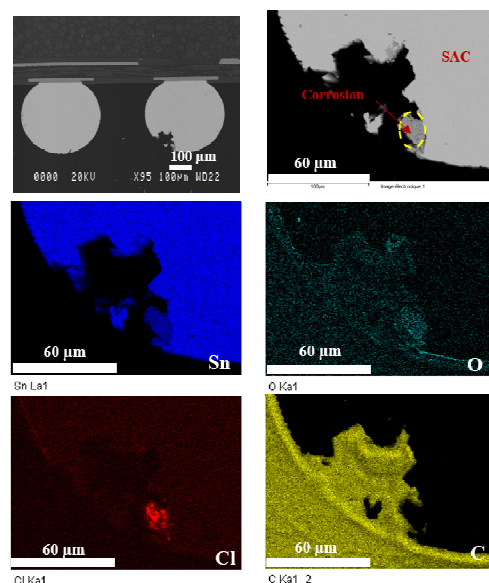
Fig. 4. EDX of as-received BGA sample solder ball (5% NaCl at 35°C) after 48h in salt spray chamber

Fig. 4 shows EDX results of the corroded area sample after 48 hours of exposure in salt spray following the ASTM B117 standard condition (5% NaCl at T=35°C). According to the EDX analysis, the corrosion product mainly contains Sn, O, and Cl.

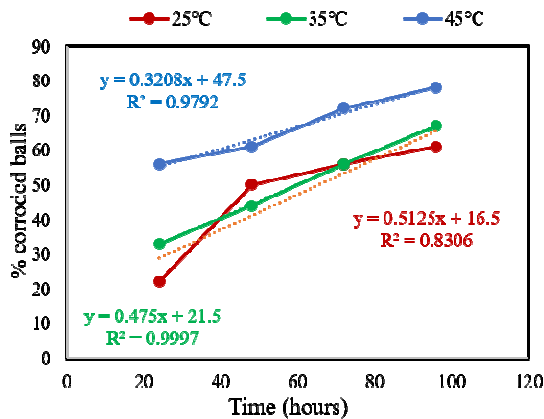
Fig. 5. Percentage of corroded balls as a function of the exposure time of the BGAs as-received samples

Fig.5 shows the percentage P_c of corroded solder balls as a function of temperature and the different exposure times defined as:

$$P_c = N_c/N_t \quad (2)$$

N_c is the number of corroded solder balls after the test. N_t is the total number of solder balls.

The data obtained at 25°C shows non-linearity, which can be explained either by the difficulty to actually assess the exact percentage of corroded areas, as at this temperature the corrosion is less severe. Or it is due to a different chemical corrosion mechanism. As a

first approximation, we select the first hypothesis and linearize all the graphs according to the dashed lines in figure 5. Then we calculated the AF and Ea, using the following equation:

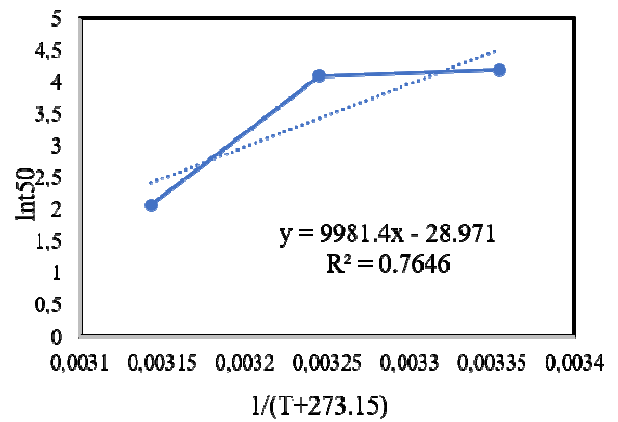
Fig. 6. $\ln t_{50}$ as a function of the $1/(T^{\circ}C + 273.16)$

So now we can use it to calculate the Ea by plotting $\ln t_{50}$ versus $1/(T^{\circ}C + 273.16)$.

This will yield an Ea estimate of 0.86 eV. The regression parameter R^2 is low, due to the imprecision previously described. This value is obviously the first estimate. However, according to the corrosion mechanism orders of magnitude for Ea (0.3 eV to 1.1 eV) [17], this Ea value is promising. The kinetic of the corrosion failure mechanisms is being investigated to predict the lifetime of the lead-free solder balls.
