Permeability Evolution During Shear Zone Initiation in Low-Porosity Rocks

Christian Kluge, Guido Blöcher, Auke Barnhoorn, Jean Schmittbuhl, David Bruhn

Christian Kluge, Guido Blöcher, Auke Barnhoorn, Jean Schmittbuhl, David Bruhn. Permeability Evolution During Shear Zone Initiation in Low-Porosity Rocks. *Rock Mechanics and Rock Engineering*, 2021, 54 (10), pp.5221-5244. 10.1007/s00603-020-02356-0 . hal-03436279

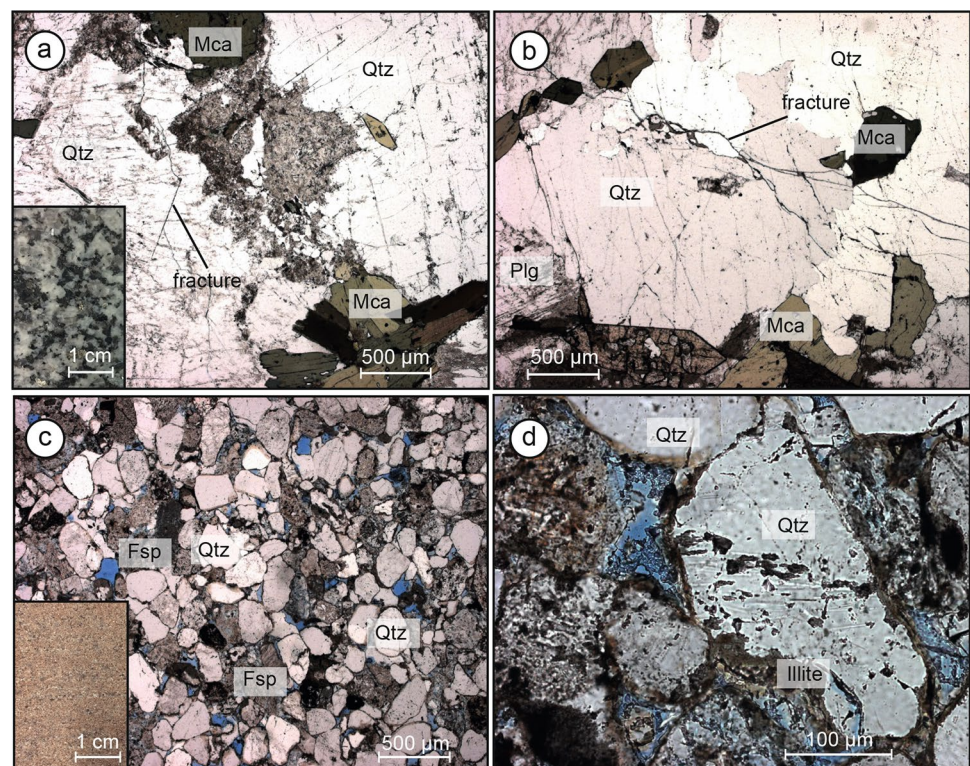
Fig. 1 Thin section images of the intact sample material of Odenwald granite (PGR6-RI) and Flechtingen sandstone (SBT6-BE)

It is a Carboniferous, fresh granite showing no sign of alterations or strong micro-fracturing (Fig. 1a, b). It is composed of quartz (Qtz) with a grain size ranging from 1 to 3 mm, feldspar (Fsp) between 2 and 3 mm and mica (Mca) between 1 and 3 mm. The minerals are evenly distributed. Quartz, as well as the darker and brighter mica are the main constituents in our samples, while feldspars are less frequent. Micro-fractures are sparse and cut through grains. They are mostly found within the less compliant quartz, or exist along grain boundaries with no visible shear offset. The porosity is less than 0.6% and the permeability is less than $1 \times 10^{-18} \text{ m}^2$.

between the grains (Fig. 1c, d). Furthermore, intragranular fractures were mainly extensional fractures sub-parallel to the maximum compressive stress direction. The clay that originally coated the quartz minerals was smeared across the fault core and produced a very fine gouge (Fig. 8b). The fault mostly propagated along grain boundaries (intergranular). Only in some locations, the quartz grains were brecciated and partially rotated (Fig. 8c, d).

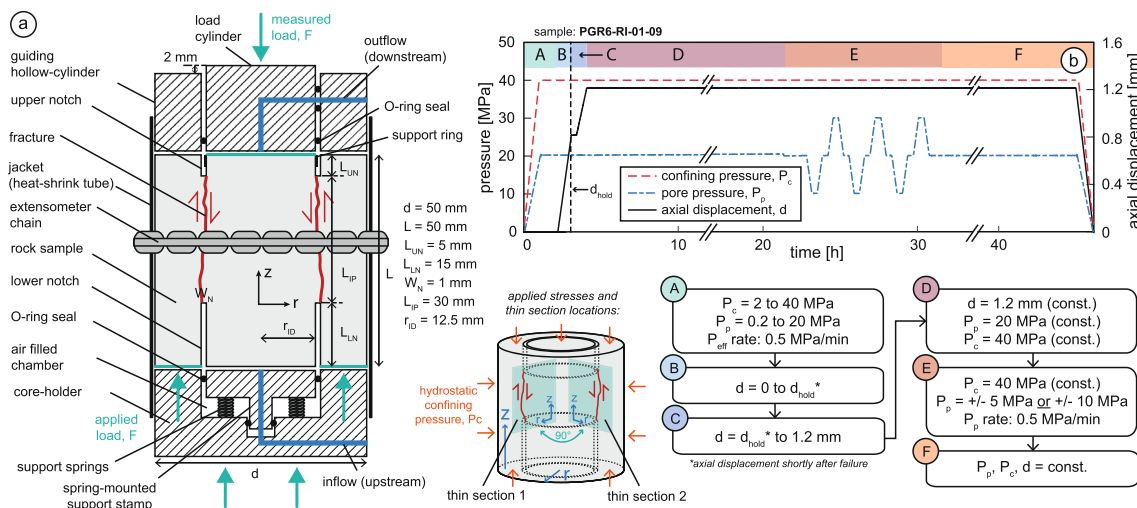
Fig. 2 Experimental set-up and sample dimension of the Punch-Through-Shear test (a) and experimental procedure for all tests (b)

The Punch-Through Shear (PTS) test allows us to induce a cylindrical shear fracture into an intact sample during fluid injection along the fracture direction. The stress concentrates at the notch tips when loading the sample causes a circular shear fracture (microfault) to propagate from the bottom to the top notch. The experimental set-up and

sample geometry are illustrated in Fig. 2a. A full description of the experimental testing procedure can be found in Kluge et al. (2020). Four tests were performed and are listed with their respective dimensions and testing conditions in Table 2.

The experimental procedure and a flow chart are illustrated in Fig. 2b. Before loading the sample axially to generate the fracture, pore and confining pressures were increased simultaneously to 20 and 40 MPa, respectively, within 1 h. An axial load was then applied by a constant axial displacement at a rate of 0.001 mm/s, pushing the inner loading cylinder down and generating a shear fracture. A drop in the axial load, F , indicated the loss of sample integrity and the consequent existence of a fracture connecting bottom and top notches. The fracturing process is described in detail in Kluge et al. (2020). To allow the pore pressure to reach steady state conditions, the axial displacement was stopped after a clear indication of failure given by the load curve.

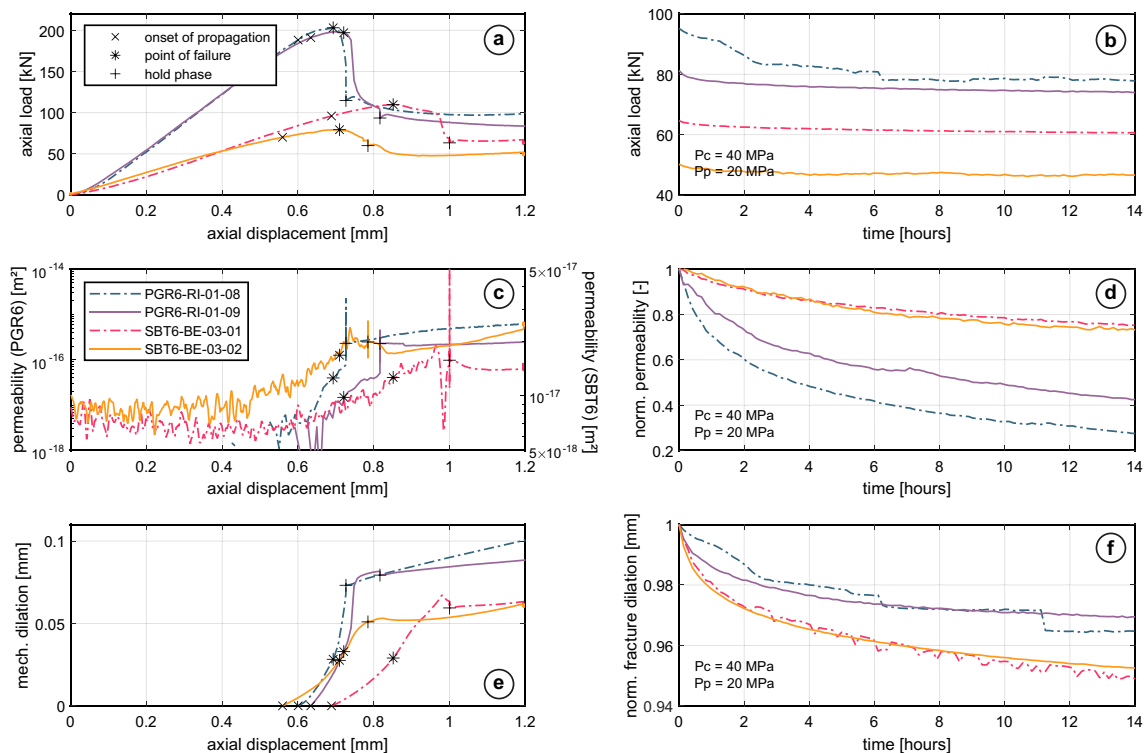
Fig. 3 Axial load (a), the permeability (b) and mechanical fracture dilation (c) evolution vs. axial displacement of the Odenwald granite (PGR6-RI-01-08 and PGR6-RI-01-09) and Flechtingen sandstone samples (SBT6-BE-03-01 and SBT6-BE-03-02) during loading, fail-

ure and shearing. Axial load (d), normalised permeability (e) and mechanical fracture dilation (f) evolution of all samples during the constant displacement phase over 14 h

The loading curves of the granite and sandstone samples tested showed a similar behaviour (Fig. 3a). The loading amplitude and the slope in the linear elastic region differ. The curve shows a higher strength and higher elasticity of the granite samples compared to the sandstone. The onset of fracture initiation in the PTS test can usually be determined by the change in inflow and outflow rate, as well as the volume change in combination with the change in slope of the load curve (Kluge et al. 2020). The change in inflow

The apparent permeability, calculated from Eq. 1, of the two granite samples (PGR6-RI-01-08 and 09) started to increase at about 70% of the peak load, i.e. an axial displacement of about 0.6 mm. This corresponded to the change in slope of the load-displacement curve (Fig. 3a). The sample integrity was lost after the load started to decrease indicating the development of a through-going fracture at a displacement of about 0.7 mm. Sample SBT6-BE-03-01 started yielding at about 0.55 mm, with failure at about 0.7 mm, similar to the granite samples. SBT6-BE-03-01 failed at a displacement of 0.85 mm, which was higher compared to all other samples. The peak load was rather plateau-like and the drop in load at about 0.95 mm was also delayed (Fig. 3a).

after peak load (Fig. 3e). During the hold phase, the Darcy permeability was first measured at steady state conditions. The increase in permeability was more than 2 orders of magnitude, from below 1×10^{-18} to about 2.3×10^{-16} m² for both samples (Fig. 3c). The mechanical fracture dilation reached a value of 0.07 and 0.08 mm (Table 3). During shearing, the permeability of sample PGR6-RI-01-08 increased from 2.3×10^{-16} to 6.0×10^{-16} m², while the permeability of sample PGR6-RI-01-09 remained relatively constant at around 2.3×10^{-16} m². A similar trend as for permeability was observed for the fracture dilation. Here, sample PGR6-RI-01-08 showed an increase from 0.07 to 0.1 mm, while sample PGR6-RI-01-09 showed an increase from 0.08 mm to almost 0.09 mm.

The pre-failure permeability of both sandstone samples (SBT6-BE-03-01 and 02) was about 1×10^{-17} m². The permeability of both samples decreased during the linear elastic loading phase (Fig. 3c). At about 0.6 mm, similar to the granite, the permeability started to increase. Sample SBT6-BE-03-01 showed a delayed increase. The permeability increased to 1.6×10^{-17} and 2.0×10^{-17} m² for sample SBT6-BE-03-01 and 02, respectively. The mechanical fracture dilation reached a value of 0.05 and 0.06 mm, which was lower compared to the granite (Fig. 3e). During

After that, the axial displacement was stopped and kept constant until the end of the experiment. Permeability was measured over the time span of at least 14 h to monitor possible longer term changes in stress, permeability and dilation (Fig. 3b, d, f). The reduction of the measured axial load after fracture generation and shearing was largest in

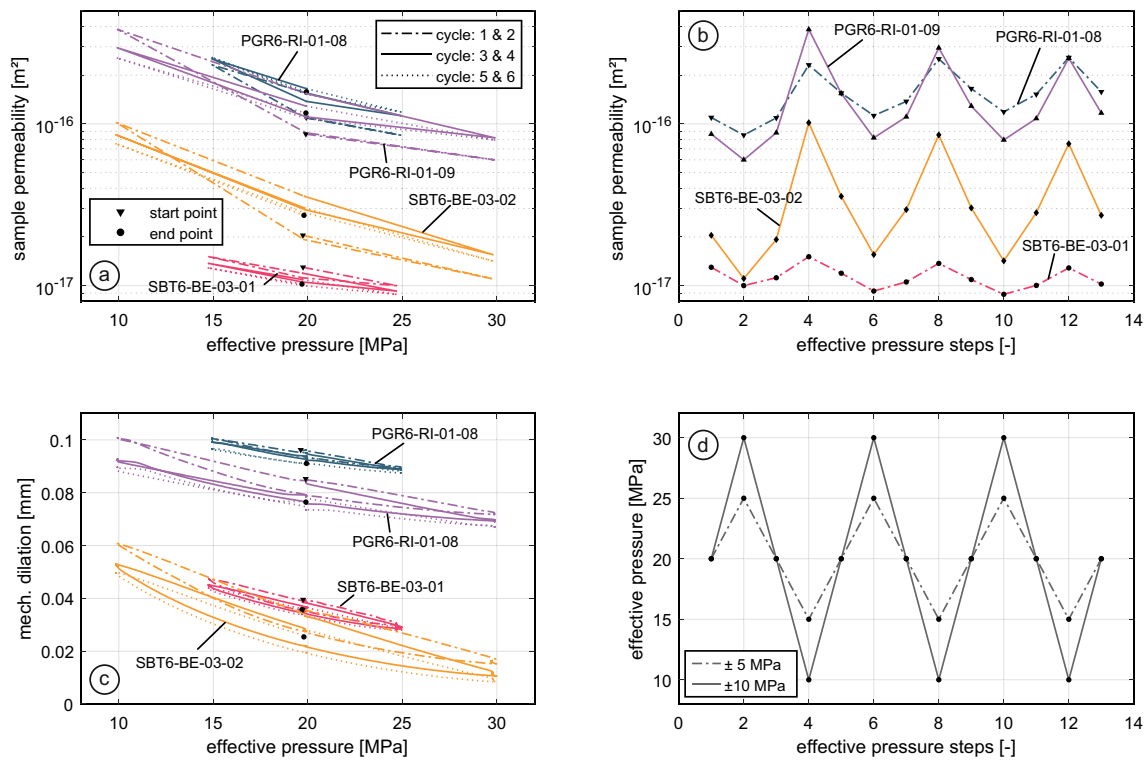
Fig. 4 Permeability and mechanical fracture dilation evolution vs. the effective pressure (a, b) and vs. the effective pressure steps (c, d)

The change in permeability and fracture dilation during effective pressure changes is crucial for an understanding of the sustainability of fractured reservoirs. Therefore, the pore pressure was varied at a constant confining pressure by ± 5 and ± 10 MPa for one sandstone and one granite sample, respectively (Fig. 4). The permeability in Fig. 4a, b is given as a point measurement at the respective effective pressure level.

were rather reversible. A slight permanent reduction in permeability for the sandstone and a slight increase for the granite after six loading cycles was found (Table 3). The fracture dilation showed a similar reversible behaviour, although the fracture dilation of the sandstone was half compared to the dilation of the granite (Fig. 4c). The mean dilation calculated from the lateral extensometer data represents the bulk changes in circumference caused by matrix and fracture.

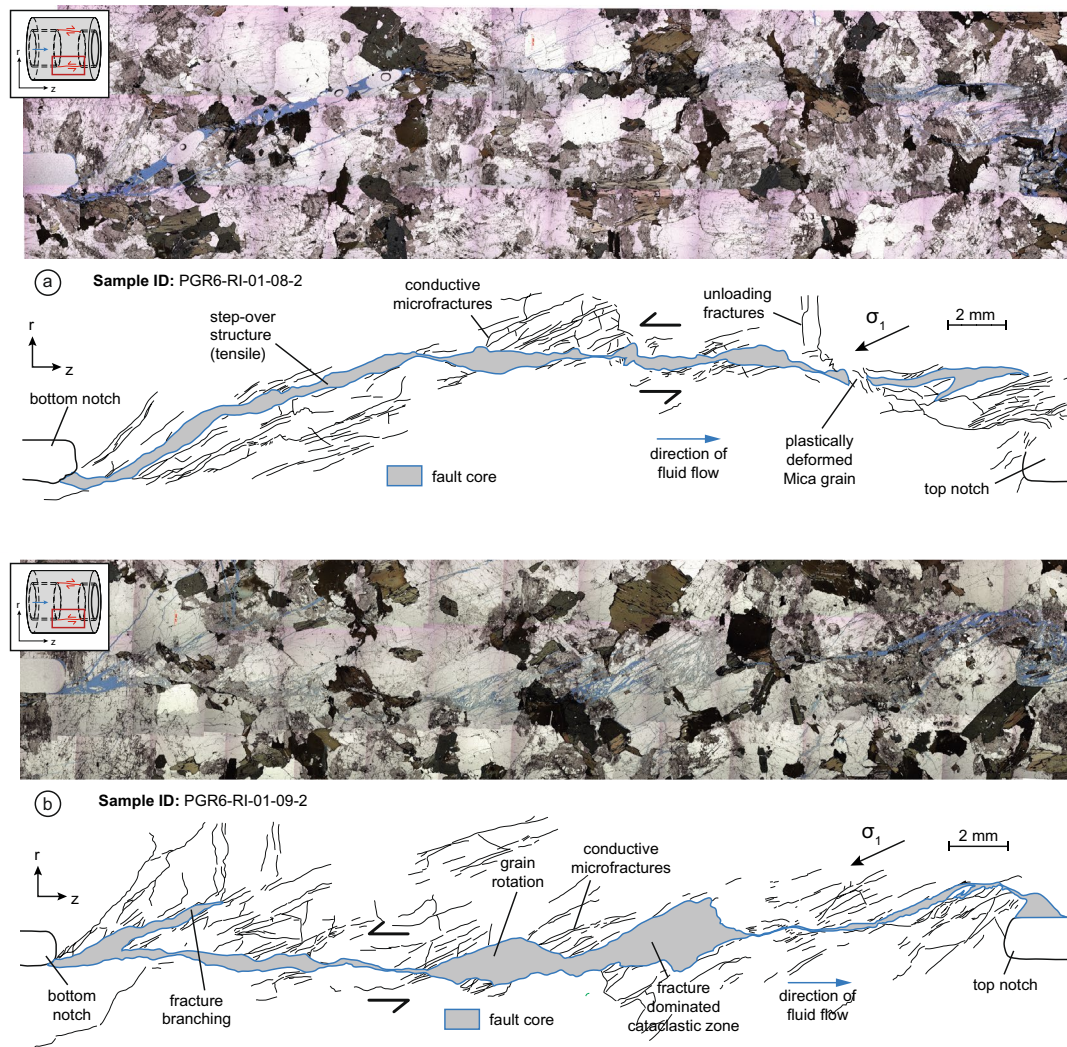
Fig. 5 Overview of the microfault connecting the lower and upper notch of the sample in thin section and interpretative drawings below indicating the structural features of a granite sample PGR6-RI-01-08-2 (a) and PGR6-RI-01-09-2 (b)

Other fractures grew radially in the r -direction and are stress-relaxation fractures formed during unloading in tensile mode (Kluge et al. 2020). Damage zone fractures are highly present in quartz and plagioclase grains, but rather localised or absent in mica grains. Fault particles are brecciated, mostly elongated and very different in size. In plagioclase, identified by their striations, a similar brecciated fault core can be observed with a maximum width of about 2 mm (Fig. 6a). K-feldspar minerals, without striations, are locally weathered and produced very fine-grained and thin fault gouge (Fig. 6b). Micas were deformed in three different modes: brittle, plastic or smeared out (Fig. 6c, d). Although some mica grains were clearly displaced, they were partly deformed without showing any clear microfractures or void spaces. The plastic deformation of micas resulted in a discontinuous fault core, i.e. no visible void space, at some locations (Fig. 5).

In a second approach, we extracted the fault core based on our structural interpretation of the thin sections (Figs. 5 and 7). We then applied the same procedure as for the original image (Fig. 9a, b). Computing the width of the extracted

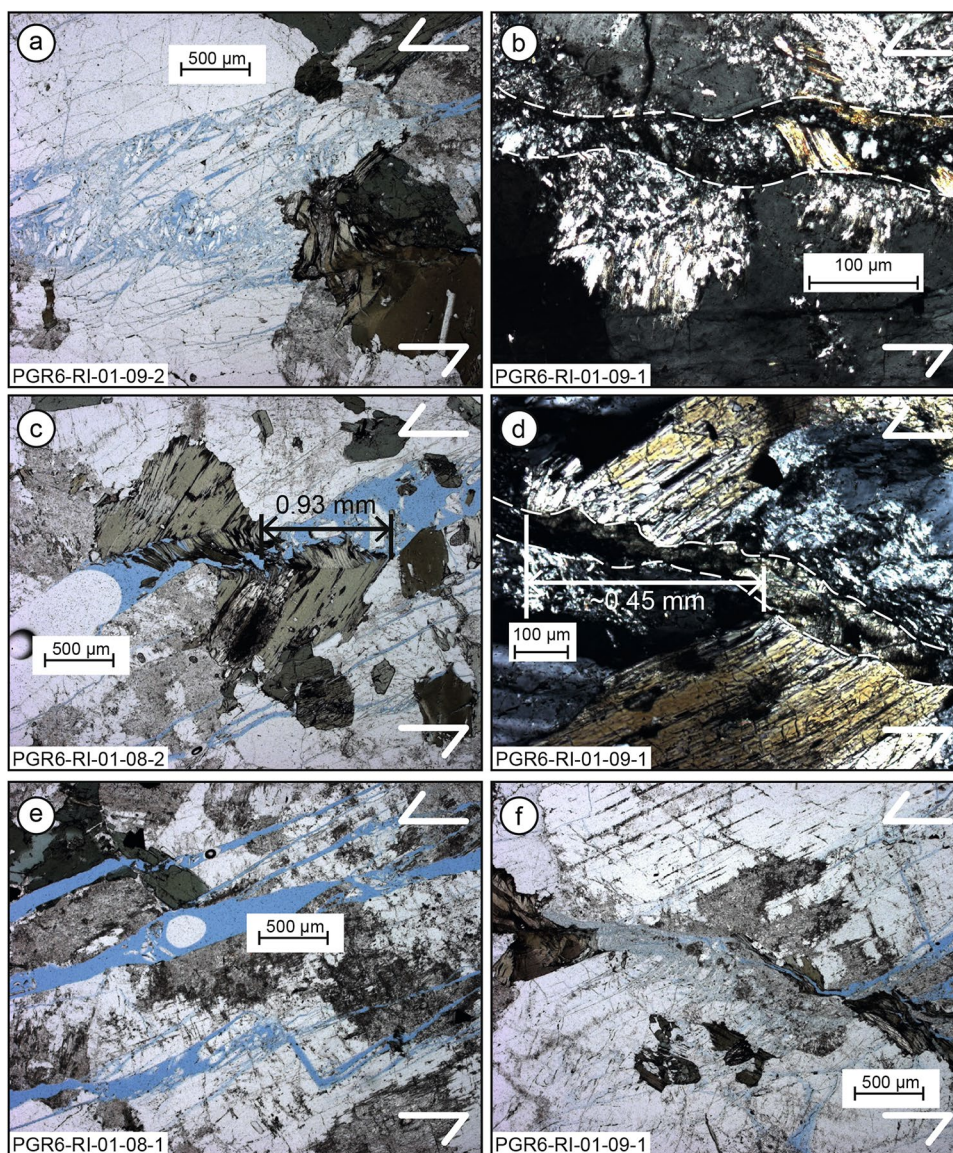
Fig. 6 Detailed view of cataclastic rock fragments in quartz (a), fine fault gouge filling the fault core (b), displaced mica minerals (c, d), tensional fractures (e) and fault core compression (f) in the Odenwald granite thin sections

Larger tensile fractures in mainly stiff minerals formed transensional wedges that lack features of brittle deformation (Fig. 6e). These wedges can be understood as step-over structures connecting zones of simple shear. In weaker minerals, such as mica or feldspar, the fault is

characterised by simple shear. In simple shear, faulting is parallel to the displacement direction, which produced a very fine fault gouge (Fig. 6f). In some areas, the orientation changed into compressional or transpressional regimes. Here, the fault core is very thin and shows several splay fractures (Fig. 6f).

The formation of joints, wedges and cavities enabled additional slip accommodation (Segall and Pollard 1983). The relative displacement was measured at displaced mica minerals at certain locations and varied from 0.45 to 0.93 mm (Fig. 6c, d). This is less than the applied axial displacement of 1.2 mm. The fracture branches were hydraulically isolated from the main fault zone, as we could not detect any microfractures connecting them to the main fault.

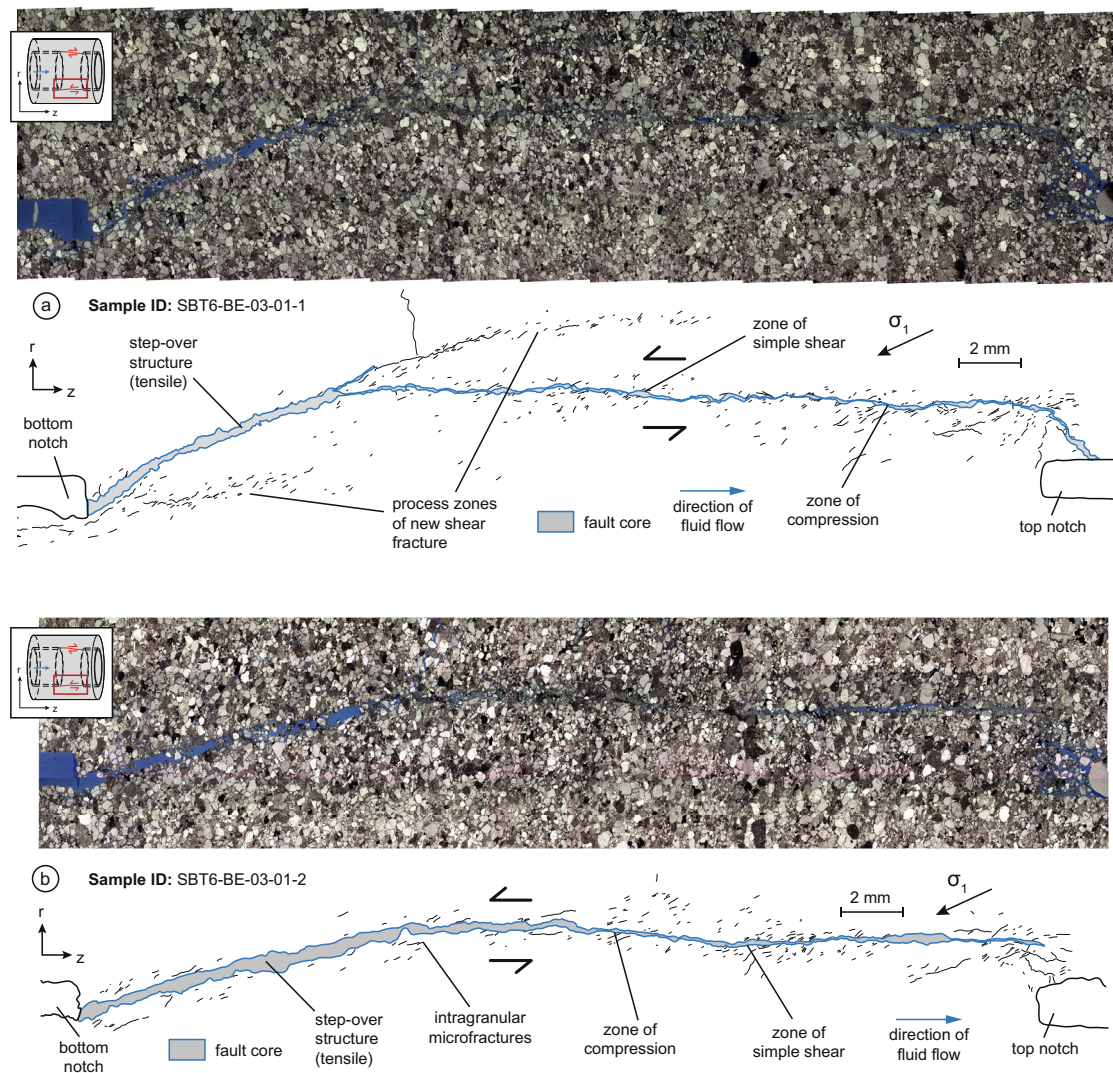
Fig. 7 Overview of the microfault connecting the lower and upper notch of the sample in thin section and interpretative drawings below indicating the structural features of a sandstone sample SBT6-BE-03-01-1 (a) and SBT6-BE-03-01-2 (b)

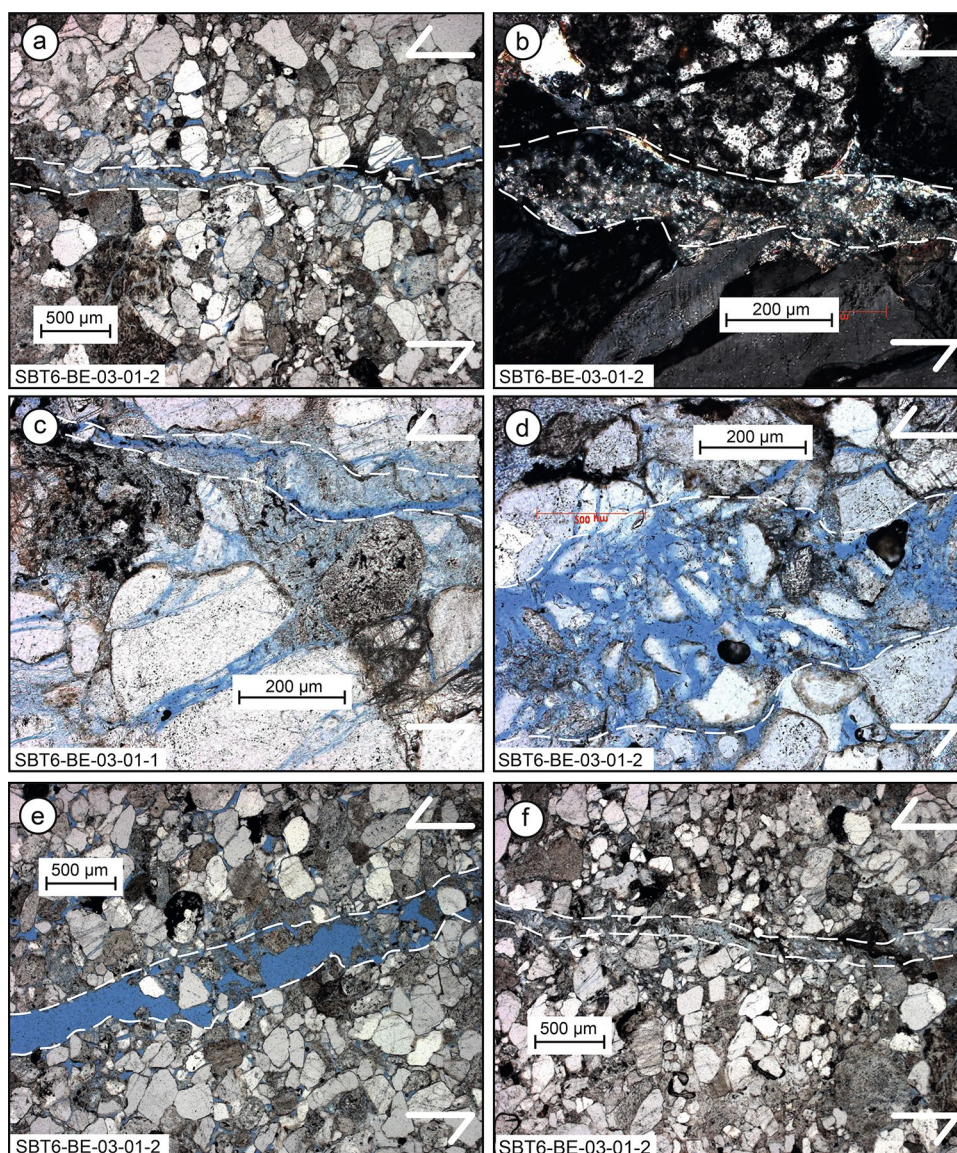
Fig. 8 Detailed view of the narrow fault core (a), fine fault gouge filling the fault core (b), grain splitting (c), grain fragmentation (d), tensional fractures (e) and fault core compression (f) in the Flechtingen sandstone thin sections

In areas where the fault core was straight, it showed a rather constant width (Fig. 8a). The fractures in the damage zone were either intragranular or intergranular and were, thus, isolated from each other, since clay was found in

In areas of transpression and simple shear, the fault zone was extremely narrow with clay smear and other fine particles along the fault zone (Fig. 8c, d). The fault was wider and more open for fluids when the fault core was oriented similar to the damage zone fractures, i.e. 20° – 30° to the axial displacement direction (Fig. 8e). Splay fractures, typical for large scale faults (Myers and Aydin 2004), were found to develop in areas of fault compression

(Fig. 8f). Step-over structures were absent in the sandstone samples, contrary to the granite fault. Furthermore, most of the displacement was accommodated by the fault core or shear band itself. Rarely any deformation or displacement accommodation was found in the damage zone. Strain accommodation within the surrounding rock matrix was hard to identify from our images.

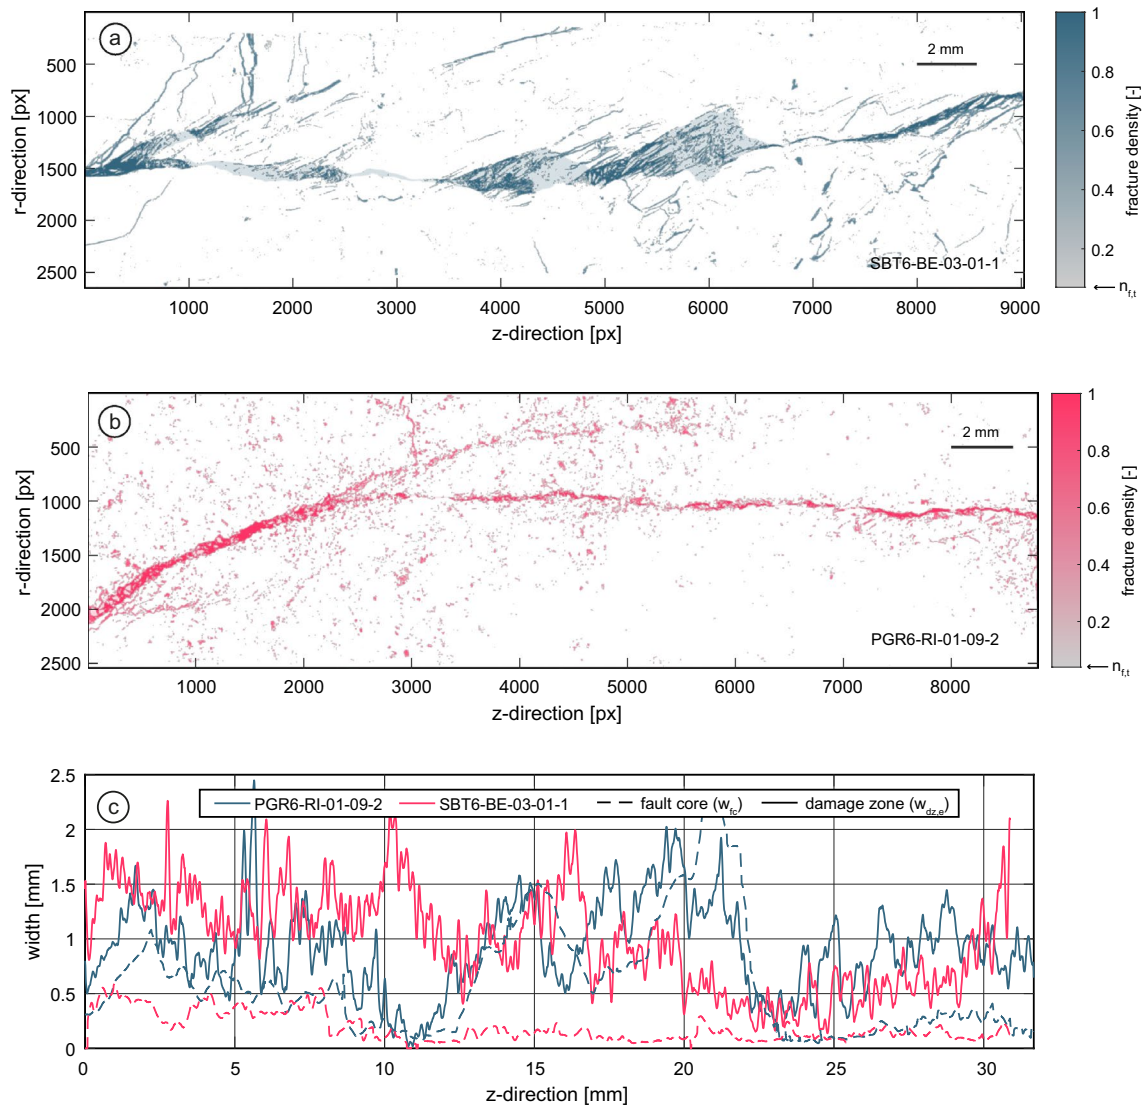
Fig. 9 Fracture density of the original image (blue or red) and the extracted fault core (grey) in the Odenwald granite (PGR6-RI-01-09-2) (a) and Flechtingen sandstone (SBT6-BE-03-01-1) (b). The effective damage zone width, $w_{dz,e}$, and fault core width, w_{fc} , of both rocks (c)

where w is the width, l_{px} is the length of a pixel (3.5 μm), N_{px} is the number of pixels of a profile, n_f is the fracture density in a single window reduced to a single pixel and $n_{f,t}$ is the fracture density threshold. The fracture density distribution for the granite and sandstone with their shear zone thicknesses are shown in Fig. 9c. The fracture density

already shows, that this calculation included high fracture densities outside the main fracture, especially for the sandstone sample. This possibly led to an overestimation of the fault zone width. Therefore, we considered this width as the effective damage zone width, $w_{dz,e}$. The mean damage zone width, $\bar{w}_{dz,e}$, was defined as the mean of the damage zone width of all profiles along the z -direction. The calculated values were 0.93 mm (± 0.42 mm) for the granite and 0.99 mm (± 0.46 mm) for the sandstone (Table 4). This width was similar for both rocks in the transtensional areas close to the lower notch. In the simple shear and transpressional regimes, however, the sandstone fault was thinner.

fault core with the same threshold, $n_{f,t}$, we found that the fault core width, w_{fc} , was much smaller for the extracted fault core in the sandstone samples compared the effective damage zone width, $w_{dz,e}$ (Fig. 9c). The fracture density threshold, $n_{f,t}$, must be about 0.5, to obtain a similar value of the mean effective damage zone width, $w_{dz,e}$, compared to the mean fault core thickness, \bar{w}_{fc} . For the sandstone, \bar{w}_{fc} was about 0.2 mm. The mean fault core width of granite was 0.60 mm (± 0.51 mm) and 0.19 mm (± 0.13 mm) for the sandstone (Table 4). In the granite sample, the thickness of the extracted fault core was little reduced compared to that of the original image.

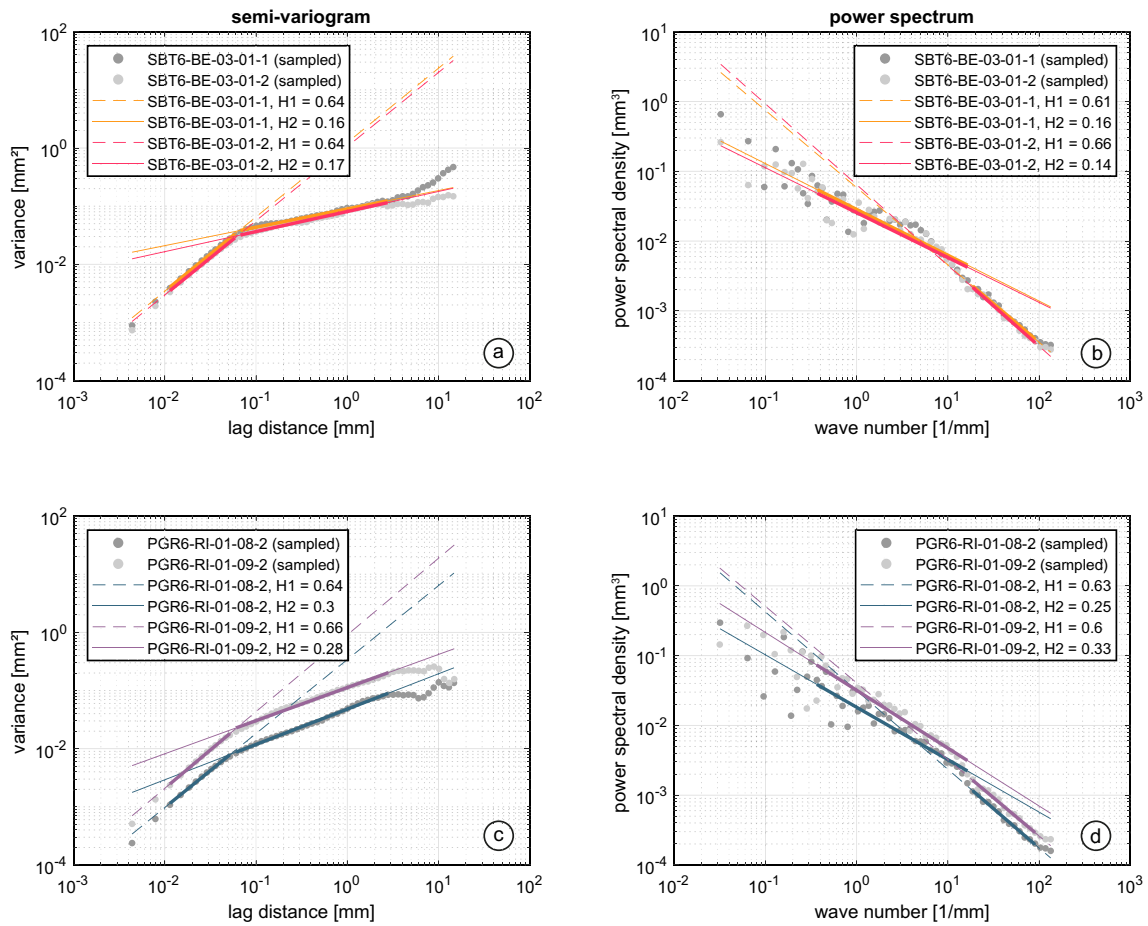
Fig. 10 Semi-variogram (a, b) and power spectrum (c, d) of the width profiles of the Flechtingen sandstone and Odenwald granite resulting from image analysis of the thin sections

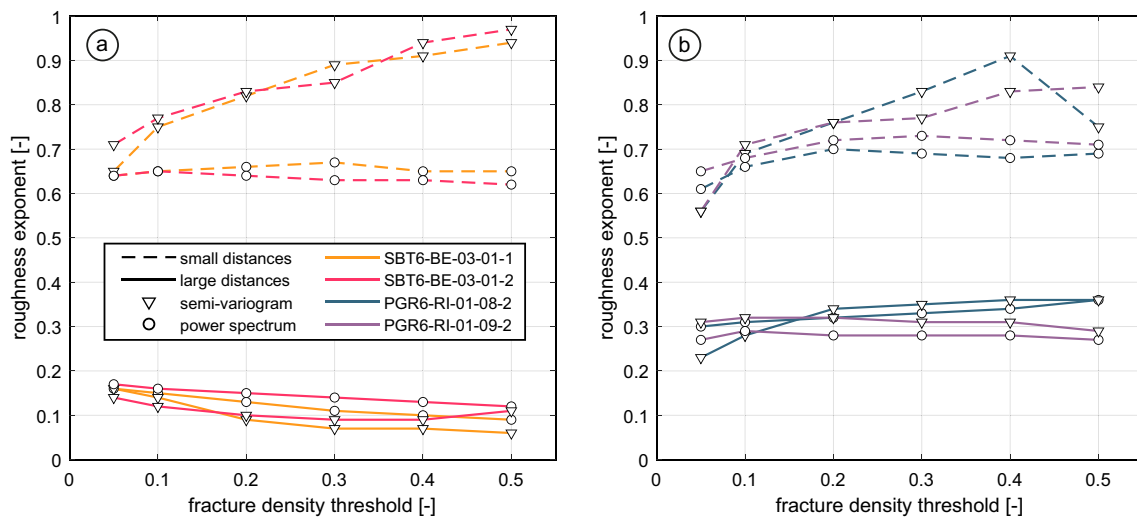
Fig. 11 Roughness exponent, H , for different fracture density thresholds, $n_{f,t}$ for the Flechtingen sandstone (a) and Odenwald granite (b) at the respective small and large distances

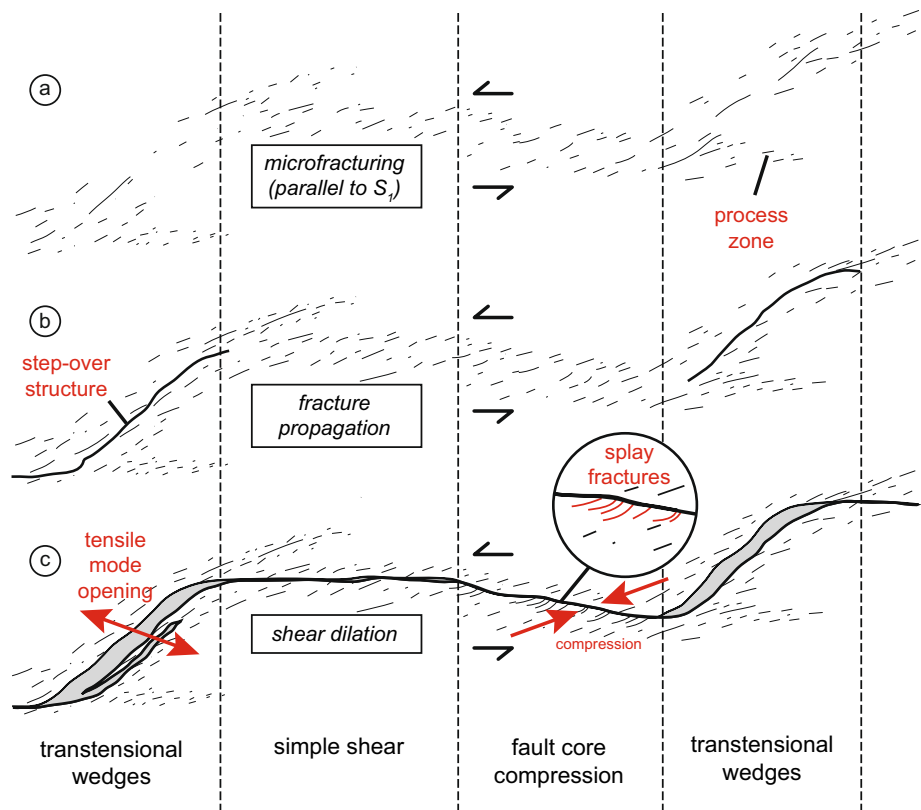
Fig. 12 Interpretational model for the fracture propagation during shear fracture growth with **a** micro-fracturing, **b** fracture propagation and **c** shear dilation, as well as the resulting structural elements of the fault zone

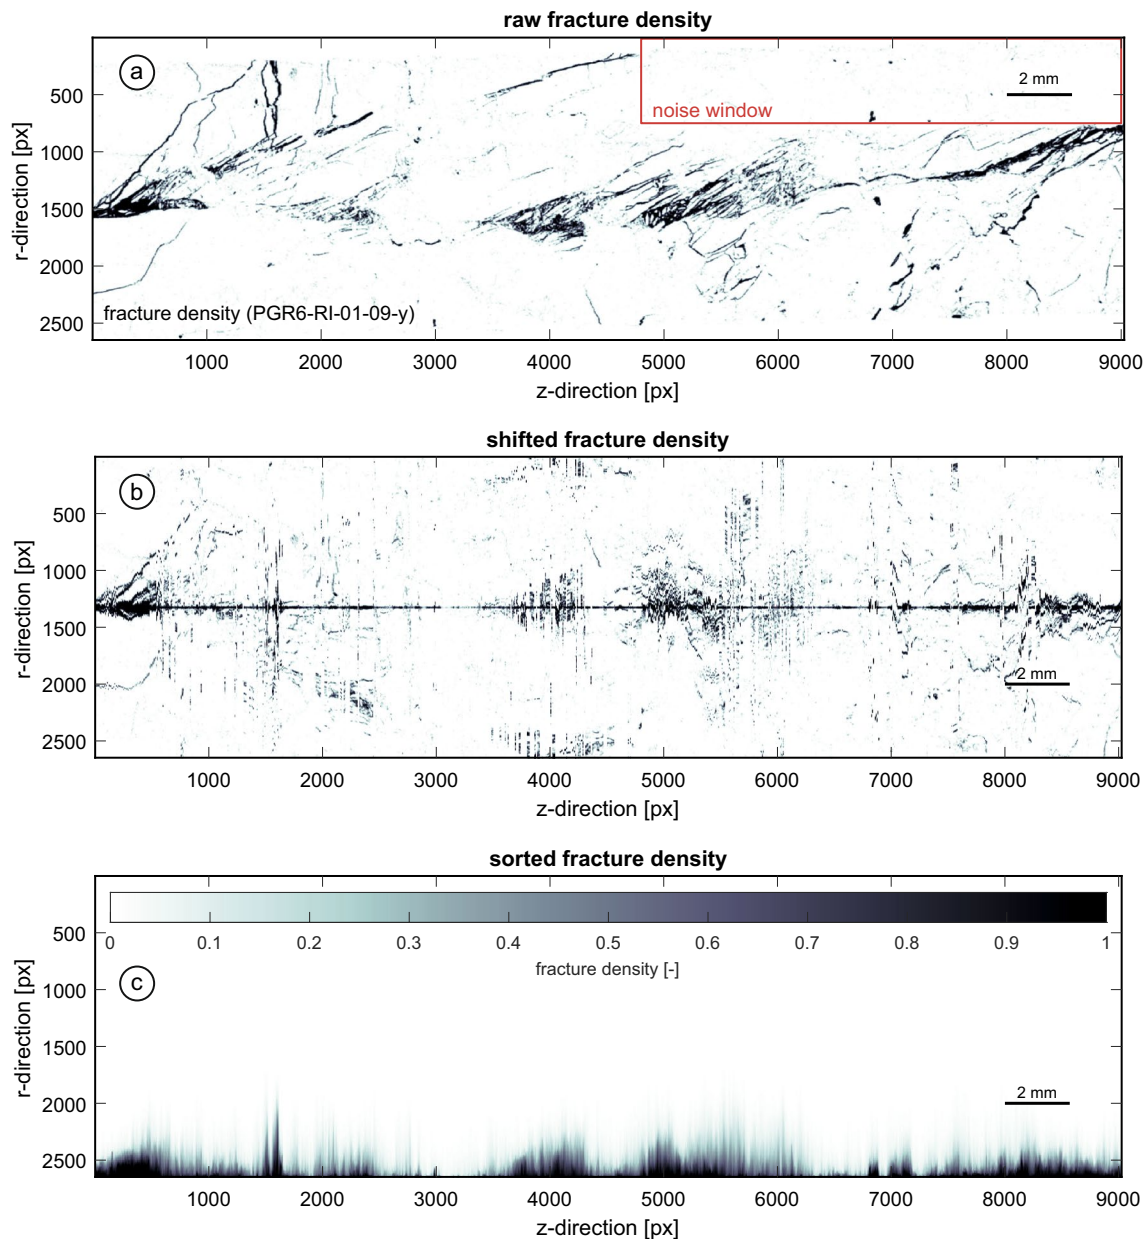
Fig. 13 Fracture density of the original binary image (a), as well as the shifted (b) and sorted (c) fracture density of granite sample PGR6-RI-01-09-2

there areas of the sandstone and granite (Figs. 13a and 14a), assuming that this area is less affected by fracturing and calculated the mean fracture density. This analysis resulted in a mean fracture density of 0.003 for the background noise of the granite and 0.015 for the sandstone (Fig. 15c, d). These values, however, were too low when considering this for the shifted fracture density of the entire image, since it is well below the limbs of the distribution. This results in an over-estimation of the fracture width. A second approach was to consider the intersection of the shifted and sorted fracture

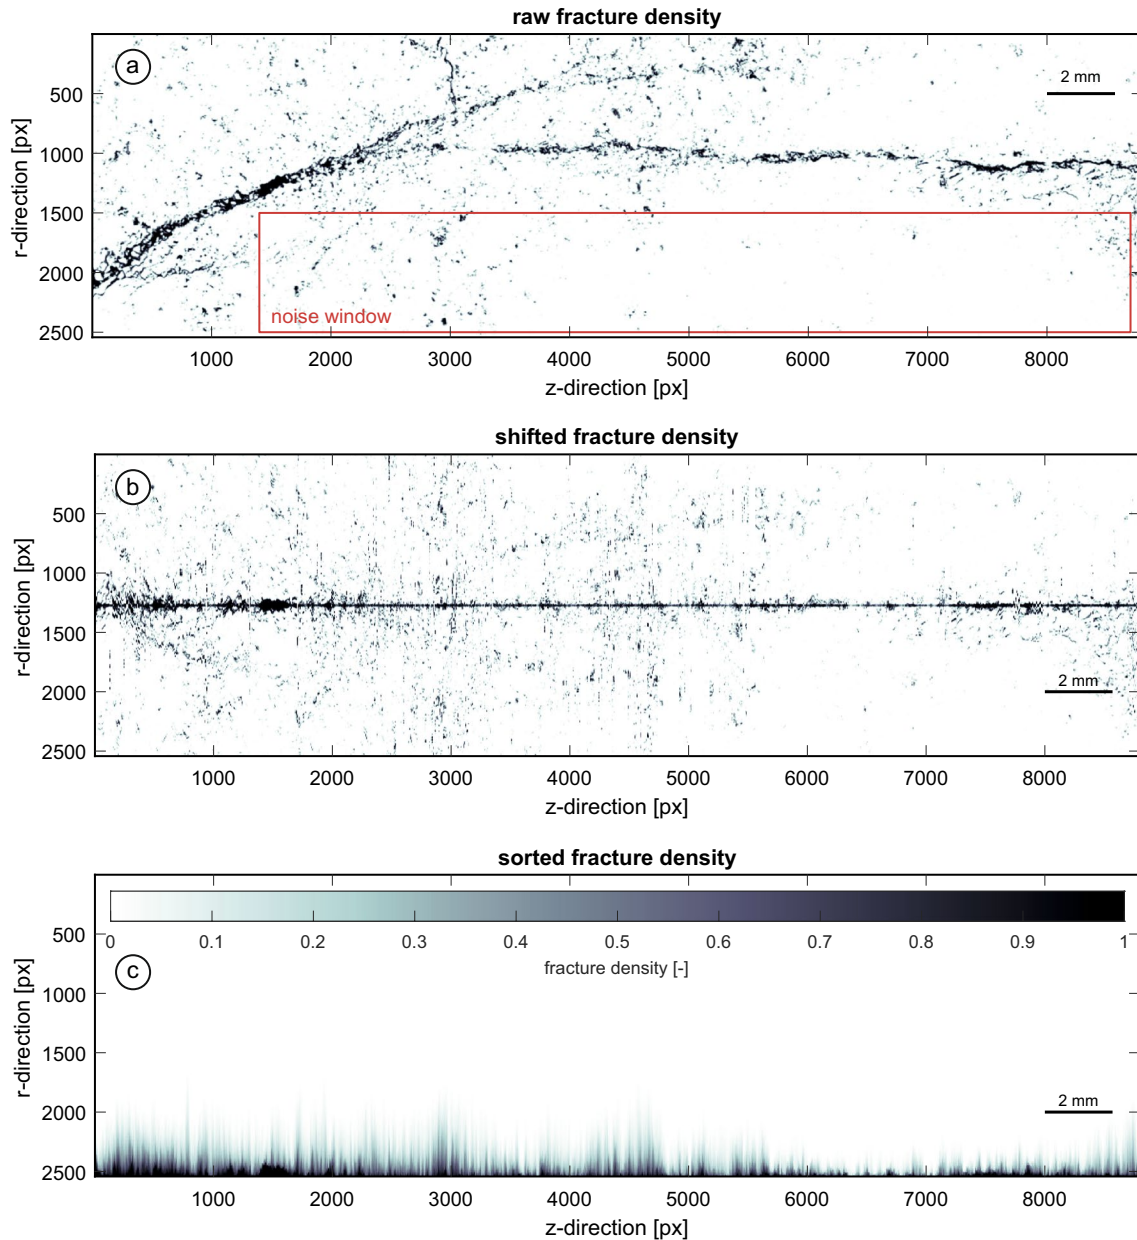
Fig. 14 Fracture density of the original binary image (a), as well as the shifted (b) and sorted (c) fracture density of sandstone sample SBT6-BE-03-01-1

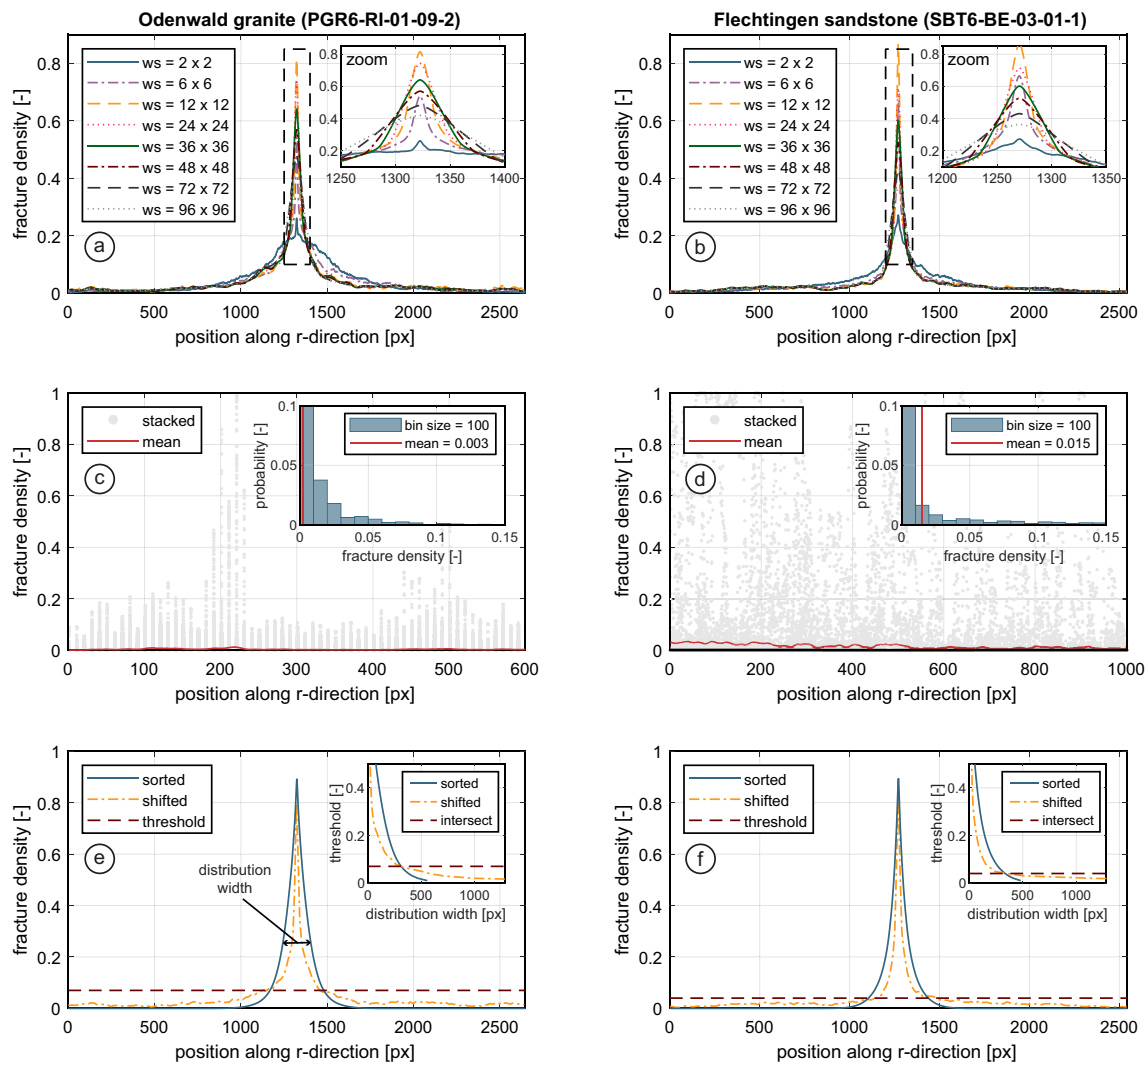
Fig. 15 Fracture density distribution: effect of window size (**a**, **b**), measured fracture density noise (**c**, **d**) and intersection of the sorted and shifted fracture density distributions (**e**, **f**)
