Accelerated Aging Behavior in Alkaline Environments of GFRP Reinforcing Bars and Their Bond with Concrete

Abstract: This study investigates the durability of glass fiber-reinforced polymer (GFRP) reinforcing bars (rebars) and their bond in concrete. Accelerated aging tests were first conducted on bare rebars that were either subjected to direct immersion in an alkaline solution or previously embedded in concrete before immersion in the solution (indirect immersion). Accelerated aging was conducted at different temperatures of the solution (20 °C, 40 °C and 60 °C) and for various periods up to 240 days. Residual tensile properties were determined for rebars subjected to direct immersion and served as input data of a predictive Arrhenius model. A large decrease in the residual tensile strength assigned to the alkali-attack of glass fibers was extrapolated in the long term, suggesting that direct immersion is very severe compared to actual service conditions. Short-beam tests were also performed on rebars conditioned under direct/indirect immersion conditions, but did not reveal any significant evolution of the interlaminar shear strength (ILSS). In a second part, bond tests were per

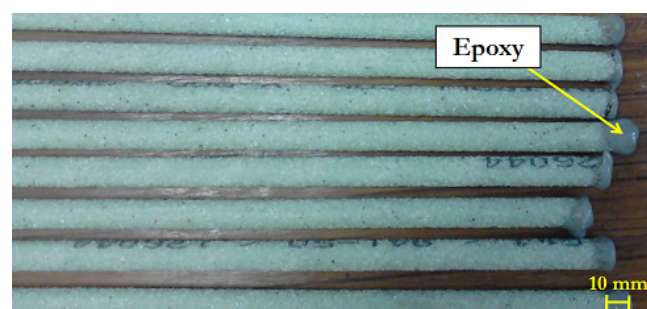
Figure 1. Rebars intended for direct immersion in the alkaline solution.

In order to evaluate the impact of direct immersion on the longitudinal tensile strength and elastic modulus of the GFRP rebars, samples of length 1.20 m were immersed in the alkaline solution (the composition of the solution is specified in Section 2.2). Before immersion, the edges of the rebars were locally sealed with an epoxy resin in order to prevent the capillary diffusion of moisture and alkali ions from the cut sections of the rebars (Figure 1).

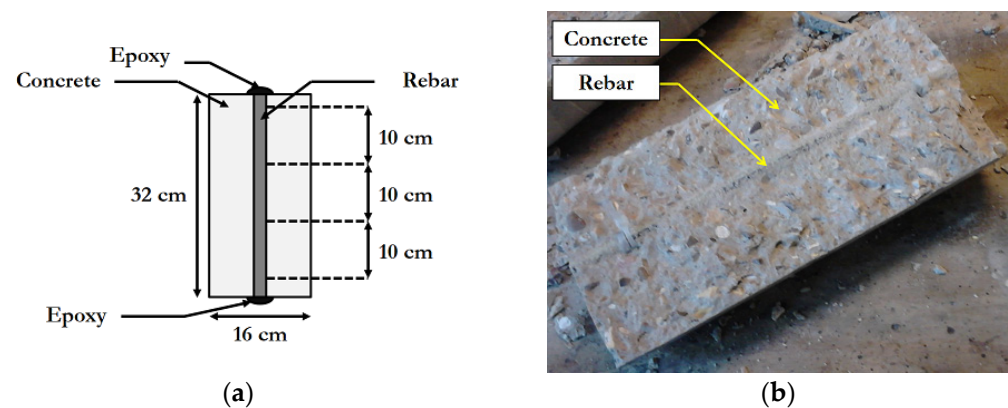
Figure 2. ILSS test specimens for indirect immersion: (a) geometry of specimens and (b) picture of a specimen after the splitting of surrounding concrete.

Some 32 cm long rebars were embedded in concrete cylinders with 16 cm diameter, before being immersed in the alkaline solution. The geometry of these specimens is shown in Figure 2a. Before immersion, the edges of the rebars were again locally sealed with an epoxy resin to prevent the penetration of alkalis through the cut sections.

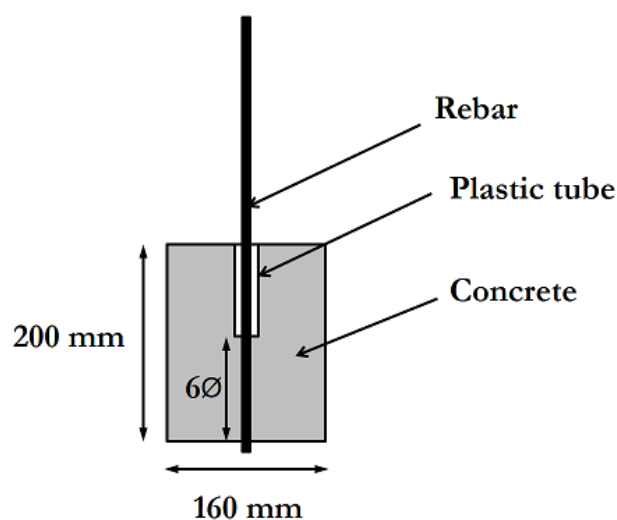
Figure 3. Geometry of the specimens used for pull-out tests.

In order to study the bond behavior between GFRP rebars and concrete, pull-out specimens were prepared according to the following procedure: 1.20 m-long straight rebars were partially embedded at the center of a normal strength concrete cylinder (of diameter 16 cm and height 20 cm). The specimen's geometry is illustrated in Figure 3. Concrete was cast while the rebar was set in the vertical position. A plastic tube, called a bond breaker, was placed between the rebar and concrete at the upper side of the concrete block, in order to prevent edge effects induced by the reaction support during pull-out tests (this test protocol is detailed in Section 2.3.7). The length of the bond breaker was chosen so that the embedment length of the bar in concrete is equal to six bar diameters (Figure 3). This condition is supposed to favor preferential failure by the slippage of the rebar [35]. It is worth noting that the same batch of concrete was used for casting the pull-out specimens and for embedding the GFRPs of short-beam specimens (series exposed to indirect immersion).

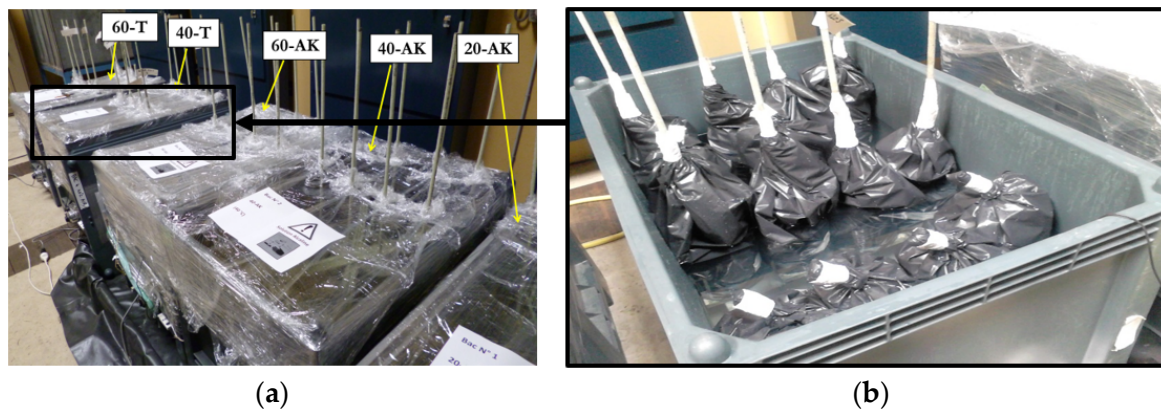
Figure 4. (a) Picture of the five thermoregulated tanks and (b) detail of the 40-T tank.

Five tanks were used for conditioning the samples in the different accelerated aging environments, as shown in Figure 4a. Three tanks, in which the aging environments were denoted 20-AK, 40-AK, and 60-AK, were filled with an alkaline solution and respectively maintained at room temperature (about 20 °C in the laboratory) and at constant temperatures of 40 °C and 60 °C (using heating resistances). These tanks were used both for the direct immersion of GFRP rebars and for the indirect aging of embedded specimens.

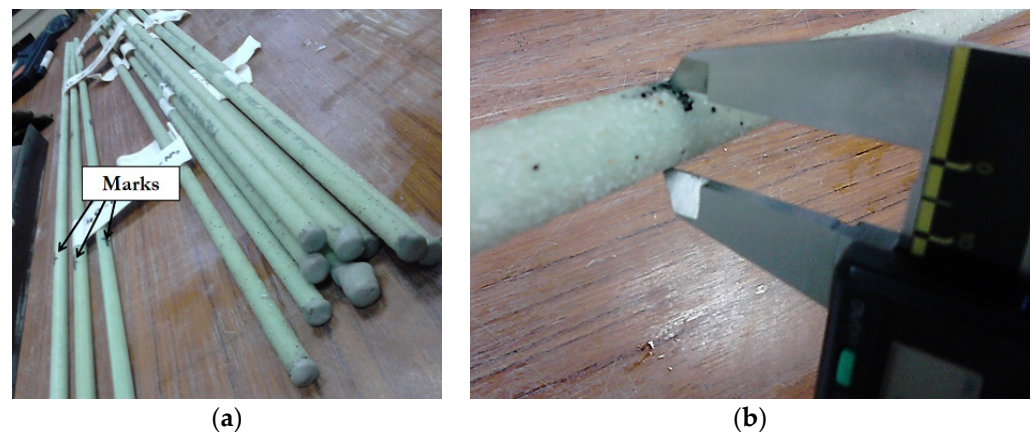
Figure 5. (a) Marked GFRP rebars used for monitoring the changes in mass/diameter over aging and (b) illustration of the diameter measurement on a sand-coated rebar (as a reminder, the nominal diameter of all rebars was 12.7 mm).

In addition, diameter measurements were performed with a caliper of precision 0.01 mm at fixed locations of the bars identified by marks (reticles) drawn at the surface (one mark per sand-coated rebar and 3 marks per smooth rebar). Such marked rebars are shown in Figure 5a, and an illustration of the diameter measurement on a sand-coated rebar is presented in Figure 5b.

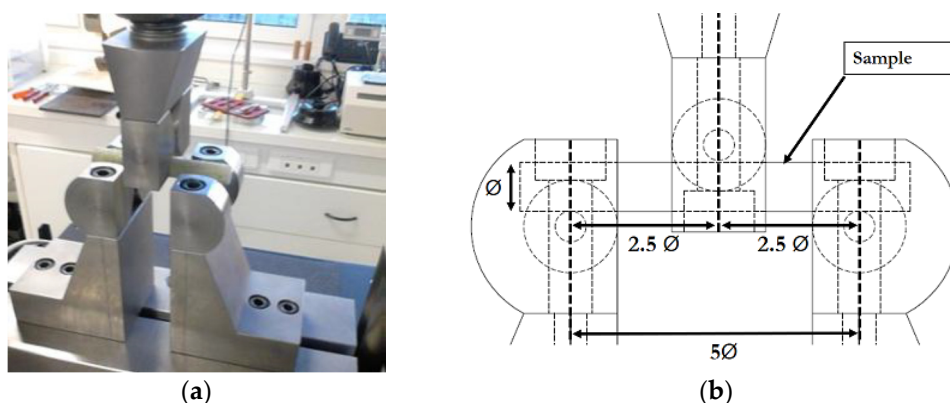
Figure 6. Short-beam test: (a) picture and (b) detailed scheme of the test configuration (dimensions are in mm).

Tests were carried out on 100 mm-long rebar samples. Three identical samples were tested for each aging condition and aging time. To perform these tests, a specific frame (Figure 6) was manufactured at the laboratory and installed on a universal testing machine of capacity 50 kN, model 5969 from Instron (Norwood, MA, USA). The specificity of this frame relies on the geometric shape of the supports, which is designed to ensure quasi-punctual contact and avoid any slip of the circular cross-section of the sample. The distance between the two lower supports was set to 5 times the rebar diameter \varnothing (Figure 6b). The test was controlled by the displacement of the upper support at a rate of 1 mm/min . The apparent interlaminar shear strength (ILSS) of the tested rebar was deduced from the ultimate load F by the relation $\text{ILSS} = 0.849 F / \varnothing^2$ [42].

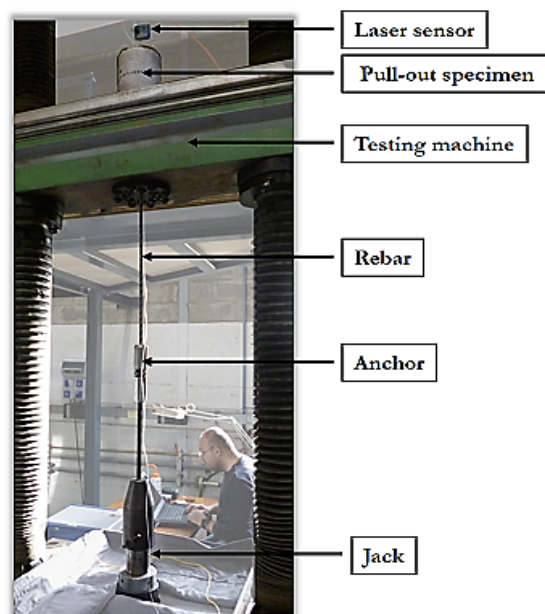
Figure 7. Picture of the pull-out test setup.

The specimens dedicated to bond characterizations were tested by the pull-out method according to the ACI 440.3R-04 guidelines [38], using a 350 kN Losen testing machine. The test setup is shown in Figure 7. Specimens were installed on the drilled horizontal crosshead beam of the machine, with the rebar passing through the beam hole. The rebar is loaded using a jack, via a wedge-type anchor. The loading is controlled by the displacement of the jack at a speed of 1.2 mm/min .

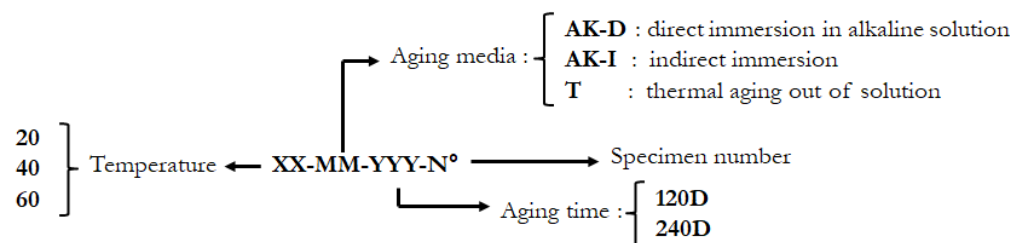
Figure 8. Nomenclature of the different aging protocols.

The 130 specimens from this study are referenced in Table 2. This list includes rebar specimens dedicated to the monitoring of the mass/diameter, which are identified by the extension –MASS-S for sand-coated rebars or –MASS-NS for non-coated rebars (smooth finish). The nomenclature of the different aging conditions is explained in Figure 8.

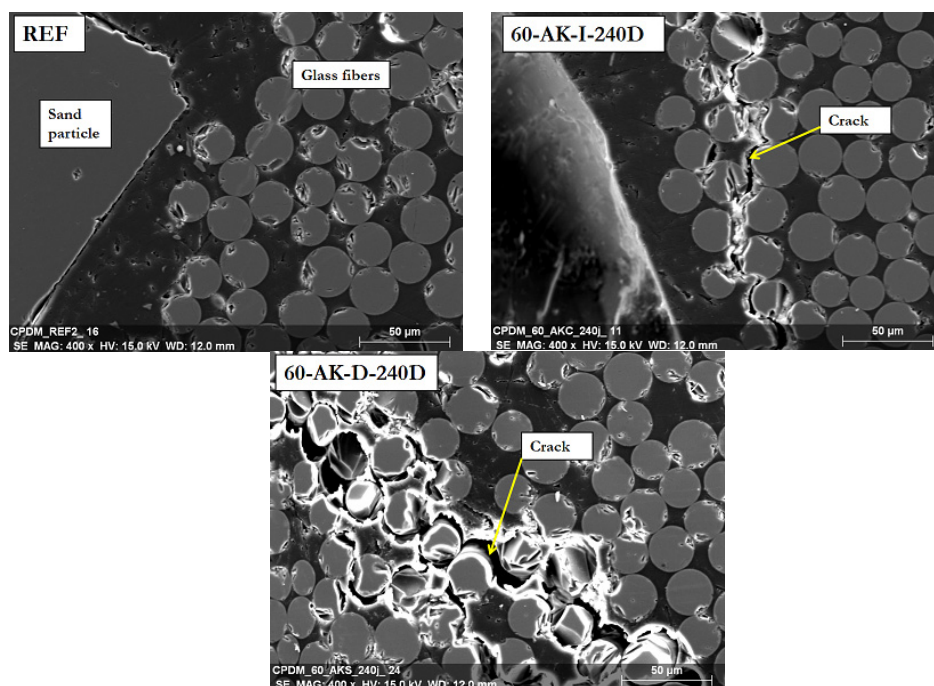
Figure 9. SEM images of the cross section of reference and aged GFRP rebars, at locations close to the external sand coating layer.

Figure 9 displays typical SEM images showing the periphery of the cross-sections of GFRP rebars after 240 days at 60 °C in AK-D and AK-I conditions. The picture of a reference rebar is also provided for comparison. One can observe many cracks on the 60-AK-D-240D sample but only exclusively near the external sand coating layer and not in the central part of the bar cross-section. Some cracks are also detected on the 60-AK-I-240D samples but to a much lower extent. Since the rebars have not been mechanically stressed during or after aging, these cracks are therefore either directly related to aging-induced degradation or due to the polishing process on samples used for SEM observation. In both cases, these cracks reveal an embrittlement of the fibers and the fiber/matrix interface induced by aging at the outermost region of the rebars, since an identical surface preparation did not

damage the reference samples. Such embrittlement process is more severe in the case of direct immersion in the alkaline solution than for the indirect aging condition.

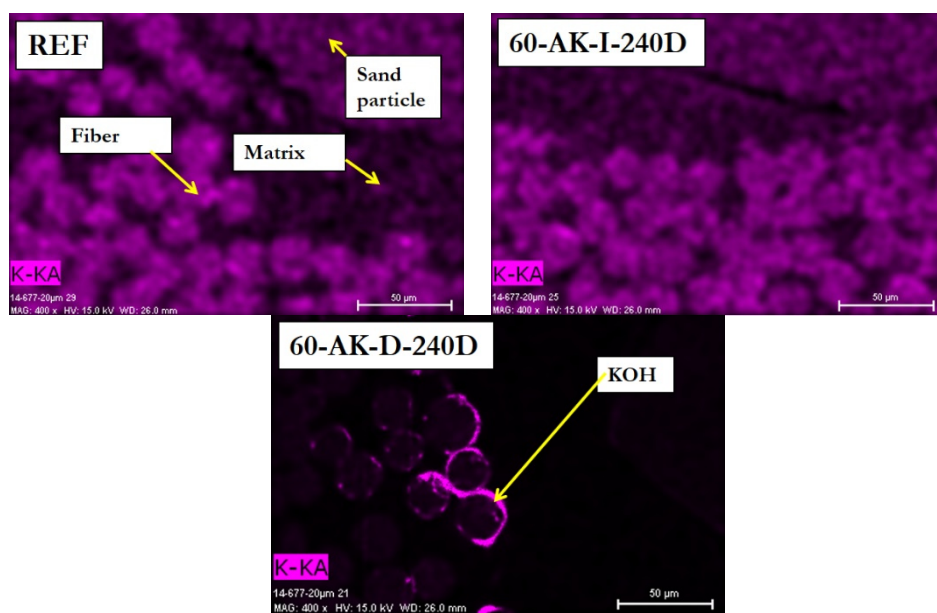
Figure 10. EDX mapping of K over cross-sections of the reference and aged GFRP rebars, at locations close to the external sand coating layer.

Complementary EDX analyses were carried out at the surface of the same polished samples, in order to monitor the possible migration of alkalis from the aging solution to the inside of the rebars. Figure 10 displays the typical mappings of the spatial distribution of potassium element (K) over the analyzed cross-sections. This element is a good marker of the alkaline solution, which is mainly composed of potassium hydroxide (KOH).

For the 60-AK-D-240D sample, the concentration of K can be observed at fiber/matrix interfaces close to the external coating of the rebar. In the reference sample and in the 60-AK-I-240D rebar, the distribution of K is much more diffuse and probably relates to some potassium initially present in the composition of the materials (especially in the glass fibers). This result suggests that the substantial diffusion of alkalis may occur within GFRP rebars subjected to direct immersion, but it remains restricted to the outermost layer of the bar.

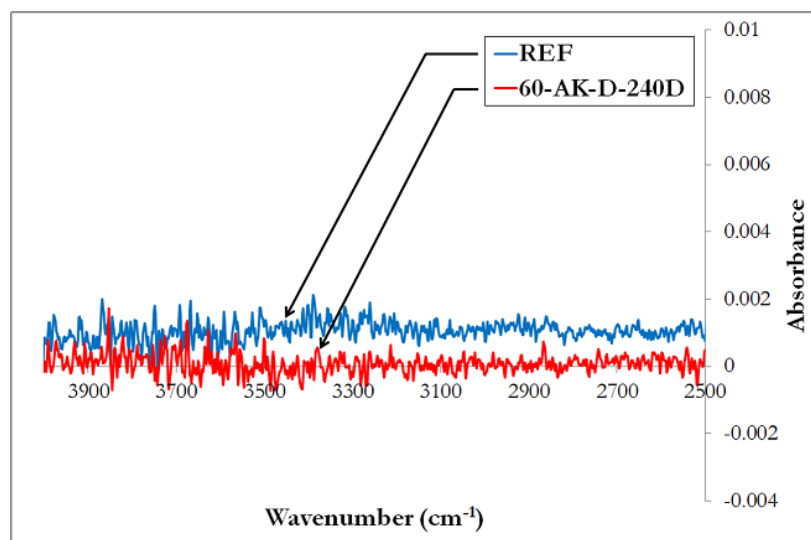
Figure 11. FTIR spectra in the region of 2500–4000 cm^{-1} from a reference sample (REF) and from a sample aged in the alkaline solution at 60 °C for 240 days (60-AK-D-240D).

Figure 11 displays the typical FTIR spectra recorded for unaged reference samples and for samples aged by direct immersion in the alkaline solution at 60 °C for 240 days (60-AK-D-240D). On these spectra, the region between 3300 and 3600 cm^{-1} is of great interest as it contains the vibration bands of hydroxyl groups (OH) [11]. In this region, the comparison of spectra from the reference and aged samples does not reveal any significant change induced by alkaline aging. In particular, no additional hydroxyl groups is detected, hence there is no evidence of hydrolytic degradation of the polymer matrix. This result is consistent with previous DSC analyses and confirms that the vinyl ester matrix used in these GFRP rebars exhibits good resistance to alkaline environments.

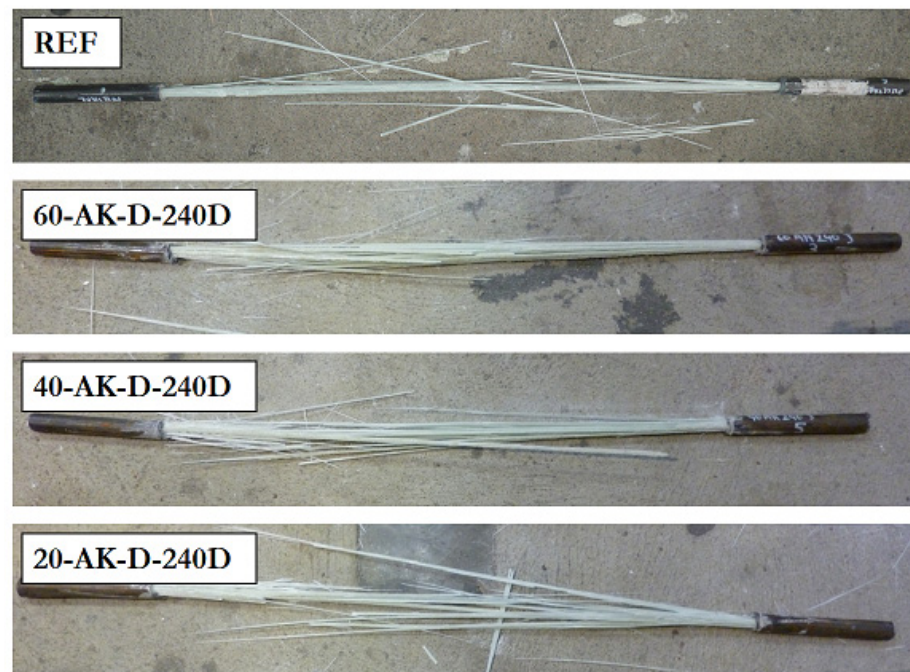
Figure 12. Typical failure modes after tensile tests on aged GFRP rebars and reference samples.

All GFRP rebars showed brittle failure during a tensile test. Figure 12 presents the typical tensile failure modes obtained in the case of GFRP rebars exposed to direct immersion in the alkaline solution for 240 days (AK-D-240D) at different temperatures and for the unaged reference bar as well. Visual observation does not reveal any change in failure mode resulting from aging.

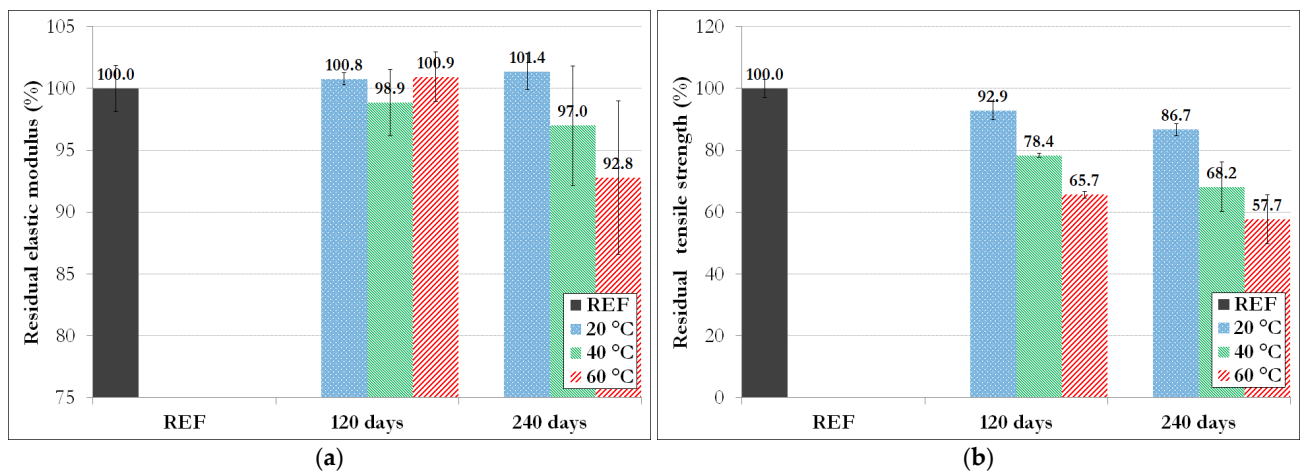
Figure 13. Residual tensile properties of GFRP rebars subjected to direct immersion in the alkaline: (a) elastic modulus and (b) tensile strength.

The elastic modulus and tensile strength determined for the reference specimens and the aged GFRP rebars are reported in Table 6 and summarized in the graphs of Figure 13.

Experimental results reveal only small variations in the elastic modulus after aging (with a maximum loss of 7% after 240 days at 60 °C). Conversely, a substantial decrease in the tensile strength is observed after aging. In particular, one can notice (i) a gradual decrease in resistance over time and (ii), at a given time, a drop of resistance when raising the aging temperature (strength loss up to 42% after 240 days at 60 °C).

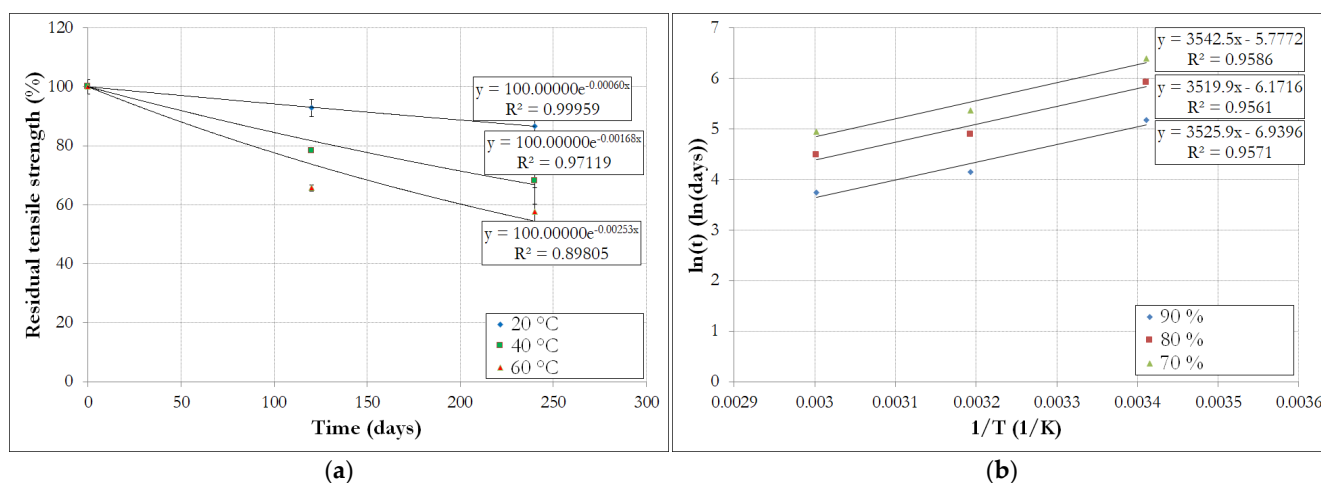
Figure 14. (a) Residual tensile strengths of GRP bars as a function of direct aging time and (b) Arrhenius lines for different retention rates of the tensile strength.

From experimental data, it is possible to trace the evolution of the residual tensile strength of rebars (in %) as a function of time for each aging temperature (see Figure 14). Although only three values of residual strength (0 days, 120 days and 240 days) are available for each temperature in our present study, exponential regressions were performed using Equation (5) on these data, in order to determine the three τ coefficients for the three test temperatures considered in this study (20 °C, 40 °C and 60 °C). The results of these identifications are displayed in Figure 14a. In order to increase the robustness of the data fitting, it would be necessary to perform other measurements at additional aging times. Unfortunately, this was not possible in the present study due to time constraints.

Figure 14b presents, from the identified curves $R(t)$ at different temperatures, the natural logarithm of the reaction time necessary to reach residual tensile strength values

It is worth noting that the three Arrhenius lines displayed on Figure 14b are almost parallel, which supports the initial hypothesis of a single degradation reaction mechanism or at least of a dominant mechanism.

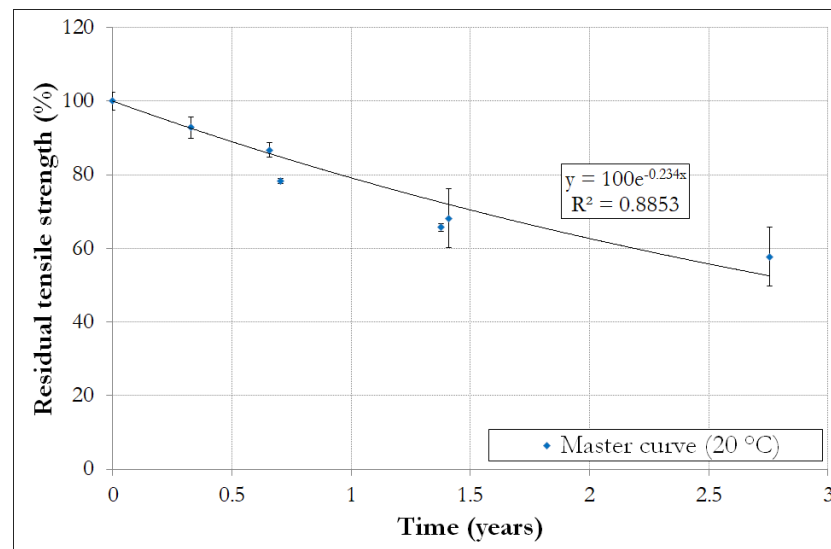
Figure 15. Master curve (residual tensile strength versus aging time) at a reference temperature of 20 °C.

Finally, knowledge of the temperature shift factors enable the construction of the master curve describing the long-term evolution of the residual tensile strength at the reference temperature of 20 °C, as shown in Figure 15.

This master curve predicts a large degradation of the tensile strength of about 40% after 2.5 years of exposure. Similar predictions were reported by [3] on glass/vinylester FRP rebars aged in an alkaline solution. However, it must be recalled that this direct aging condition is very harsh and provides extremely pessimistic results.

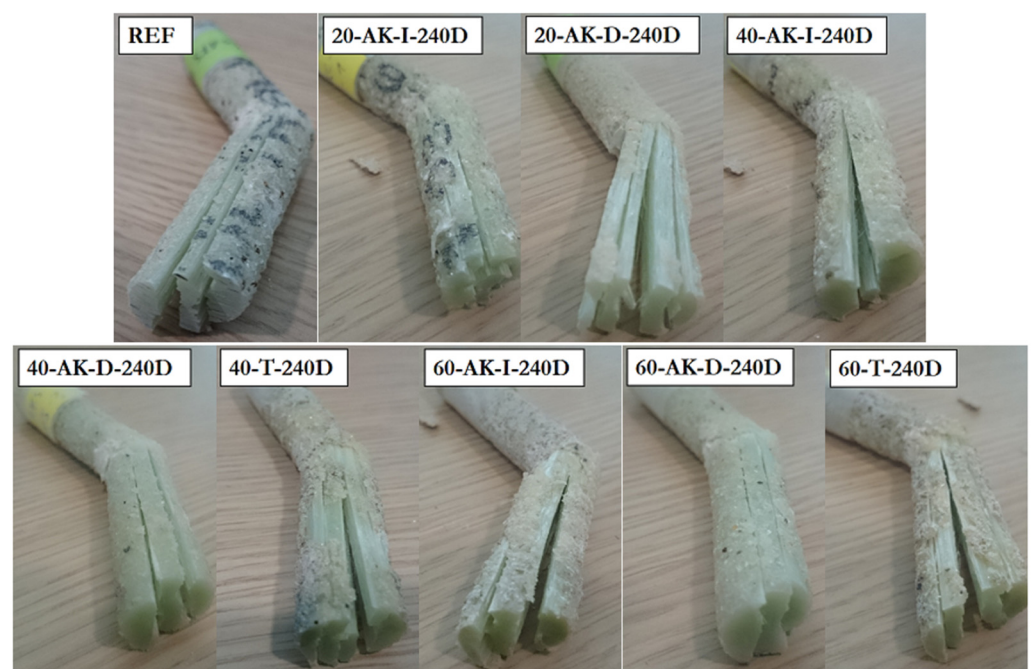
Figure 16. Failure modes observed after short-beam tests on reference and aged GFRP rebars.

Short-beam tests were performed on reference samples and on GFRP rebars exposed for 240 days to direct (AK-D) and indirect (AK-I) immersion in the alkaline solution at different temperatures and to pure thermal aging (T) as well. Figure 16 shows that the failure mode was identical for all specimens and was initiated by delamination at the neutral axis of the GFRP bars.

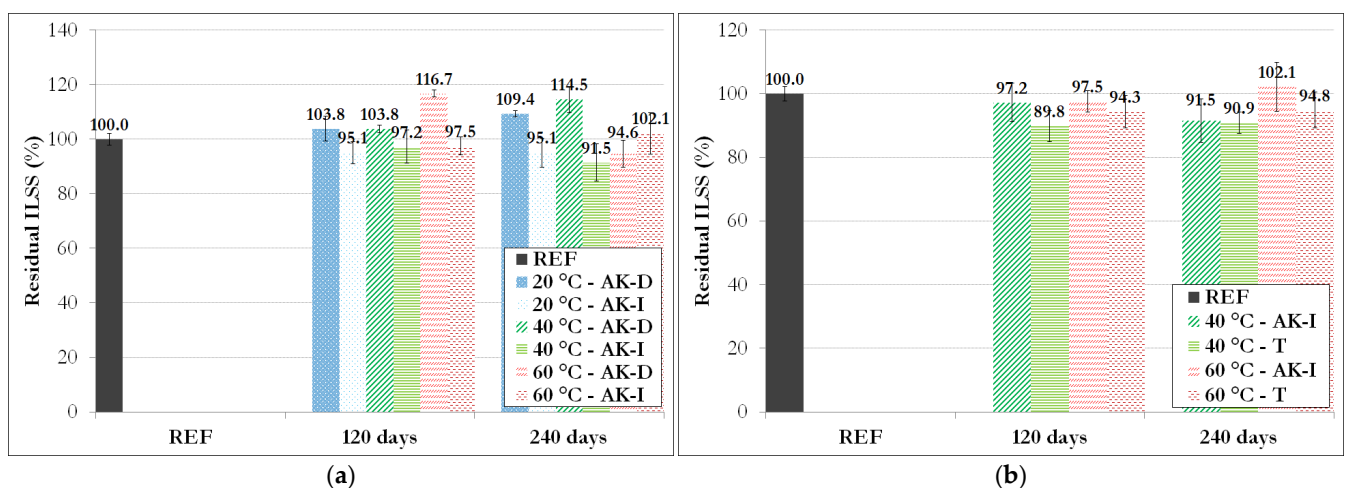
Figure 17. Residual interlaminar shear strength of GFRP rebars after aging in different environments: (a) AK-D versus AK-I and (b) AK-I versus T.

ILSS values determined on the various specimens are referenced in Table 8 and summarized in Figure 17.

At first, the results show that accelerated aging does not induce a significant decrease in the ILSS of GFRP rebars, whatever the type of accelerated environment. With regard to rebars subjected to direct immersion in the alkaline solution (AK-D), it is even possible to note slight increases in ILSS (except for the 60-AK-D-240D samples). The trend observed here is therefore very different from that previously described for the tensile strength. Note that the failure mechanisms of these two tests are very different, because the ILSS value relates more to the properties of the matrix and fiber/matrix interface, while the longitudinal tensile strength is mainly governed by the tensile properties of glass fibers. The relative stability of the ILSS of aged bars would therefore confirm the good chemical resistance of the vinyl ester matrix that had already been demonstrated previously by DSC and FTIR analyses and also the good resistance of the fiber/matrix interface (at least in the core specimen, as SEM observations revealed some cracks in the outermost region).

In addition, for a given temperature and exposure time, rebars exposed to direct immersion (AK-D) exhibit slightly higher ILSS values compared to rebars exposed to indirect immersion (AK-I), and some values may even be greater than the initial ILSS (up to a 17% increase for 60-AK-D-120D rebars). Because this property (ILSS) related the chemical resistance of the matrix and the fiber/matrix interface, direct immersion in the alkaline solution does not therefore represent a particularly penalizing condition.

The results also highlight higher ILSS values for the rebars subjected to the AK-I environment compared to pure thermal aging out of solution (T). This phenomenon could result from a possible confinement effect of the fibers in the AK-I condition, driven by the swelling of the polymer matrix due to the absorption of some interstitial solution. Such a confinement effect would be beneficial to the fiber/matrix load transfer and hence to the ILSS. Finally, the overall higher ILSS values obtained for rebars aged in direct immersion (AK-D) compared to those aged in the two other environments could result from a greater diffusion of the solution in these AK-D samples, hence a larger swelling phenomenon of the polymer matrix and a stronger confinement effect of the fibers. However, this hypothesis

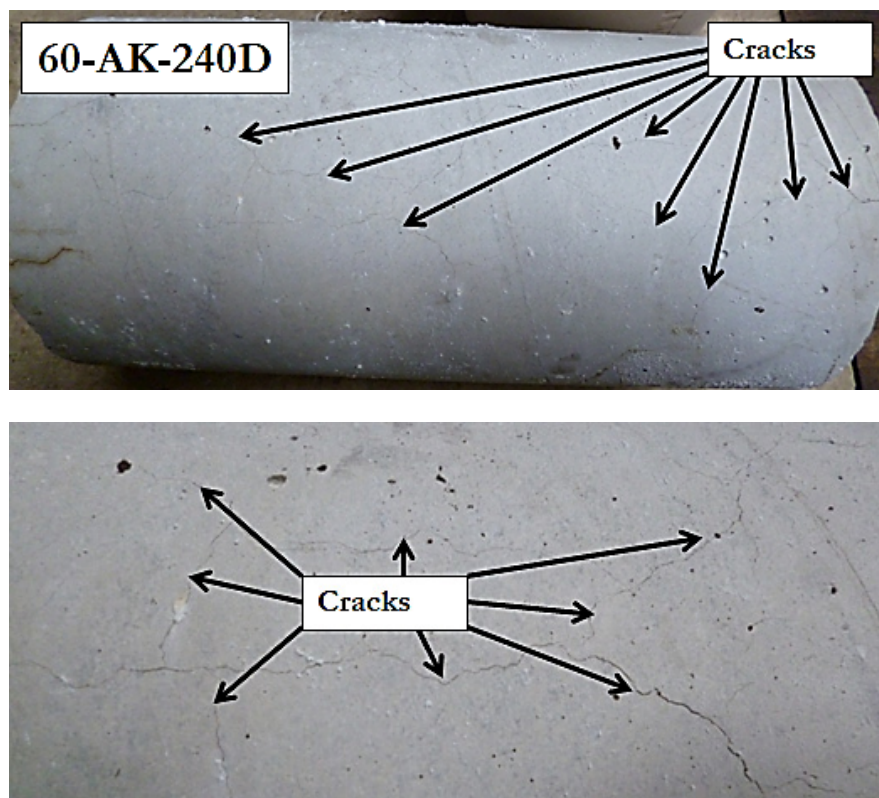
Figure 18. Typical surface aspect of 60-AK-240D concrete cylinders.

Results of the compression tests are reported in Table 9 for both aged specimens and reference samples. Overall, one can notice an increase in the compressive strength after aging, which accounts for a notable post-curing effect related to the progress of cement hydration reactions with time. As an exception, the 60-AK-240D specimens were the only one that exhibited a loss in compressive strength, which nevertheless remained limited (about 10%). This phenomenon was correlated to the development of multidirectional cracks regularly distributed at the surface of the cylinders, as illustrated in Figure 18. These cracks suggest a possible internal swelling reaction of the concrete, but further investigations would be necessary to identify more precisely the origin of this phenomenon.

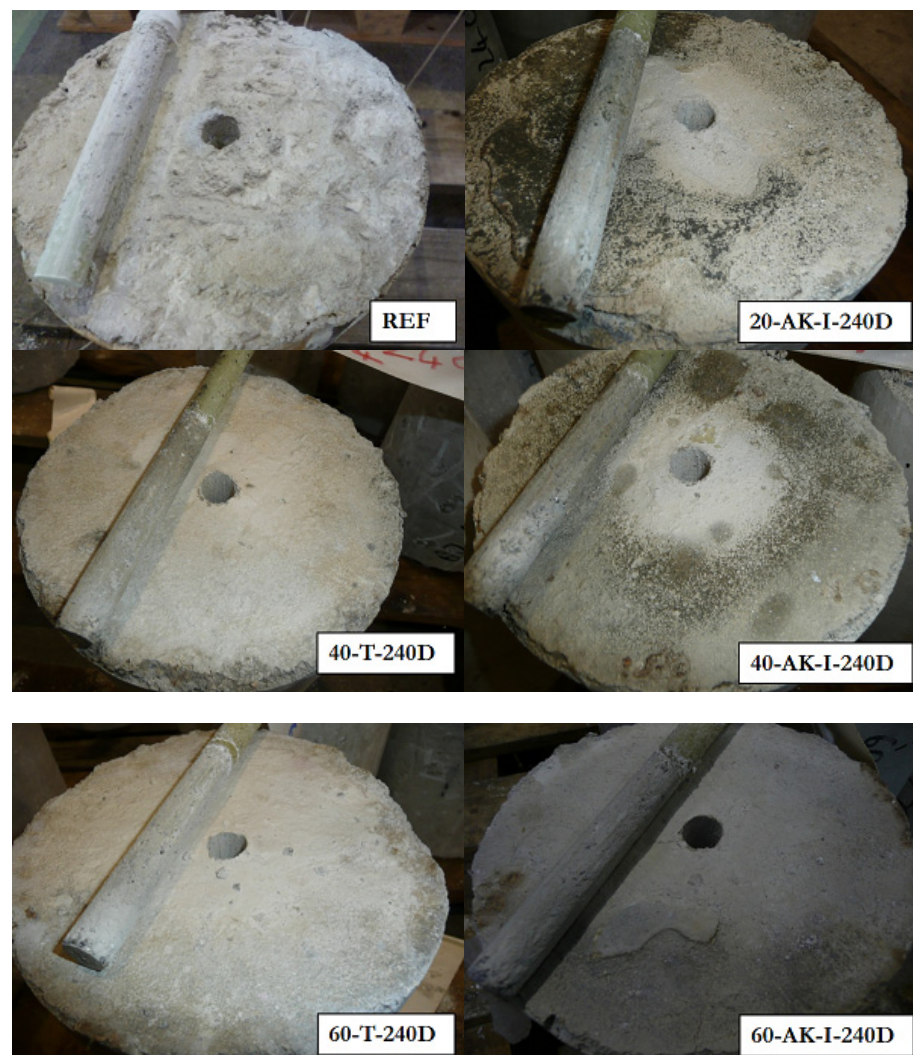
**Figure 19.** Typical failure modes observed after pull-out tests on reference and aged specimens.

Pull-out tests were then carried out on specimens aged for 240 days in the different environments, and the typical failure modes are illustrated in Figure 19. Overall, there is very little difference between the failure modes before and after aging, regardless of the type of aging environment. Failure always occurs at the interface between concrete and the sand coating of the GFRP rebar.

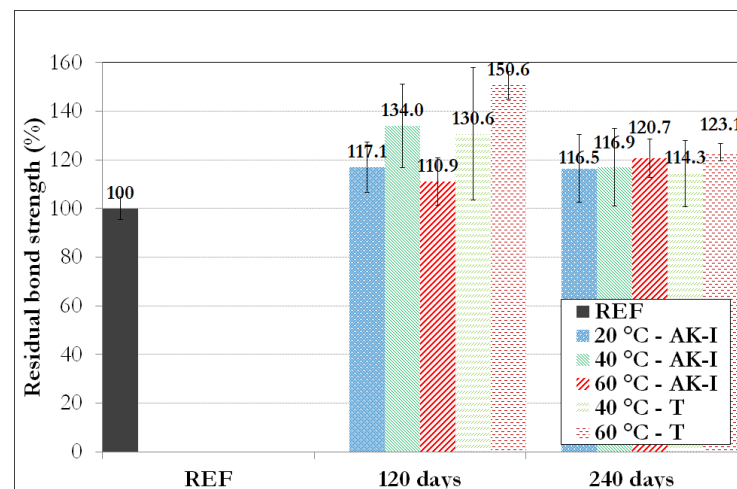
**Figure 20.** Residual bond strengths of pull-out specimens exposed to the different aging environments for different periods.

Bond strength values determined on reference and aged pull-out specimens are reported in Table 10 and summarized in Figure 20.

Globally, an initial increase in bond strength is observed over the first 120 days of exposure, regardless of the type of aging environment, followed by a decreasing trend between 120 days and 240 days. The bond strength values at 240 days of exposure still remain higher than that of the reference specimens. Note that experimental dispersion was rather large in the case of aged samples, which made comparisons difficult.
